**DEPARTMENT OF TRANSPORTATION  
Federal Railroad Administration**

**FRA Emergency Order No. 24**

**Emergency Order Requiring Special Handling, Instruction and Testing of Railroad Operating Rules Pertaining to Hand-Operated Main Track Switches**

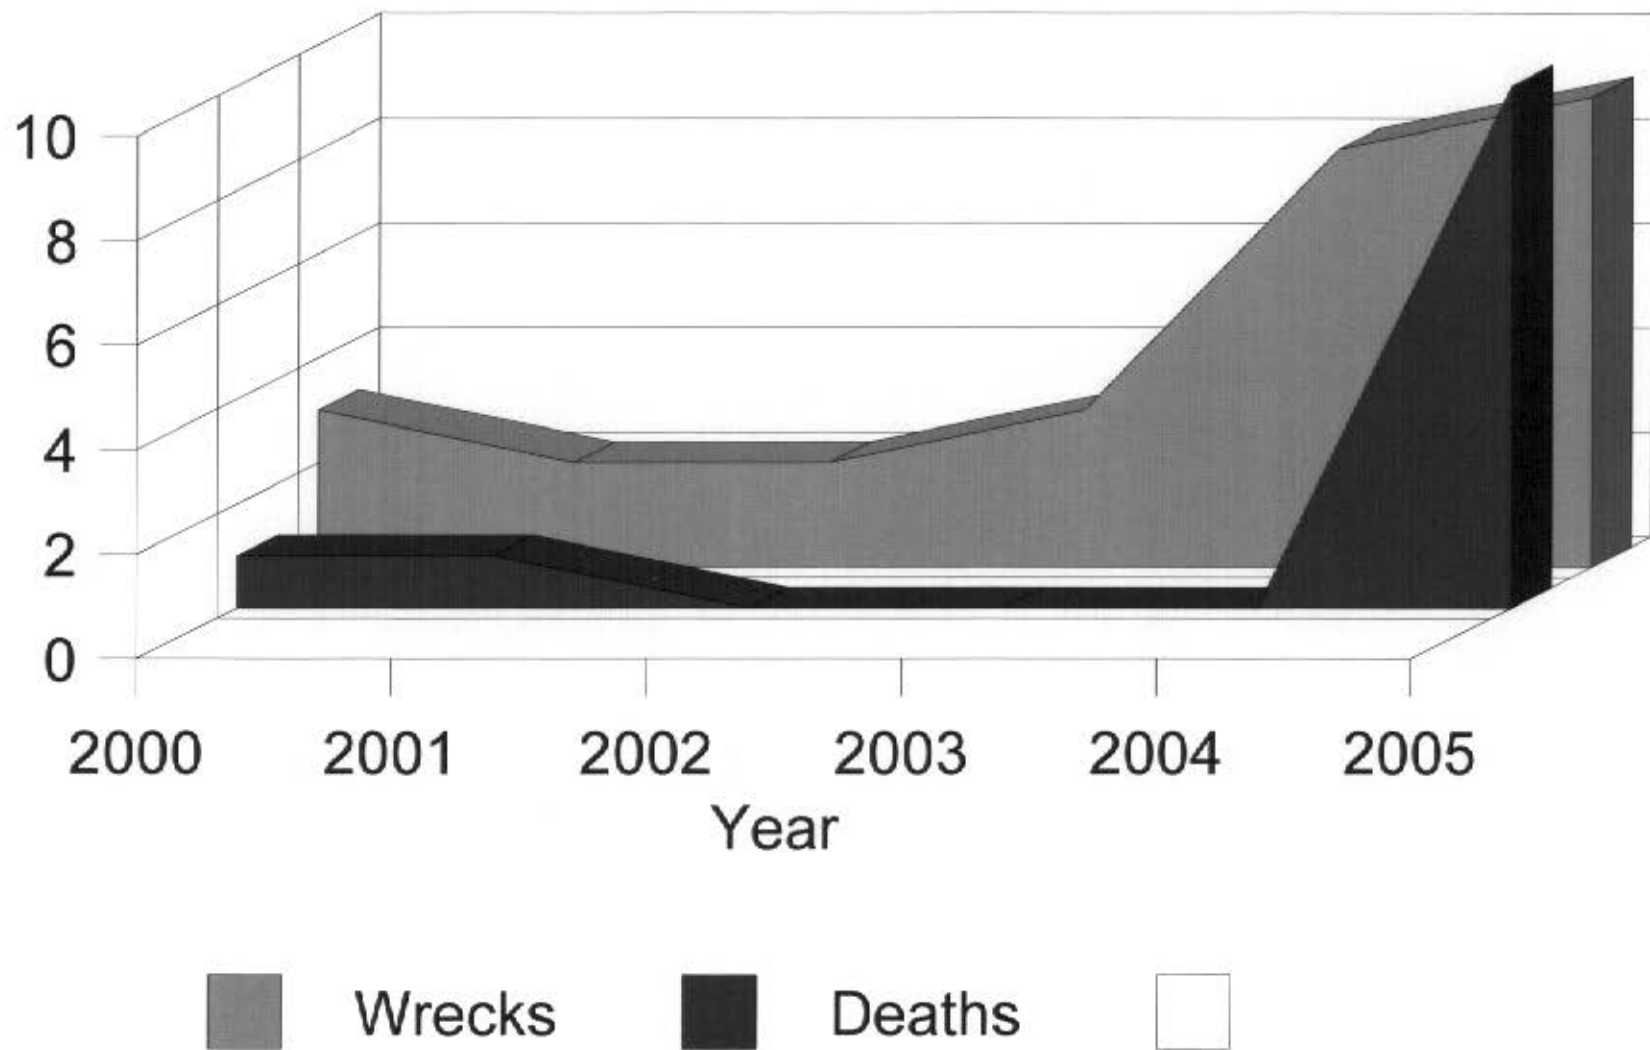
# Wrecks & Deaths

In comparison, in 2004 there was a sharp increase in the frequency and severity of collisions resulting from improperly lined main track switches as shown on the attached charts. In 2004, there were a total of eight accidents resulting in eight injuries to railroad employees. The increase in the number of accidents and injuries did not go unnoticed by the industry as some railroads amended their operating rules to address this issue.

**FINDING AND ORDER:** Collisions, deaths and injuries resulting from improperly lined main track switches began in 2004 to rise very sharply as shown on the attached charts. FRA's issuance of a Safety Advisory in early January 2005, recommending practices designed to prevent such events, led to a nearly six month respite. The sharply rising and accelerating trend of collisions, deaths and injuries resulting from improperly lined main track switches, which the Safety Advisory abated only temporarily, constitutes an emergency situation involving a hazard of death or personal injury which FRA must act to stop.

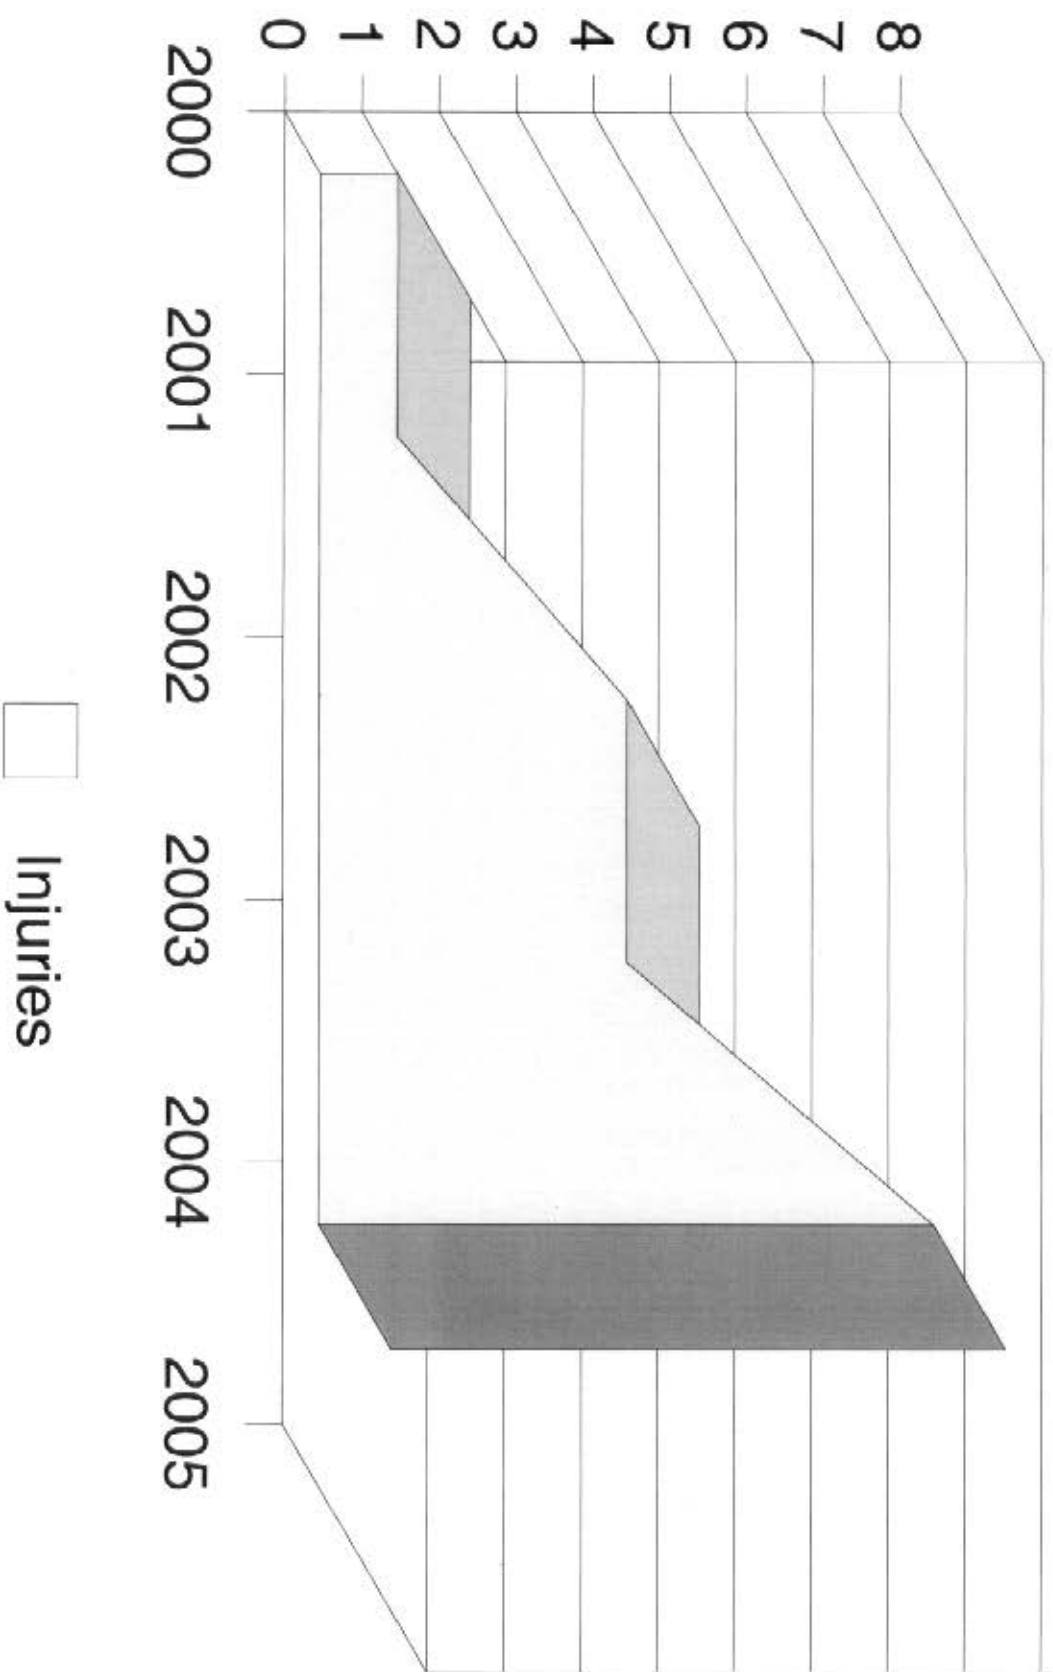
# Injuries 2000 Through 2004

During the years 2000 through 2003, railroads reported no more than three accidents per year that were caused by improperly lined hand-operated main track switches in non-signaled territory and one of the most serious of those wrecks was caused by vandalism. During that four year period, there were ten total injuries and two fatalities (all to railroad employees).

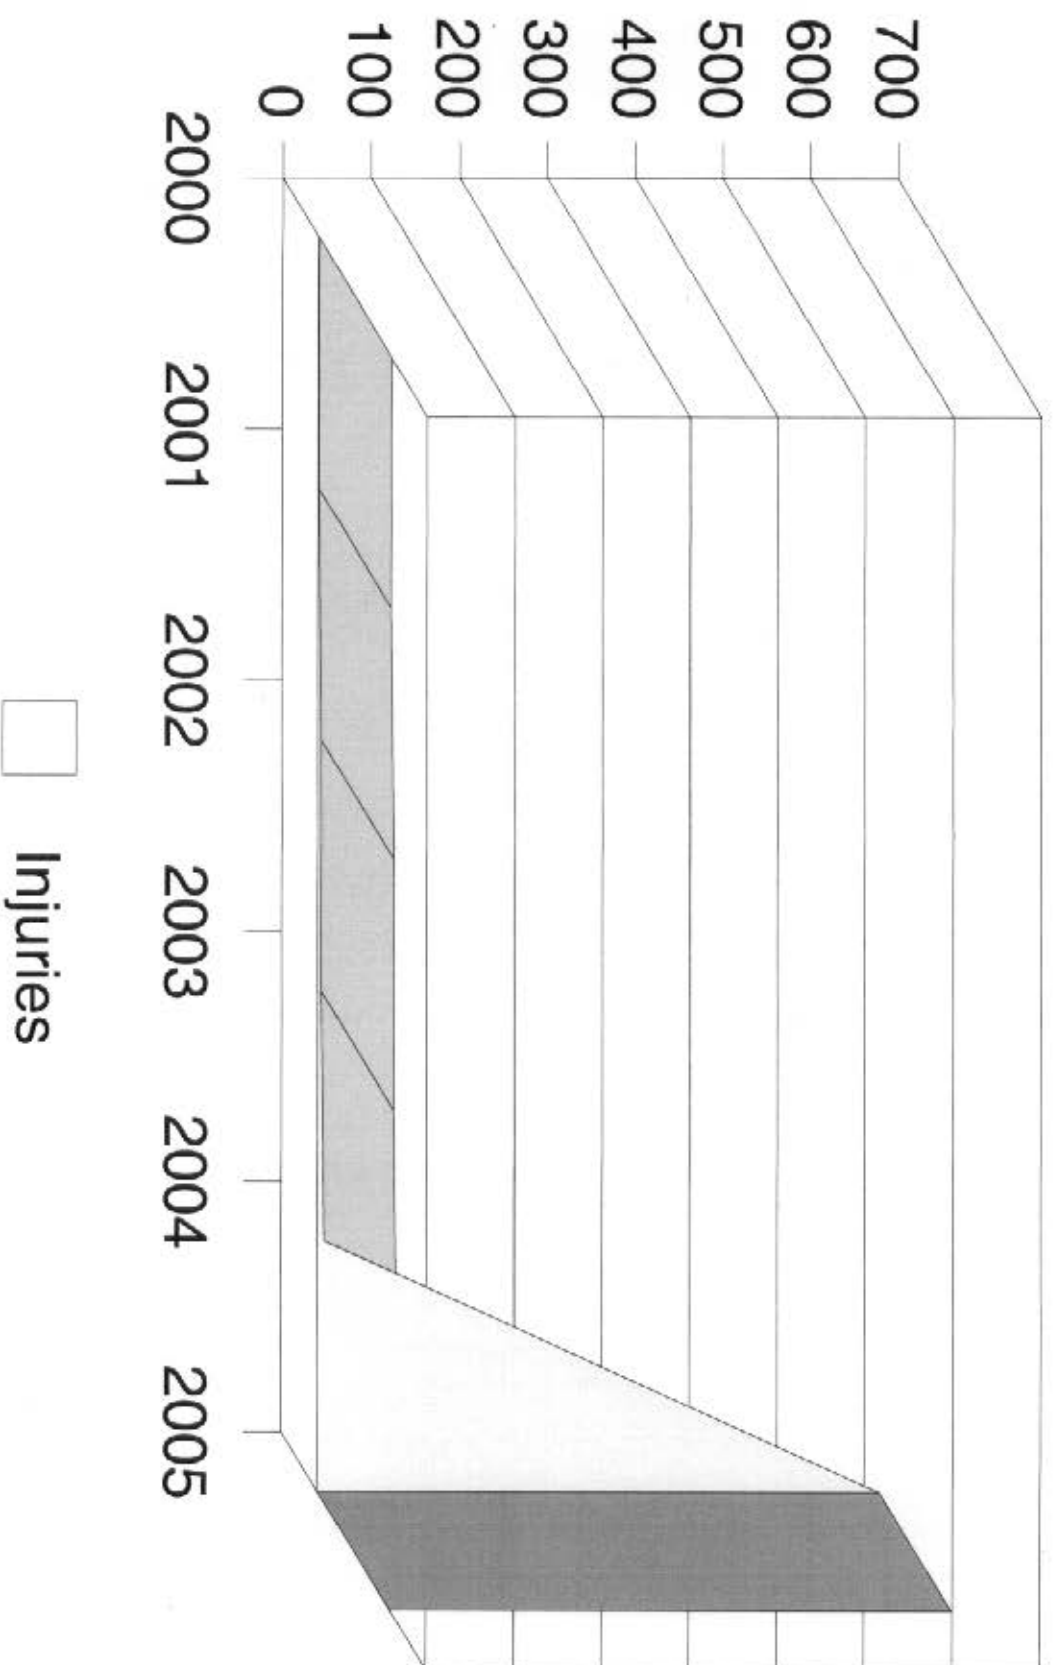
# Injuries 2000 Through 2005

Even considering the nearly six-month respite from January 12 through July 6, the Nation has experienced more accidents resulting from improperly lined hand-operated switches on main track in non-signaled territory than it experienced in any of the previous five years. To date in 2005, there were nine accidents resulting in 640 injuries and 10 fatalities. Given the cloud of chlorine that covered much of Graniteville, South Carolina, on January 6, 2005, as a result of one of these accidents, it is fortuitous that the death toll is not significantly higher; in addition, the same could be said for the Nickerson, Kansas and Shepherd, Texas accidents that occurred on August 19, 2005 and September 15, 2005 respectively as trains involved in those accidents were transporting tank cars containing hazardous materials. Any reasonable extrapolation of the current trends of wrecks, deaths, and injuries makes clear that more accidents of this type will occur in the absence of this EO, that many of those accidents will result in injuries or deaths, or both, that a significant percentage of those wrecks will involve trains carrying hazardous materials, and that each of those wrecks will pose a significant risk that a large amount of hazardous material will be released. Considering the severity of accidents related to improperly
