Report Issued: October 31, 1996

Report #: 413.62-96.34

Laboratory Test Report

SUBJECT: LEAK IN GAS LINE DFM-3, BETWEEN SANTA CRUZ AND DAVENPORT

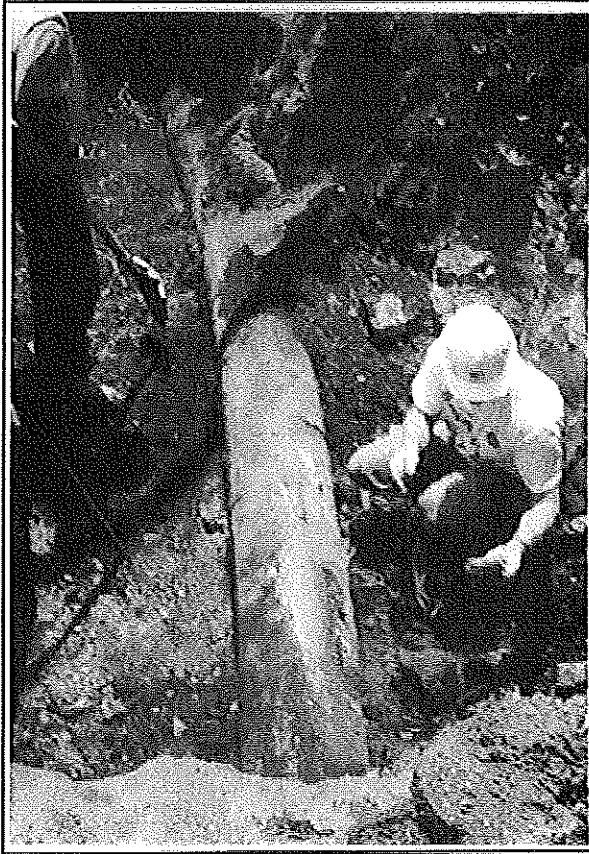
In June of 1996 a leak was discovered during a walk-down of the DFM-3 gas line, between Santa Cruz and Davenport (installation year 1957). The leak was located in a section of pipe where the line had been field bent to transit down an embankment (Figure 1). After excavation, the TES Welding and Inspection Services Unit performed visual, wall thickness and x-ray inspection of an eight foot section. No evidence of pitting or other wall loss due to corrosion was found. Wet fluorescent magnetic particle examination found a linear indication that ran longitudinally along the pipe and encompassed all six leak sites (Figures 2 and 3). It was recommended to remove the entire spool piece. The section that had been inspected was sent to the TES Metallurgy Lab for evaluation.

Figure 1 (left). DFM-3 pipe while being excavated. Note bend in pipe necessary to transit down embankment.

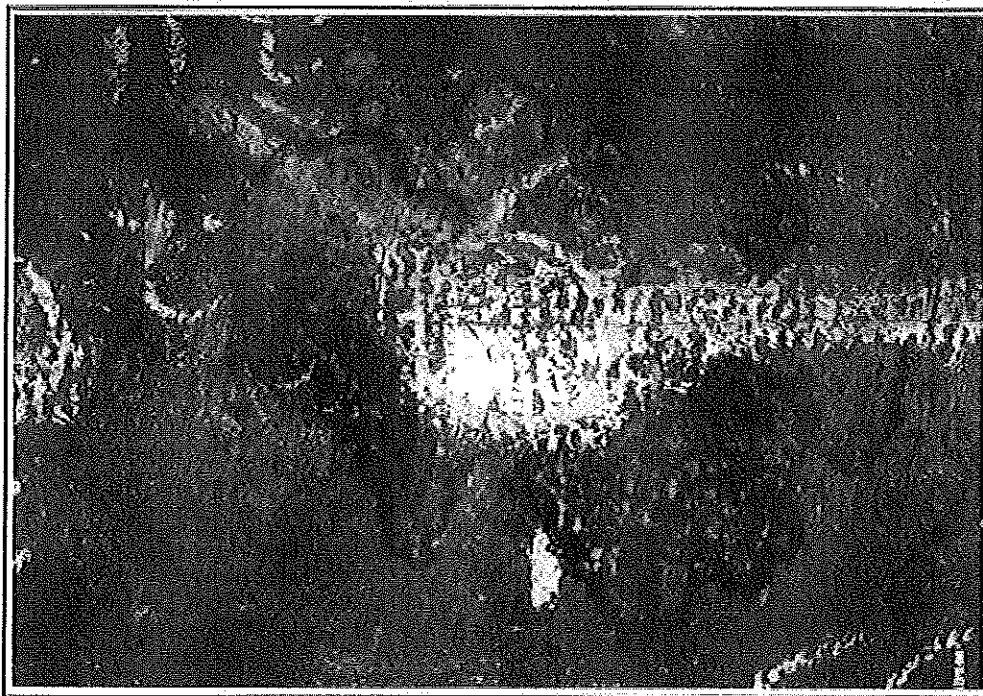
Figure 3. Close-up of linear indication. It runs left to right, about midway through the picture.

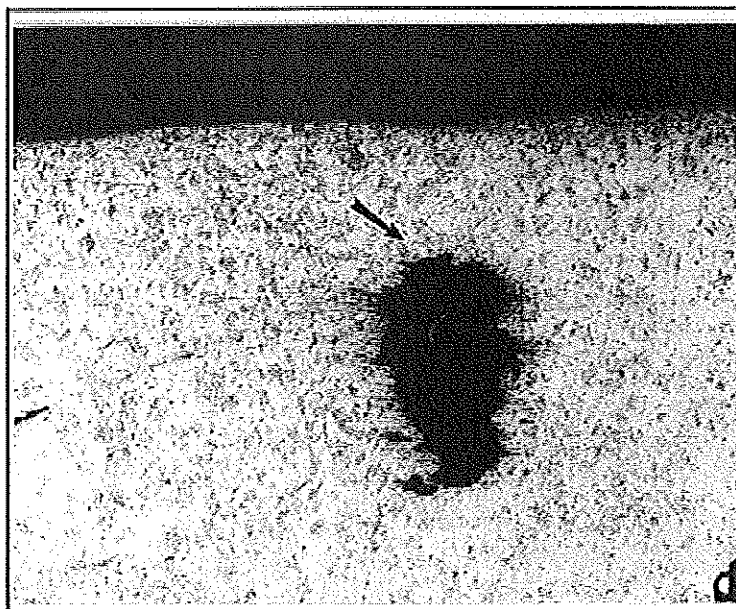
Figure 5. Another defect seen on the forge weld. this is most likely due to a slag inclusion. Index marks on the outside of the picture indicate location of forge weld (both pictures 15X, nital etch).
