# Continental Motors

## ENGINE FIELD INSPECTION REPORT RIGHT ENGINE

| ENGINE MODEL | IO470D (19) |
| CMI FILE NUMBER | 15-562 |

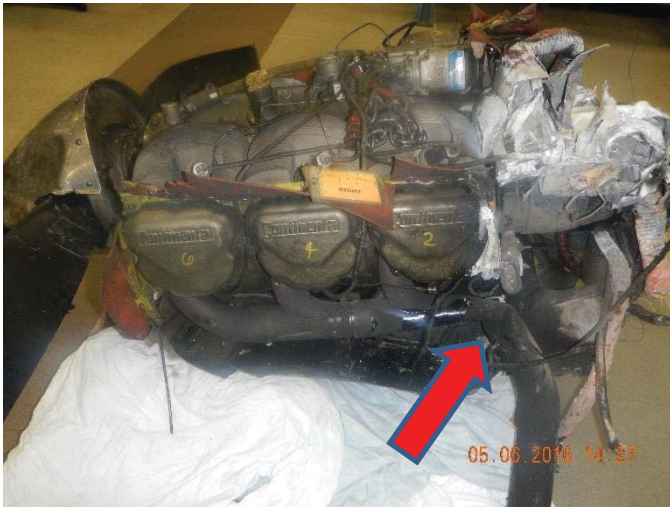
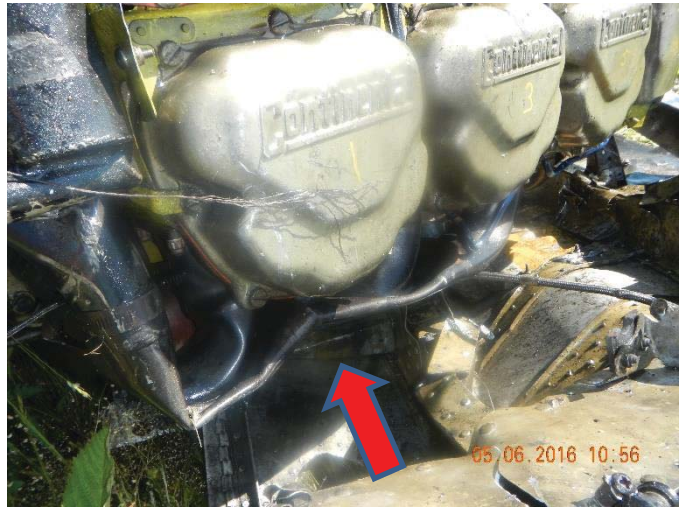
### EXHAUST SYSTEM

Condition: The exhaust collector was crushed and the rear collector pipe was twisted and bent due to impact forces. Red arrows point to damage.

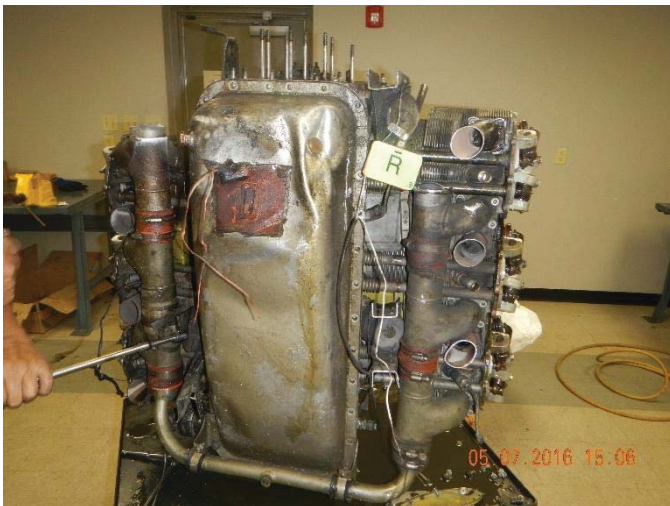
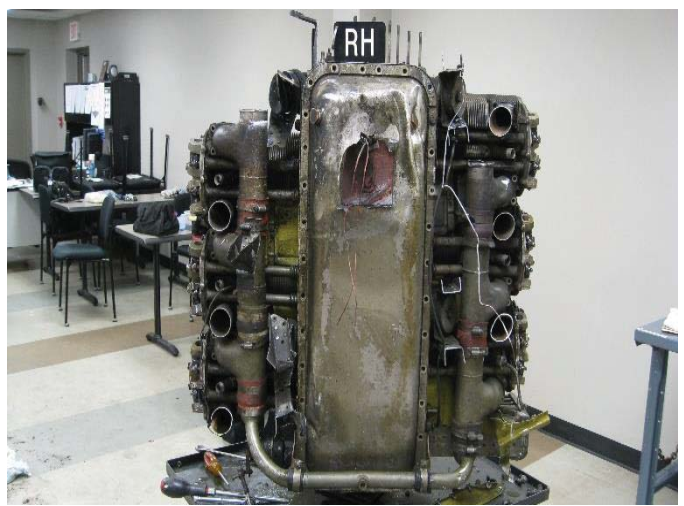
### INDUCTION SYSTEM

Condition: The induction system was intact with the exception of the rear wye pipes and connectors which separated. The front balance tube exhibited impact damage.

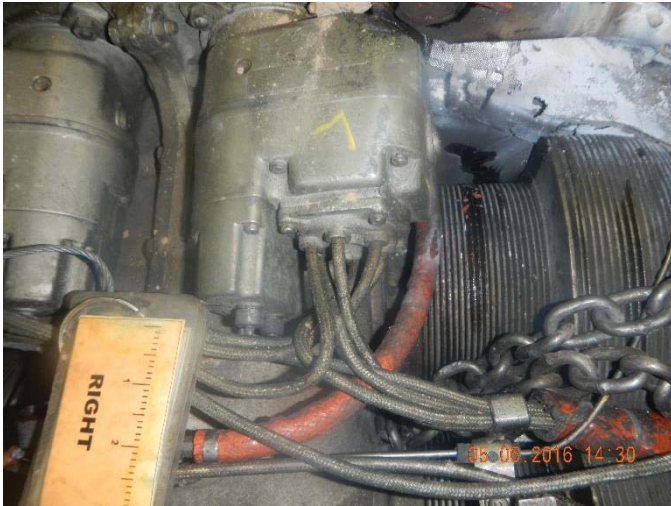
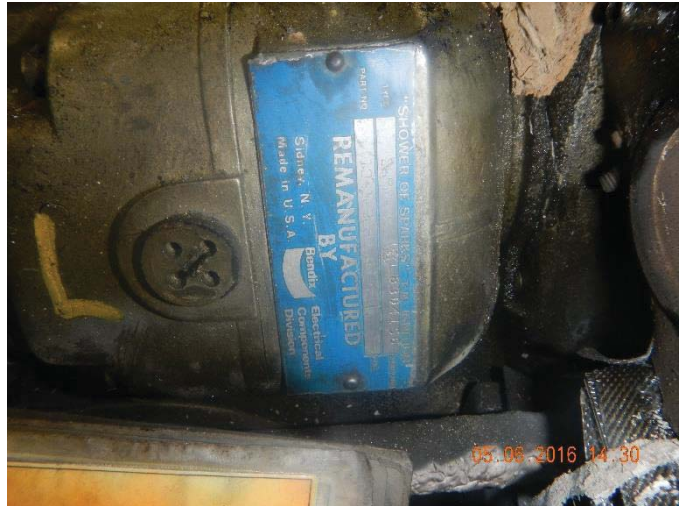
| <b>LEFT MAGNETO</b> | Manufacturer: Bendix | P/N: 10-163020-3 | S/N: 83004156 |

| Condition: | The left magneto remained attached and intact. The magneto was removed from the engine, bench tested and found to be functional | | |

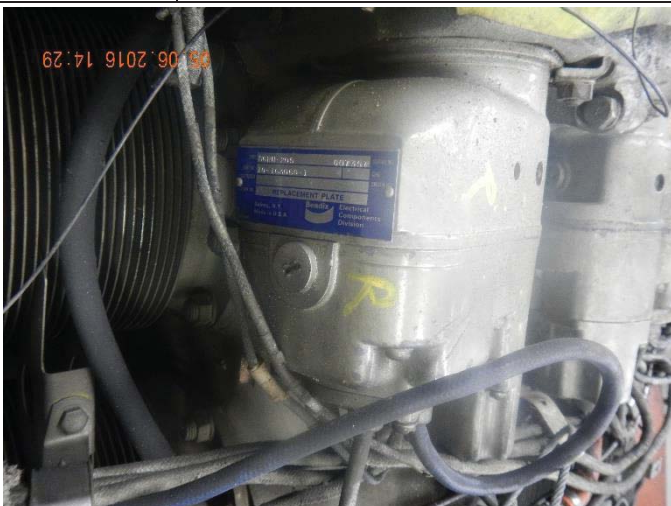
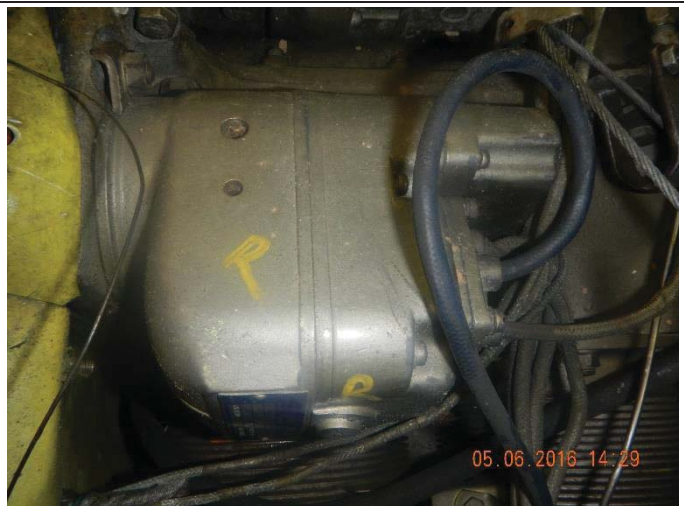
| <b>RIGHT MAGNETO</b> | Manufacturer: Bendix | P/N: 10-163060-1 | S/N: 007357 |

| Condition: | The right magneto remained attached and intact. The magneto was removed from the engine, bench tested and found to be functional with the exception of one ignition lead which was stretched and damaged. The damaged lead was removed and the magneto tested using a metal clip. The magneto produced spark between the metal clip and the magneto housing when rotated, | | |

| Condition: | The ignition harness appeared undamaged with the exception of the right magneto lead for cylinder # 2 which was stretched and shorted inside the harness cap. When the magneto was bench tested, the lead caused a misfire. When the lead was removed and a jumper wire was used, the magneto operated normally. | | |

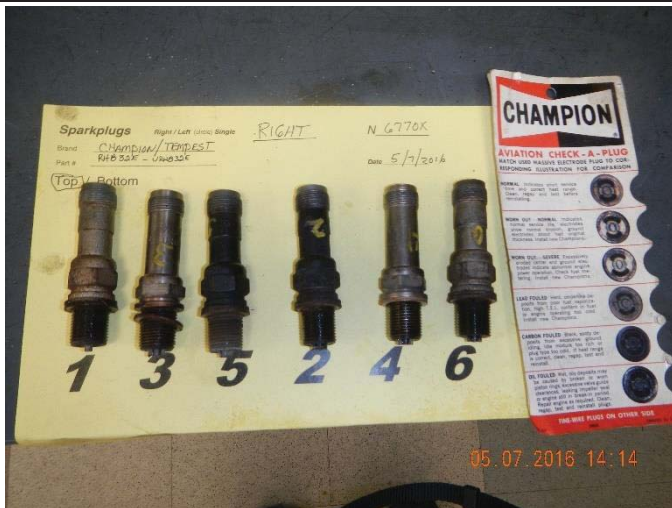
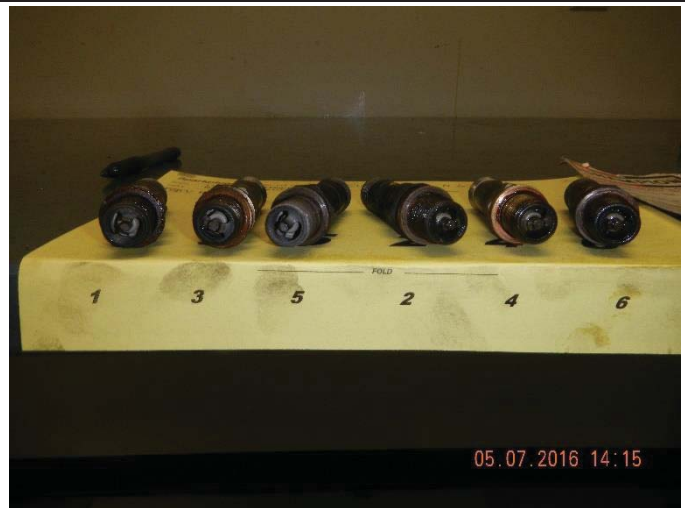
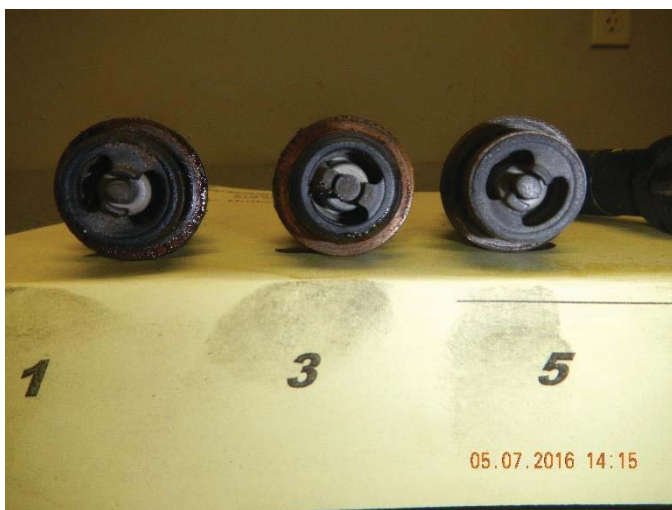
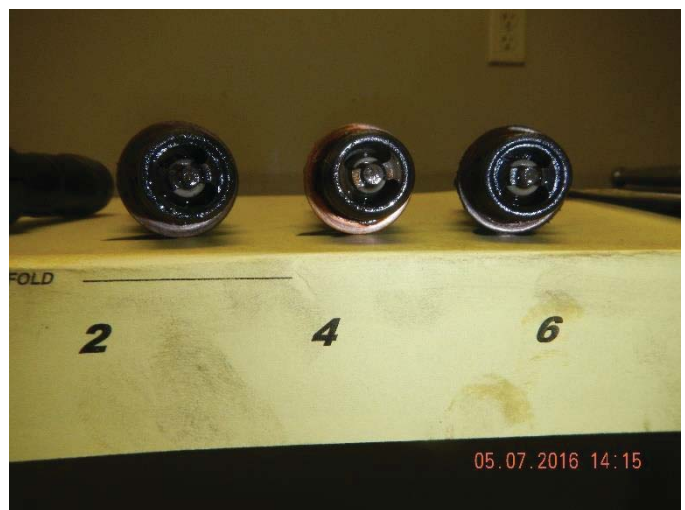
| <b>SPARK PLUGS</b> | Manufacturer: Mix of Champion and Tempest | P/N: RHB32E - Champion<br>P/N URHB32E - Tempest | |

| Condition: | Normal to worn out normal, according to a Champion Check A Plug chart. Sparkplugs removed from the top of cylinders 2,4&6 were oily which could be due to the engine being upside down at the accident site. | | |

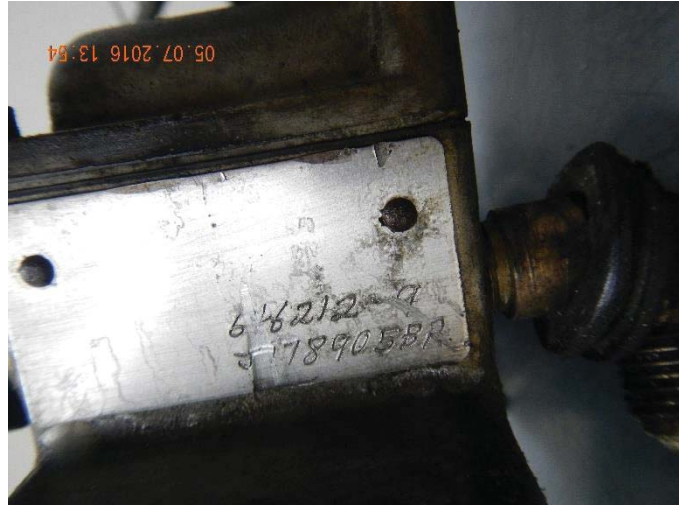
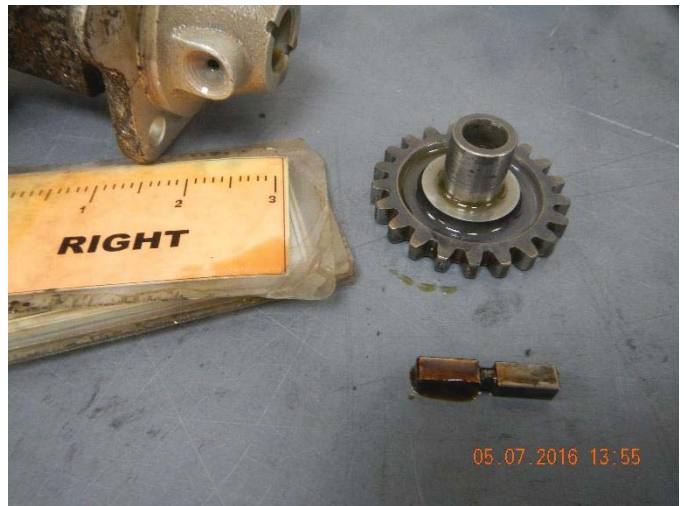
**FUEL PUMP**

The engine driven fuel pump exhibited thermal damage. Once removed, the fuel pump rotated smoothly when manually rotated. Fuel was present in the fuel hoses and the drive pin was intact

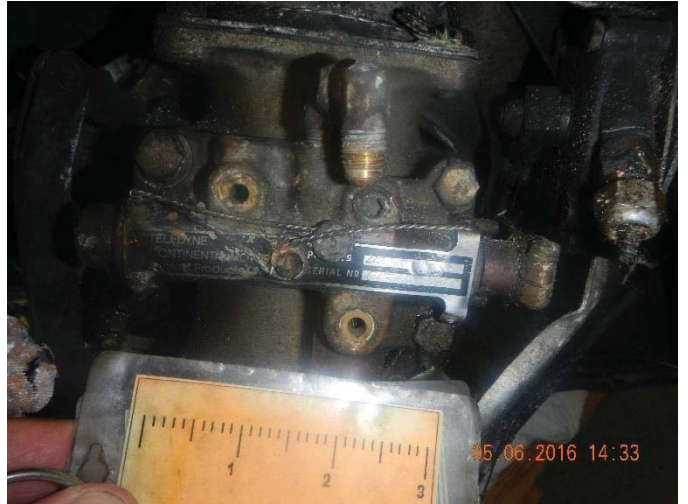
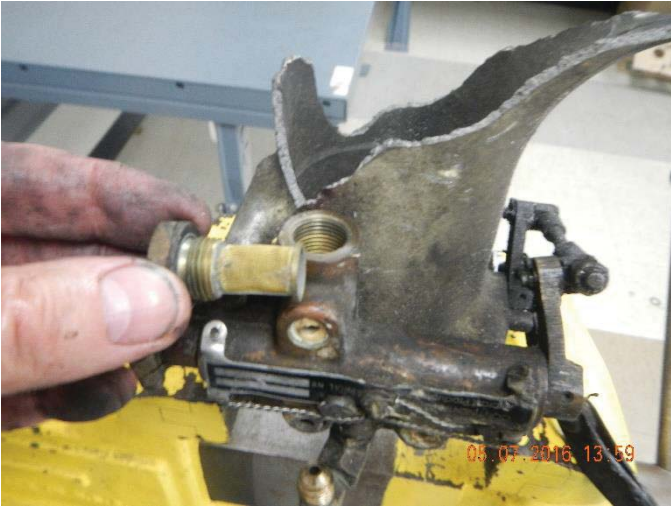
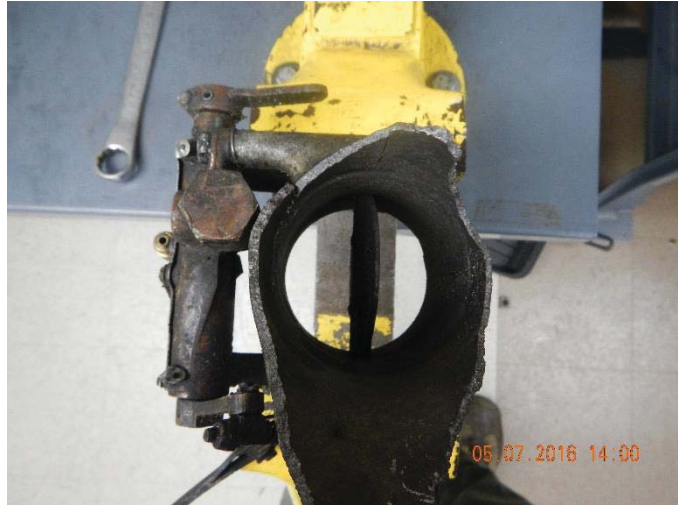
| <b>THROTTLE BODY METERING UNIT</b> | Manufacturer: TCM | P/N: 625219-2 | S/N: J178931AR |

| Condition: | The fuel hose nipples separated. The fuel screen was removed. No contaminate was present. The throttle plate was found in the wide open position but could be manually opened and closed by moving the throttle arm. | | |

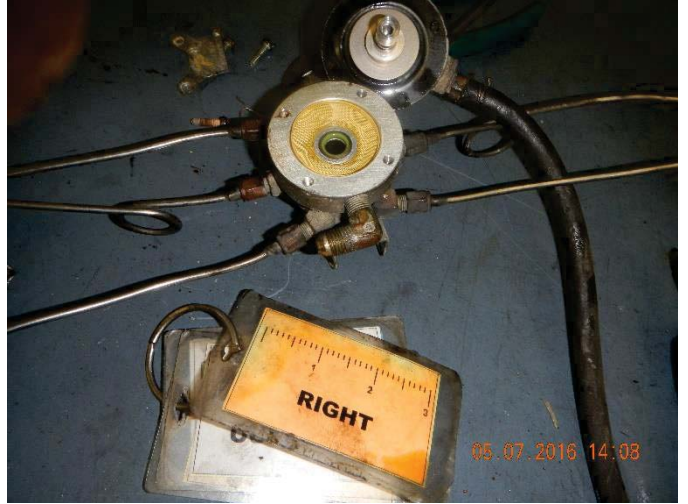
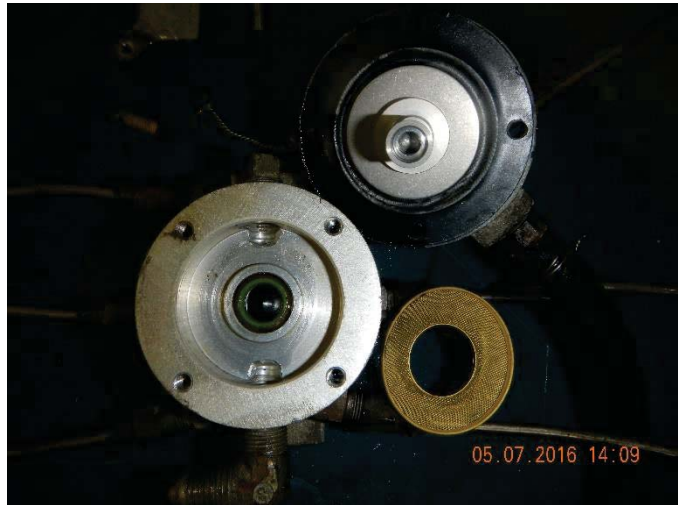
| <b>FUEL MANIFOLD VALVE</b> | Manufacturer: TCM | P/N: 631427422 | S/N: J175902CR |

Condition: The manifold contained uncontaminated fuel. All components were intact and the fuel screen was uncontaminated.

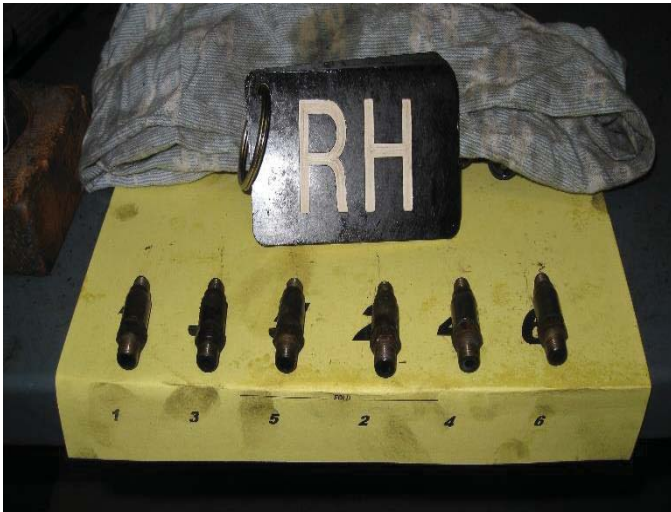
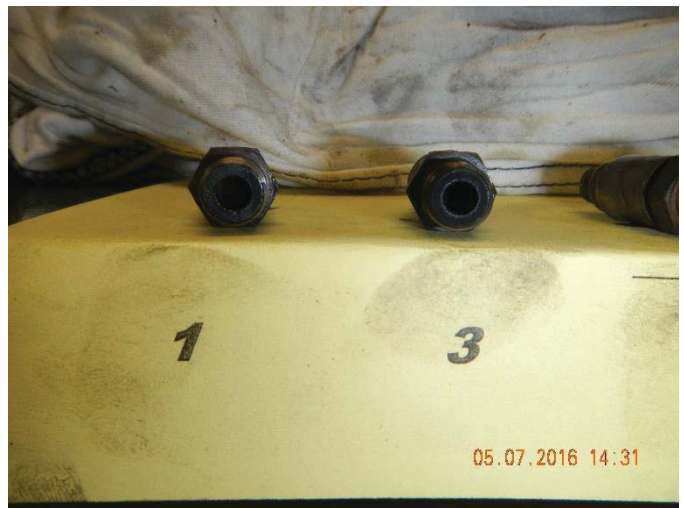
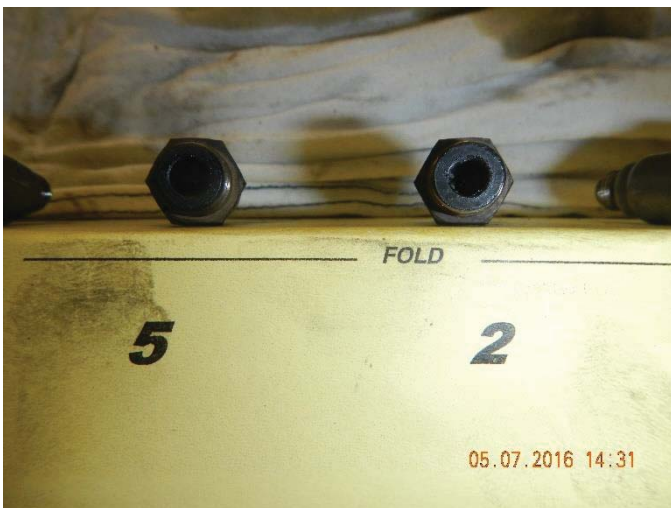
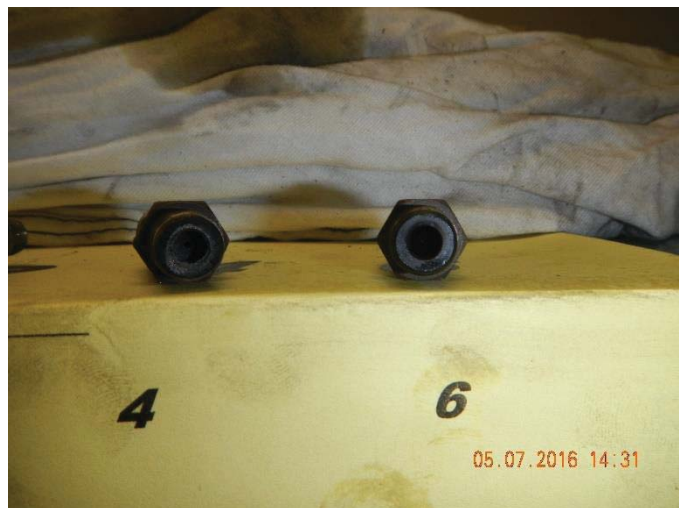
| <b>FUEL NOZZLES AND LINES</b> | Manufacturer: TCM | | | | | |

| Condition: | All fuel injectors were open and clear of debris. All injectors appeared dark in color with an oily film present. | | | | | |

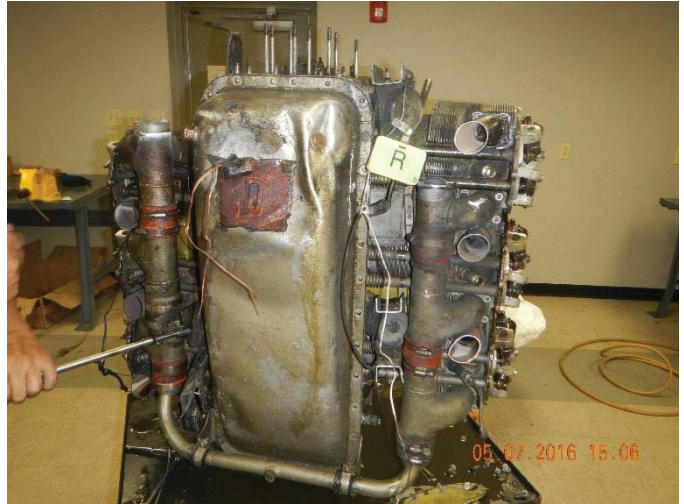
**OIL SUMP**

The oil sump was impact damaged but remained intact.

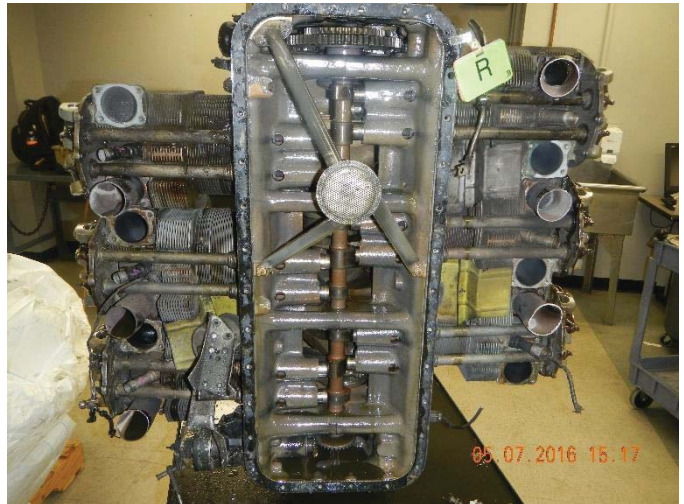
**OIL PICK-UP  
TUBE &  
SCREEN**

The screen was intact and contained only a small amount of contaminant

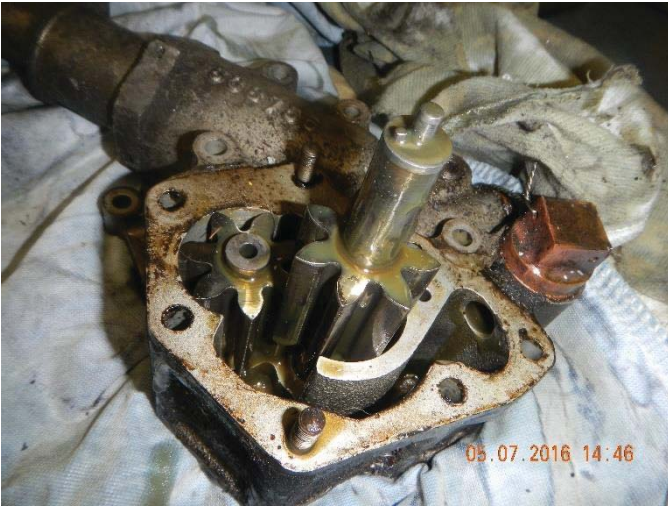
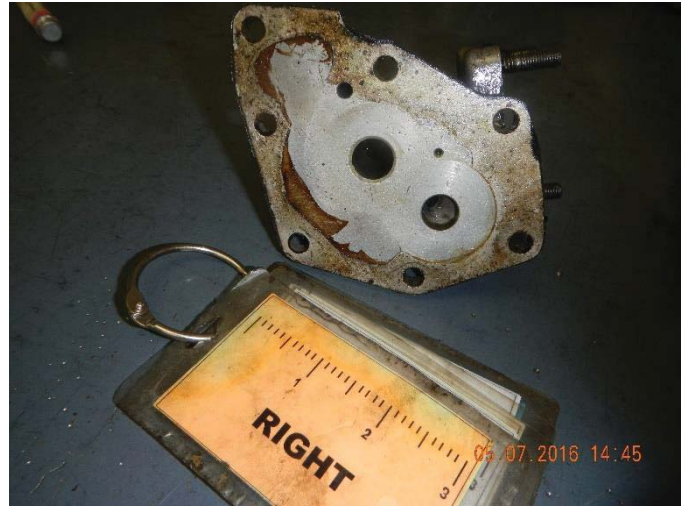
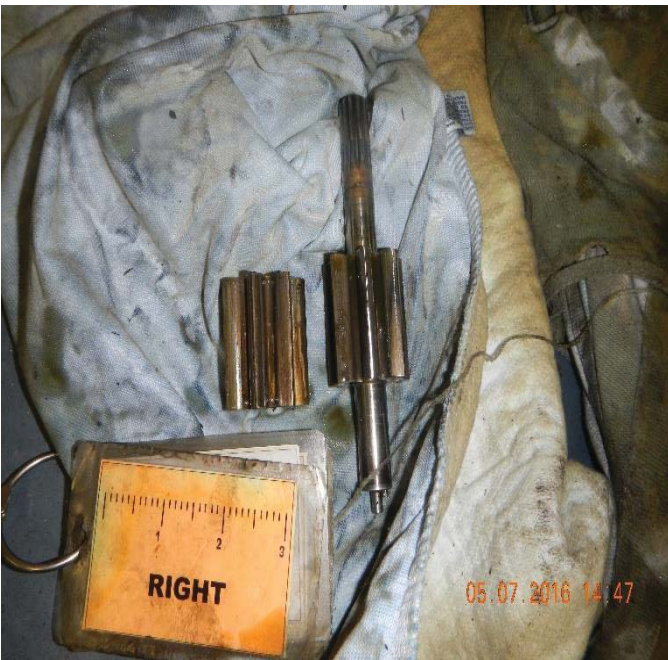
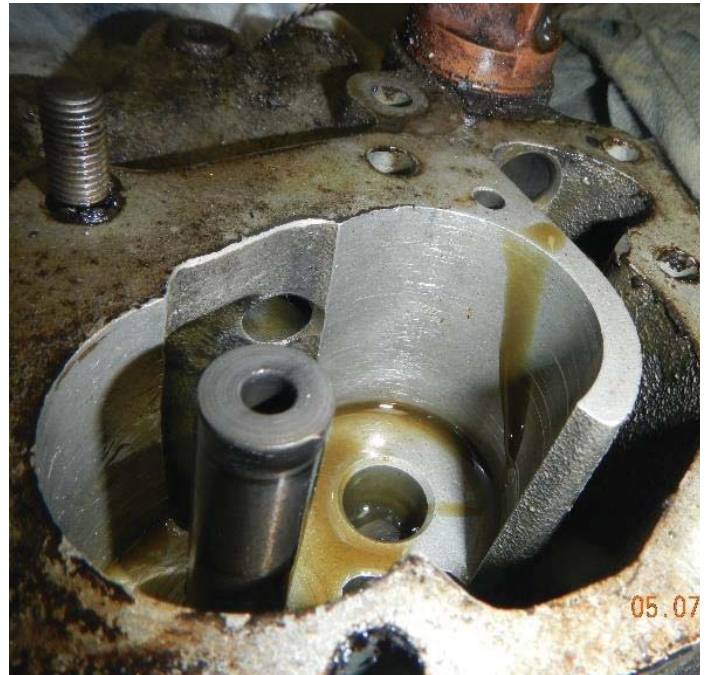
**OIL PUMP**

The oil pump was disassembled and showed no evidence of hard particle passage

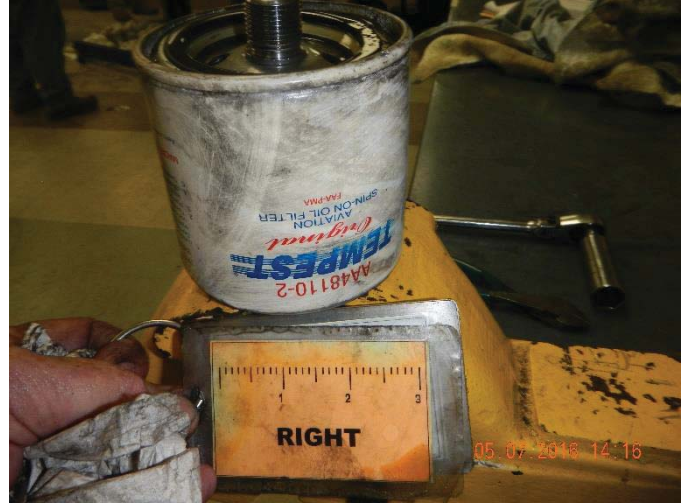
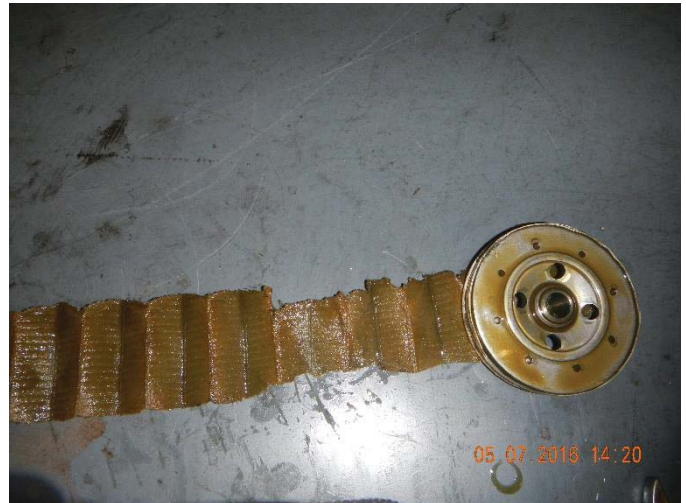
## OIL FILTER

The engine oil sump exhibited damage consistent with impact damage. The spin on type oil filter received impact damage but remained attached. The oil filter security safety wire was incorrectly installed to pull toward a loosening position.

The outer shell was impact damaged. The filter was opened and inspected for contaminants. Only a small amount of contaminants resembling carbon was noted. No metal was found. Red arrow points to incorrectly installed safety wire.

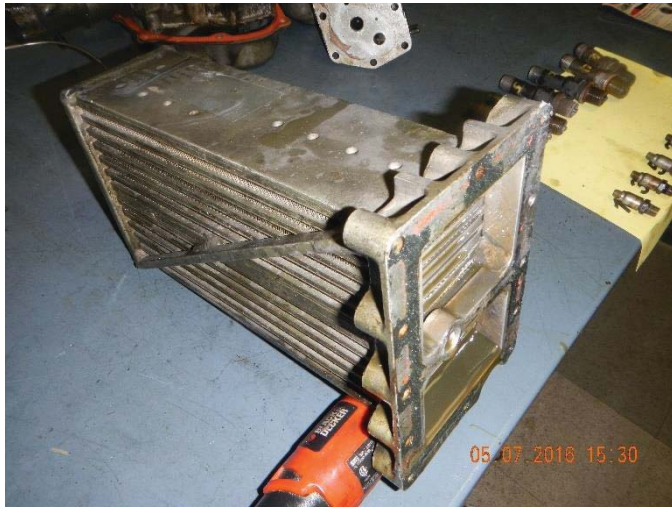
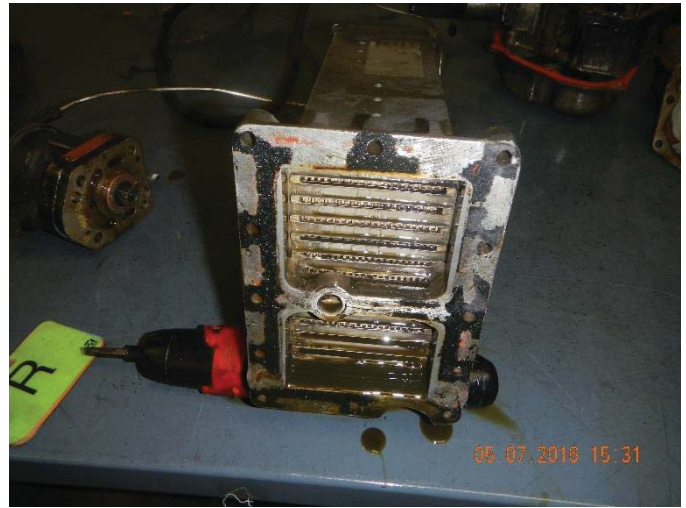
**OIL COOLER**

The oil cooler did not display any impact damage

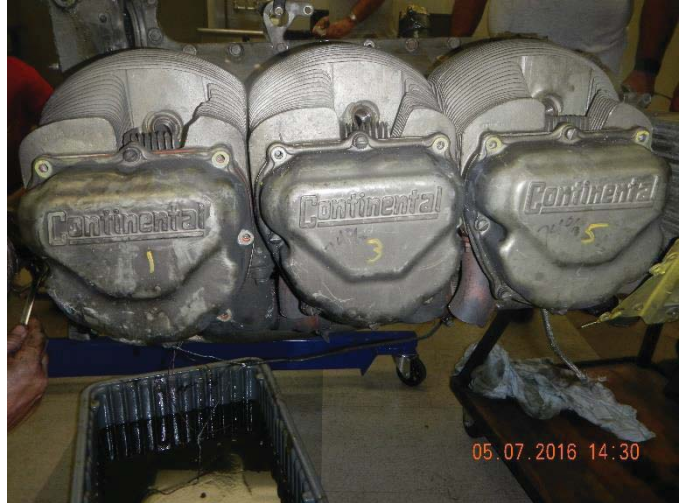
| <b>CYLINDER #1</b> | P/N: 354781 | S/N: Undetermined | Head Date: 12/84 |

| Condition: | Cylinder assembly was undamaged. Red arrow indicates cylinder # 1 | | |

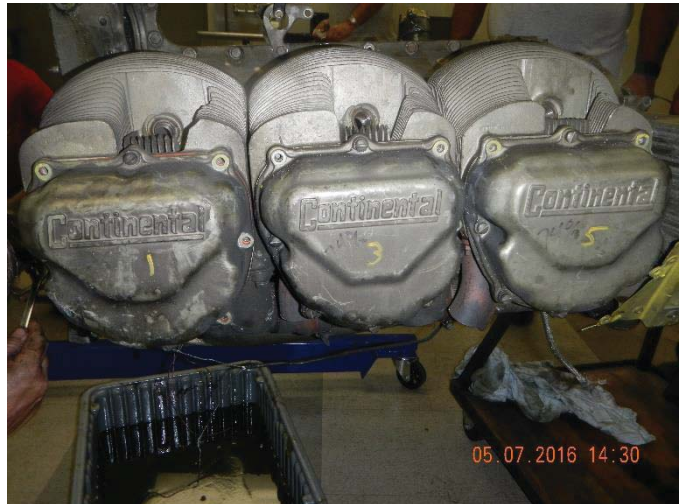
| <b>CYLINDER #3</b> | P/N: 35478 | S/N: Undetermined | Head Date: Undetermined |

| Condition: | Cylinder assembly was undamaged. Red arrow indicates cylinder # 3 | | |

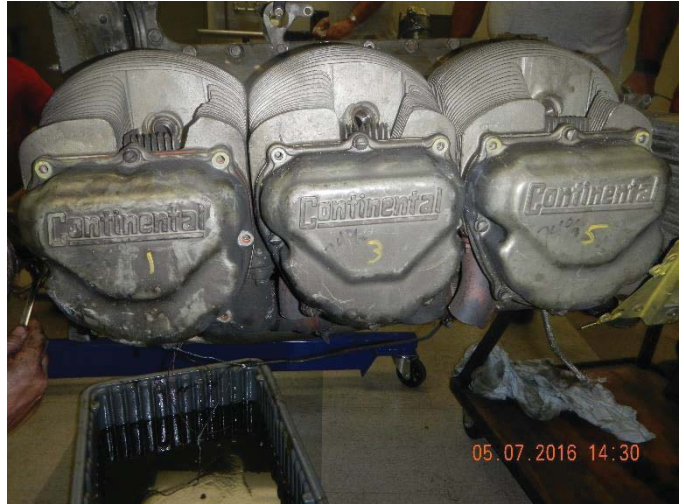
| <b>CYLINDER #5</b> | P/N: 186073 | S/N: Undetermined | Head Date: Undetermined |

| Condition: | Cylinder assembly was undamaged. Red arrow indicates cylinder # 5 | | |

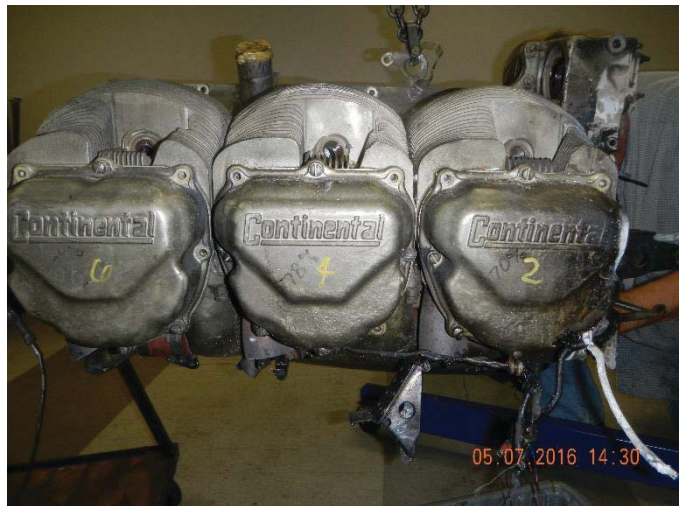
| <b>CYLINDER #2</b> | P/N: 354782 | S/N: Undetermined | Head Date: Undetermined |

| Condition: | Cylinder assembly was undamaged. Red arrow indicates cylinder # 2 | | |

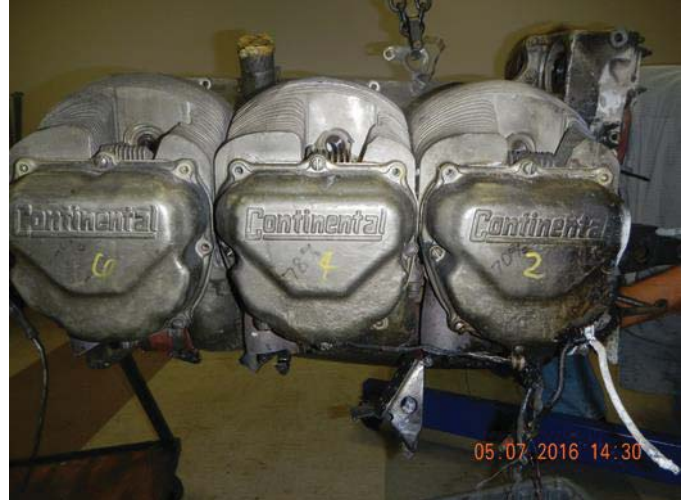
| <b>CYLINDER #4</b> | P/N: 035124 | S/N:186072 | Head Date:<br>Undetermined |

| Condition: | Cylinder assembly was undamaged. Red arrow indicates cylinder # 4 | | |

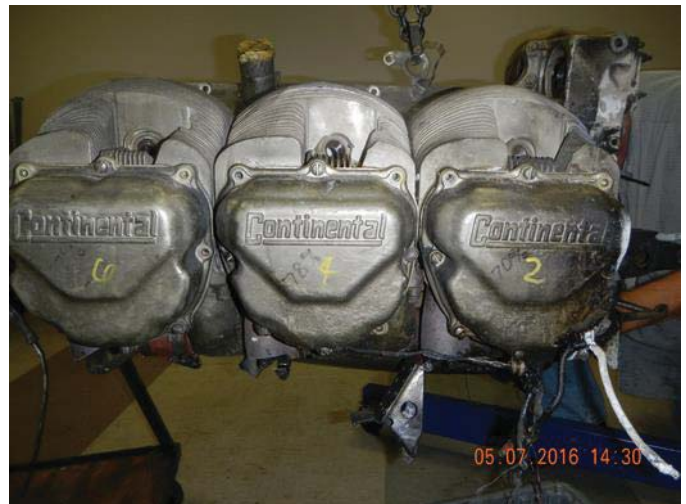
| <b>CYLINDER #6</b> | P/N:812376 | S/N: J8963-2 | Head Date: |

| Condition: | Cylinder assembly was undamaged. Red arrow indicates cylinder # 6 | | |

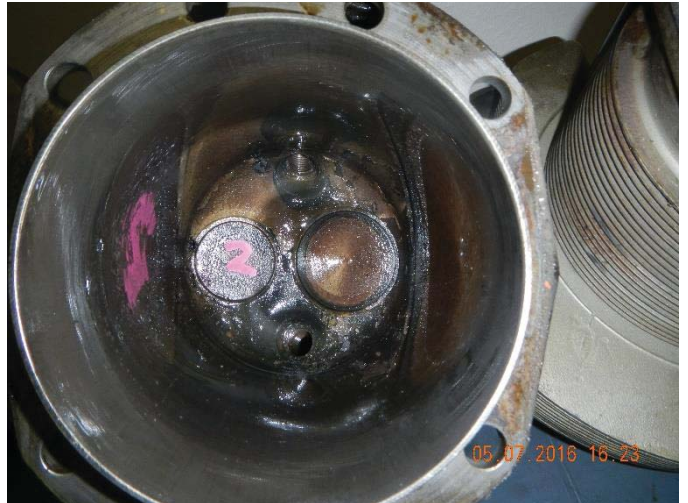
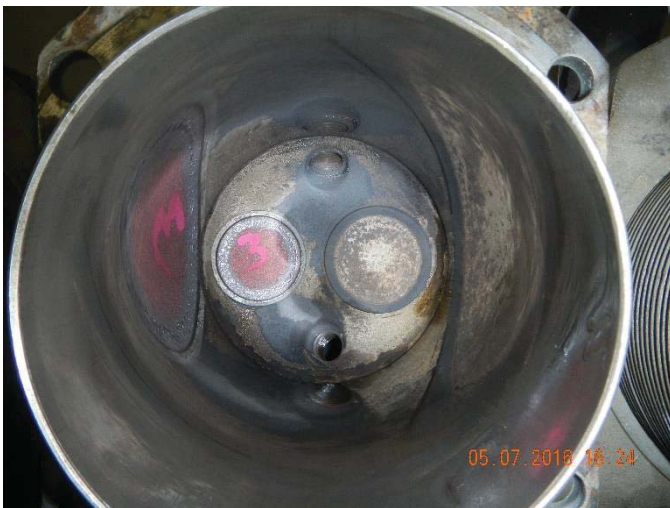
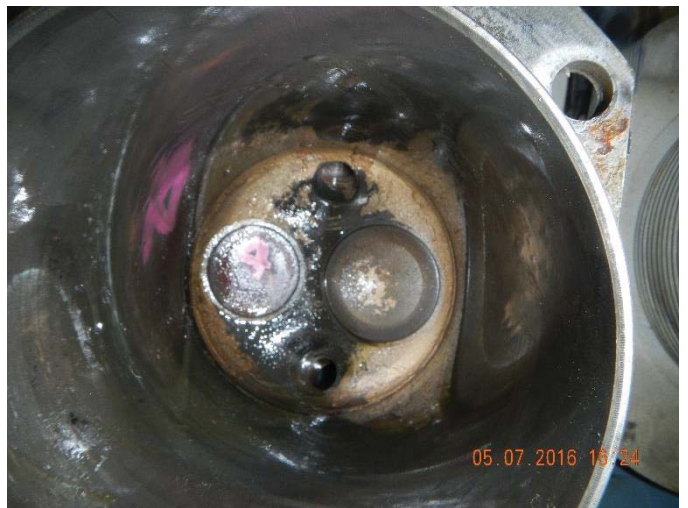
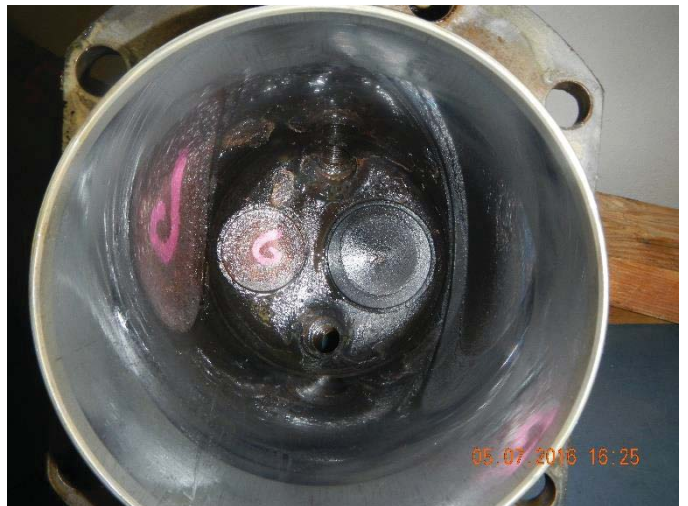
VALVES

All valves were intact and exhibited normal combustion signatures

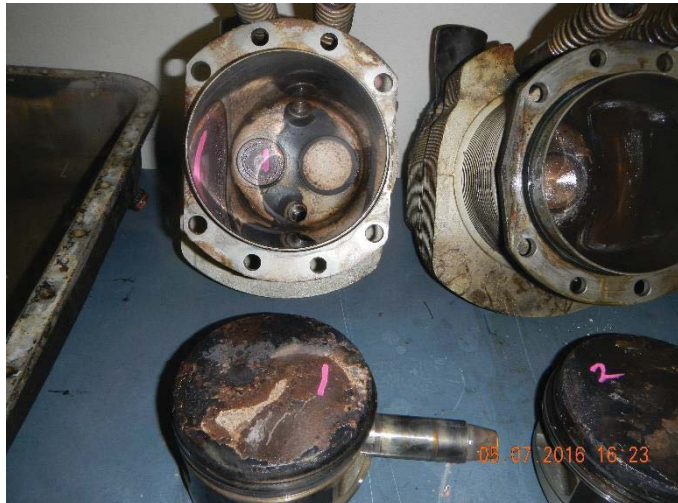
**#1 PISTON, RINGS AND PIN**

Pistons and rings appeared normal with normal wear and combustion deposits

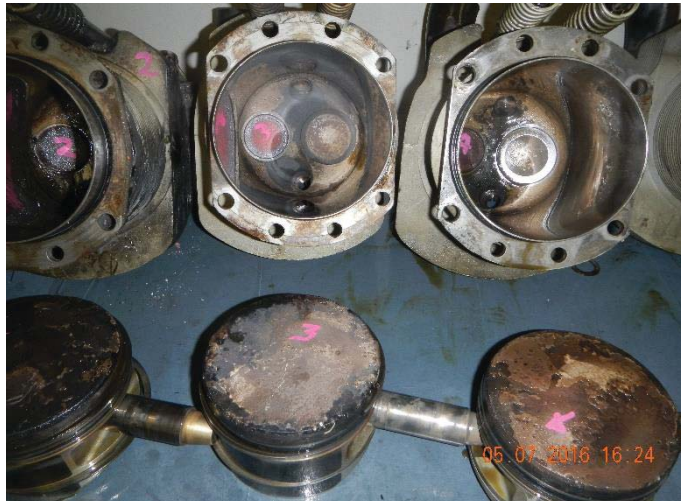
**#3 PISTON, RINGS AND PIN**

Pistons and rings appeared normal with normal wear and combustion deposits

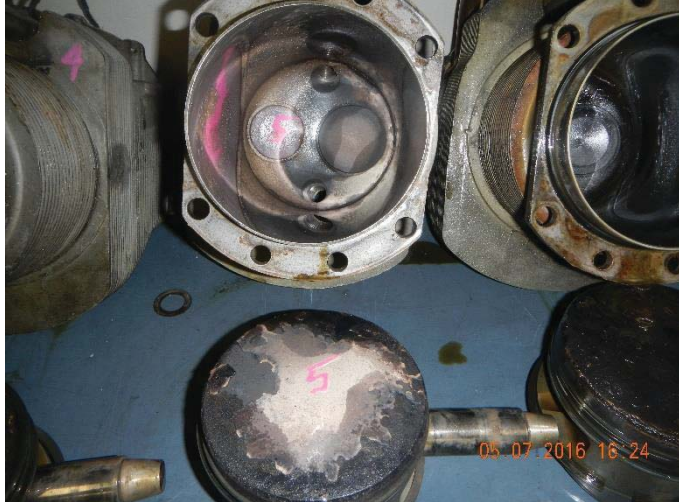
**#5 PISTON,  
RINGS AND PIN**

Pistons and rings appeared normal with normal wear and combustion deposits

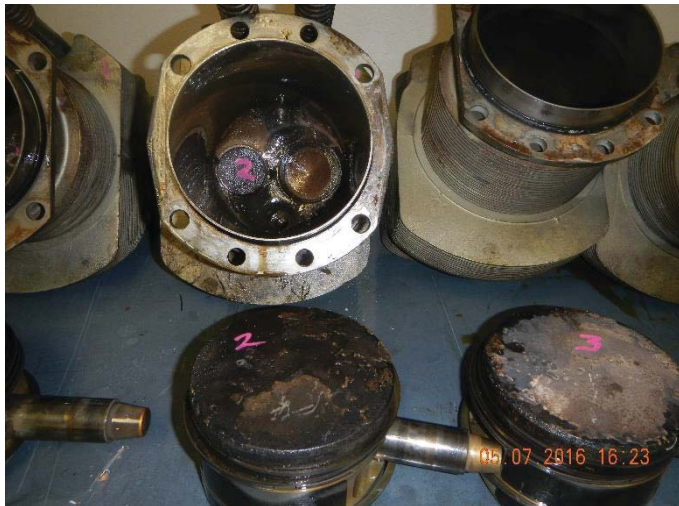
**#2 PISTON,  
RINGS AND PIN**

Pistons and rings appeared normal with normal wear and combustion deposits

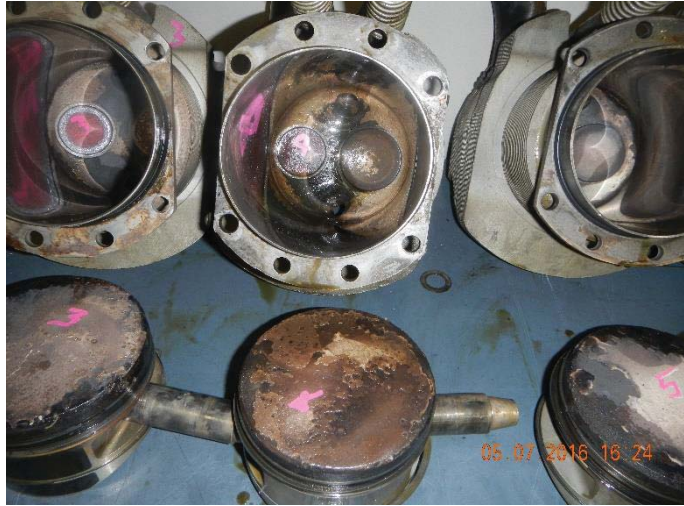
**#4 PISTON,  
RINGS AND PIN**

Pistons and rings appeared normal with normal wear and combustion deposits

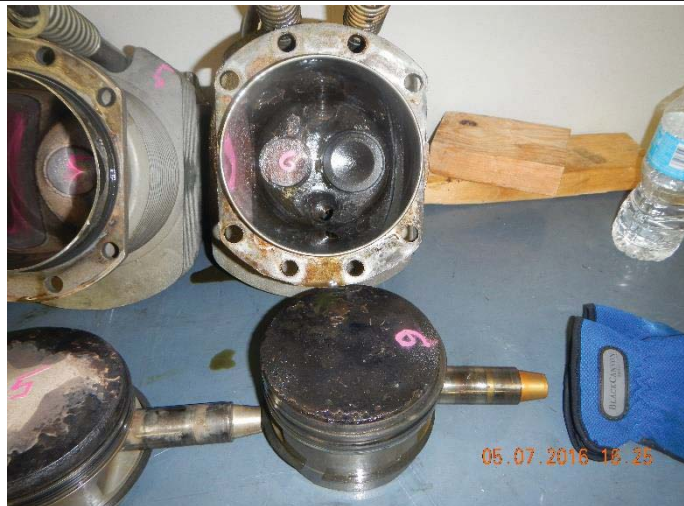
**#6 PISTON,  
RINGS AND PIN**

Pistons and rings appeared normal with normal wear and combustion deposits

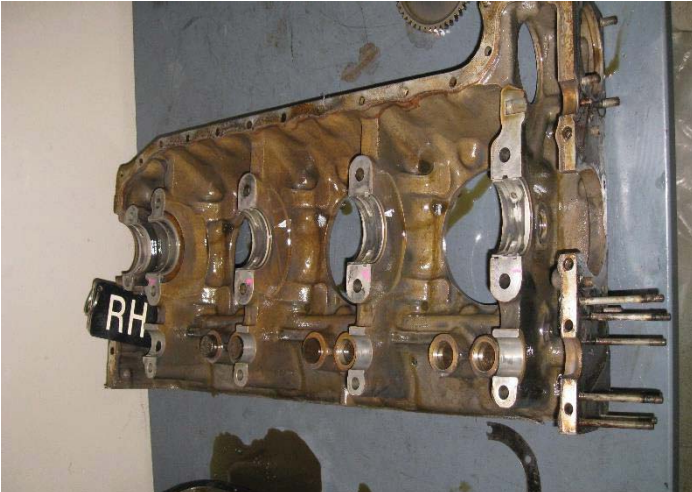
| <b>#1 MAIN BEARINGS</b> | P/N: SA630464 | Date Code: Not legible |

| <b>Condition:</b> | Bearings appear to exhibit normal wear |

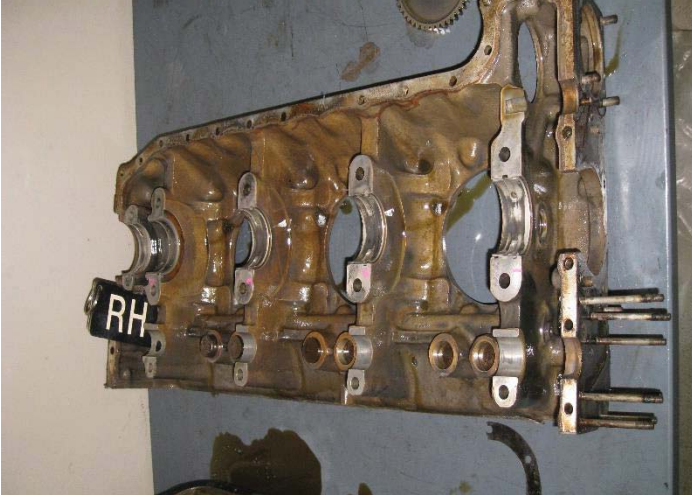
| <b>#2 MAIN BEARINGS</b> | P/N: SA630464 | Date Code: Not legible |

| Condition: | Bearings appear to exhibit normal wear | |

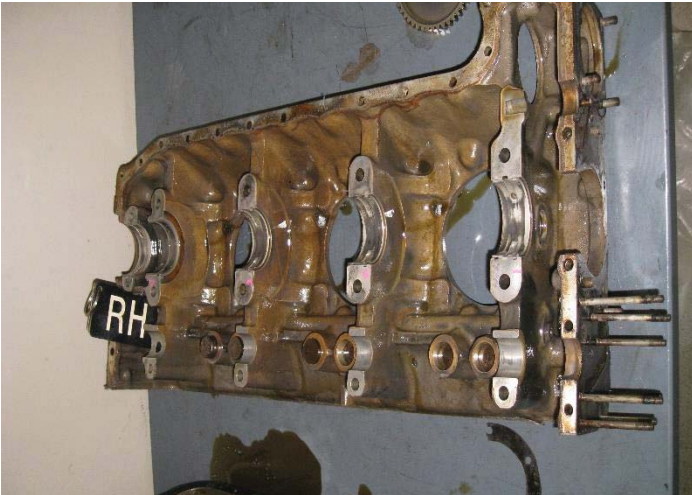
| <b>#3 MAIN BEARINGS</b> | P/N: SA630464 | Date Code: Not legible |

| Condition: | Bearings appear to exhibit normal wear | |

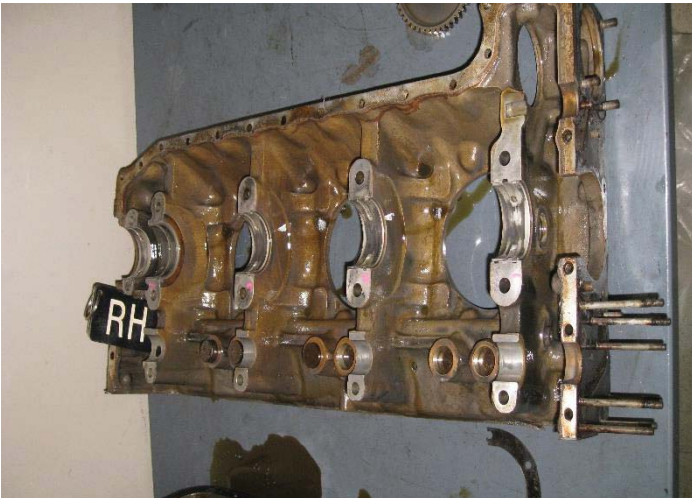
| <b>#5 MAIN BEARINGS</b> | P/N: SA63464 | Date Code: Not legible |

| Condition: | Red arrow points to # 5 bearing. Bearings appear to exhibit normal wear | |

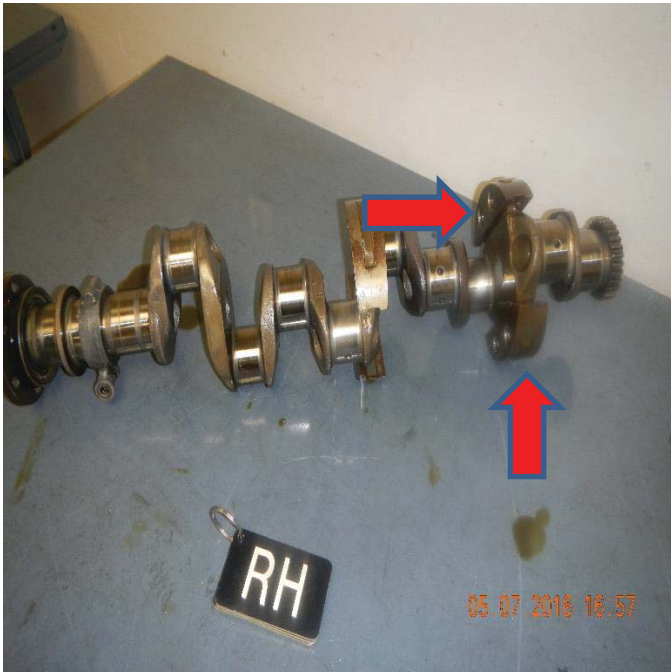
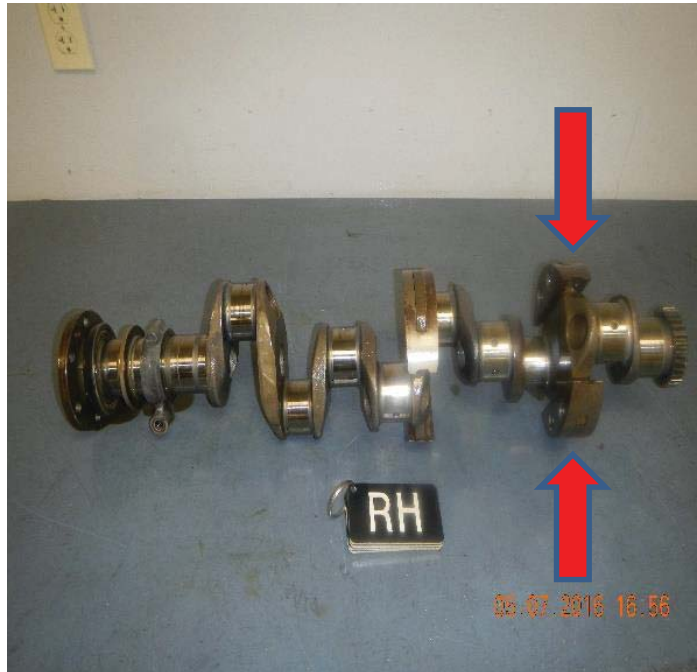
| <b>COUNTER WEIGHTS</b> | |

| Condition: | Counter weights were intact and moved freely on pins. Red arrows point to counterweights |

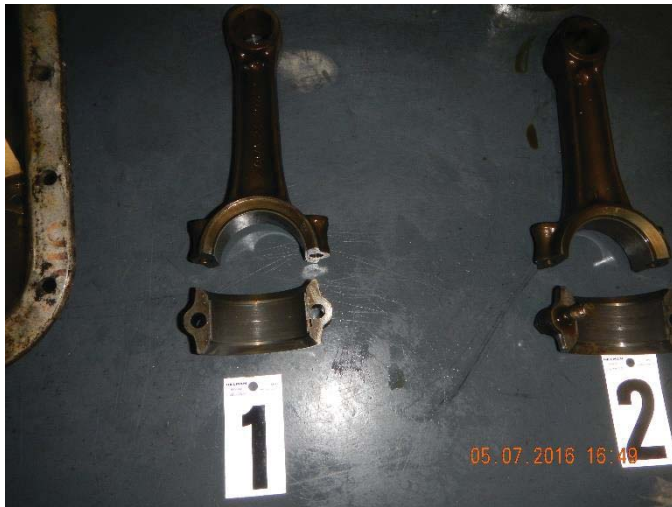
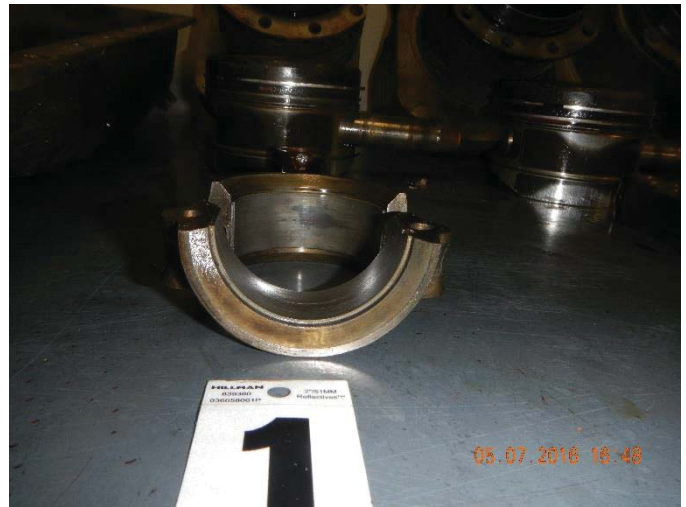
**#1 CONNECTING  
ROD**

Normal wear was exhibited

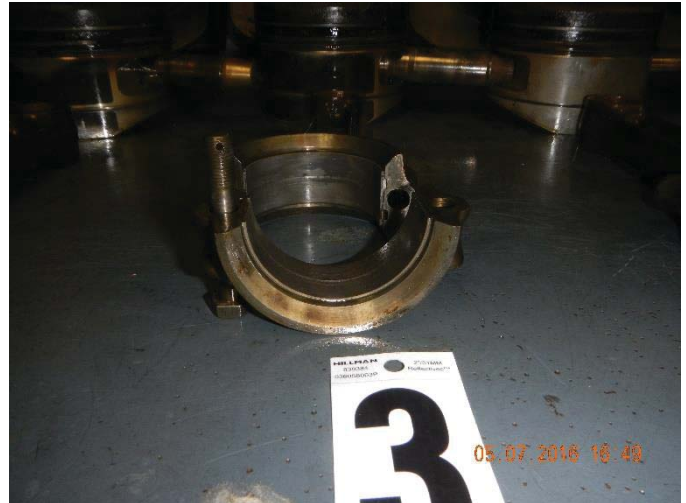
| <b>#3 CONNECTING ROD</b> | P/N: Undetermined | |

| Condition: | Normal wear was exhibited | |

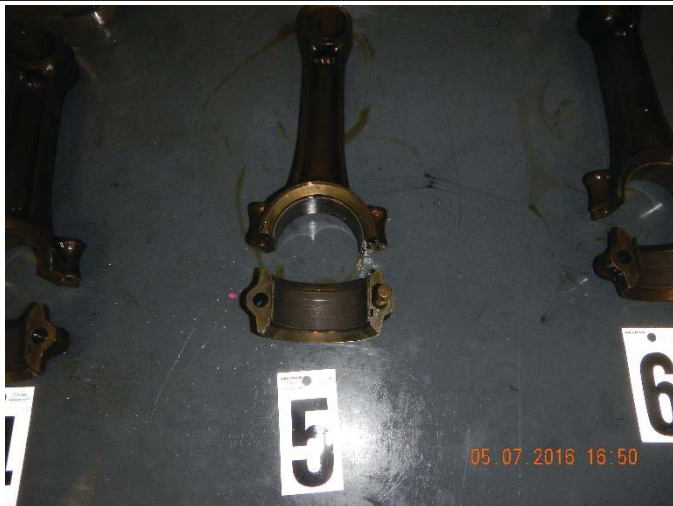
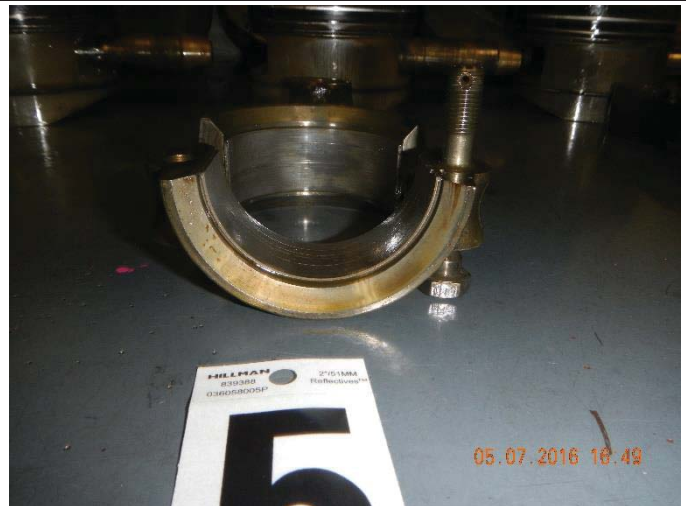
| <b>#5 CONNECTING ROD</b> | P/N: Undetermined | |

| Condition: | Normal wear was exhibited | |

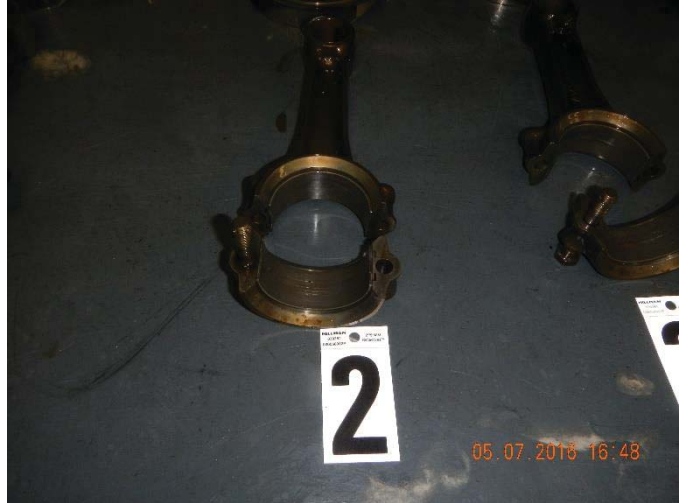
| <b>#2 CONNECTING ROD</b> | P/N: Undetermined | |

| Condition: | Normal wear was exhibited | |
