# Continental Motors

## ENGINE FIELD INSPECTION REPORT RIGHT ENGINE

| ENGINE MODEL | IO470D (19) |
| CMI FILE NUMBER | 15-562 |

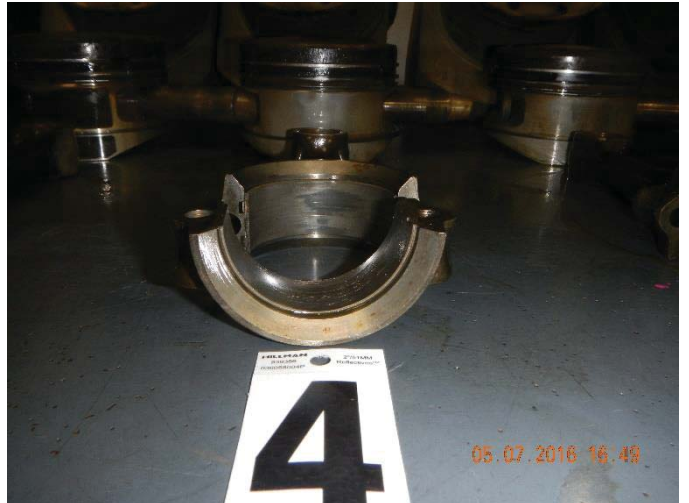
| <b>#4 CONNECTING ROD</b> | P/N: Undetermined | |

| Condition: | Normal wear was exhibited | |

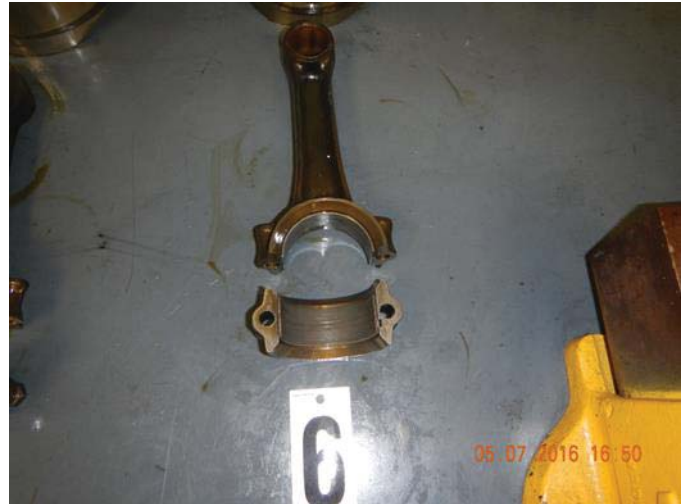
**#6 CONNECTING  
ROD**

Normal wear was exhibited

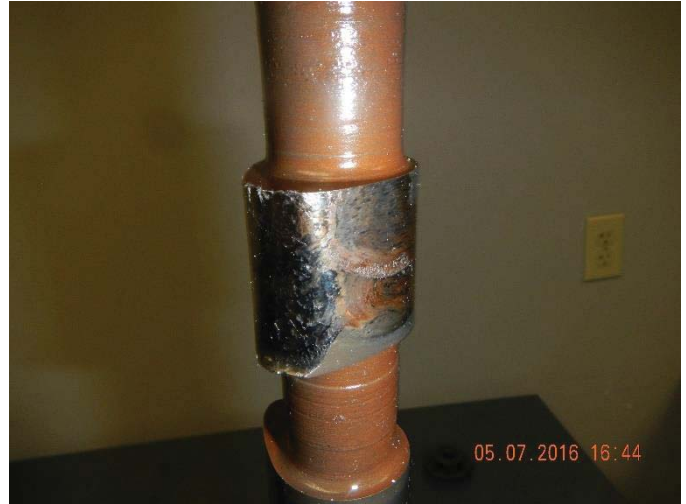
| <b>CAMSHAFT</b> | P/N: 535661 | S/N: Undetermined |

| Condition: | The camshaft was intact but exhibited spalling and abnormal wear on the # 5 & 6 intake lobe. | |

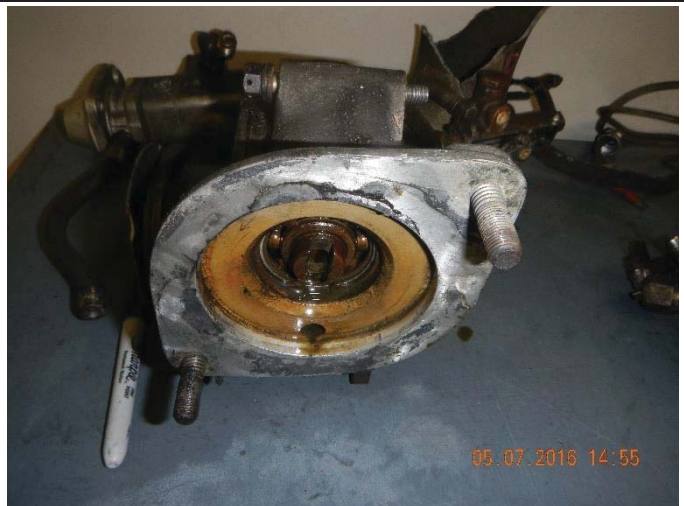
| <b>STARTER ADAPTER</b> | P/N: Undetermined |

The pulley extending from the starter adapter which drives the belt driven generator was broken and the belt separated.

| Condition: | The starter adapter was removed and visually inspected. The shaft rotated easily when the gear was rotated manually. The accessory drive pulley was impact damaged. |

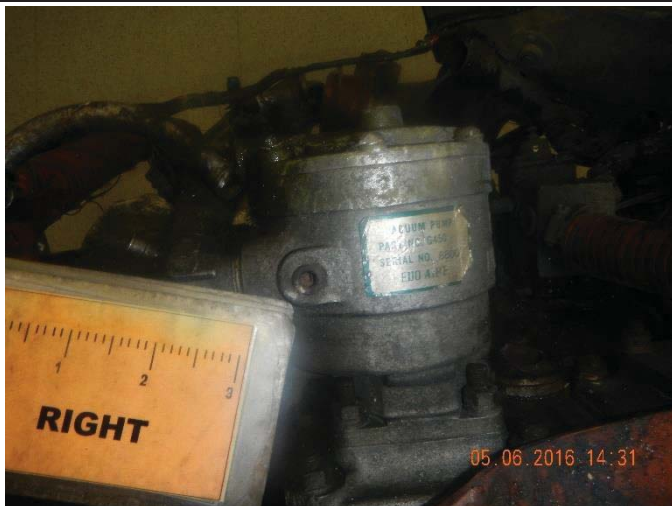
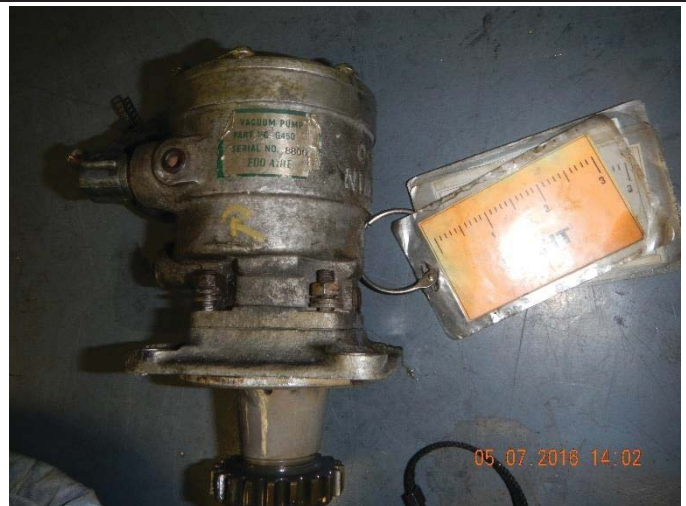
| <b>VACUUM PUMP</b> | Manufacturer: Edo Aire | P/N: G450 | S/N: 8800 |

| Condition: | The vacuum pump was removed and inspected. The pump produced suction on the inlet fitting when the pump was rotated manually | | |

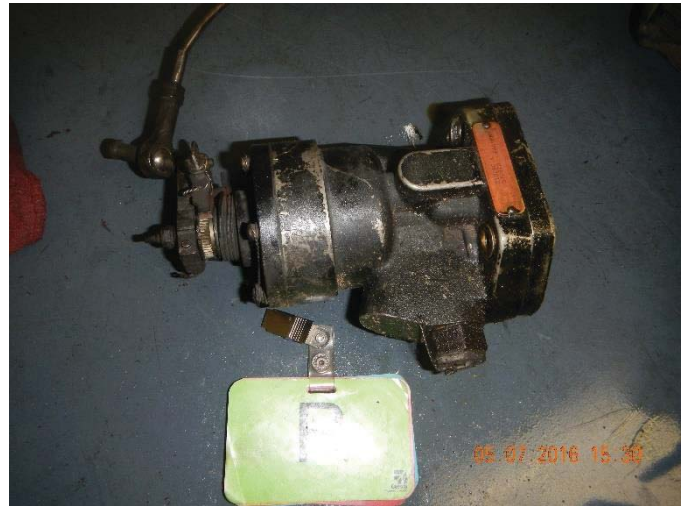
**PROPELLER GOVERNOR**

The governor was removed and inspected. No pre-impact damage was noted

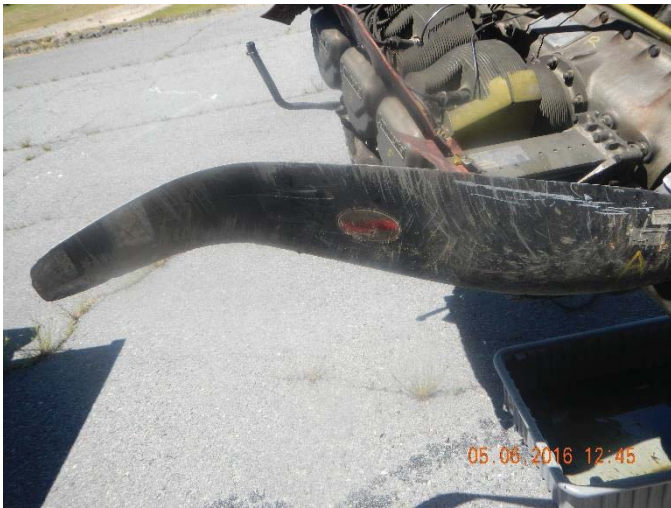
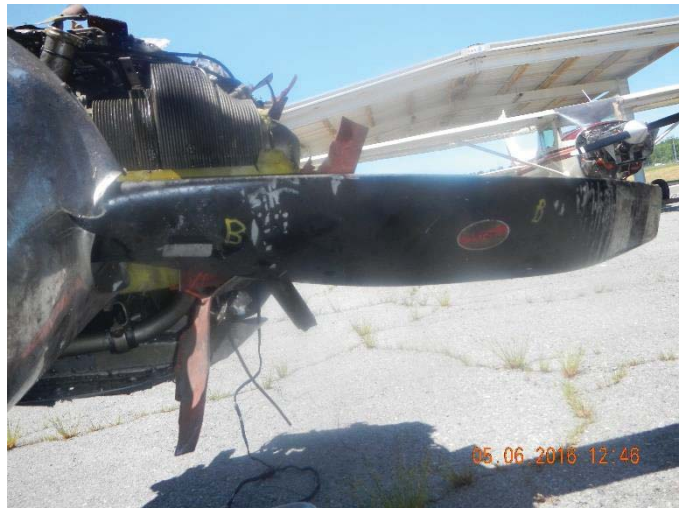
| <b>PROPELLER</b> | Manufacturer: Hartzell | P/N: HC-C2YF-2CUFC 8468-3 | S/N: AN 7312B |

| Condition: | Blade A exhibited twisting rearward bending beginning approximately 4" outboard of the propeller blade root. A forward bending motion began at approximately 24" outboard of the blade root. Propeller blade B exhibits a slight rearward bending motion approximately 12" inboard from the propeller tip. The propeller spinner received crushing due to impact with the ground. Neither blade appeared to be in a feathered position. | | |
