Engine Investigation

**Allison
Model 250-C30P
Engine CAE 890569**

**Bell 206 L-4
Registration: N57AW**

**Accident date: December 31, 2014
Investigation date: January 1-3, 2015
Report date: January 9, 2015**

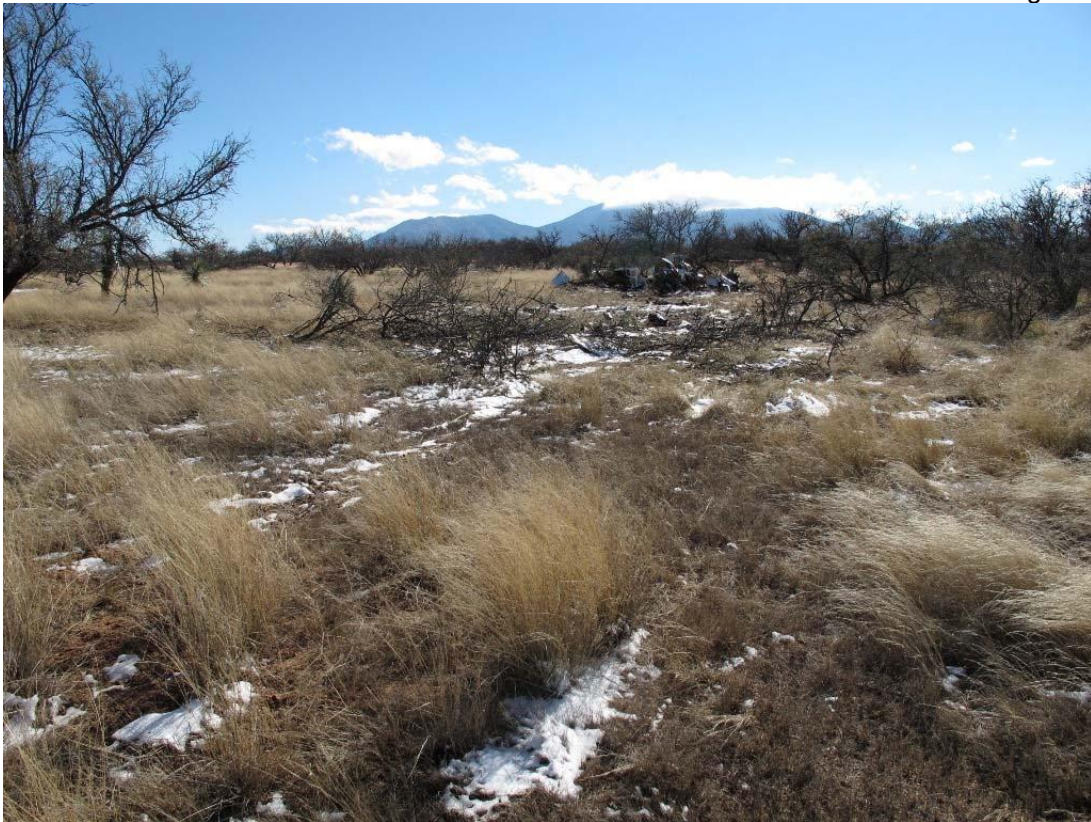
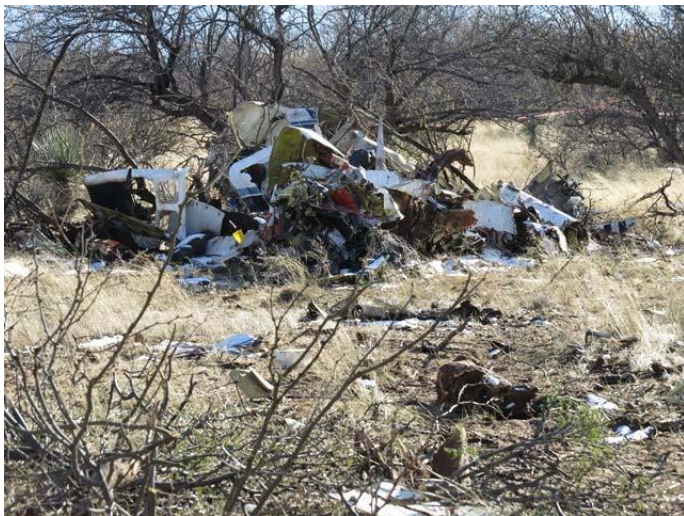
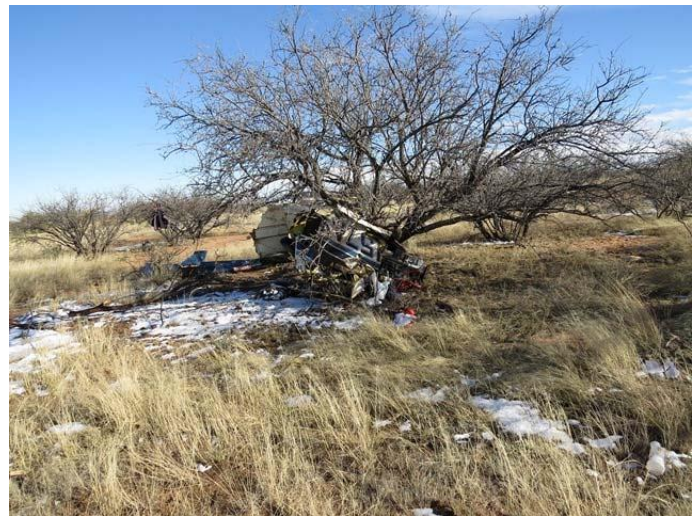
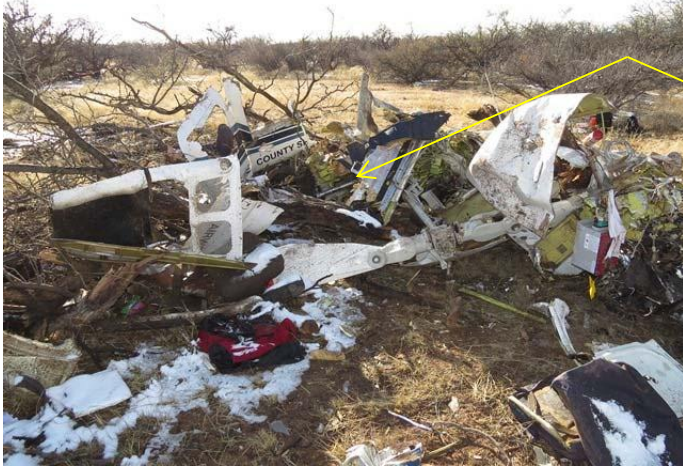
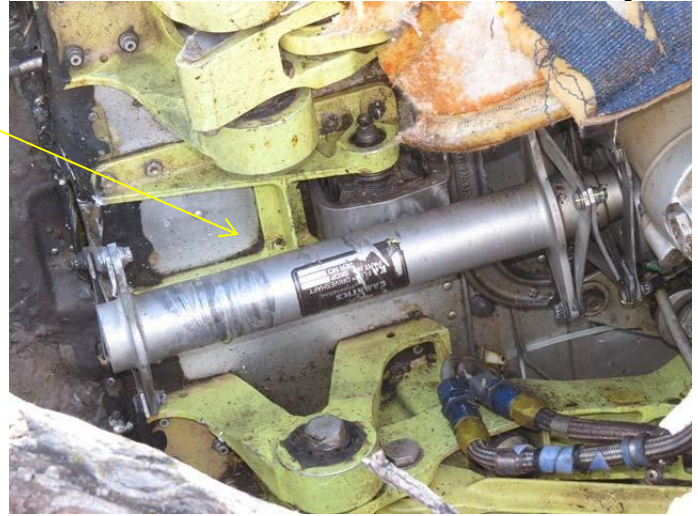
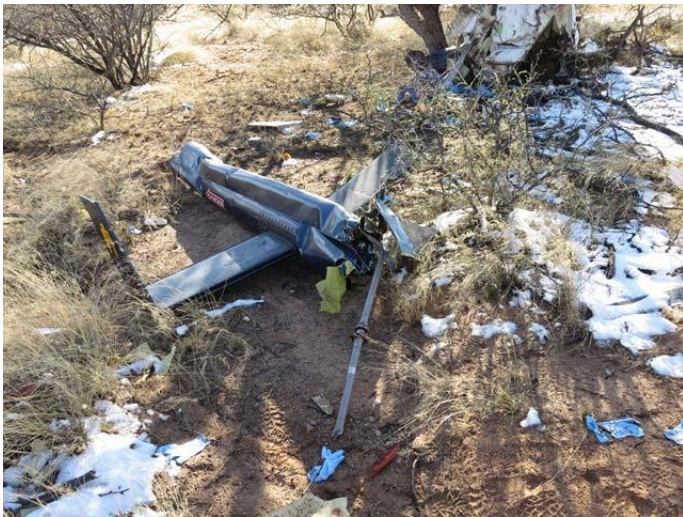
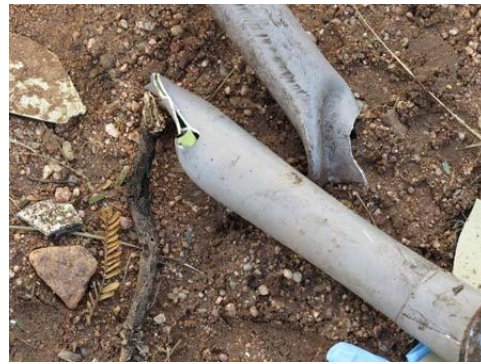
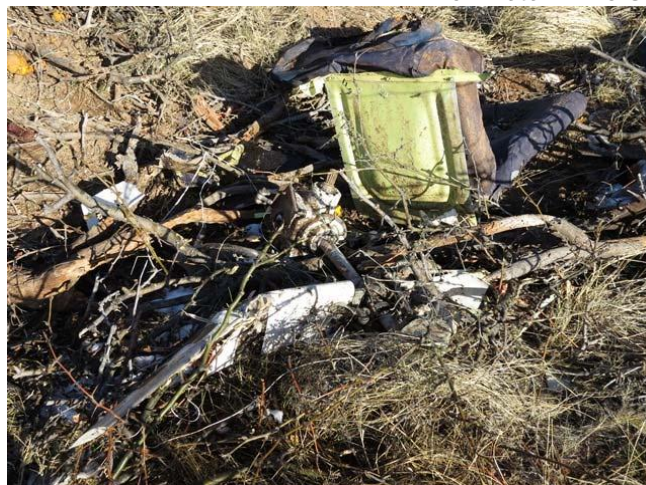
Fig 1

The airframe was completely fragmented over an approximate 180 foot debris path, and no cockpit crew occupiable space remained. Both main rotor blades had separated outboard of the doublers. One separated blade section was measured as 12 feet in length and the other blade section measured 8 feet in length. The main rotor blades exhibited leading edge bending and chordwise scratches. The tail rotor and gearbox separated from the tail boom. One blade on the tail rotor was absent half the blade with the other displaying both spanwise and chordwise bending. The tail rotor drive shaft remained with the tail boom. Both the forward end of the drive shaft and the tail rotor end of the drive shaft exhibited torsional overload separations. The main transmission remained attached to fuselage with transmission mount assembly. (Fig 1)

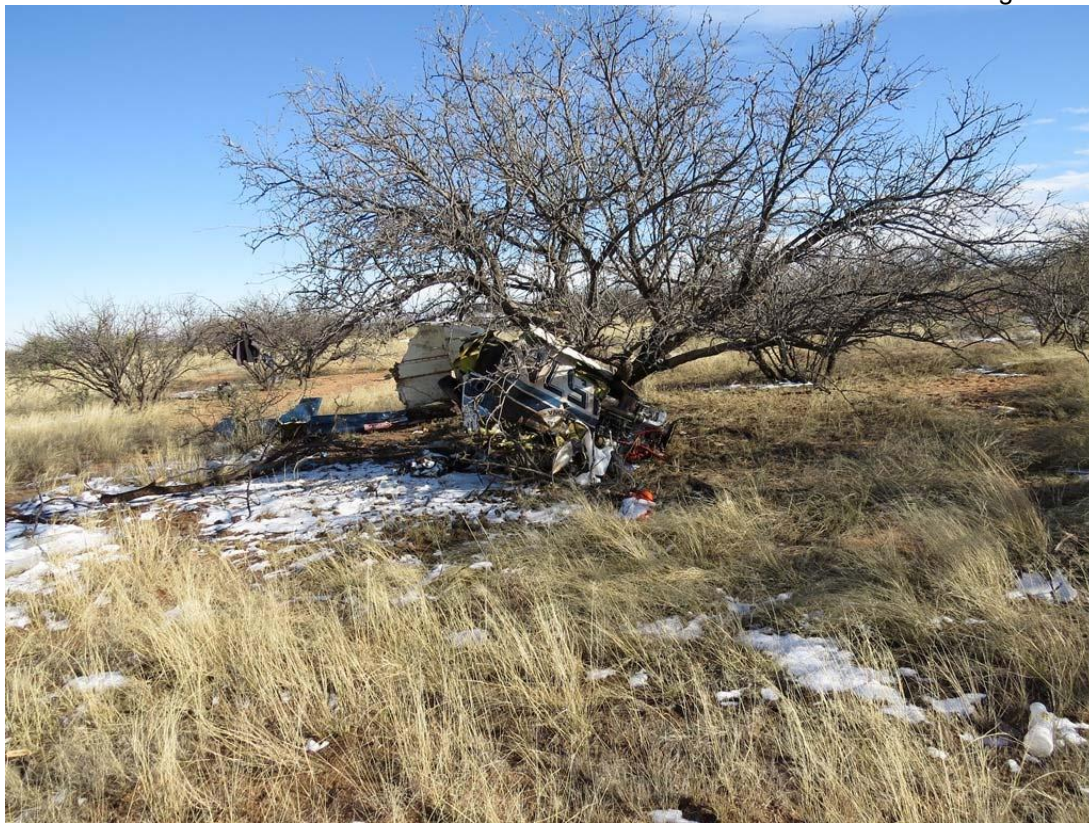
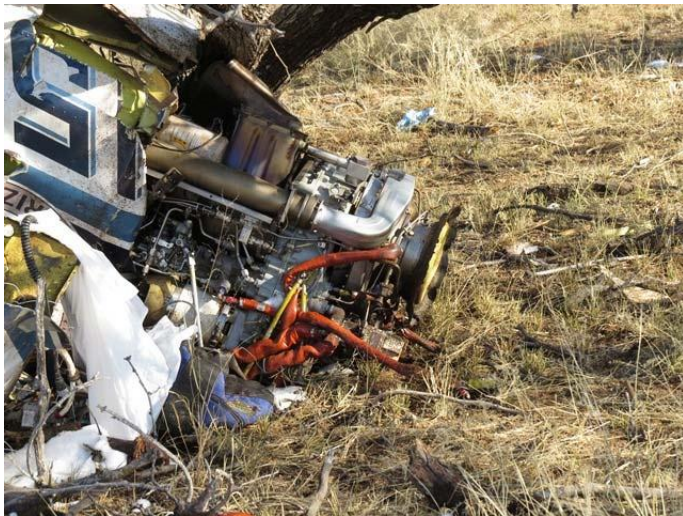
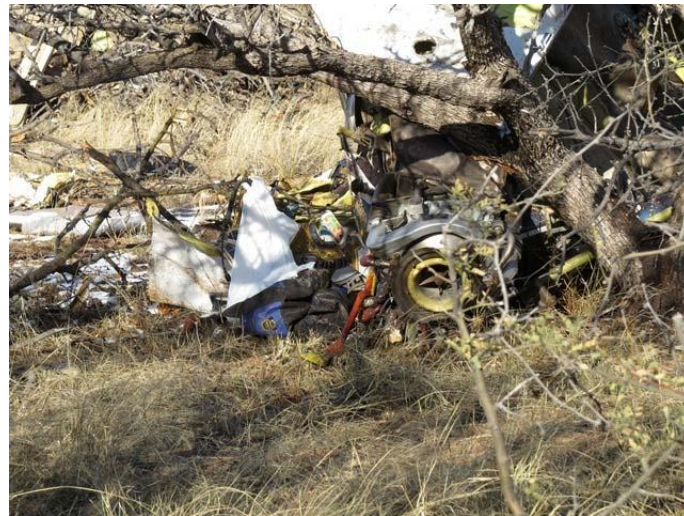
Fig 2

The engine was located along with an aft section of airframe at the downstream end of the debris field resting against a tree. With the exception of several oil lines and some wiring the engine was separate from the airframe. All mounting arms had been fractured. The engine was resting on the ground in a generally upright position. The left side of the airframe exhaust stack as well as the left side of the exhaust collector support stack was crushed in a downward direction. The left side scroll and the left side compressor air discharge tube displayed denting and impact damage. Bending of four compressor impeller blades opposite direction of rotation was noted. The power turbine governor displayed a fracture of the after body at the split line. Other than some bending of engine lines from impact, externally the balance of the engine was in visually good condition. (Fig 2)

Engine on Site

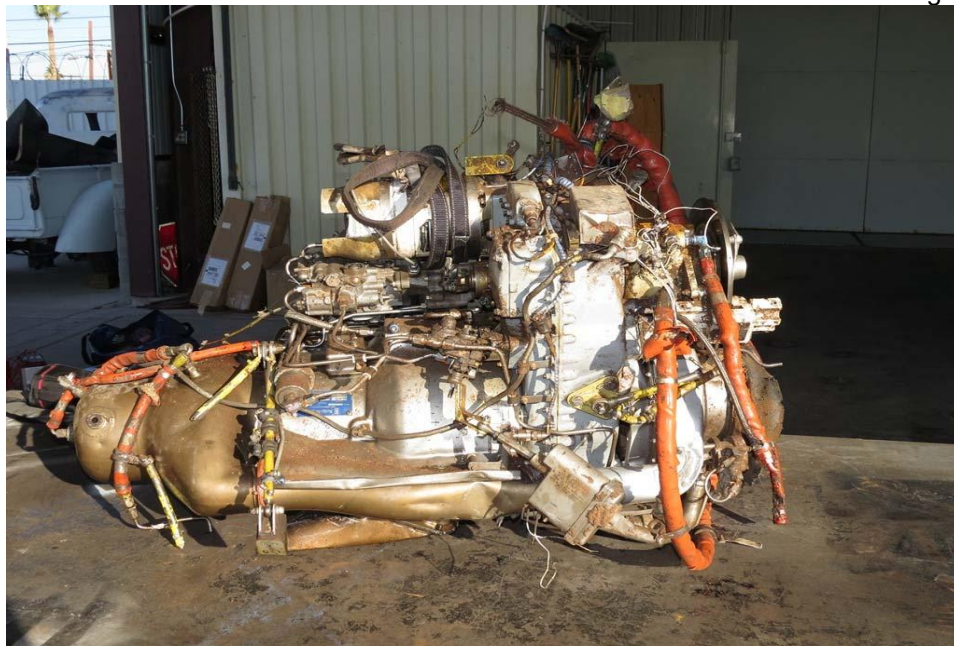
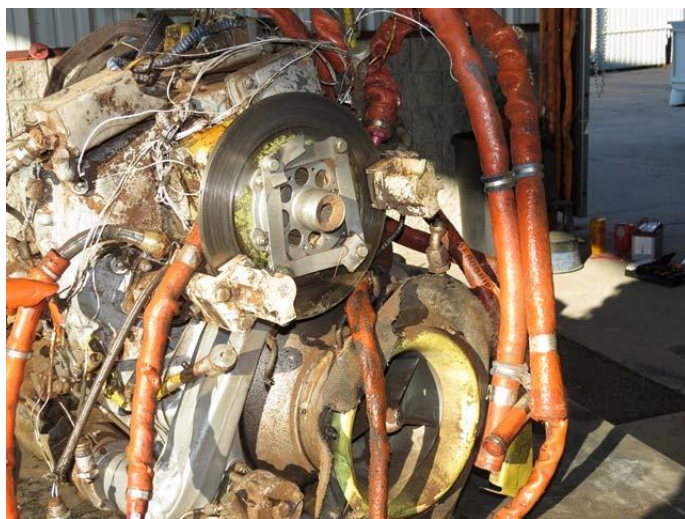
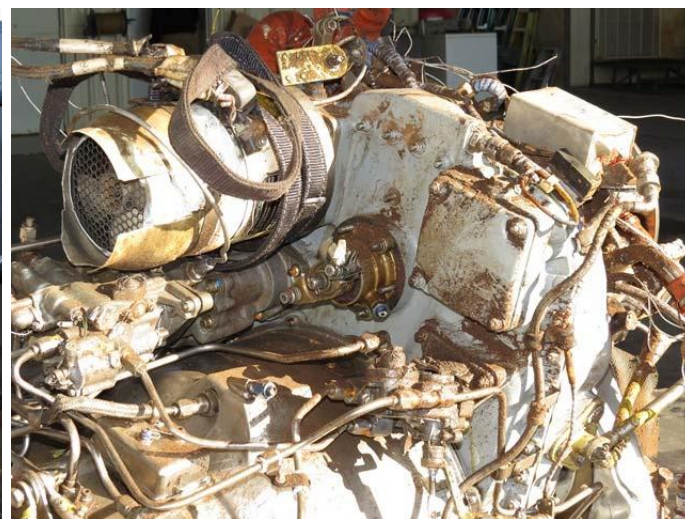
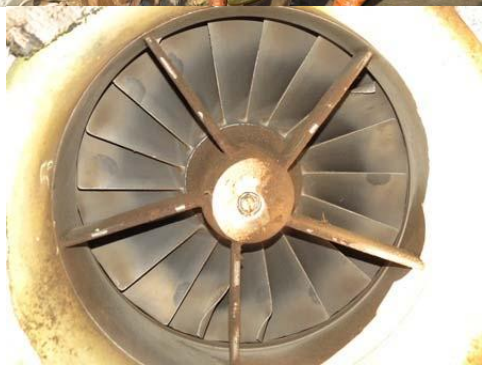
Fig 3

The wreckage was recovered to Air Transport in Phoenix AZ for further examination. Other than damage noted on site, the compressor impeller was found to exhibit the blade tips and leading edges of at least four blades to have bending and deformation opposite the direction of rotation. Manual rotation of both the N1 and N2 drive trains at their respective tachometer generator drive pads revealed free rotation and continuity. N1 exhibited smooth rotation with N2 exhibiting a light drag. The engine was then prepared for movement to AeroMaritime for disassembly and further investigation. The freewheeling unit and other airframe components were removed prior to transport as were all engine fuel, oil and pneumatic lines. During removal all “B” nuts were found at least finger tight with no evidence of leakage. (Fig 3)

Engine at Recovery

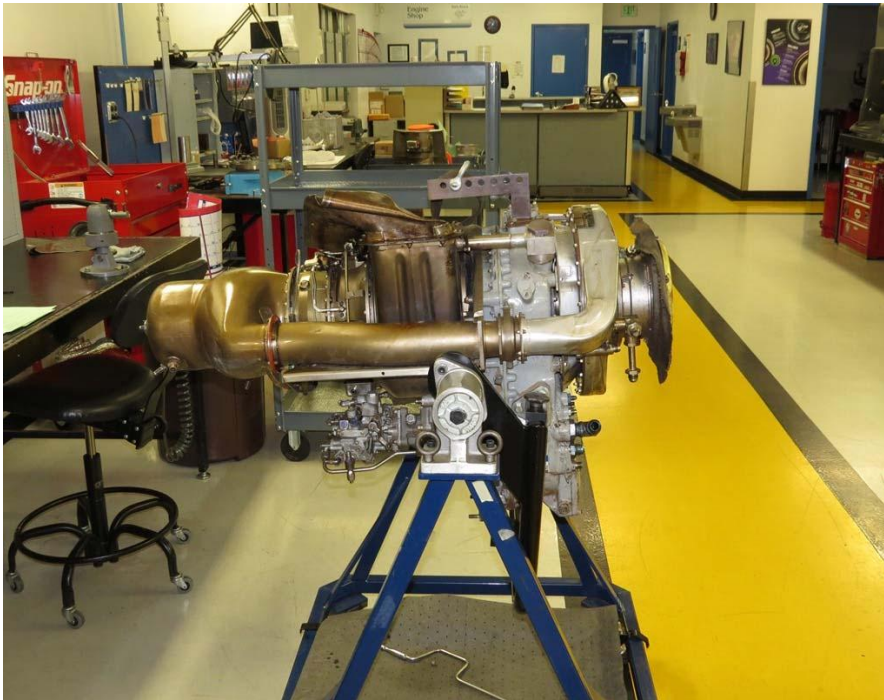
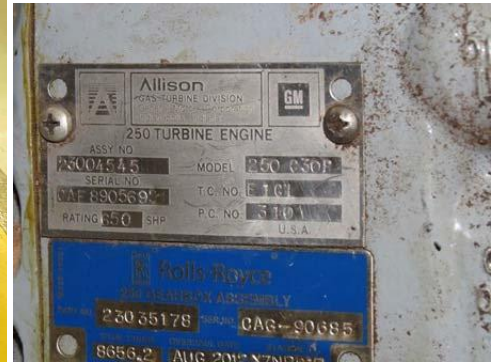
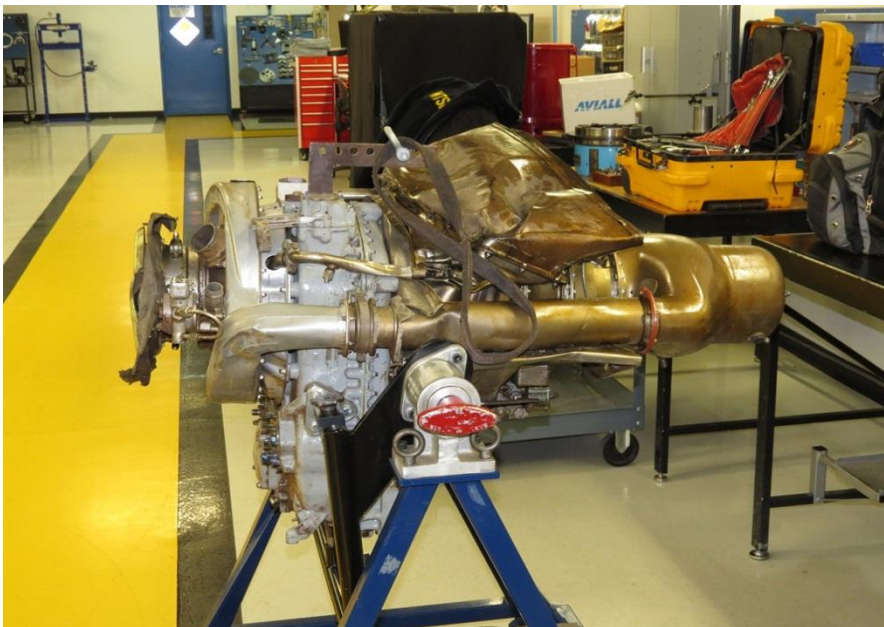
Fig 4

Engine investigation and disassembly was conducted on January 3, 2015 at AeroMaritime in Mesa Arizona under the auspices of an NTSB investigator. The following represents the facts and findings of that investigation. (Fig 4)

Engine as Received for Disassembly

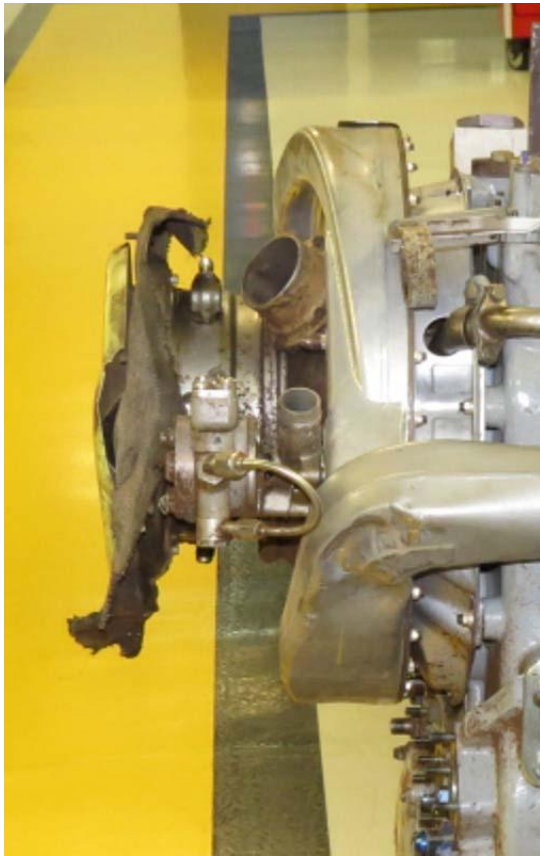
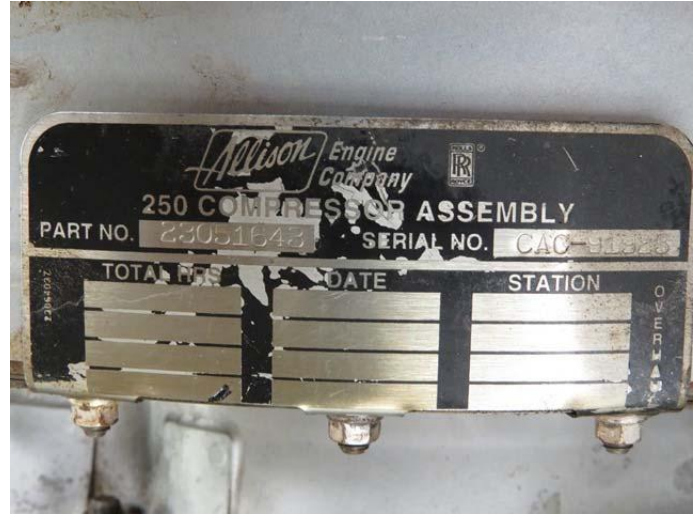
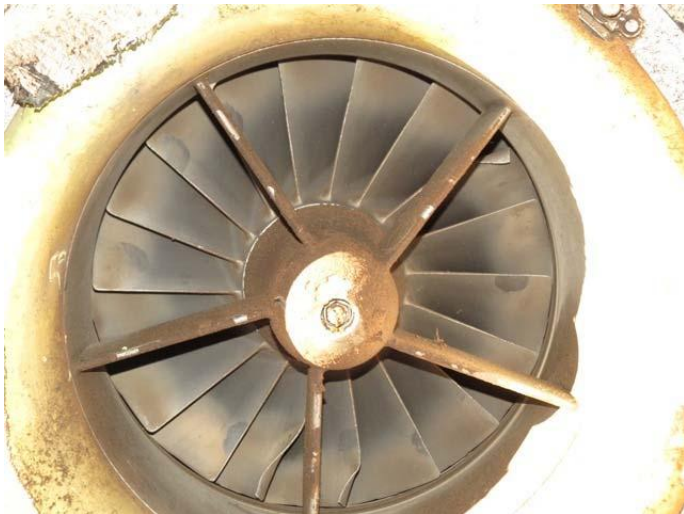
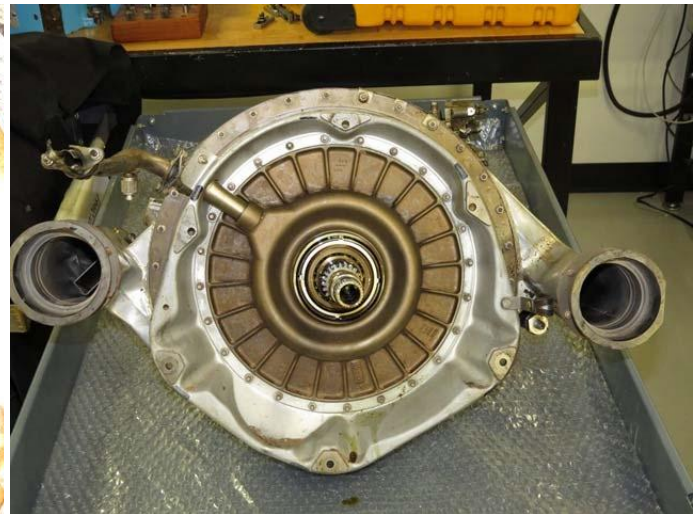
Fig 5

Externally the compressor displayed minor impact damage to the outside left shoulder area of the scroll but was otherwise visually normal. Visual examination of the impeller revealed bending of four blades tips and outboard ends of the leading edges in the direction opposite of impeller rotation. Removal of the compressor from the engine revealed smooth and continuous rotation of the compressor during manual rotation by the spur adapter gear shaft. No further disassembly of the compressor was conducted. (Fig 5)

Compressor

Compressor Inlet / Impeller

Compressor Aft Side

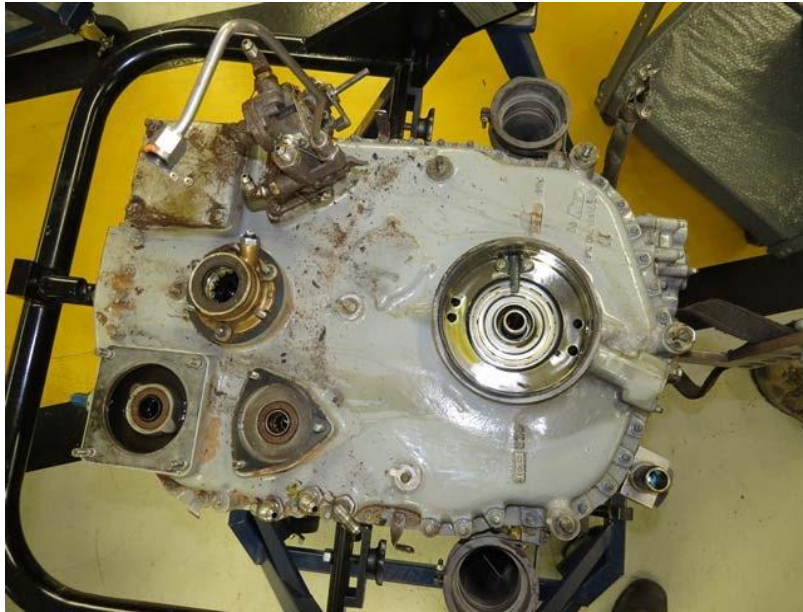
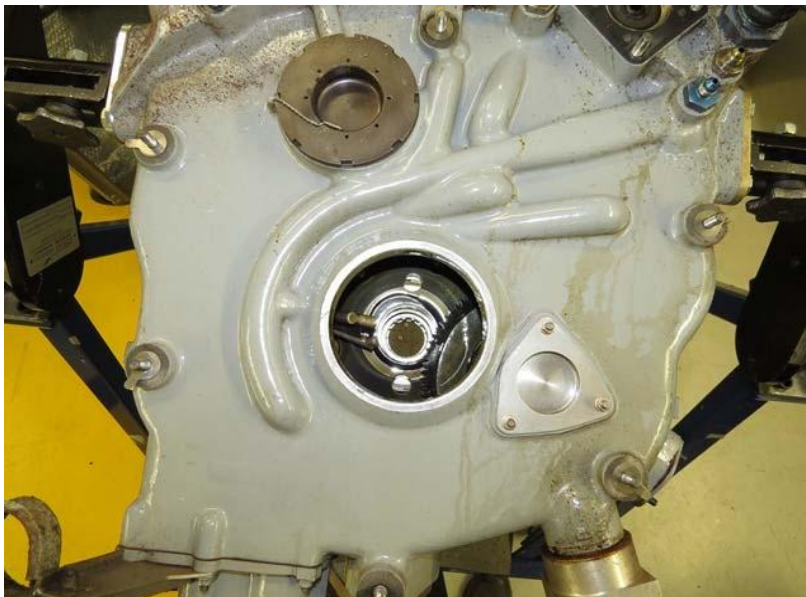
Fig 6

The accessory gear box was not opened. No damage to the gear box was noted. Manual rotation of both N1 and N2 drive trains at the tachometer generator pads resulted in smooth and continuous gear rotation of both N1 and N2 drive trains through the gear box. (Fig 6)

Accessory Gearbox

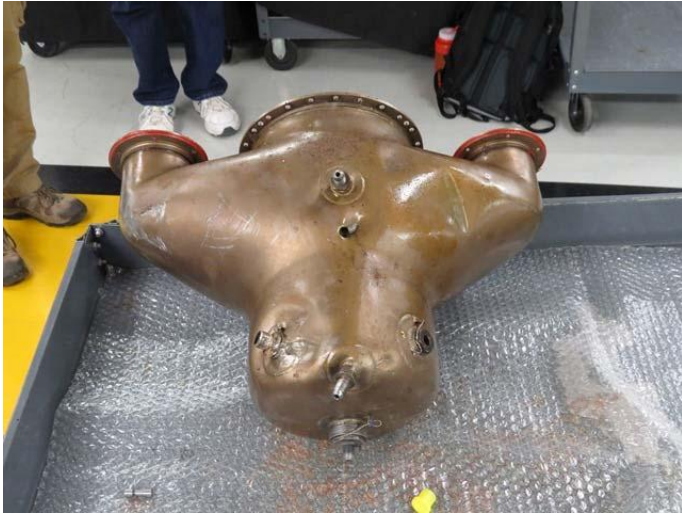
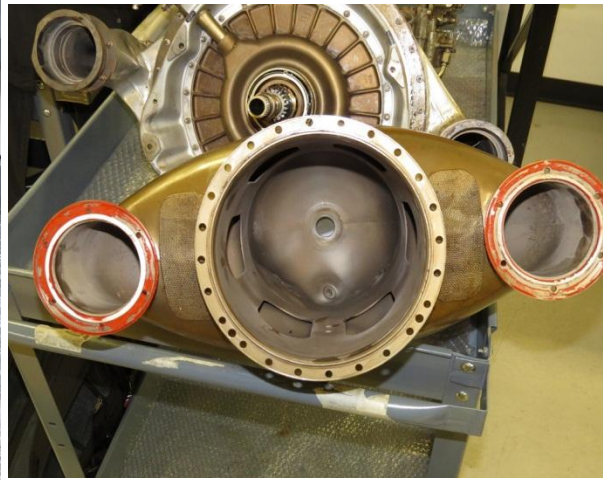
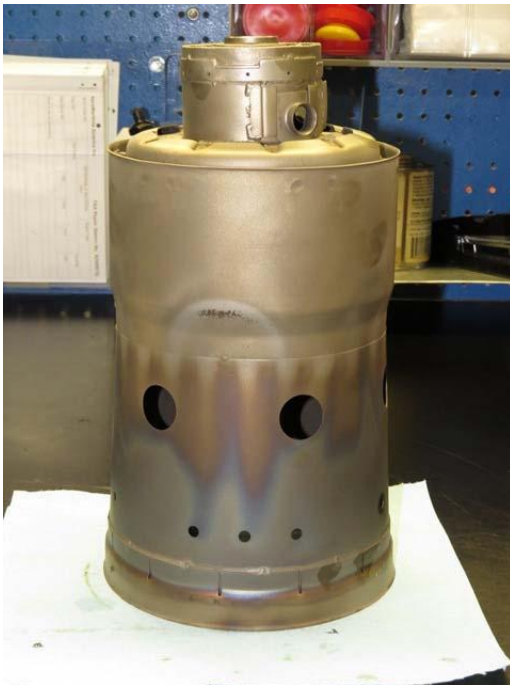
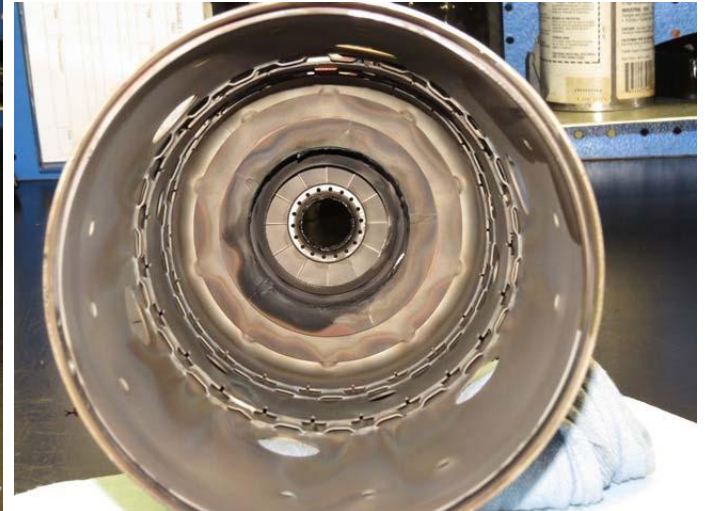
Fig 7

The outer combustion case exhibited impact damage across the bottom surface. A small puncture hole was noted just forward of the combustor drain emanating from the outside inward. The combustor liner was in position and visually undamaged. Removal and examination of the combustor liner revealed it to be normal in appearance with no evidence of unusual streaking or thermal damage. Both left and right side compressor air discharge tubes were in position and properly seated. The left air tube exhibited impact denting along its length with the right side being visually normal. A light dirt coating was noted throughout both air discharge tubes and internally on both the outer combustion case and combustor liner. (Fig 7)

Outer Combustion Case

Combustor Liner

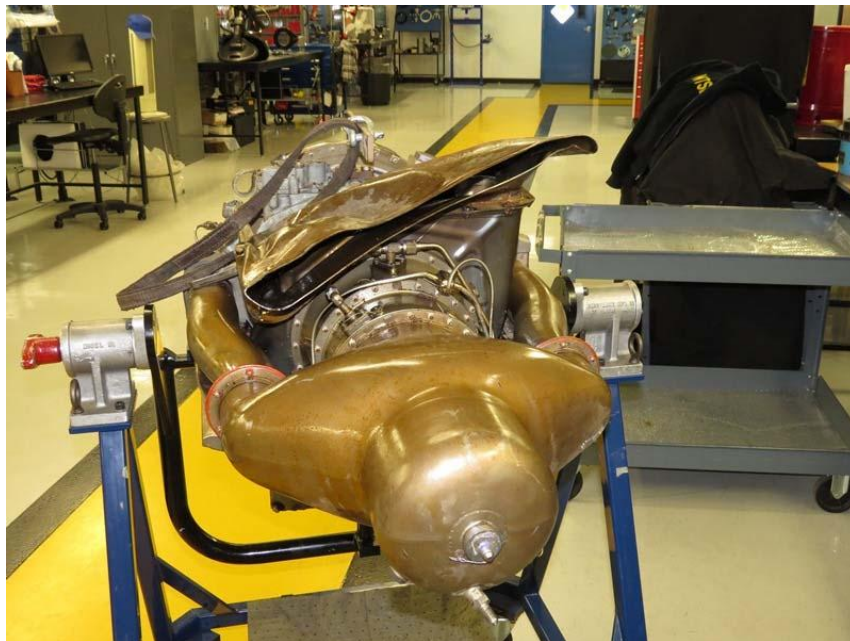
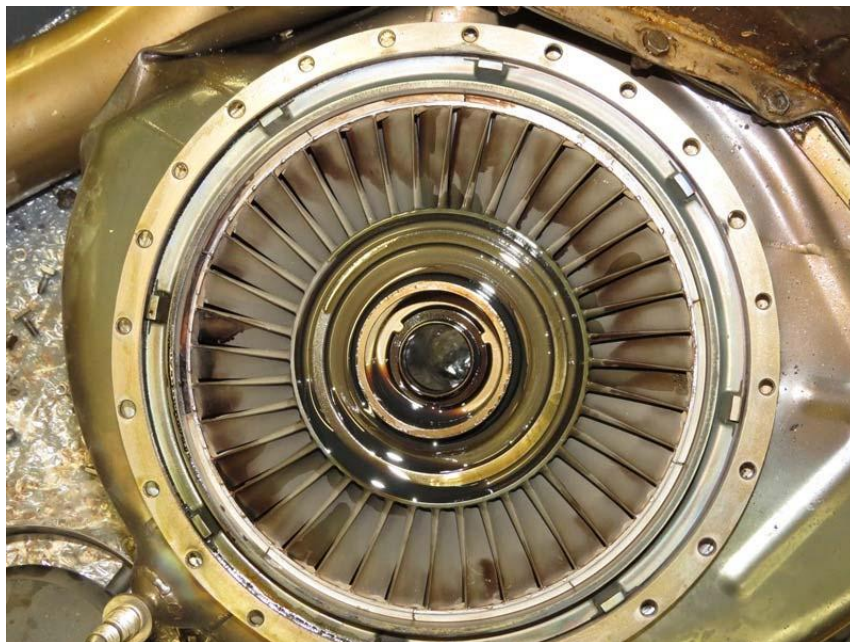
Fig 8

Both the gas producer and power turbine supports were visually normal and undamaged. The gas producer rotor was freely rotatable and undamaged. The power turbine rotor was easily rotatable but did exhibit a slight drag due to the impact damage sustained to the exhaust collector support causing an out of round condition in the blade track of the stage three and stage four wheels. (Fig 8) The turbine was separated from the exhaust collector support allowing visual access to the pressure side of the stage three wheel and the suction side of the stage three nozzle. Removal of the stage three nozzle allowed for visual examination of the suction side of the stage two wheel. Thermocouple harness probe tips revealed no evidence of over temperatures. Dirt adhesion was noted throughout the gas path across vane and blade surfaces with heavier amounts observed on the inside of the outer rim area of the stage three wheel. The stage three wheel was otherwise

Exhaust Collector Support Damage

Power Turbine Rotor in Position inside exhaust Collector Support

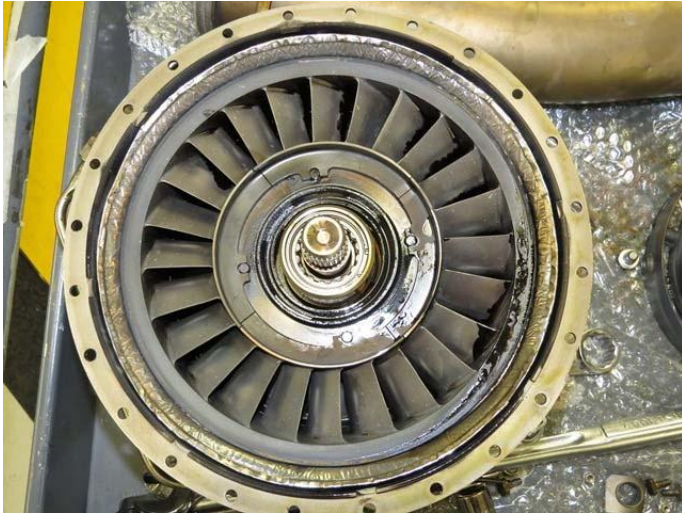
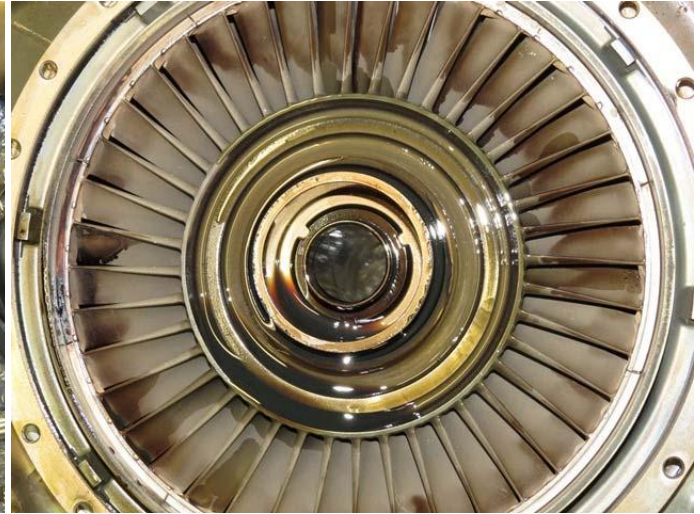
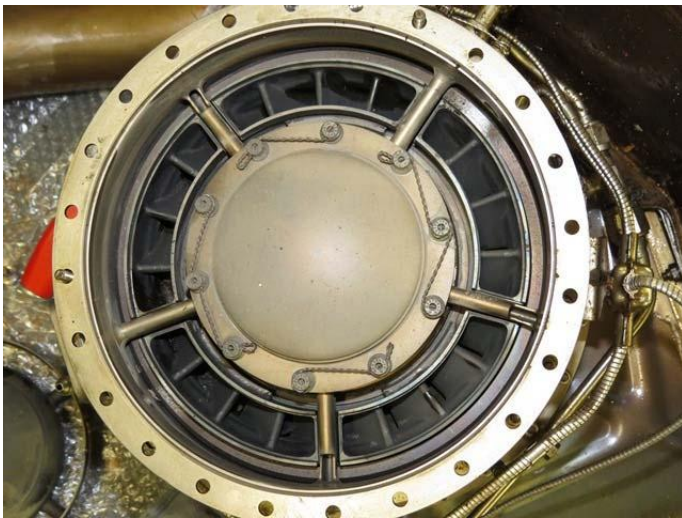
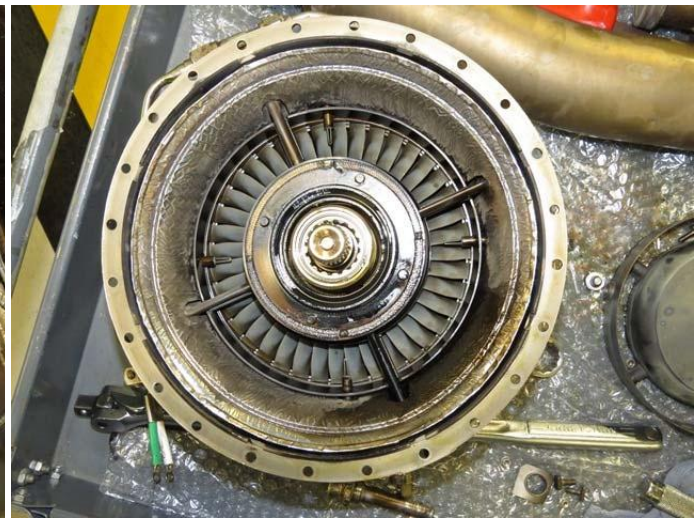
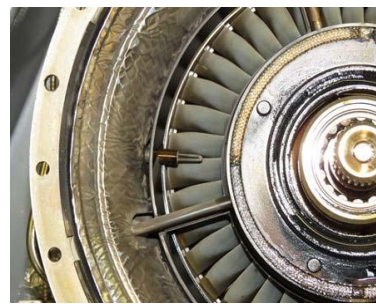
Fig 9

visually normal and undamaged. The stage four nozzle was in position and undamaged. The stage three nozzle was undamaged but exhibited light spatter across vane surfaces. Coked oil was noted on the suction side near bore and outer rim areas. The stage one wheel and nozzle and the stage two wheel and nozzle were visually normal and exhibited no damage. (Fig 9)

Stage Three Nozzle

Stage Three Wheel

Stage One Nozzle

Stage Two Wheel

Thermocouple Probe

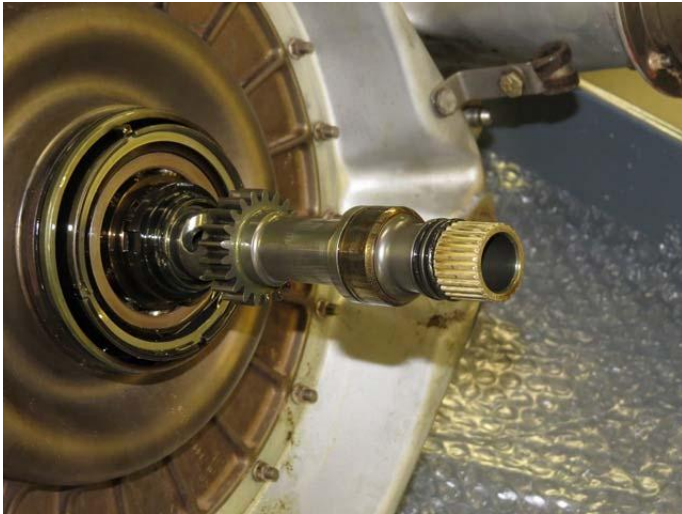
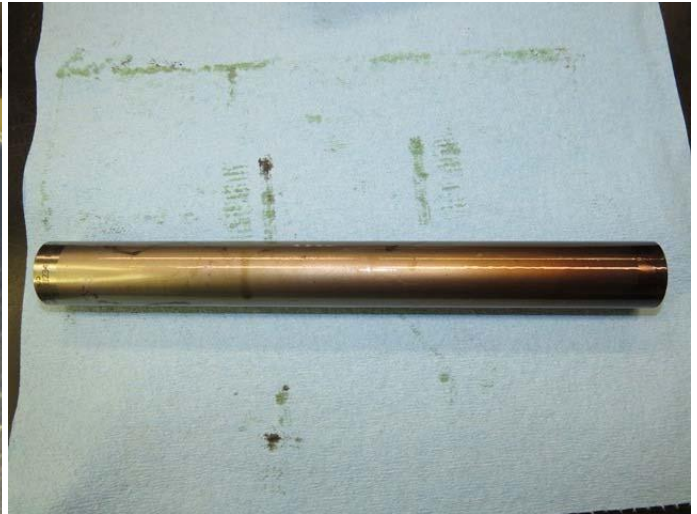
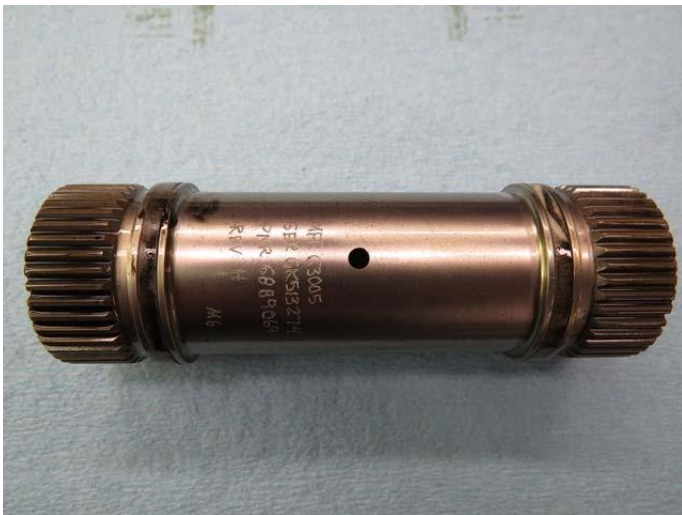
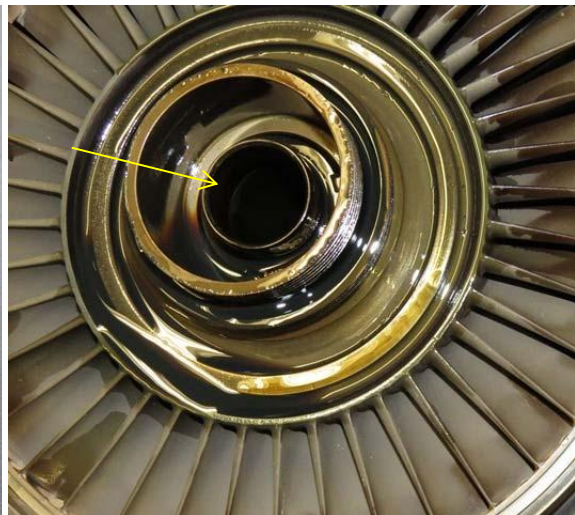
Fig 10

Examination of N1 shafting consisting of the turbine to compressor coupling and spur adapter gear shaft revealed both to have been properly seated, oil coated and visually normal in appearance. The power turbine to pinion gear coupling was in normal position, undamaged and oil coated. The power turbine rotor was not separated however both the power turbine inner shaft and power turbine outer shaft were in normal position and undamaged. (Fig 10)

Spur Adapter Gear Shaft on Position

Turbine to Compressor Coupling

Power Turbine to Pinion Gear Coupling

Aft End of Power Turbine Inner Shaft in Position

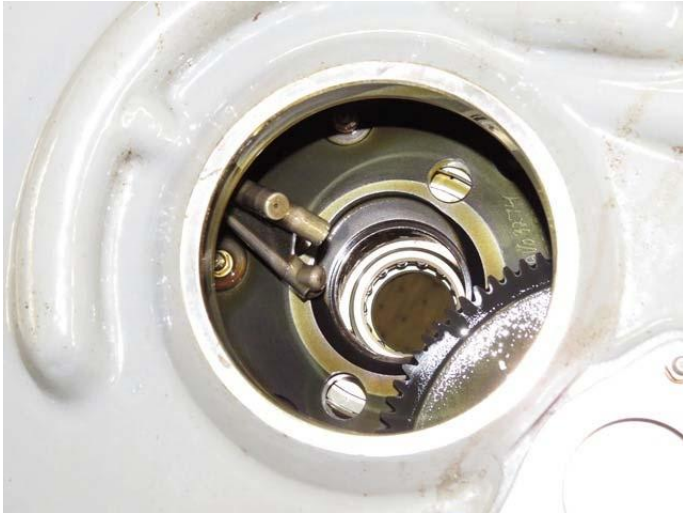
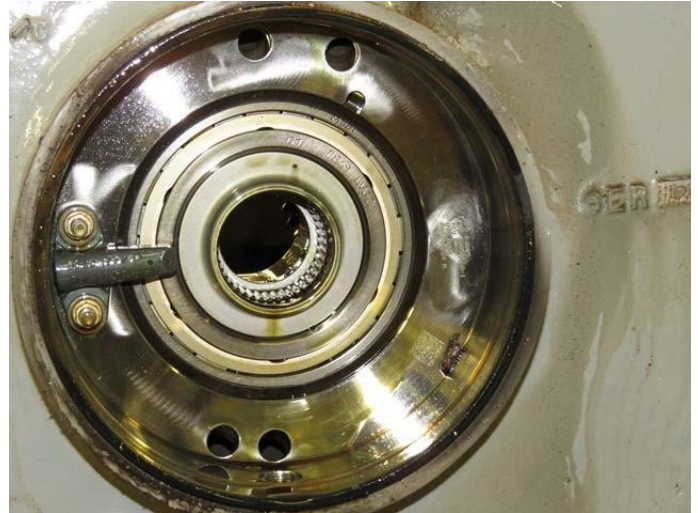
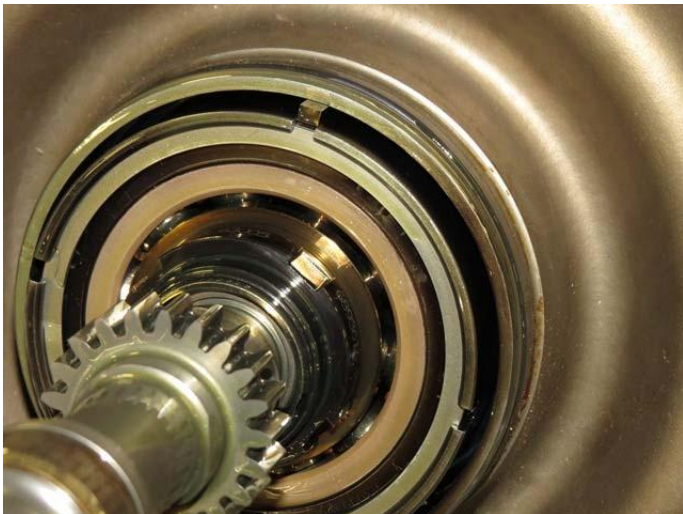
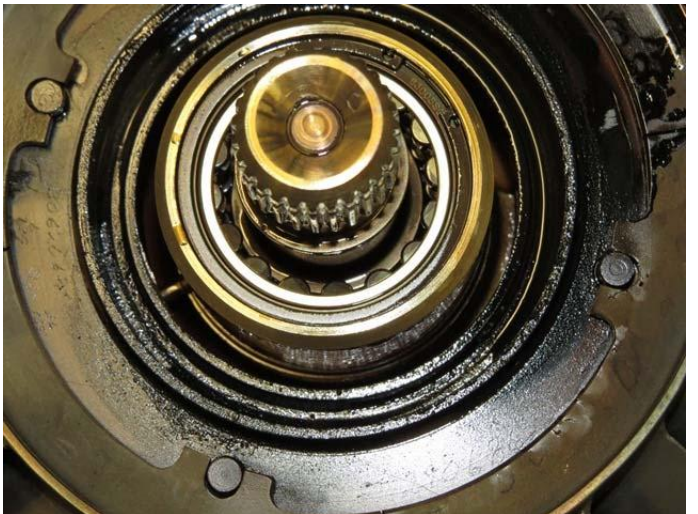
Fig 11

Manual rotation of the N1 gear box drive train resulted in smooth rotation of the oil pump. The internal portion of the accessory was coated with clean oil. The piccolo tube was in position and undamaged. The #4 bearing oil nozzle was in proper position and visually undamaged. The # 1 and #8 bearings were not removed but rotated freely during manual rotation. Engine bearings #2, 2 ½, 3, 4, 5 and 6, were all visually and tactilely examined. Each was found in proper position, oil coated with all balls and or rollers in position and undamaged. (Fig 11) Both the upper and lower chip detectors were void of metal. (Fig 12)

Piccolo Tube and #2 1/2 Bearing in Position

4 Bearing and #4 Bearing Oil Nozzle

2 Bearing in Position

#6 Bearing in Position

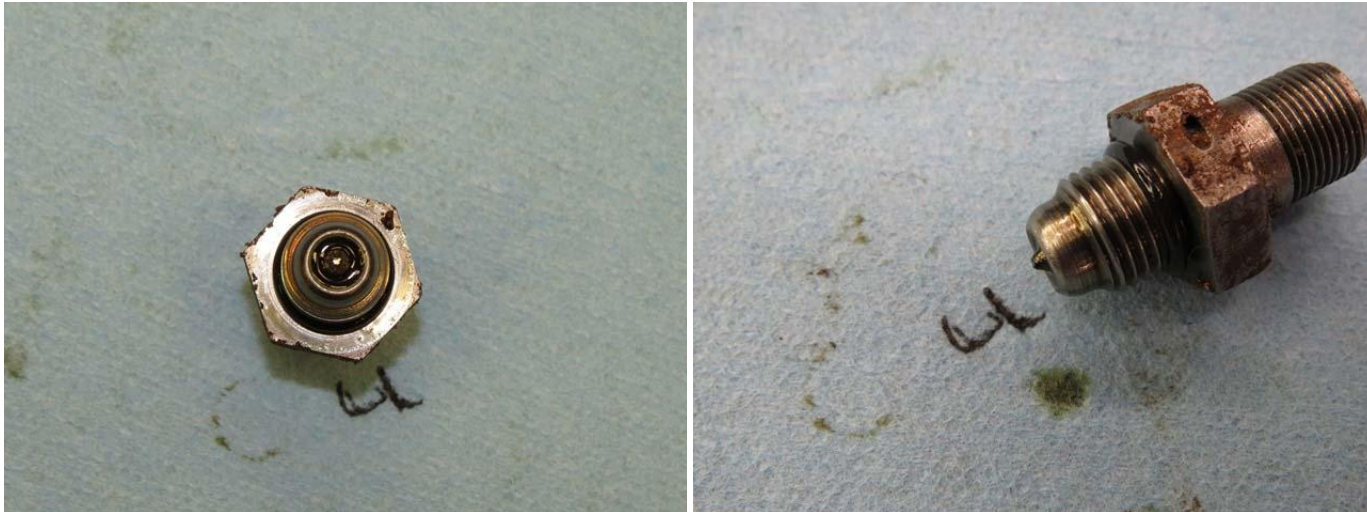
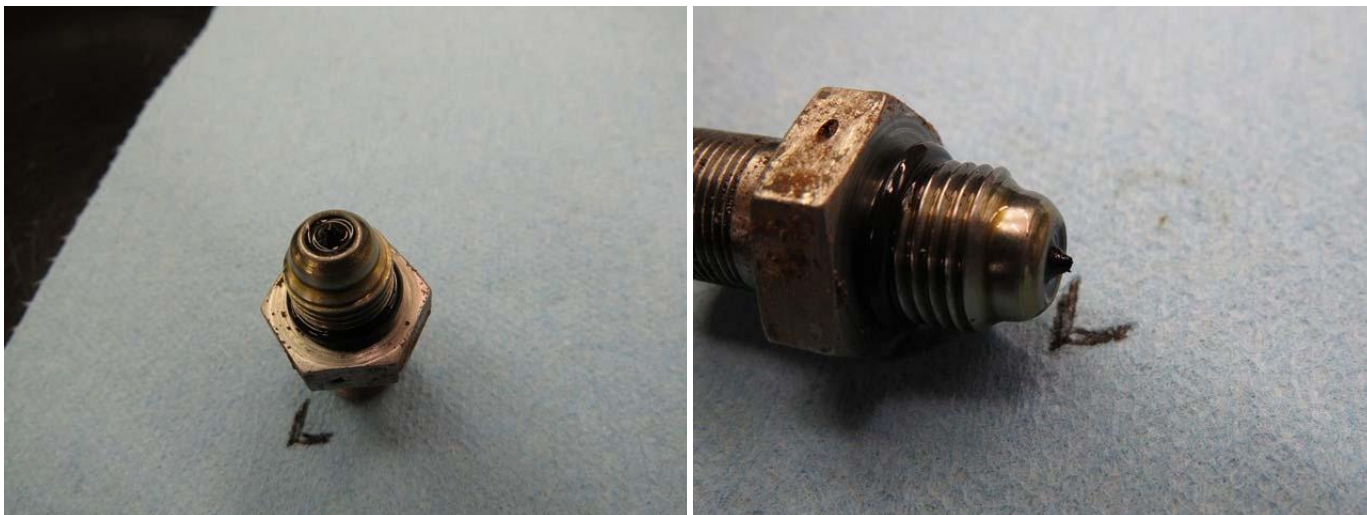
Fig 12

Upper Chip Detector

Lower Chip Detector

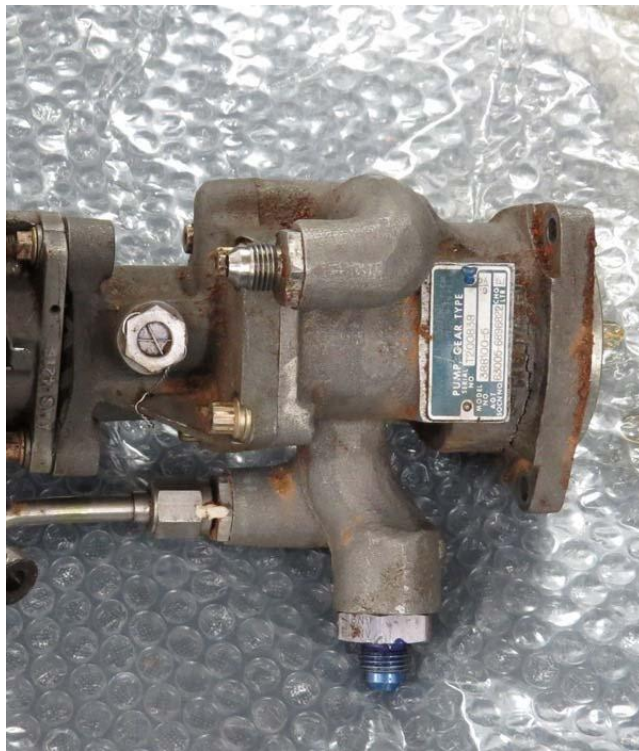
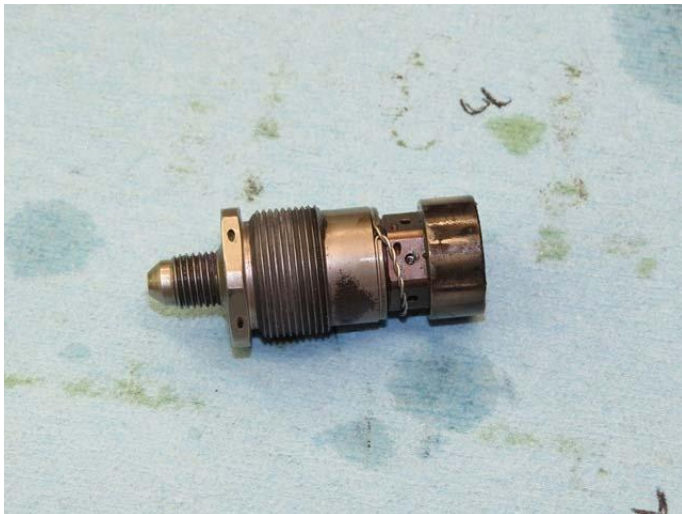
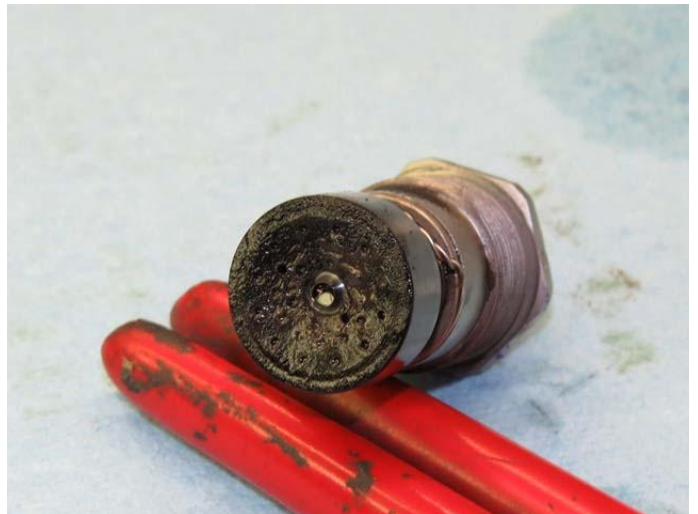
Fig 13

Fuel system examination consisted of visual examination of the engine fuel pump and all associated engine fuel lines and visual examination of the fuel nozzle. The engine fuel pump was in position with no visible damage. At fuel pump removal the pump drive shaft was normal in appearance and undamaged. Removal of fuel lines at the fuel pump revealed fuel present in the lines. Removal of the fuel line between the check valve and fuel nozzle revealed fuel present in the line. The fuel nozzle was visually normal with no excessive carbon on the outer air shroud. (Fig 13)

Fuel Pump

Fuel Nozzle

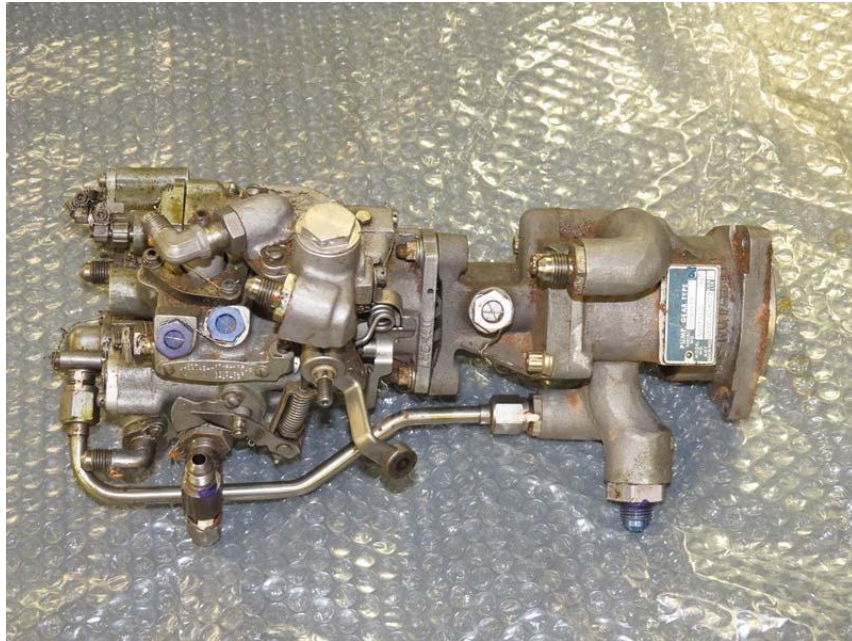
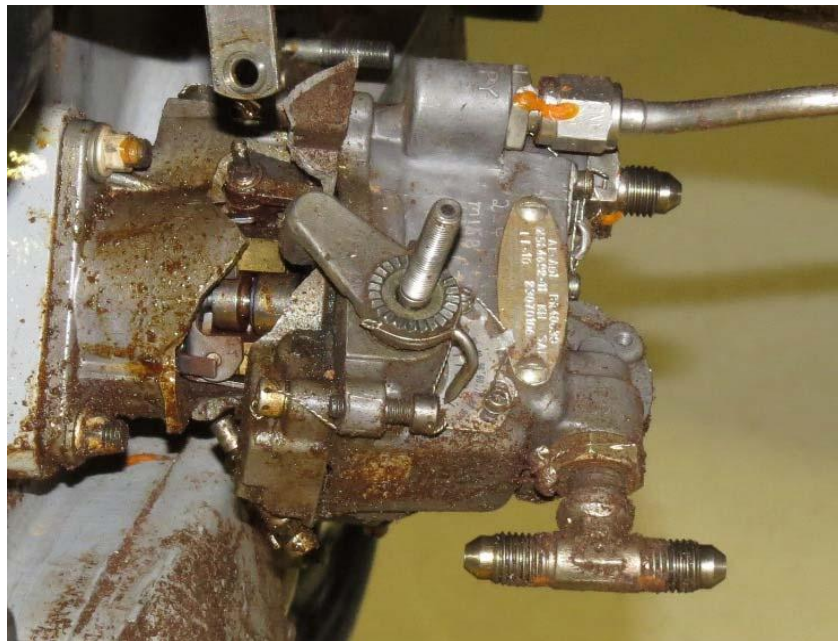
Fig 14

The fuel control unit was normal in appearance with no visible damage. Manual operation of the fuel control unit throttle arm resulted in full and smooth travel from stop to stop. The power turbine governor was fractured from impact at the at the split line forward of the after body and could not be actuated due to damage but was otherwise visually normal. (Fig 14)

Fuel Control with Fuel Pump

Power Turbine Governor
