## **Engine Investigation Report**

**Rolls-Royce Model 250-C30P  
Engine CAE 896108**

**Bell 206L-4  
Registration: N405MR**

**Incident date: June 30, 2013  
On-Site Examination Date: July 2, 2013  
Examination at Keystone Date: July 11, 2013  
Examination at Rolls-Royce Date: Sep 25-26, 2013  
Report date: 18 March, 2014**

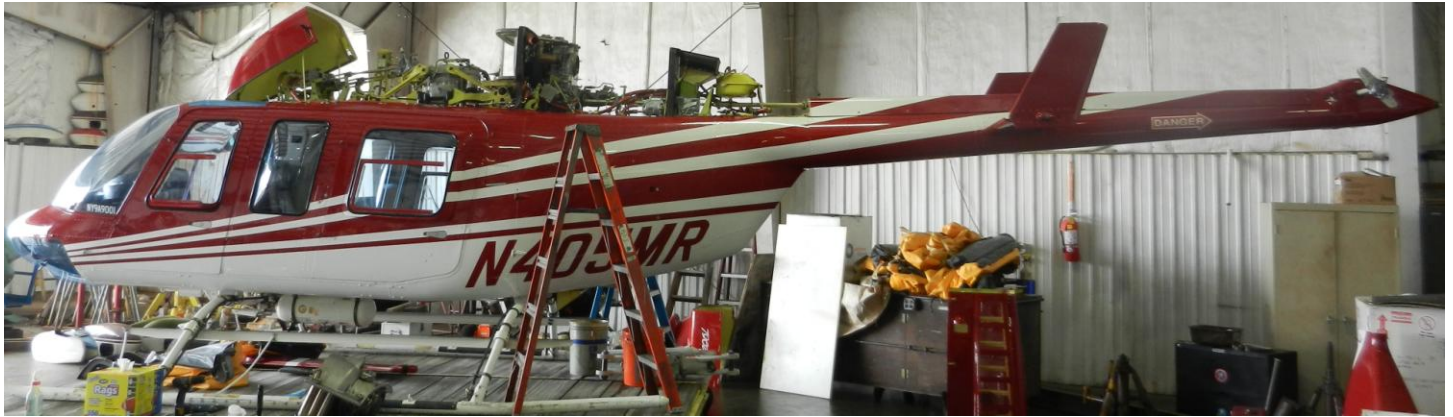
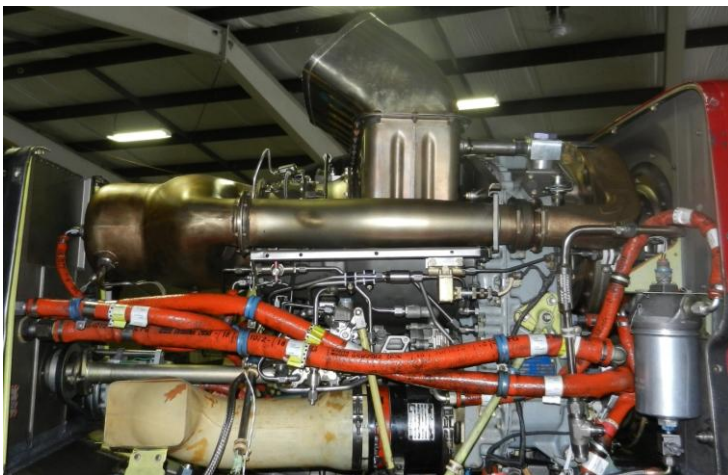
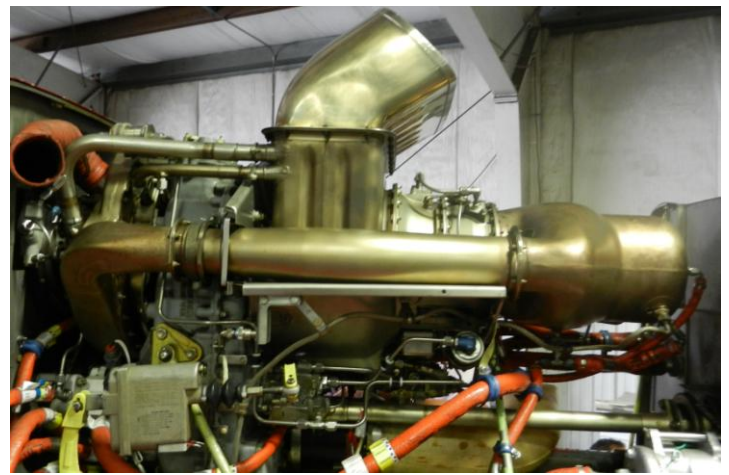
Fig: 1

With battery power applied to the aircraft the engine chip light was illuminated. The lower chip detector was disconnected and the chip light remained illuminated. The lower chip detector was reconnected and the upper chip detector was disconnected and the light remained illuminated,

indicating that metallic debris was located on both chip detectors. Both chip detectors were removed for inspection. The upper chip detector contained small amounts of metallic debris and metallic paste. The lower chip detector also contained metallic paste, metallic debris, along with a several metallic flakes. The aircraft scavenge oil filter bypass indicator was not extended. The filter bowl was removed and contained metallic particulate. The filter was clean other than a small amount of metal particles.

Aircraft at Recovery

Engine Installed at Recovery

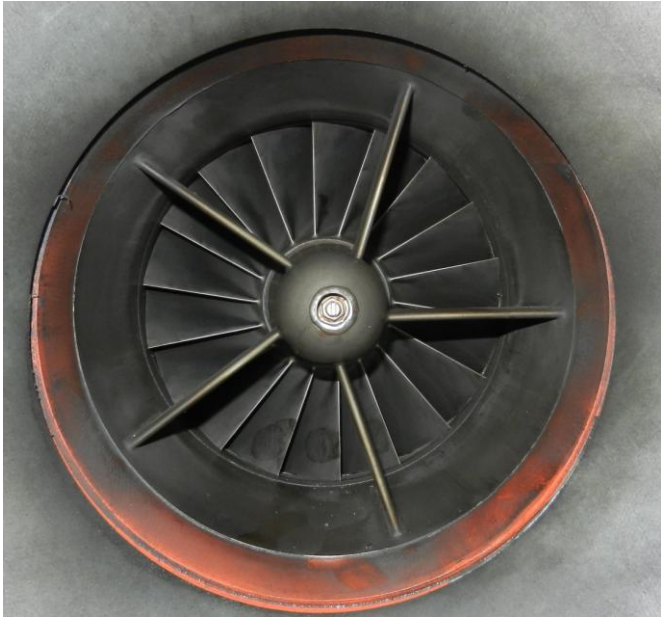
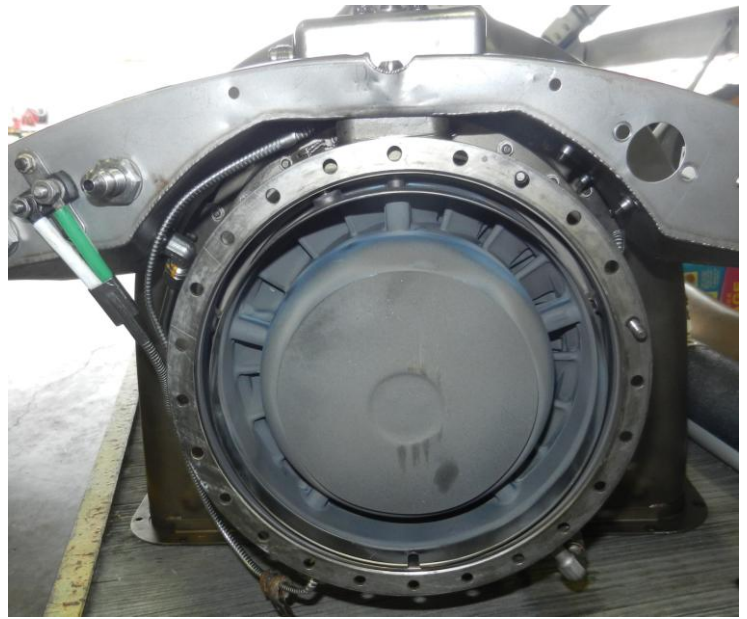
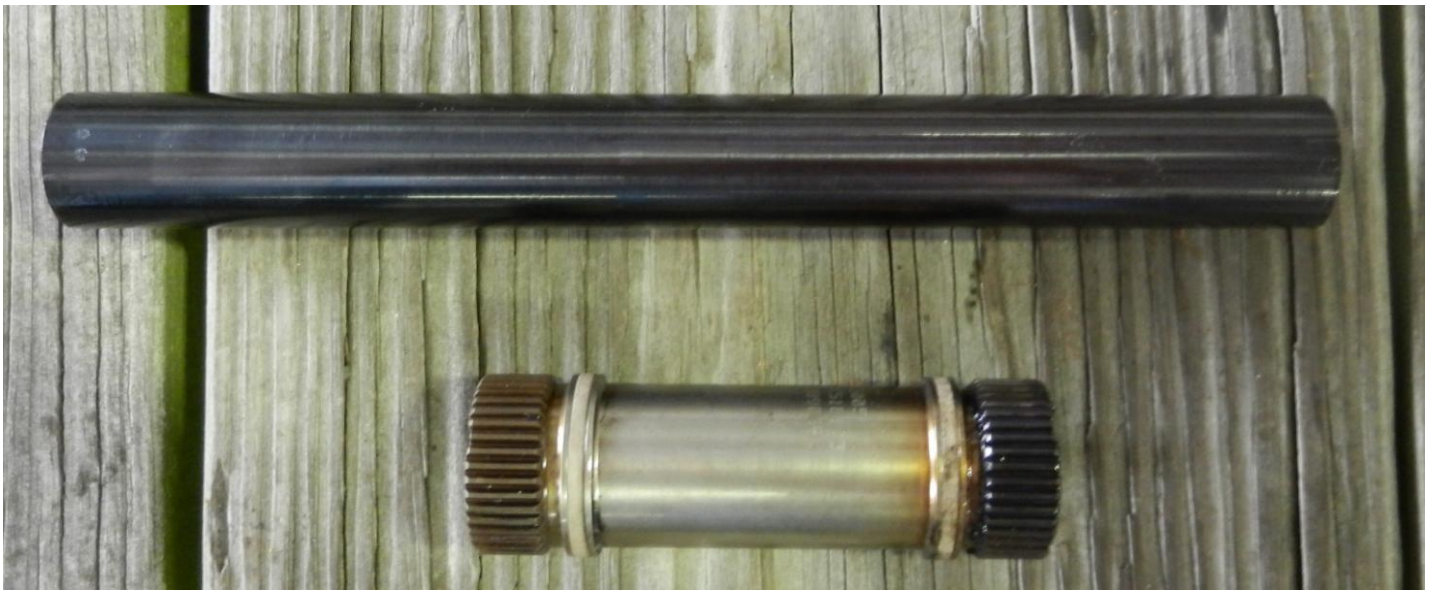
Fig 2:

Attempts to motor the engine were unsuccessful with no N1 rotation as the starter/generator was turning. The compressor was attempted to turn by hand, but was rough and would bind after about a quarter turn.

The Turbine Module was removed from the engine and showed no signs of damage. The outer combustion case and combustion liner were removed to facilitate further inspection. Inspection of the combustion section revealed metallic spatter coating the inside of the combustor liner and both air discharge tube. There was evidence of carbon within the combustion liner and on the face of the fuel nozzle, but no excessive hot spots on the combustion liner assembly. The combustor liner was otherwise normal in appearance. The gas producer and power turbine supports were unremarkable. Both the Gas Producer Turbine and the Power Turbine turned freely by hand. Examination of the 1<sup>st</sup> stage turbine nozzle and nozzle shield revealed metallic spatter across the nozzle shield face and 1<sup>st</sup> stage nozzle surfaces. Visible portions of the 1<sup>st</sup> stage turbine wheel were normal in appearance. The power turbine to pinion gear coupling and turbine to compressor coupling were in place and undamaged. **Fig 2:**

Compressor As Installed

Stage Turbine After Removal

Power Turbine To Pinion Gear Coupling And Turbine To Compressor Coupling

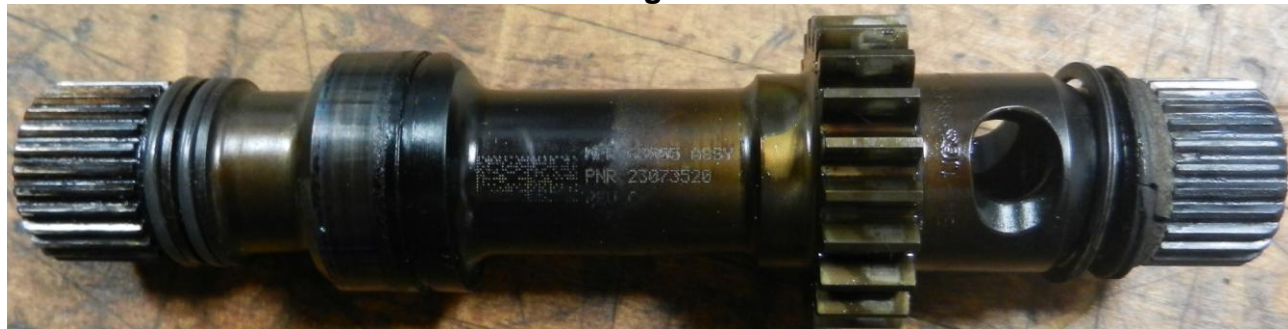
**Fig 3:**

The Compressor was removed from the shipping box for examination. The compressor impeller remained locked. The spur adapter gearshaft was in place with slight damage to the teflon seal. It was covered with a carbon substance, but was otherwise unremarkable **Fig 3**. The No. 2 bearing was dry and damaged with signs of heat distress. The bearing was removed and showed further signs of damage to the bearing and inner race. The forward side of the bearing revealed the most significant damage **Fig 4**. The compressor was further disassembled and the impeller shroud showed signs of significant rub damage from the impeller with corresponding rub indications 360 degrees around the impeller blades **Fig 5**. The No. 1 bearing was oil wetted and did not show any signs of damage.

Spur Adaptor Gearshaft

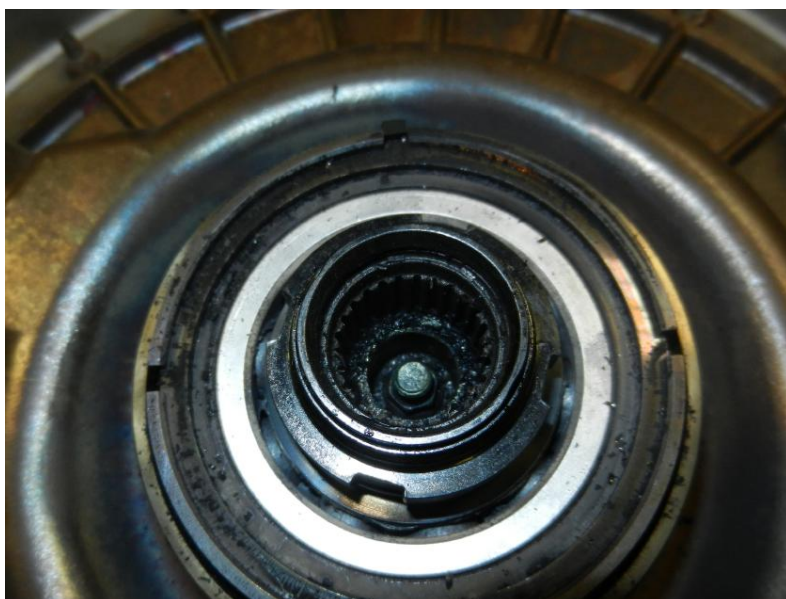
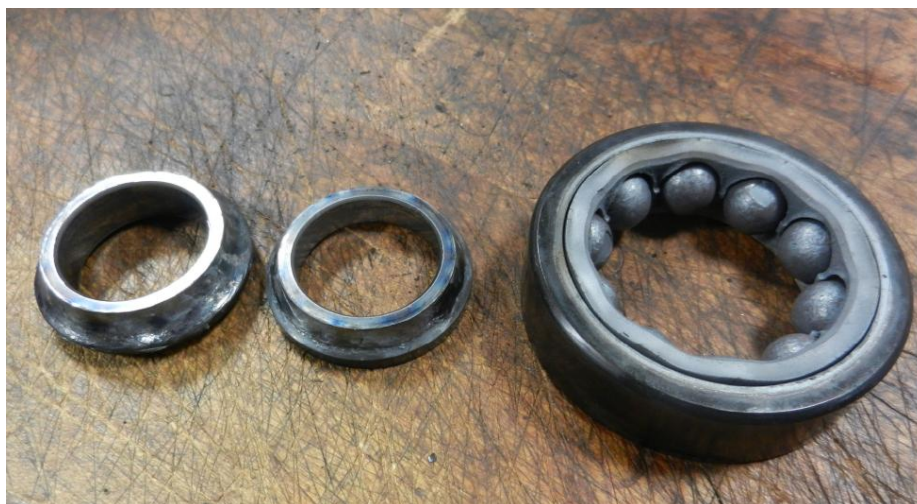
**Fig 4:**

No. 2 Bearing While Installed In Support

No. 2 Bearing Removed at Keystone

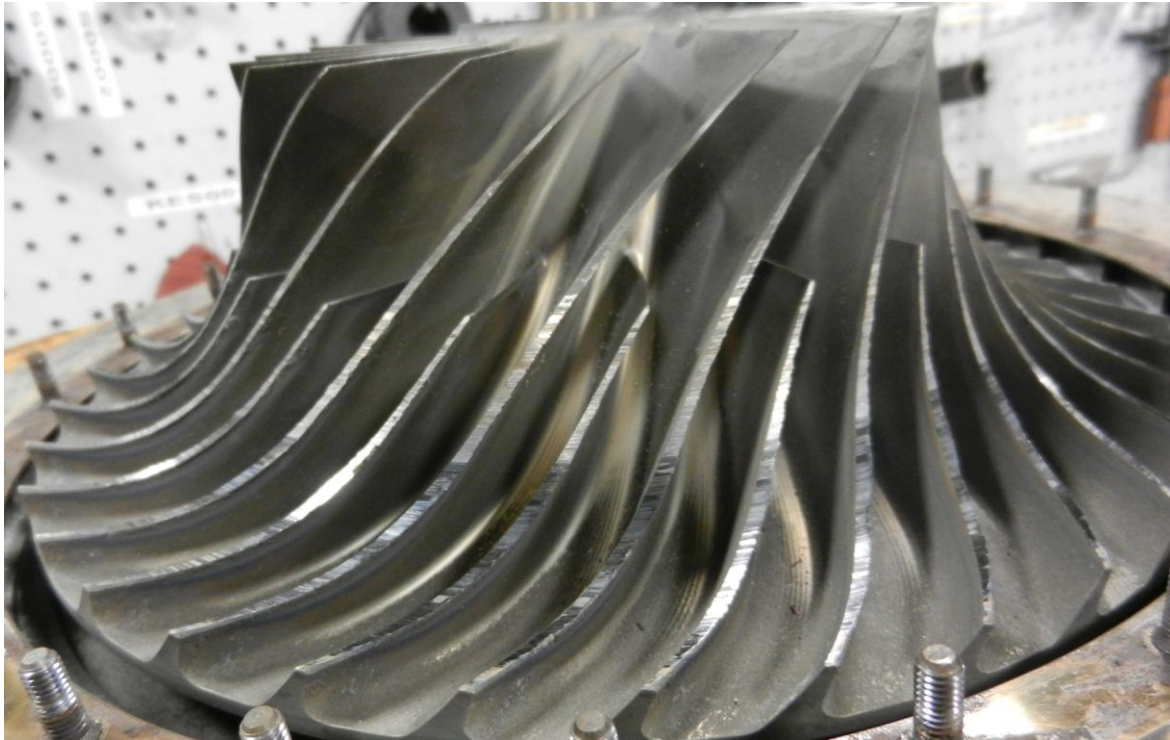
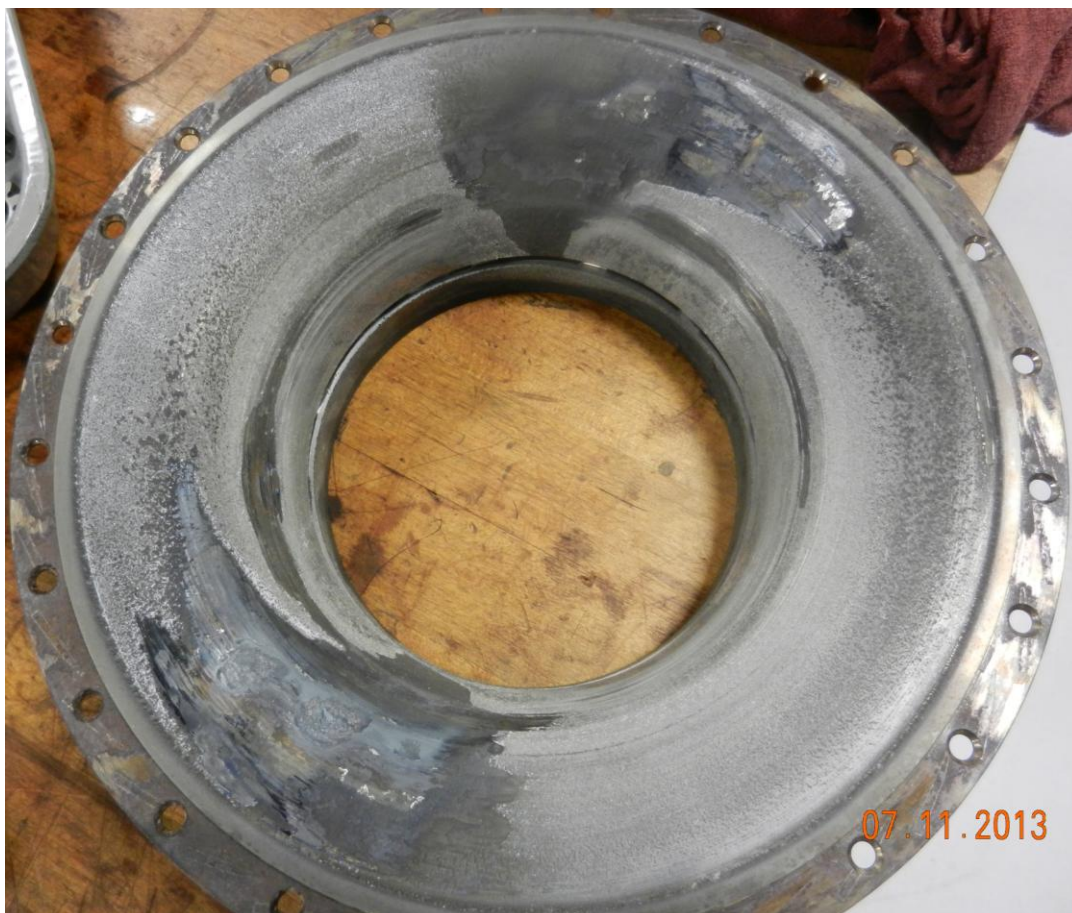
Fig 5:

Impeller

Impeller Shroud

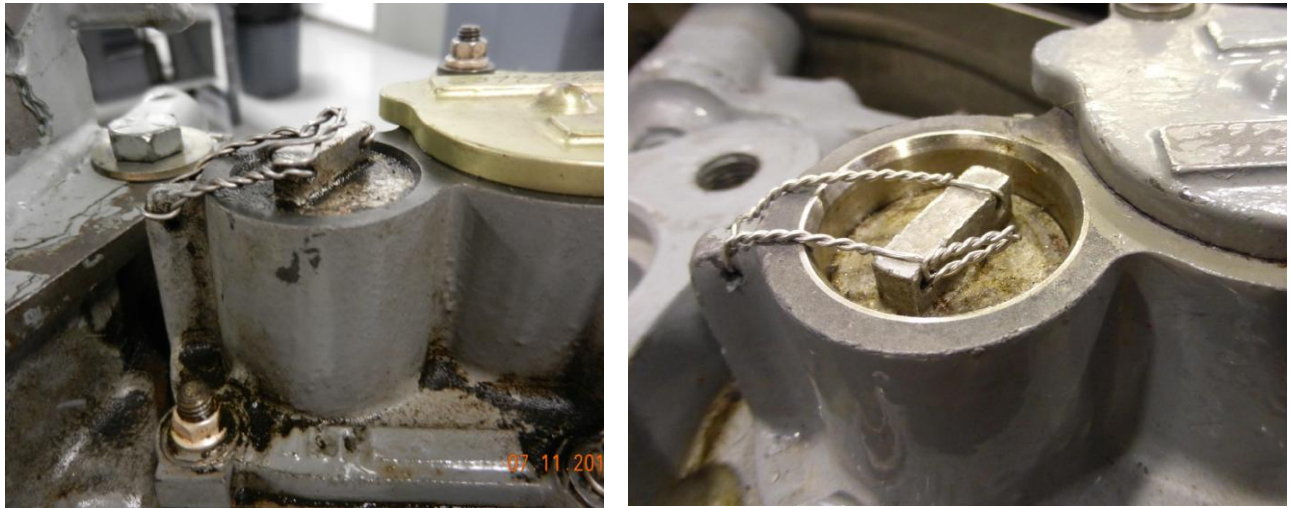
**Fig 6:**

The gearbox assembly was removed from the shipping box for examination. Visual examination of the gearbox did not reveal any damage. It was noted that the oil pressure regulator adjustment was backed out with the poppet guide observed abnormally close to the outer lip of the housing. After removal of the lock wire, and unscrewing the poppet guide outward approximately one turn, the O-ring was visible. **Fig 6** shows the regulator in the position as found during examination compared to a similar regulator adjusted in a more typical position on an engine coming in for repair.

An initial approximate adjustment is made by bottoming the valve and then backing it out 5 - 1/2 turns. Backing out (counter clockwise turning) of the regulator adjustment would decrease system oil pressure. One turn of the adjustment will change the oil pressure approximately 13 psig. Rolls-Royce maintenance manual states "Except for initial adjustments on newly installed engines, do not adjust the pressure regulating valve to correct for high oil pressure. Do not make a pressure regulating valve adjustment to correct for a sudden increase or rapid change in oil pressure. These conditions are cause to suspect other oil system problems have developed".

Oil Pressure Regulator As Found At Keystone (Left) Compared To An Oil Pressure Regulator Adjustment On A Similar Engine At A Repair Facility(Right)

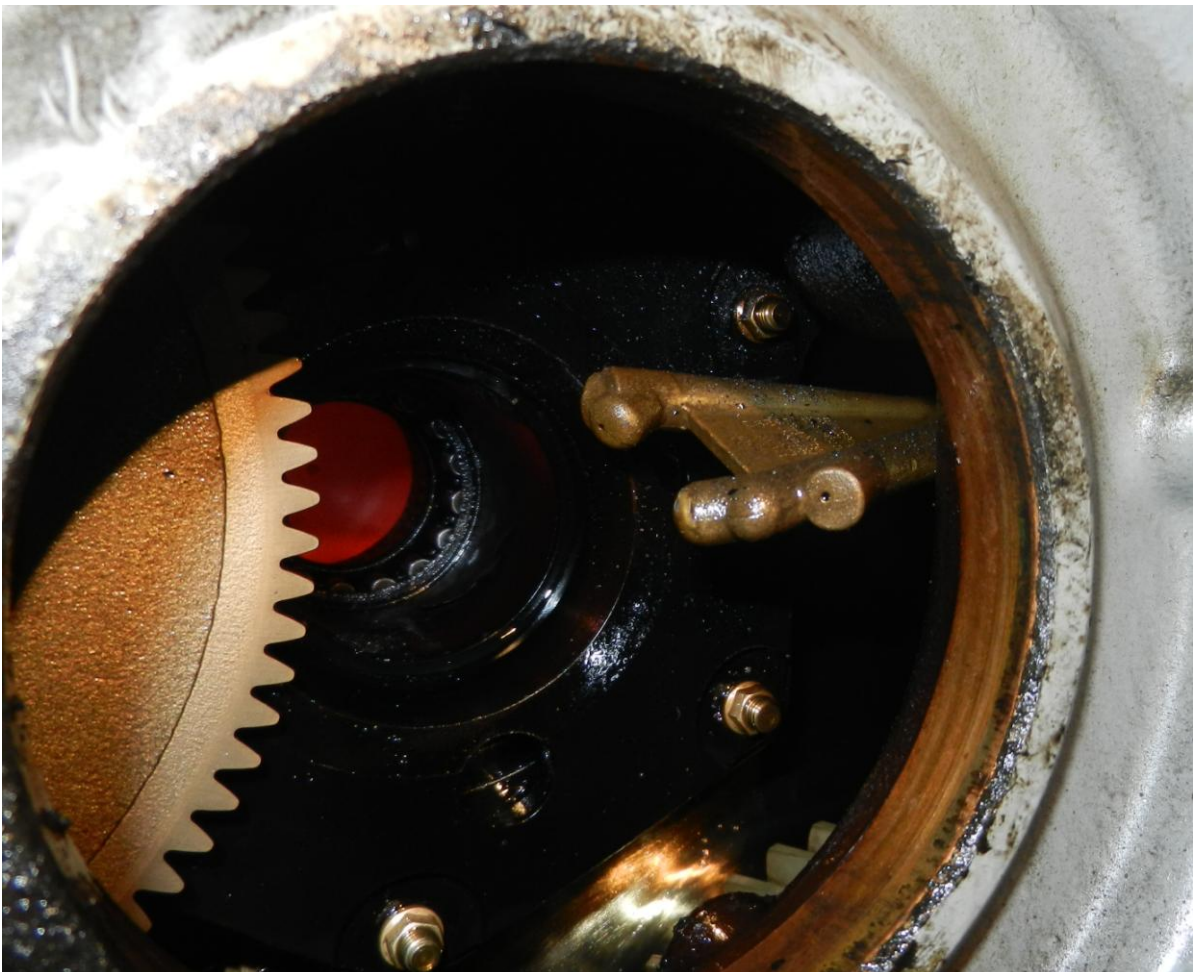
**Fig 7:**

Oil flow through the gearbox was tested by connecting an oil reservoir to the gearbox oil inlet and turning the oil pump by using a pneumatic ratchet and splined adaptor. Oil flowed through all visible oil passages except one oil jet located on the oil delivery tube (piccolo tube) used to lubricate the # 2 bearing. The gearbox was disassembled for further examination. The interior of the gearbox did not show signs of any abnormalities. The oil pump was disassembled and was unremarkable other than slight scaring, indicating that metallic fragments may have passed through the pump. The piccolo tube and pressure screen upstream of the piccolo tube were removed. The screen has heavily coated with an undetermined black substance. The piccolo tube did not show any signs of damage and none of the oil jets were visually blocked **Fig 7**.

Piccolo Tube As Installed

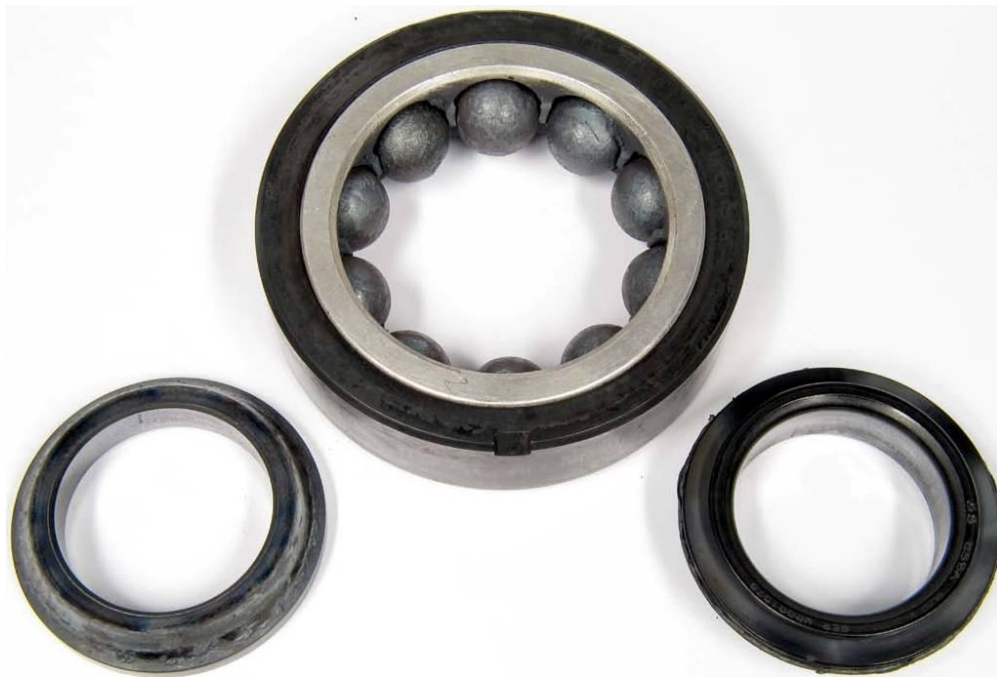
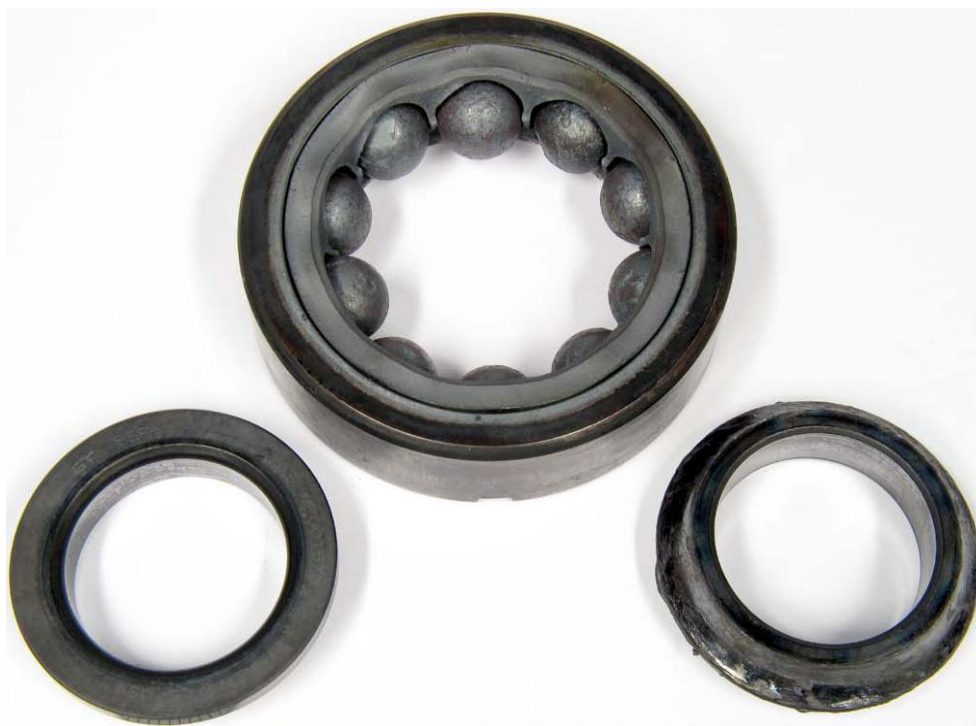
**Fig 8:**

Visual examination of the bearing revealed signs of thermal distress. The forward side of the bearing was thermally distressed more than the aft side and the separator showed plastic deformation. All ten balls were in place and generally round, however some areas were rough and exhibited loss of material. Material from the balls was transferred onto both the inner and outer races. Metallographic examination revealed thermal distress to the raceway surfaces consistent with the bearing operating with reduced oil flow. Thermal distress extended completely through the ball cross-section and localized spalling damage was evident along the ball surface. The separator showed thermal distress across approximately 75% of the cross-section extending from the forward face aft. A hardness test was not conducted due to the thermal distress of the bearing. The microstructure and chemistry of the bearing and associated hardware conformed to the engineering drawing requirements **Fig 8**.

The No. 2 bearing failed due to thermal distress. Findings were consistent with reduced oil flow to the bearing. Thermally degraded MIL-PRF-23699 type turbine oil was found throughout the engine oil system. The pressure oil screen located upstream of the No. 2 bearing oil delivery tube was almost completely blocked and total flow from the oil delivery tube No. 2 bearing orifice was below engineering requirements. After cleaning and retesting, the total flow of the orifice met engineering drawing requirements. The cause of the degraded oil within the system could not be determined during this investigation. The damage associated to the compressor was consistent with damage that would occur after the No. 2 bearing failure.

Aft Side Of No. 2 Bearing At Rolls Royce

Forward Side Of No. 2 Bearing At Rolls Royce

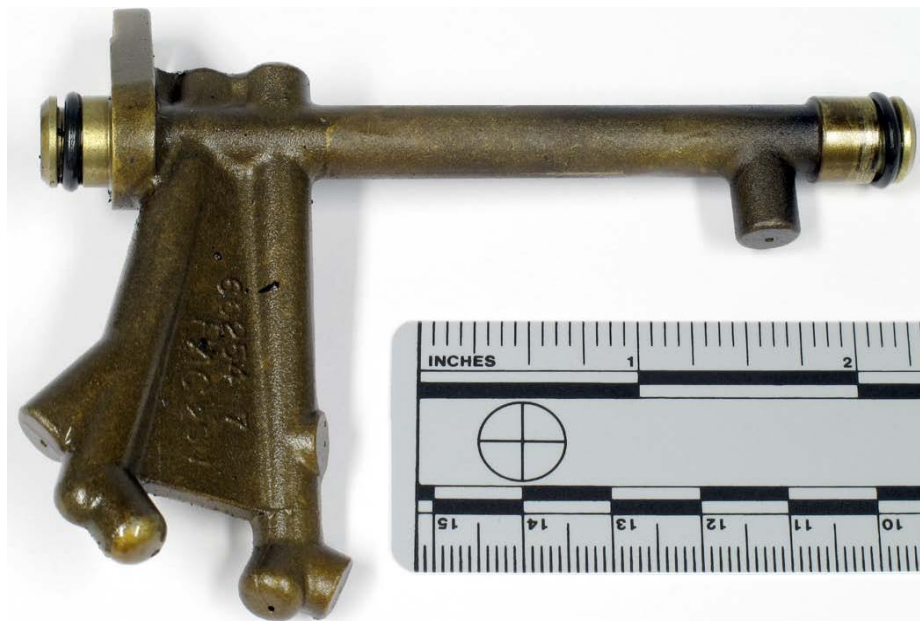
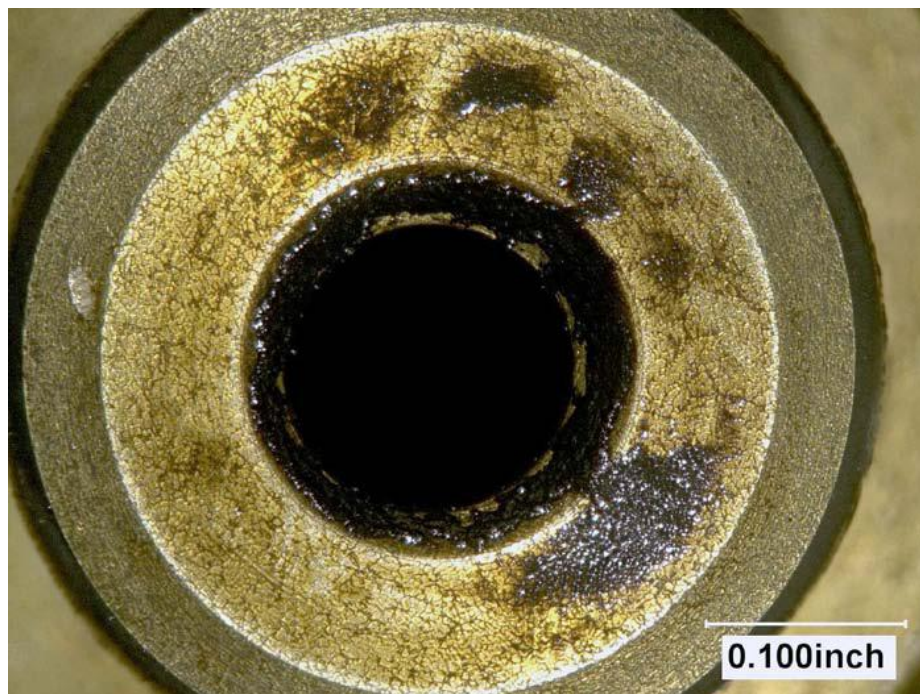
Fig 9:

Visual examination of the forward opening of the tube (oil inlet) revealed a thick-dark substance adhered to the face and chamfer. Analysis of the substance determined it was consistent with thermally degraded MIL-PRF-23699 type turbine oil. The oil jet that lubricates the No. 2 bearing did not show obvious obstruction in the orifice. The oil delivery tube was x-ray inspected for internal blockage. No restrictions were detected in any of the oil passageways. Two flow tests of the oil delivery tube were conducted. The orifice that lubricates the No. 2 bearing was below the engineering drawing total flow requirement in the as-received condition. The tube was cleaned ultrasonically while being submerged in various cleaning solutions (methanol, acetone, isopropanol, and methanol) a total of four times. The amount of debris collected decreased after subsequent cleanings. After cleaning of the internal passageway the total flow of the # 2 bearing orifice met the engineering drawing requirement during retesting **Fig 9**.

Piccolo Tube At Rolls-Royce

Face And Chamfer Of The Piccolo Tube Inlet.

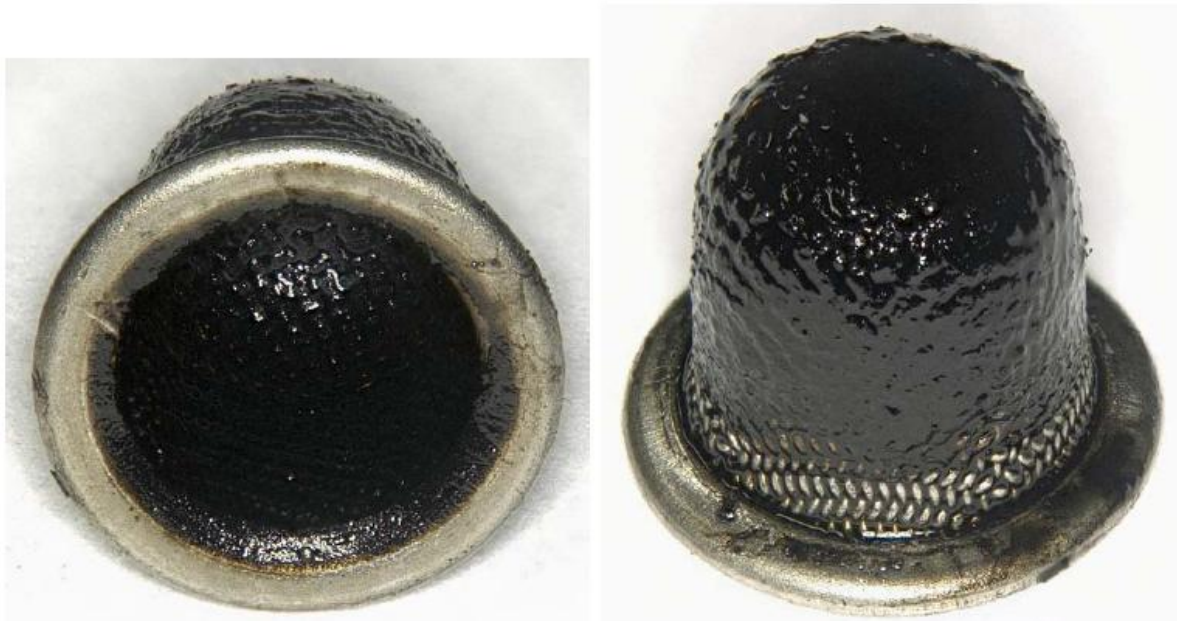
**Fig 10:**

Nearly the entire surface of the screen was covered in a thick-dark substance. The area that was not blocked was covered by the O-ring. A sample of the substance from the screen assembly was consistent with thermally degraded MIL-PRF-23699 type turbine oil **Fig 10**.

Pressure Oil Screen Located Upstream of Piccolo Tube

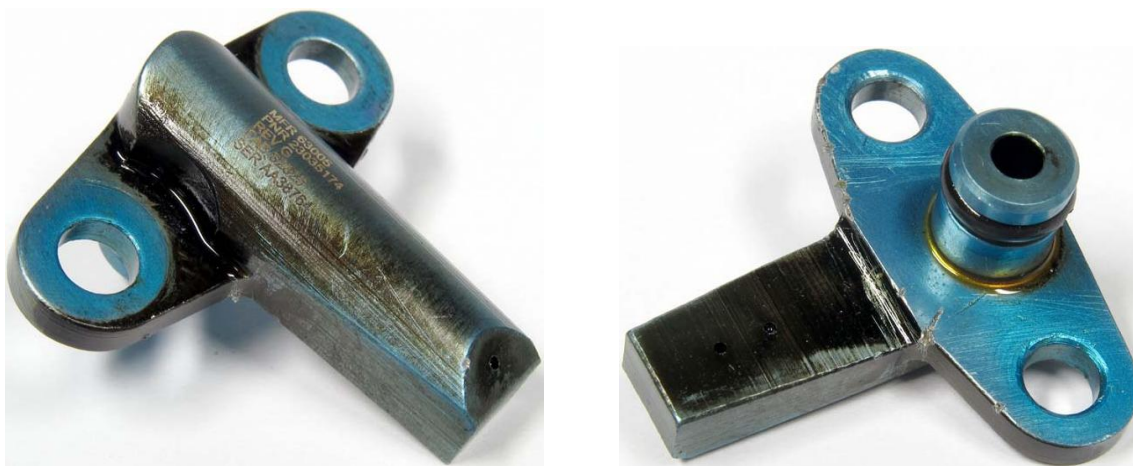
**Fig 11:**

The pinion bearing oil nozzle supplies lubrication to the No. 4 and No. 5 bearings. Binocular examination of the three orifices showed no obvious blockages. The oil nozzle was flow tested two times. Both tests conformed to the engineering drawing requirements **Fig 11**.

Pinion Bearing Oil Nozzle

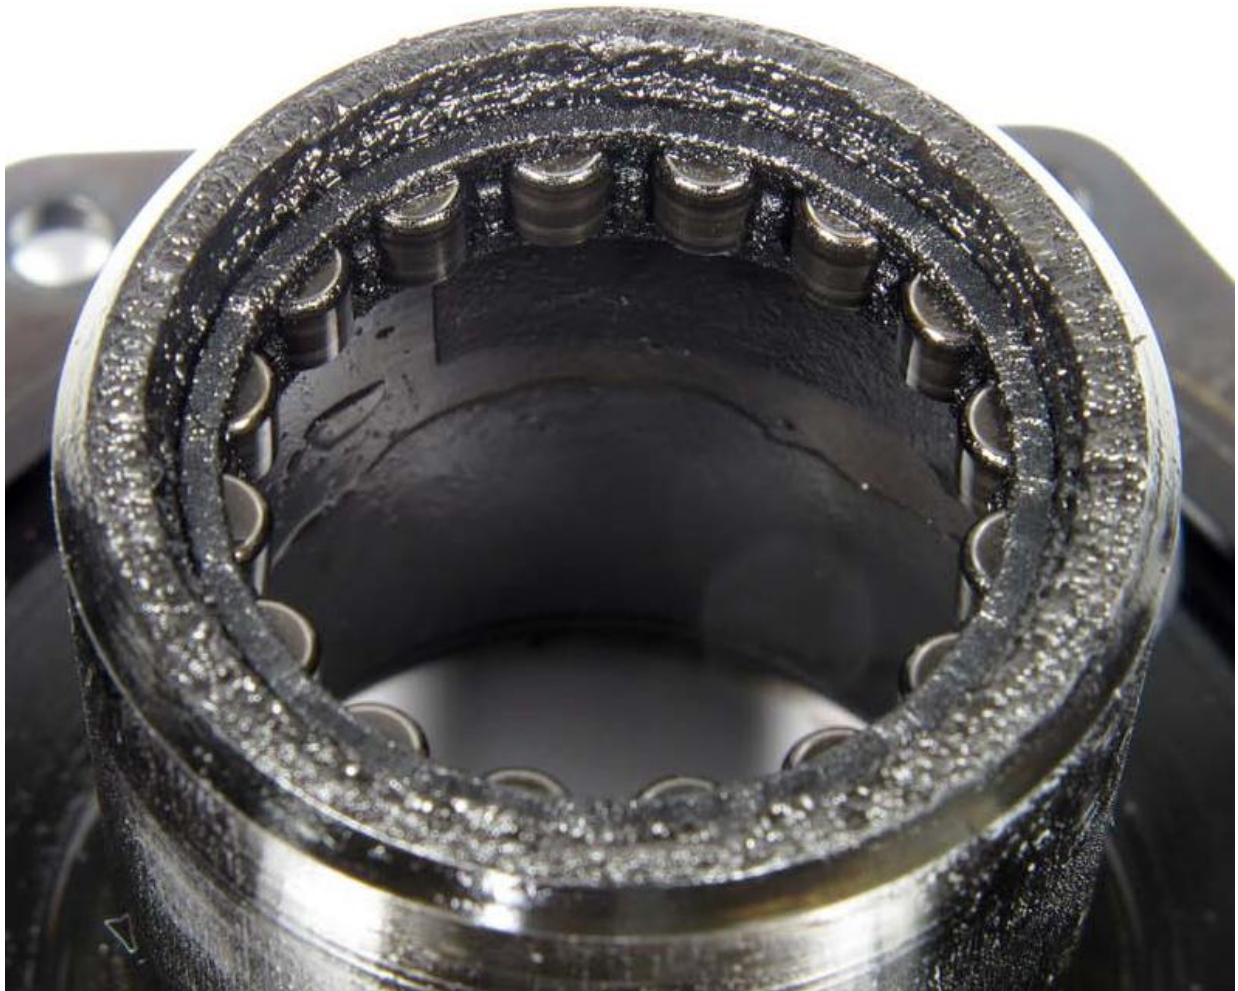
Fig 12:

Hard coked oil deposits were adhered to the surfaces of both components. The bore of the support cage had sheets of a thick-dark substance that were peeled off the surface. A sample of the substance from the bore of the support cage was consistent with thermally degraded MIL-PRF-23699 type turbine oil **Fig 12**.

No. 2 ½ Bearing And Support Cage

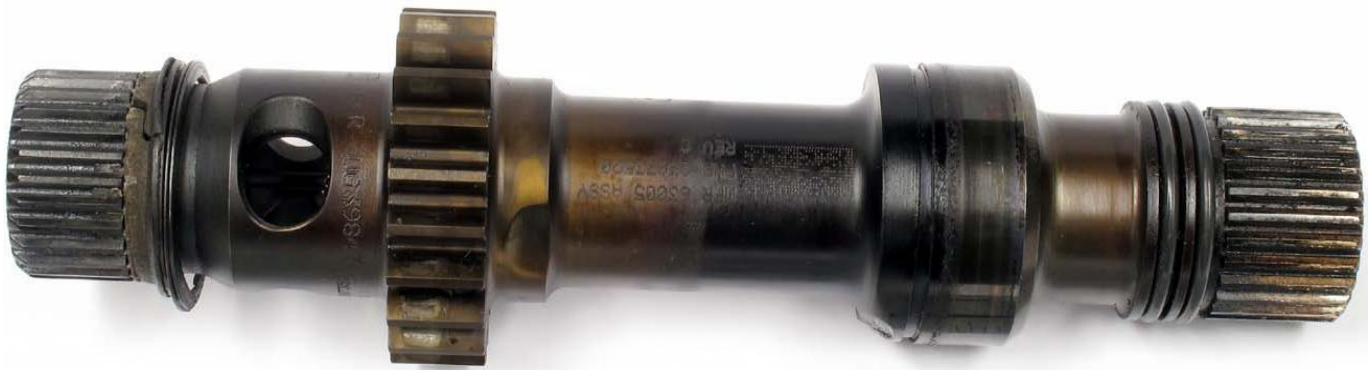
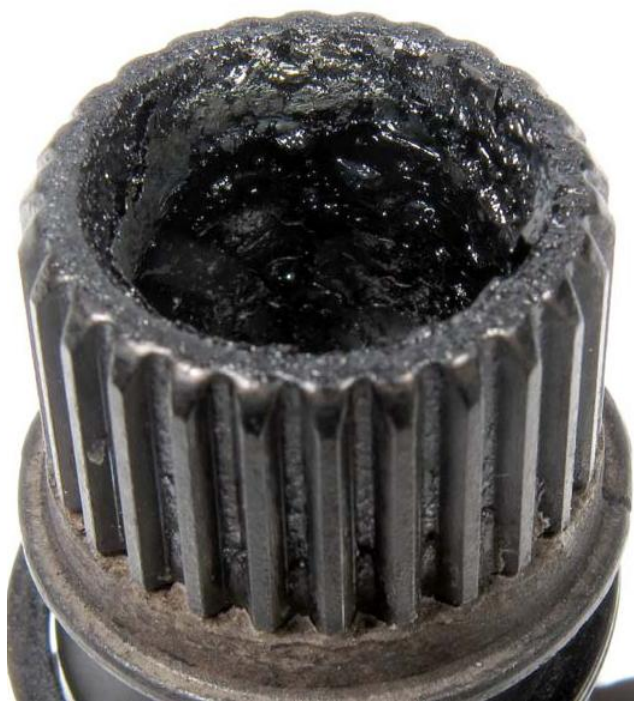
Fig 13:

The teflon seal just aft of the forward splines was distorted and appeared partially melted. There were coked oil deposits along the shaft in the area of the No. 2.5 bearing inner ring. The inside surface of the gearshaft (forward end) was covered with coked oil **Fig 13**.

Spur Adaptor Gearshaft

Forward End Of Spur Adapter Gearshaft

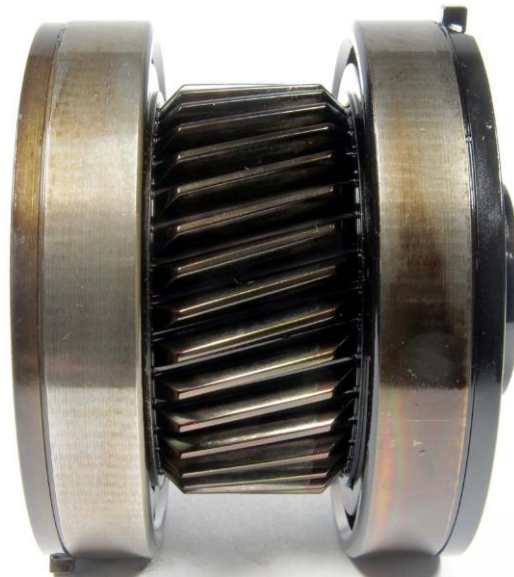
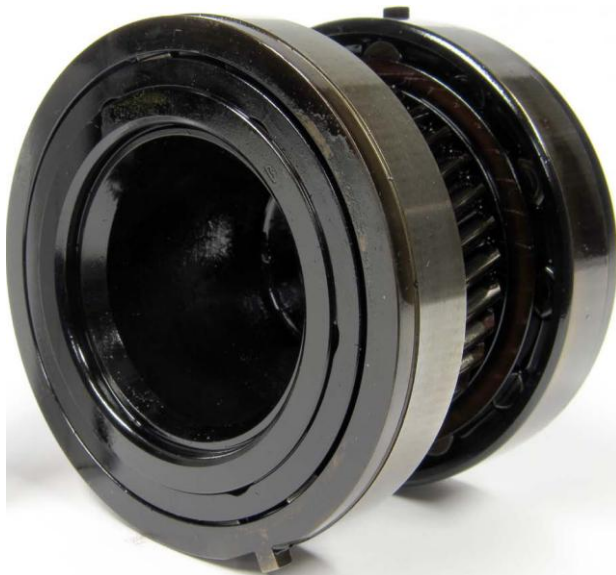
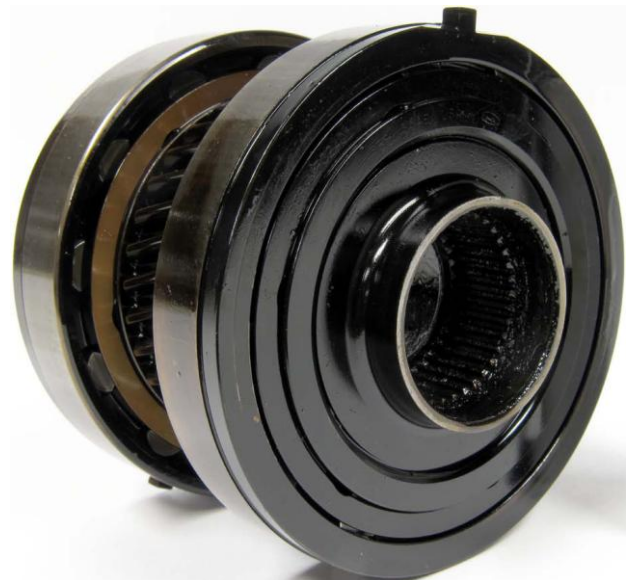
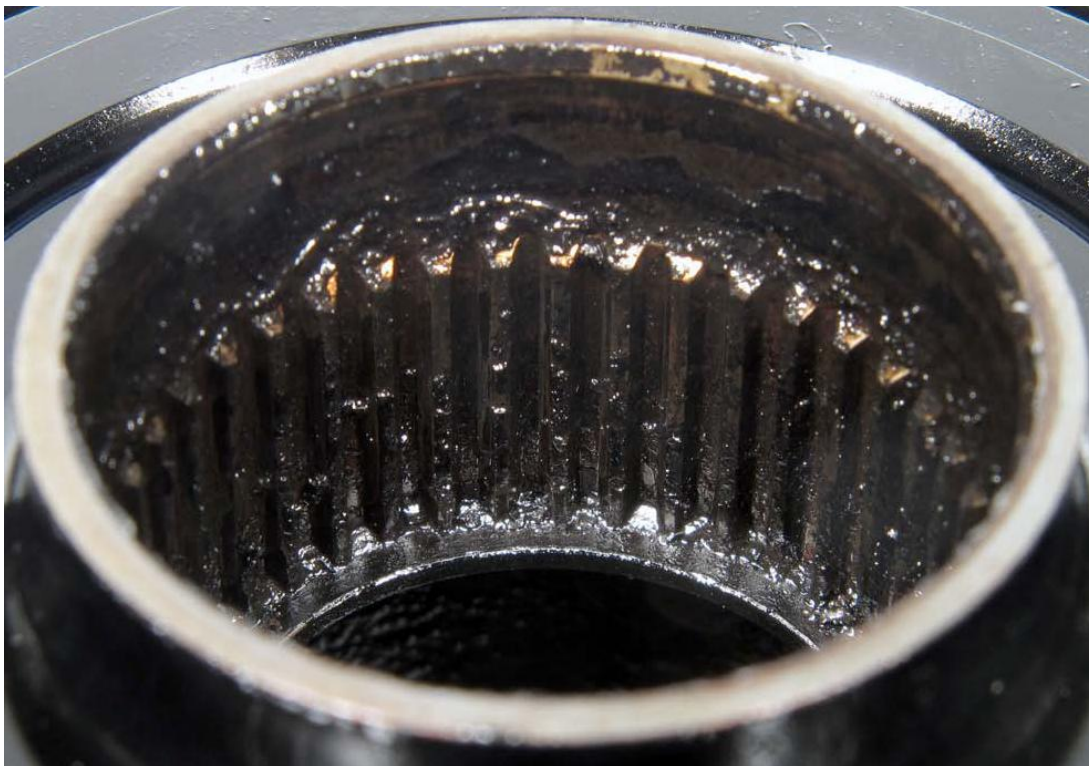
Fig 14:

The forward and aft sides of the assembly were dark black in color. The deposits could be partially wiped off with a rag indicating the oil had not completely coked. However, the internal splines did show coked oil deposits **Fig 14**.

Bearing, Pinion Gear, And No. 4 Bearing

Forward Side Of No. 3 Bearing

Aft Side Of No. 4 Bearing

Pinion Gear Aft Spline Surfaces

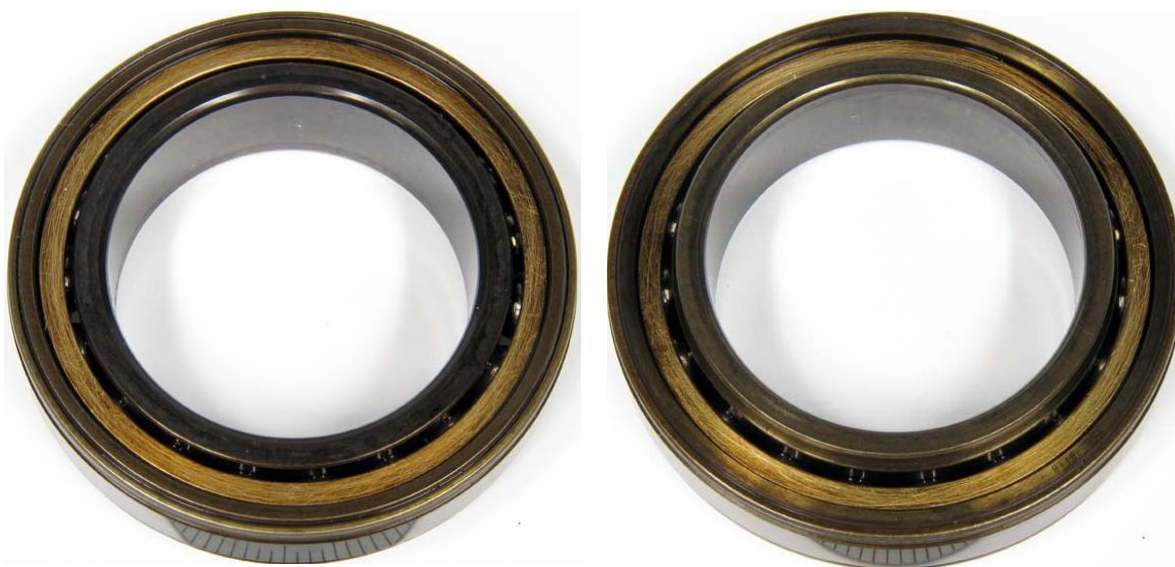
**Fig 15:**

The bearing was a brownish color but it appeared free of coked oil deposits. No destructive evaluations of the No. 5 bearing were conducted **Fig 15**.

No. 5 Bearing

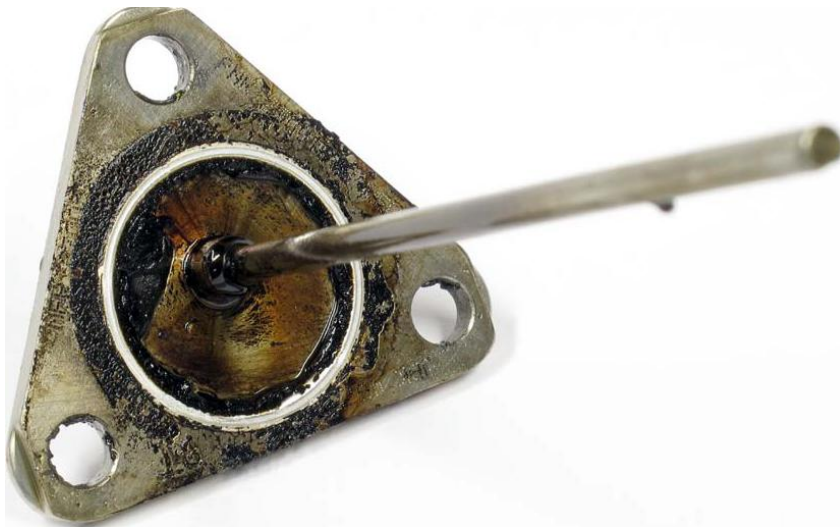
**Fig 16:**

The oil nozzle had a thick-dark substance adhered to the inboard surface similar to the material adhered to the surface of the pressure oil screen **Fig 16**.

Power Turbine Support Pressure Oil Nozzle

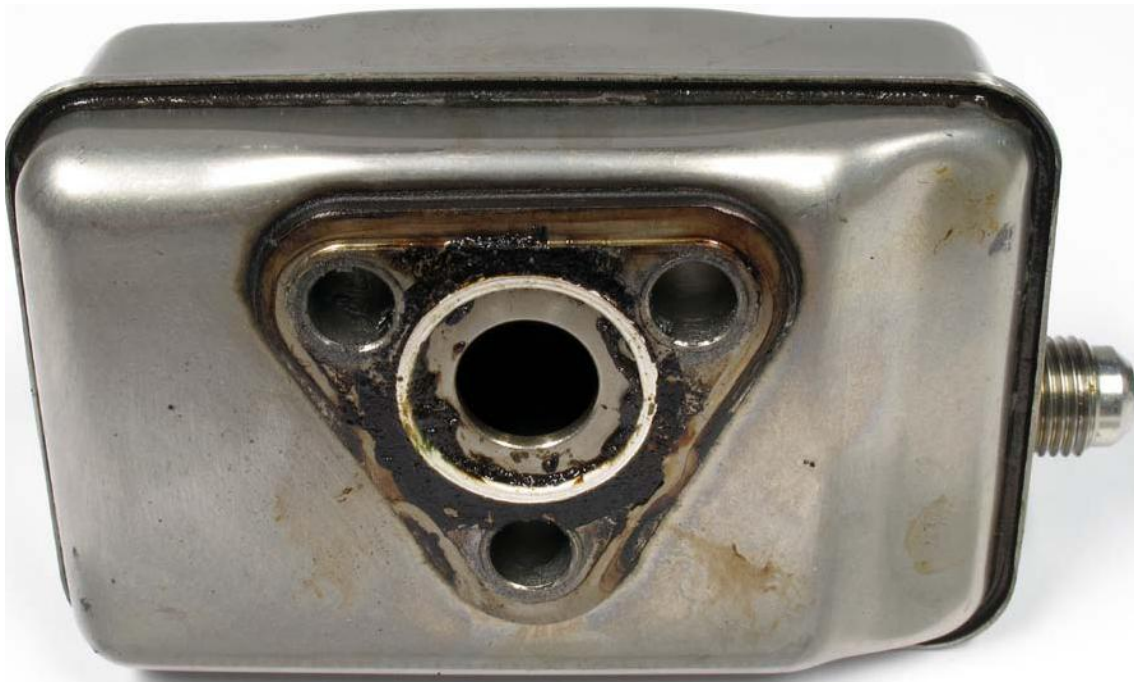
**Fig 17:**

A thick-dark substance similar to the material adhered to the surface of the pressure oil screen assembly was adhered to the inboard surface of the sump. The substance was determined to be consistent with thermally degraded MIL-PRF-23699 type turbine oil. An oil sample from the sump assembly was also collected. Analysis of the oil sample determined it to be consistent to MIL-PRF-23699 type turbine oil **Fig 17**.

External Scavenge Oil Sump

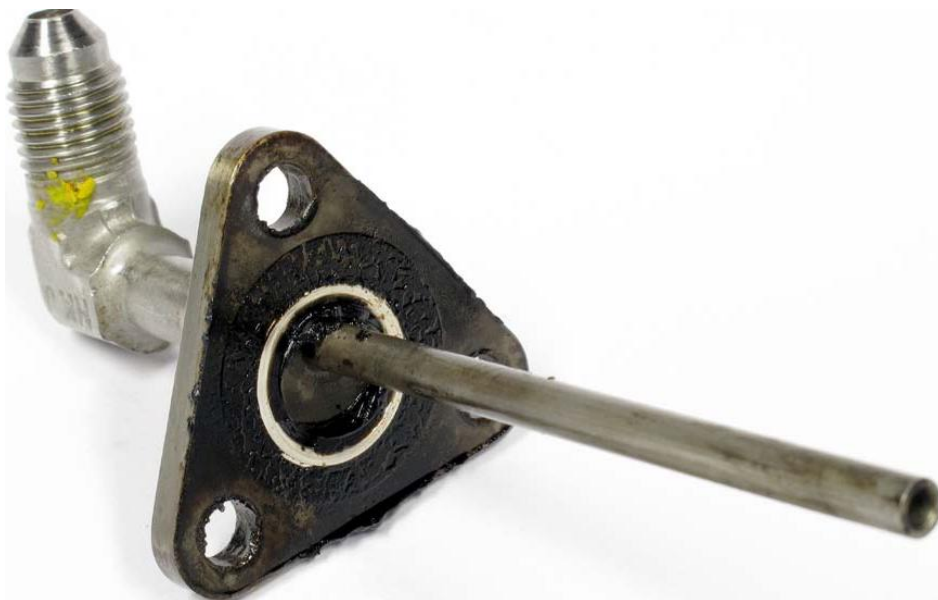
**Fig 18:**

The gas producer support pressure oil fitting assembly displayed thick-dark substance adhered to the inboard surface. Analysis of the substance determined it to be consistent to thermally degraded MIL-PRF-23699 type turbine oil **Fig 18**.

No. 8 Bearing Pressure Oil Nozzle

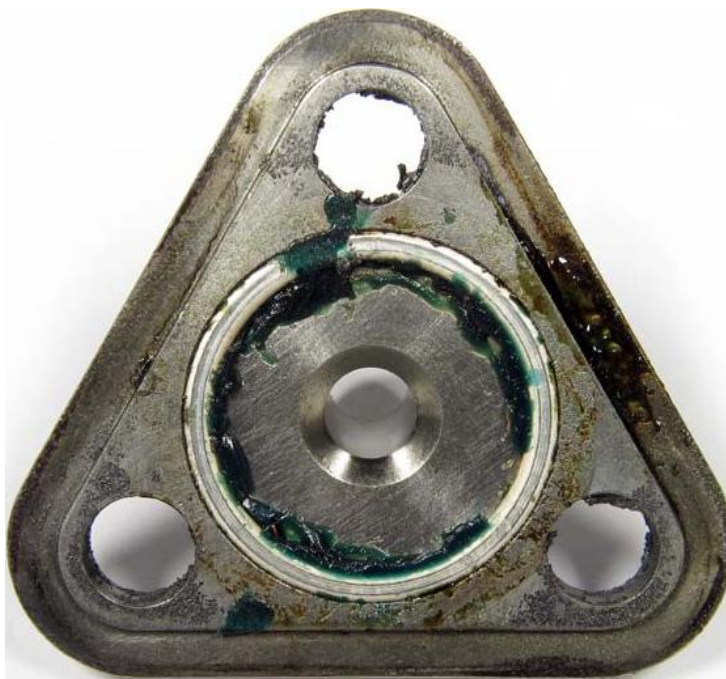
**Fig 19:**

A thick-dark substance similar was adhered to the inboard surface of oil drain fitting. Analysis of the substance determined it to be consistent to thermally degraded MIL-PRF-23699 type turbine oil **Fig 19**.

Gas Producer Scavenge Oil Drain Fitting
