## **Engine Investigation Report**

**Rolls-Royce Model 250-C30P  
Engine CAE 896108**

**Bell 206L-4  
Registration: N405MR**

**Incident date: June 30, 2013  
On-Site Examination Date: July 2, 2013  
Examination at Keystone Date: July 11, 2013  
Examination at Rolls-Royce Date: Sep 25-26, 2013  
Report date: 18 March, 2014**

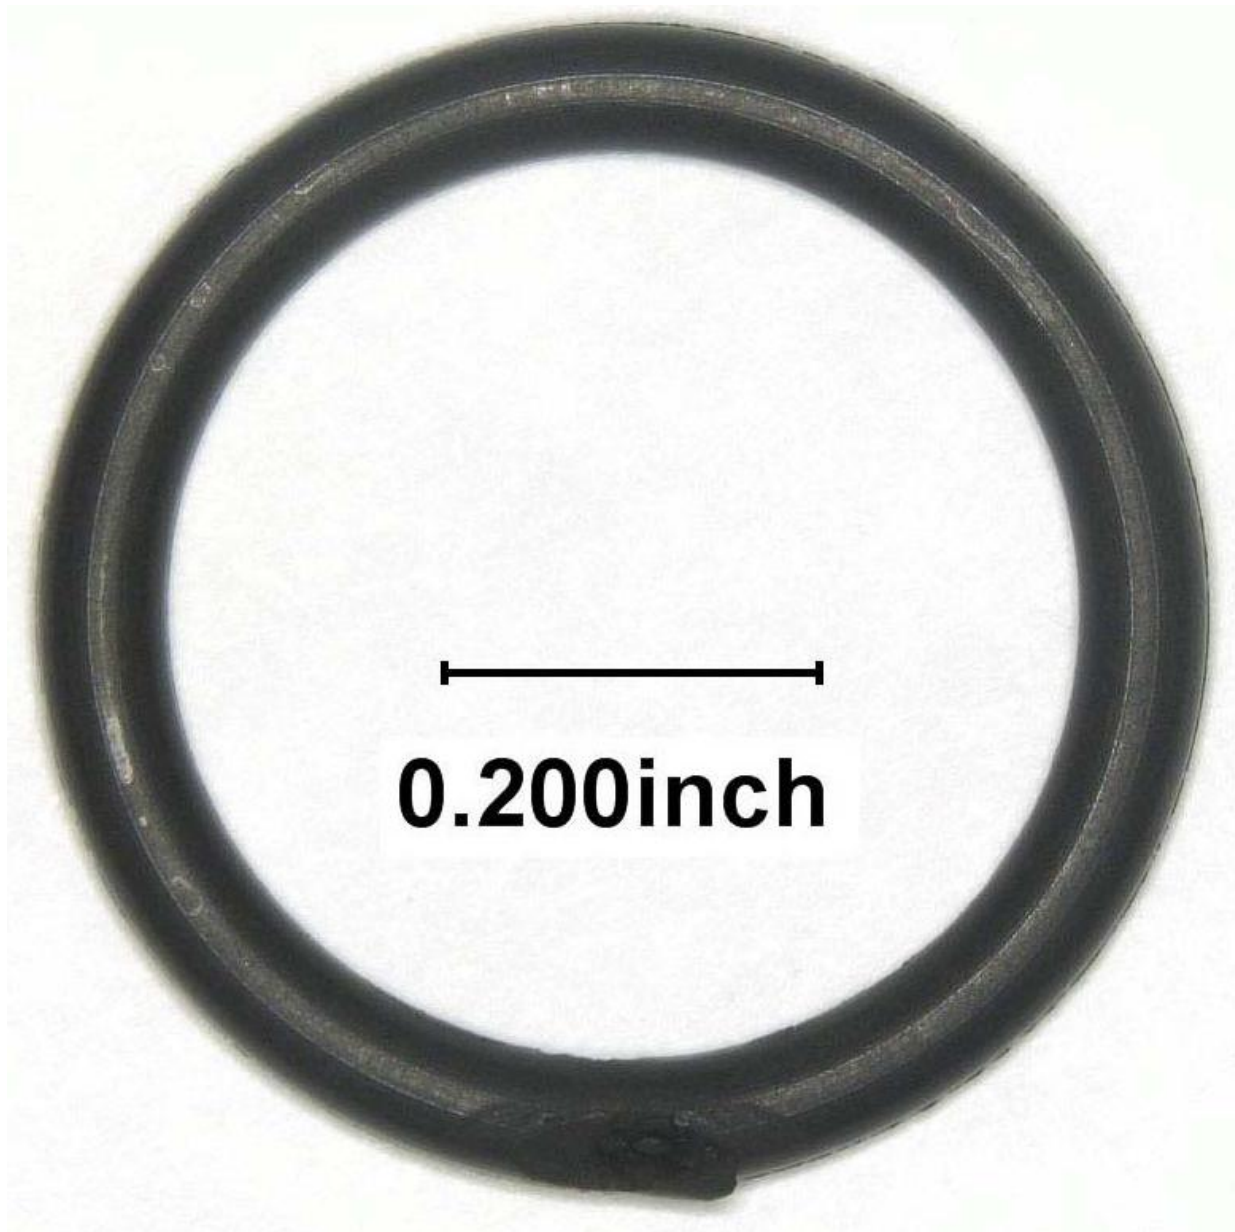
Fig 20:

The oil filter was not provided for examination, however the O-ring that seats against the filter remained in the filter bowl. The O-ring showed damage to the outer surface. Visual inspection of the internal cavities of the housing showed no evidence of the thick-dark substance as observed on other engine components described earlier **Fig 20**.

Oil Pressure Regulator Filter O-Ring
