Rolls-Royce

Engine Investigation Report

**Rolls-Royce Corp.
Model 250-C47B
Engine CAE 848151**

**Hillsboro Aviation Inc
Togwotee Pass, WY**

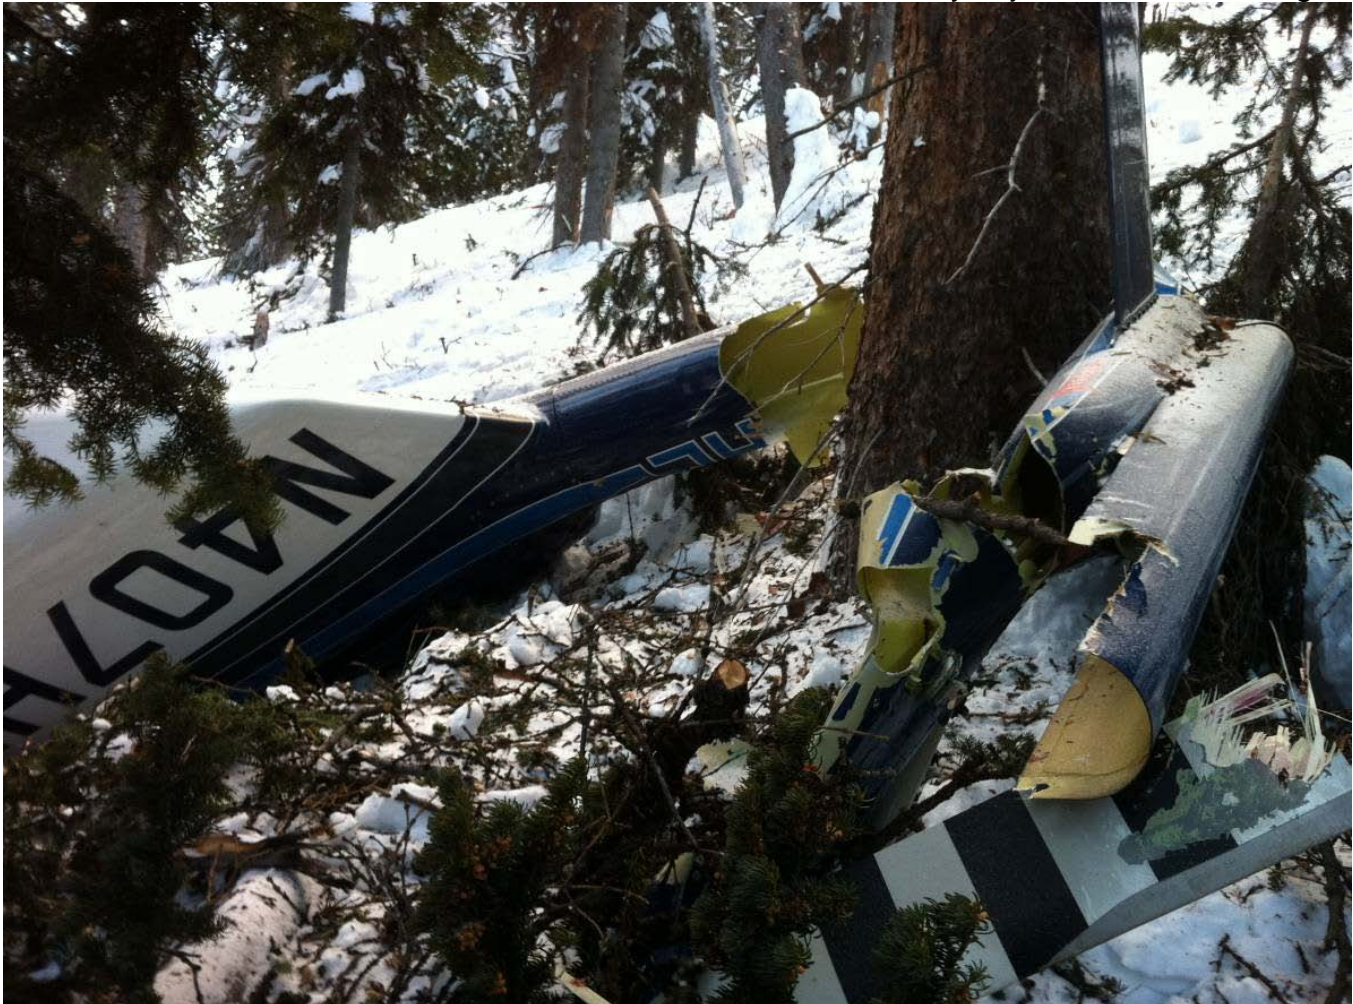
These photographs show the helicopter lying on its starboard side on heavily forested, steeply sloped terrain. The wreckage is partially buried in deep snow. Broken and chopped tree branches litter the ground immediately surrounding the wreckage. Small pieces of main rotor blade are also shown scattered about the crash site. The tail boom was severed forward of the horizontal stabilizer, but the remains of the tail boom were located immediately adjacent to the wreckage.

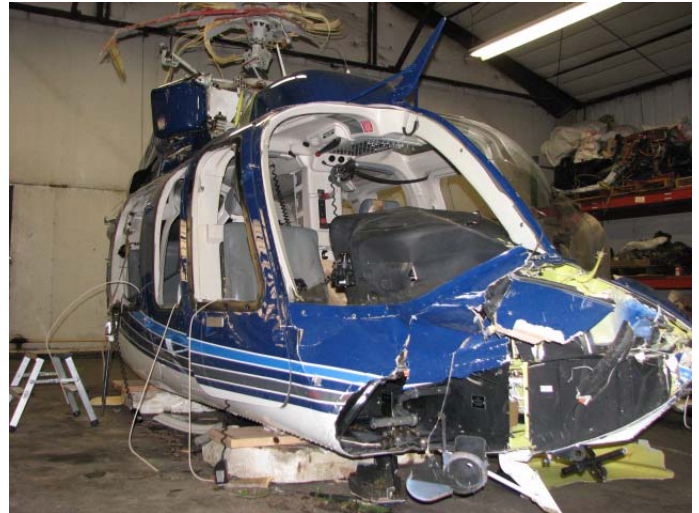
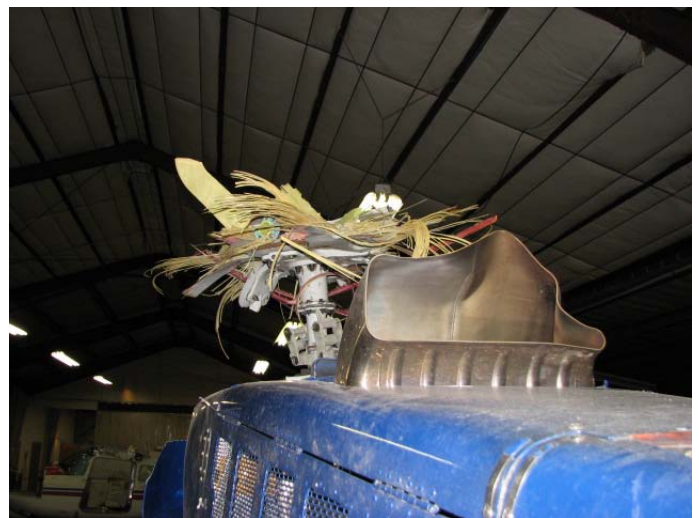
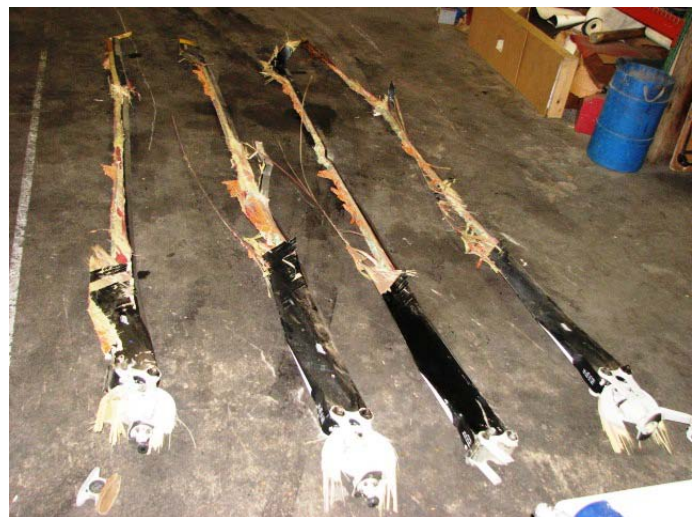
The forward floor of the cockpit exhibited crushing damage; the remainder of the fuselage exhibited no substantial impact damage.

The main rotor mast was displaced ~5 degrees to port. The main rotor blades had all separated from the mast at the yokes, with the fragmented remains of the yokes all exhibited rotational damage. According to the Bell Helicopter representative, damage to all main rotor blades was consistent with power delivery at impact.

The tail boom was fractured approximately three feet aft of the fuselage. The tail rotor drive output shaft (steel shaft) was intact and remained coupled to the engine and tail rotor drive shaft. The steel shaft exhibited rotational witness marks where the shaft passed through the oil cooler fan bulkhead, suggesting the tail rotor drive was rotating at impact.

The tail rotor blades also exhibited impact damage consistent with power delivery at impact.

The collective was fractured at the base, preventing control continuity verification to the engine.

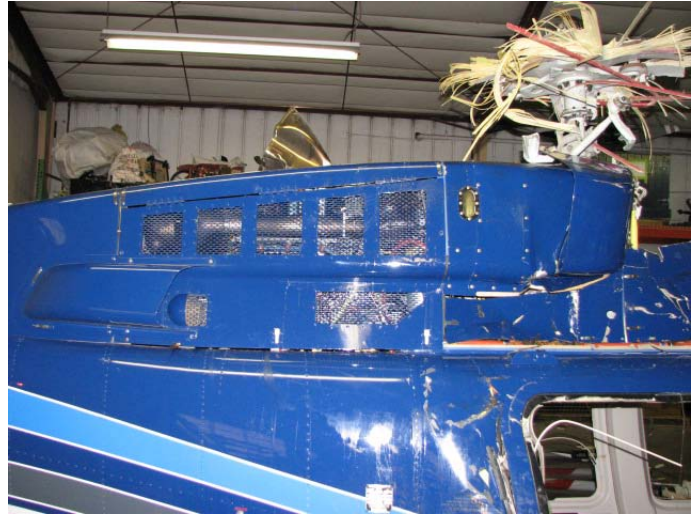
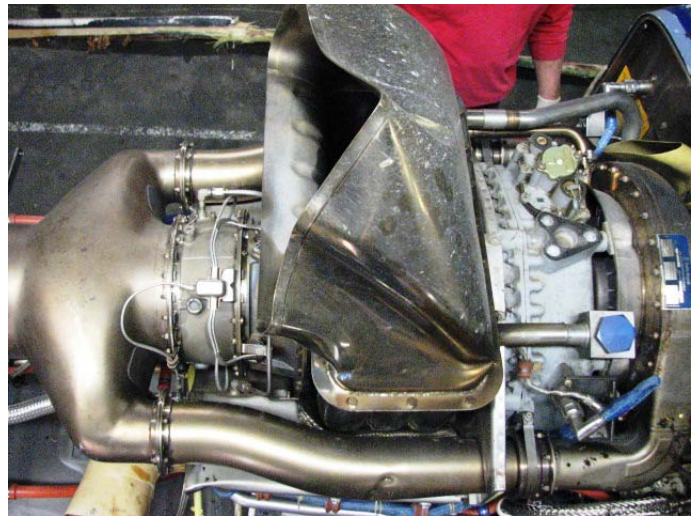
The engine was presented for examination installed in the helicopter. Inspection of the engine exterior did not reveal any obvious signs of damage from impact forces or internal engine failure. The engine mounting structure was intact and properly secured within the compartment. No evidence of oil or fuel leaks was observed in the engine bay or surrounding area.

The exhaust plenum and visible turbine sections were inspected and found to have no evidence of damage or failure. The exhaust duct exhibited crushing damage, which was attributable to the accident sequence.

The power turbine was then visually examined. The 4th stage turbine blades were smooth to the touch and exhibited no evidence of FOD or thermal degradation. There was no impact damage, metal splatter or evidence of rubbing around the air shrouds.

Inspection of the inlet plenum chamber did not reveal any evidence of foreign material or missing hardware. Inspection of the compressor inlet revealed no visible damage or signs of foreign object ingestion.

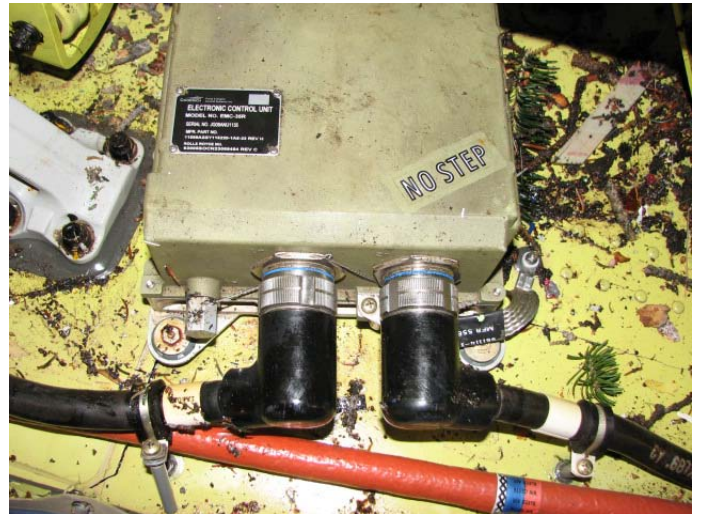
The Engine Control Unit (ECU) was visually examined and found to be undamaged and in suitable condition for a field download of data. Extraction of the ECU IR (Incident Recorder) data was accomplished, revealing a total of 15 data-points, recorded at 1.2 second intervals. In addition to IR data, eight additional “Snapshot” data lines were recorded in a separate file. Snapshot data is recorded immediately following an engine exceedance. All snapshot data lines were recorded within the final three seconds of the accident flight.

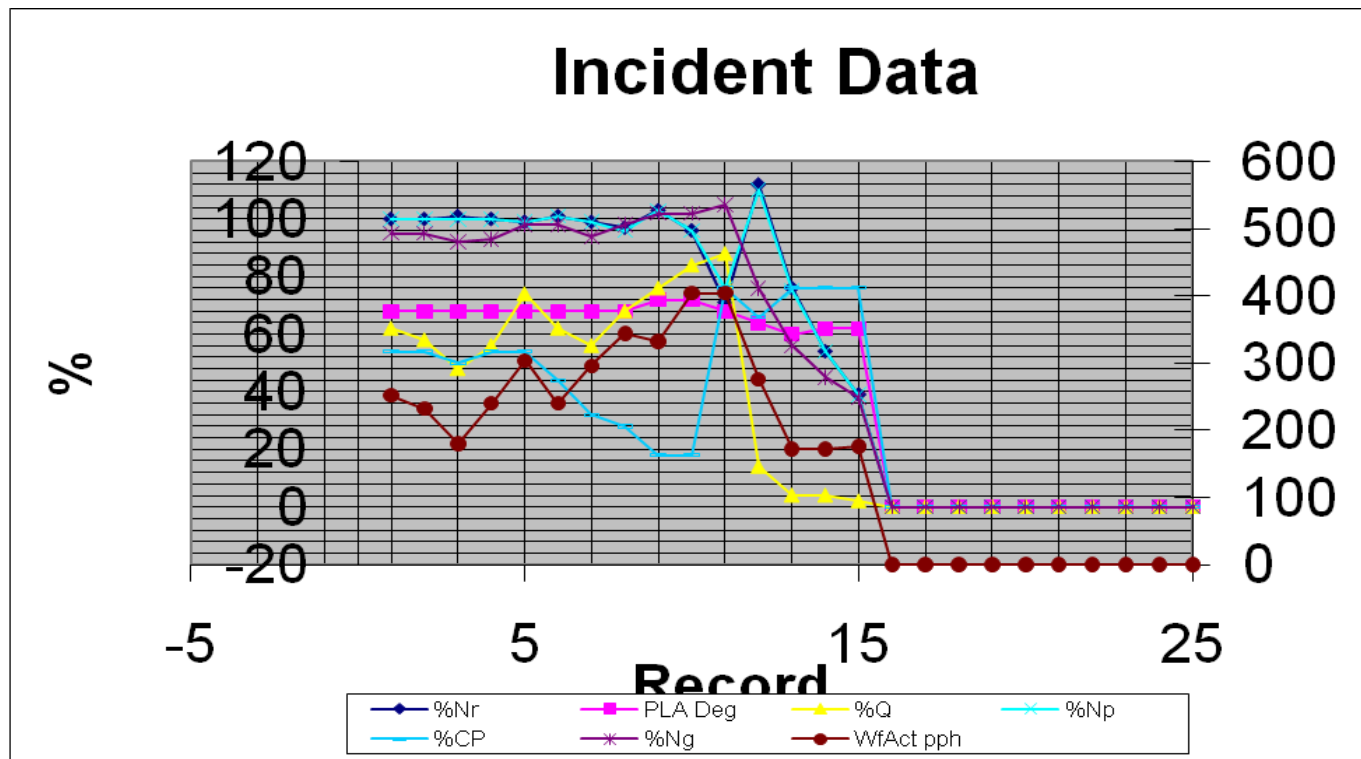
Examination of ECU IR data recorded during the accident sequence revealed the engine responding normally to control inputs.

The ECU's incident recorder function was triggered at timestamp 986:28:20.232. The first snapshot data is recorded at 986:28:20.544.

The ten data lines recorded prior to the triggering event, indicate the pilot was holding collective at a relatively constant 54%, and then gradually lowered collective to 18% over a period 4.8 seconds. Collective is then suddenly increased and held relatively constant at 76% until power is lost to the ECU.
