Accident investigation (Engine Report)

Rolls-Royce Engine
Model 250-C47B
S/N CAE 847542

Med-Trans Corporation
Newberry, South Carolina

Accident date: July 13, 2004
Investigation Dates: July 13-16, 2004
Report date: October 29, 2004

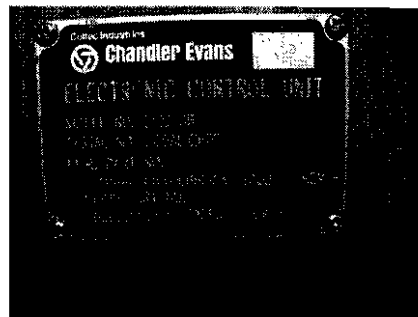
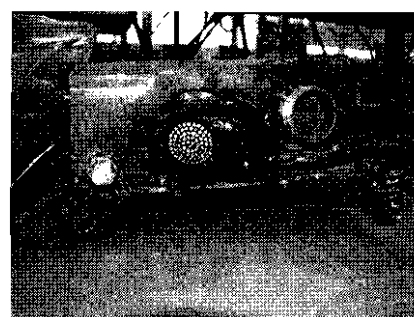
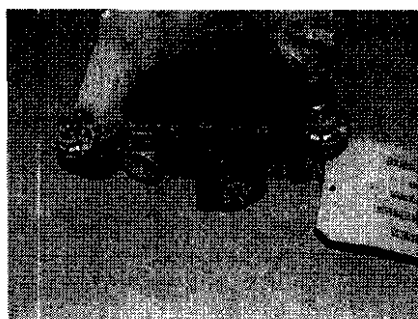
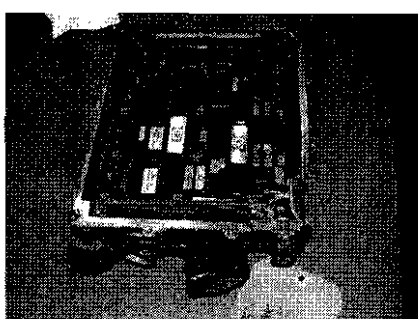
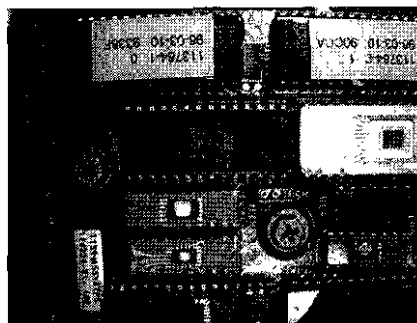
Appendix I.
ECU Investigation Images.

- The starter/generator driveshaft and splines were intact
- The 4th stage turbine wheel was intact with no damage noted
- The Electronic Control Unit (ECU) for the FADEC was recovered. The electrical connectors were damaged and the case was damaged and sooted, but there was no evidence of internal damage to the circuit boards. The ECU was shipped to Goodrich Pump and Engine Control

2.13 Additional Information. The FADEC Electronic Control Unit (ECU) was found in the wreckage with a damaged case and connectors. It was returned to Goodrich Pump and Engine Control Systems (GPECS) for download of the incident recorder data, which was conducted on July 21, 2004 in the presence of the NTSB IIC and other party members. The downloaded data showed that there were no FADEC fault conditions preceding the first Incident Recorder event. Snapshot data showed a Torque Rate Limit, Nr Droop Record, Torque Exceedence, NP Exceedence and Overspeed Solenoid Energised. Throughout the entire sequence, the data showed NG in the 97 to 99 percent range. Refer to the Goodrich report in Appendix 4.3 for additional information.

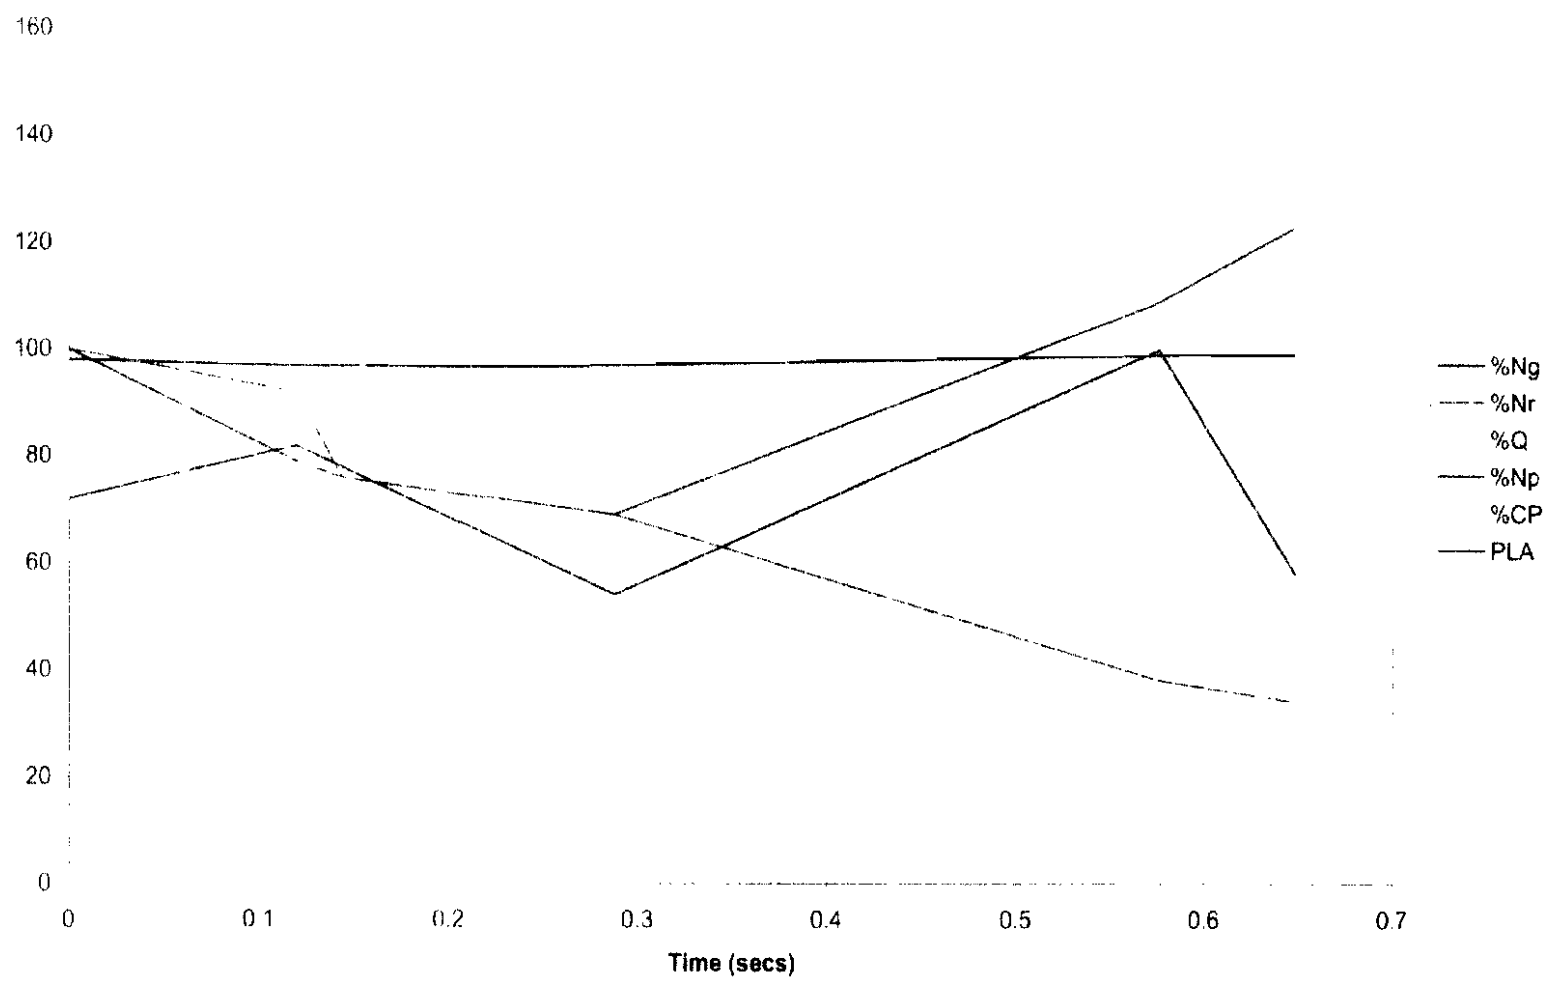
ECU (SN 570) Incident Snapshots 7/21/2004

3.2 Downloaded EEPROM data from the FADEC ECU Incident Recorder showed that engine performance was normal and was operating in a steady state condition prior to Snapshot 1 indicating a Torque Rate Limit.

3.3 The FADEC Incident Recorder data had five Snapshot records showing (1) torque rate limit, (2) Nr droop record, (3) torque exceedence, (4) NP exceedence and (5) overspeed solenoid energized.

3.4 Gas Producer (NG) speed remained in the 97 to 99 percent range throughout the accident sequence.
