# **Accident investigation**

On-site engine Investigation report

Rolls-Royce Corporation Model T56-A-9D Engines AE100843, AE101504, AE101267, A100814

Accident date: June 17, 2002

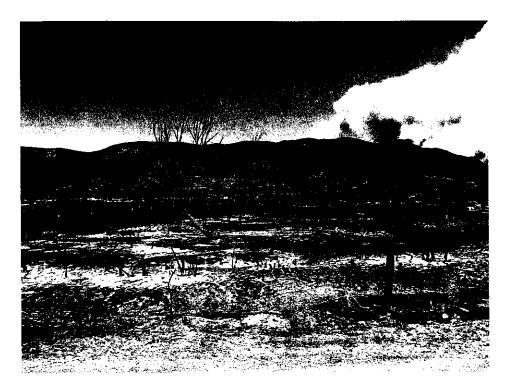
Photo #1 – Engine wreckage field

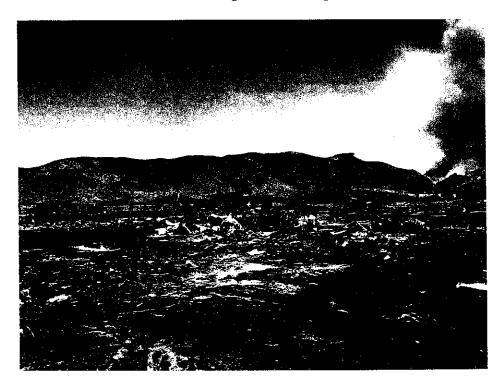
Photo #2 – Engine wreckage field

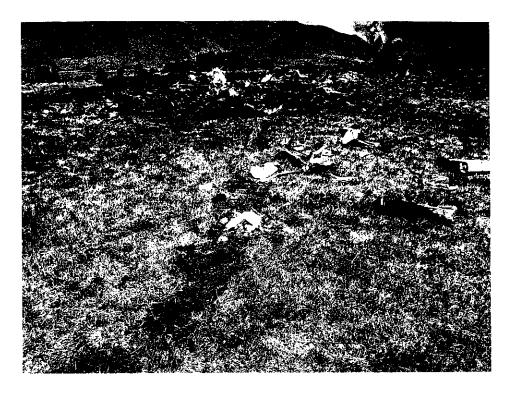
Photo #3 – Aircraft wreckage field

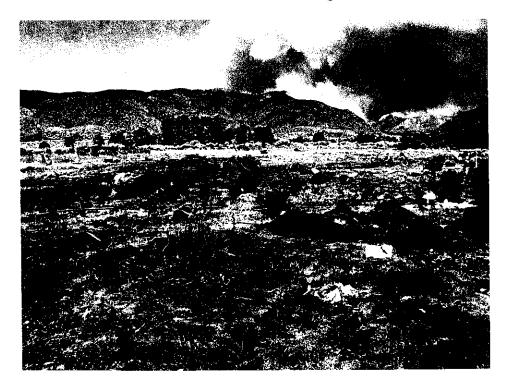
Photo #4 – Aircraft wreckage field

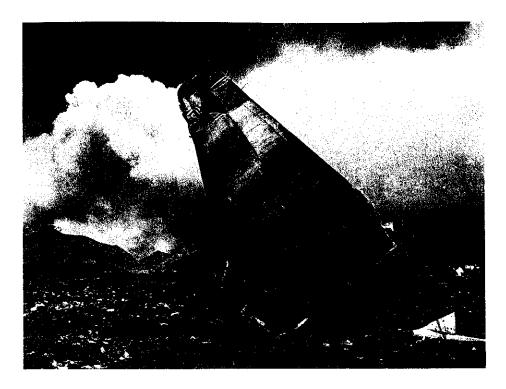
Photo #5 - Aircraft parts

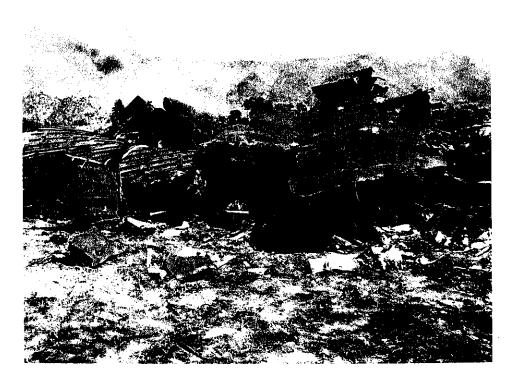
Photo #6 – Aircraft debris

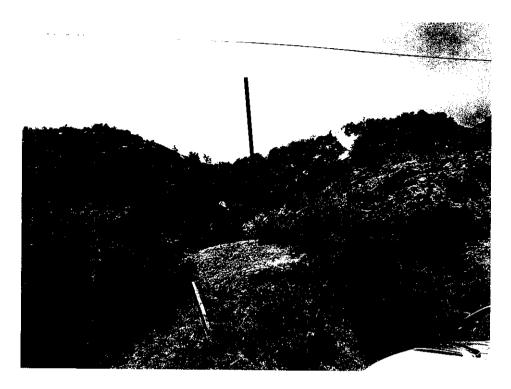
Photo #7 - Flight path

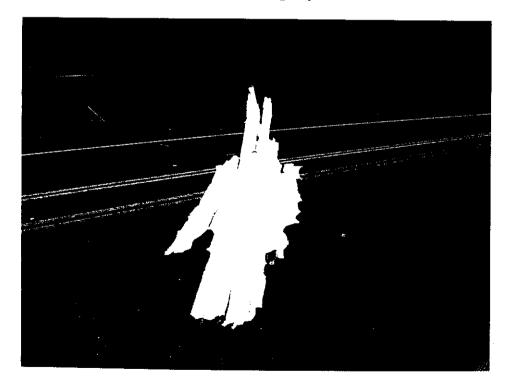
Photo #8 - Debris on road

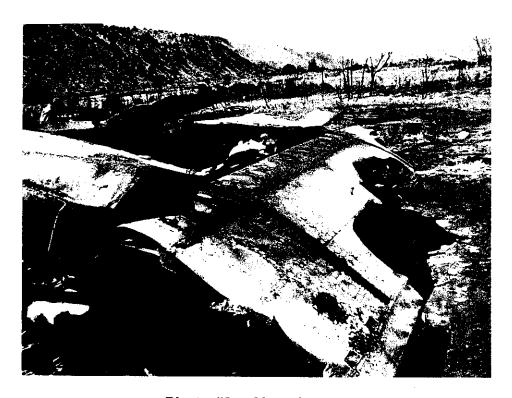
Photo #9 – Aircraft wing

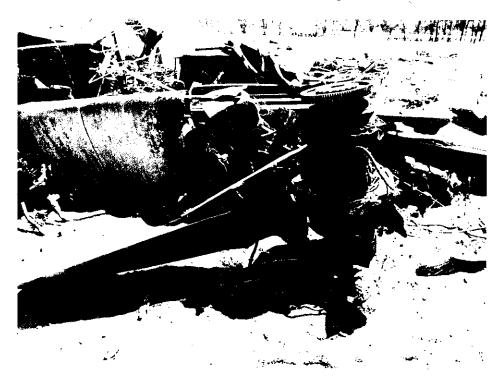
Photo #10 - Prop and gearbox assembly

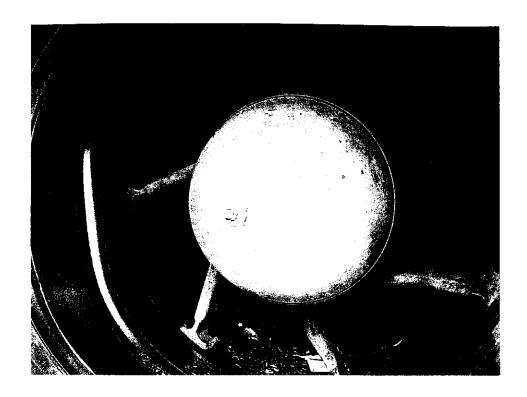
Photo #13 – Engine rear turbine area

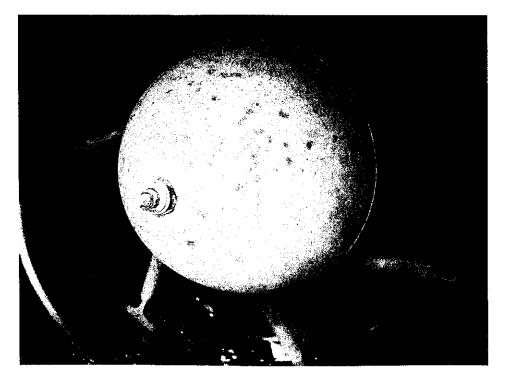
Photo #14 – Engine rear turbine area

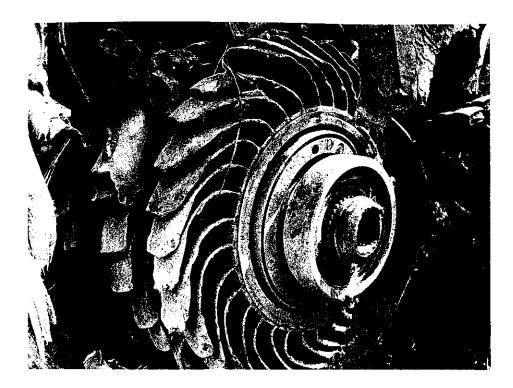
Photo #15 - Engine compressor

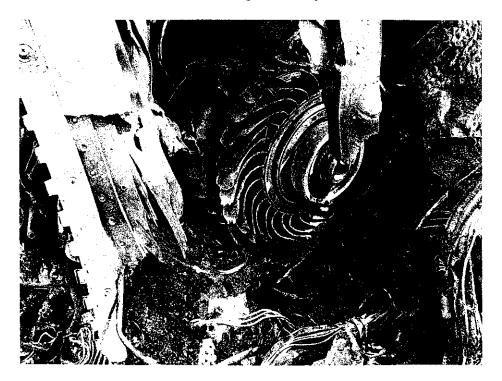
Photo #16 – Engine compressor

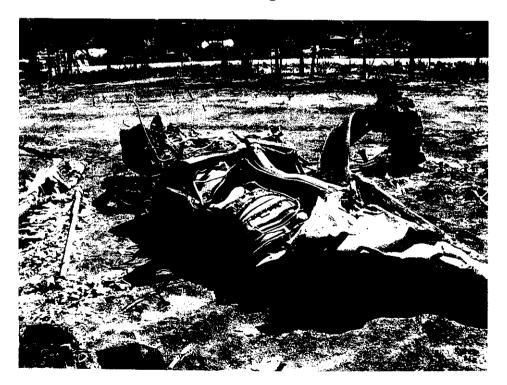
Photo #18 – Engine debris

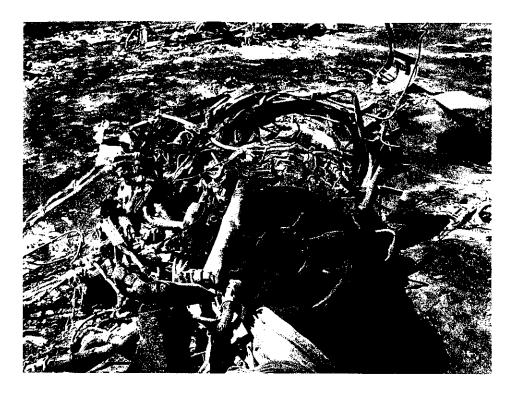
Photo #19 -- Engine debris

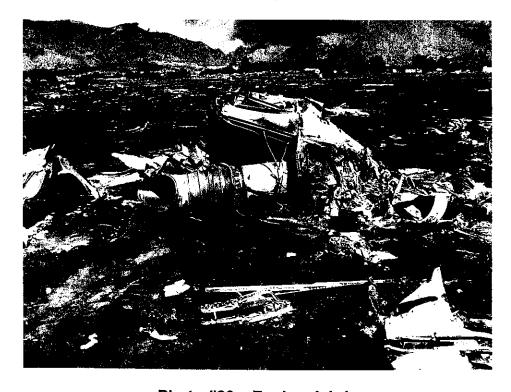
Photo #20 - Engine debris

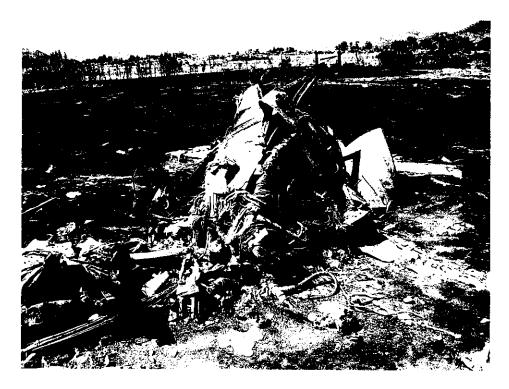
Photo #21 - Engine debris

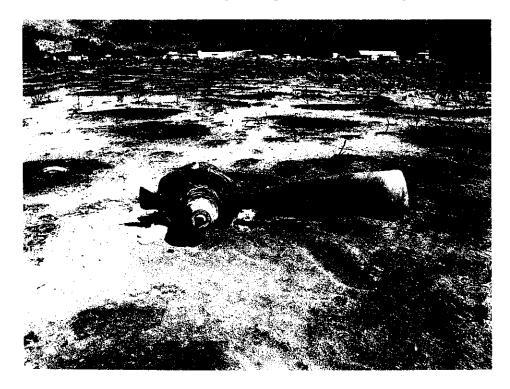
Photo #24 – Prop and gearbox assembly
