INVESTIGATION REPORT

DATE	ENGINE MODEL	ENGINE SERIAL NO	REGISTRATION	File number
12/19/2015	Rotax 582 mod 99	6140712	N124LP	2015-083

NTSB Preliminary

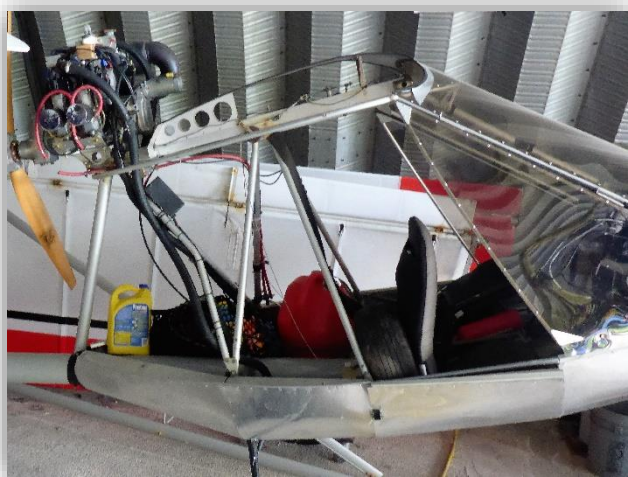
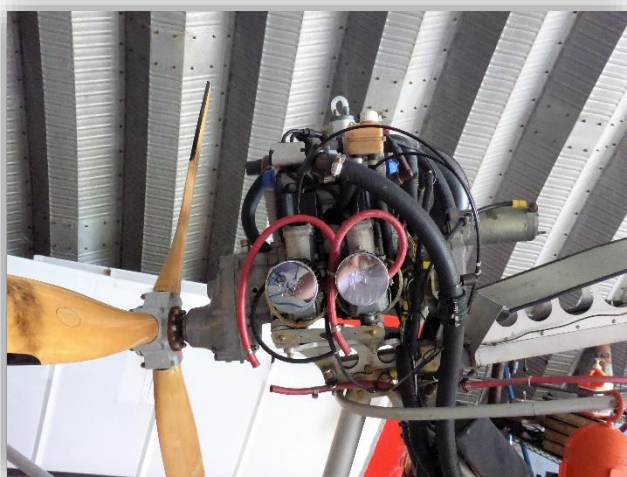
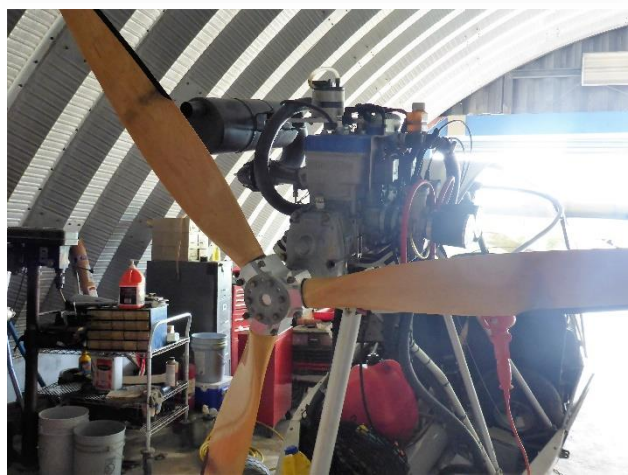
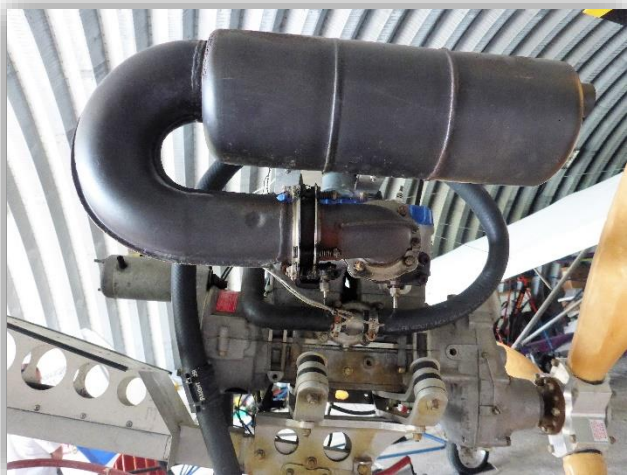
The aircraft suffered impact damage to the landing gear and fuselage. The wings were not attached to the aircraft (previously removed). The aircraft was a pusher configuration with the engine at the back of the fuselage. The engine was found undamaged with the carburetors, exhaust and propeller still attached.

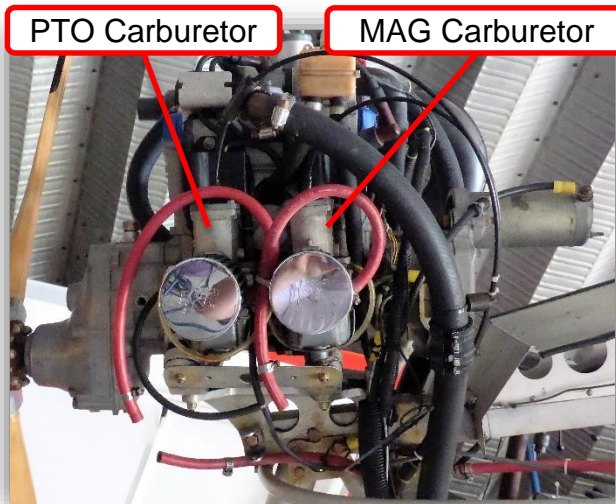
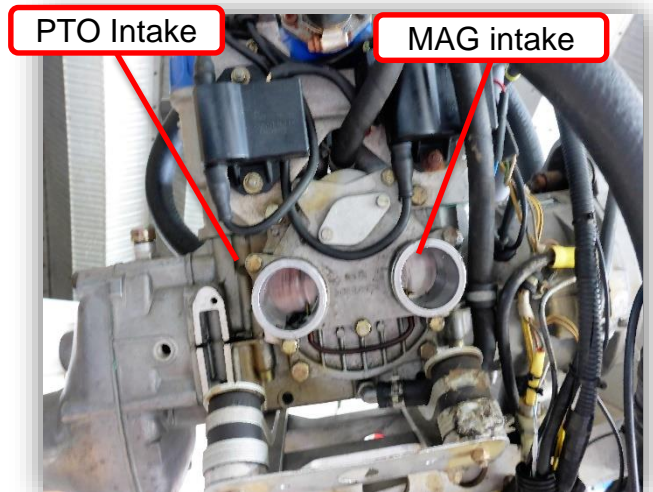
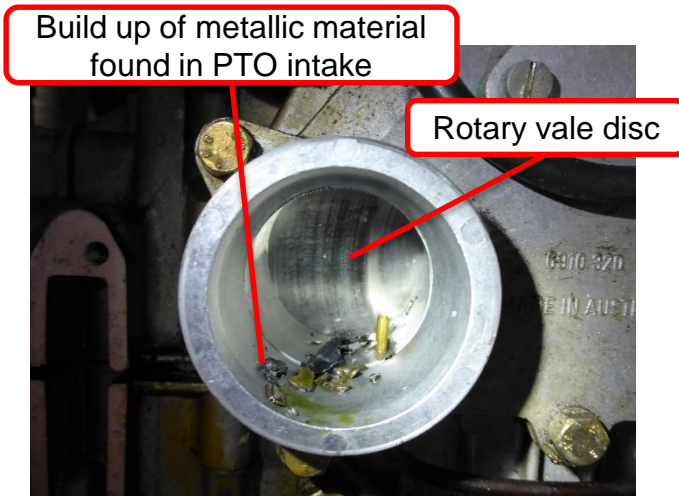
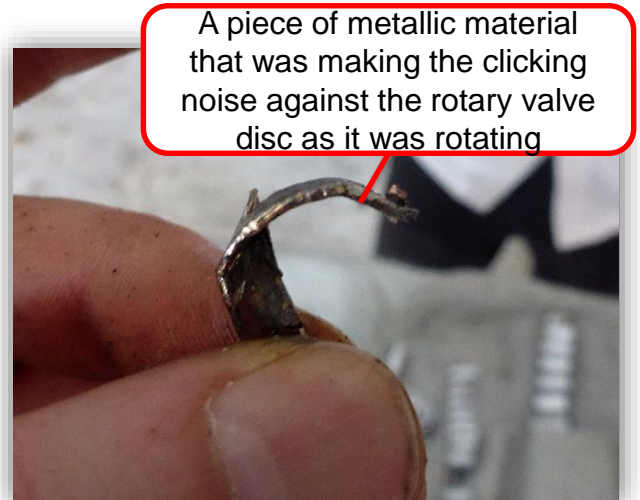
Both carburetors were removed to inspect the intake of the engine. The PTO (Power take off) intake had a build up of metallic material contained within and it was making contact with the rotary valve disc, as the engine was rotated. The clicking noise was from the Rotary valve disc making contact with this build up of metallic material.

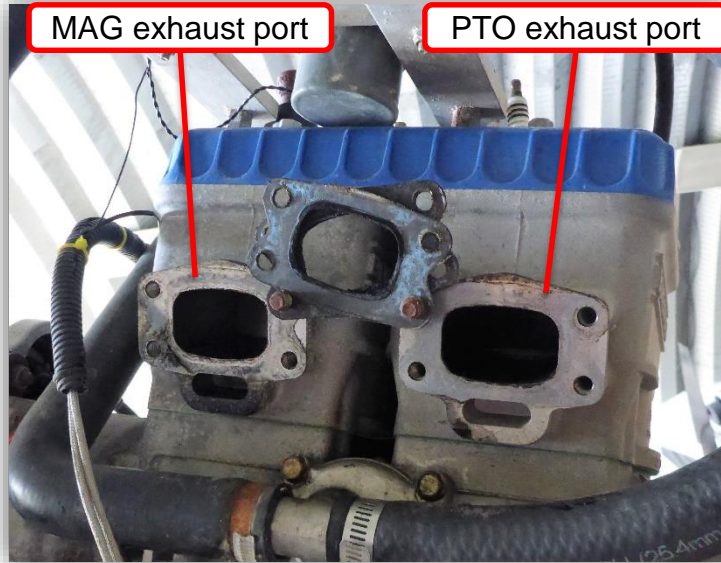
There was no metallic material or any foreign objects found in the MAG side of the intake. This indicated that the metallic material only affected the PTO side of the engine. The exhaust system was removed to determine if the same material was found on the exhaust side of the PTO cylinder.

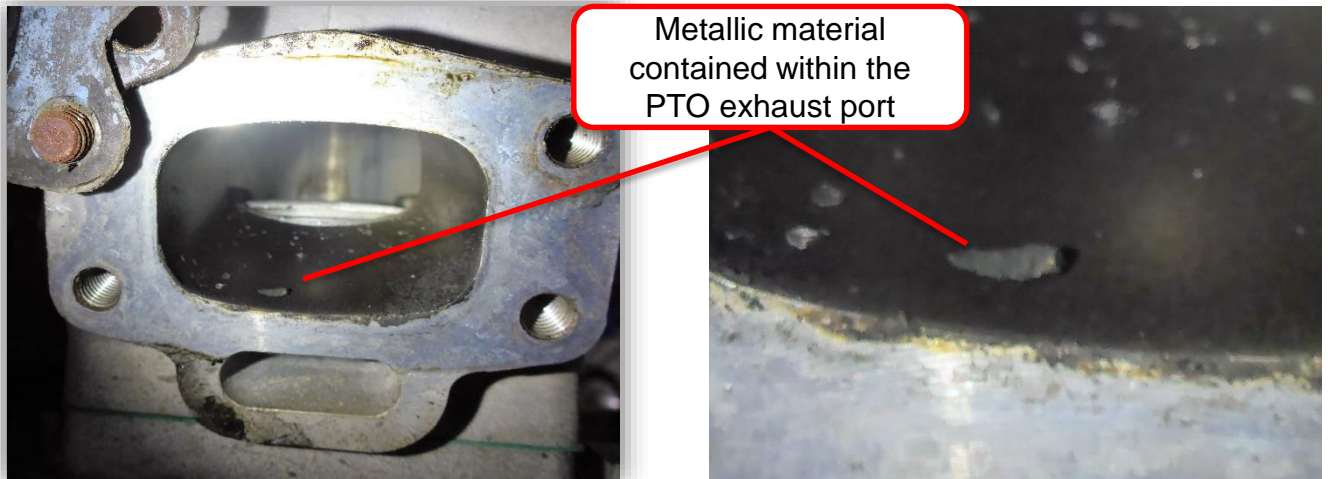
With the exhaust system removed, examination into the PTO exhaust port showed the same metallic material contained within. This indicated that metallic contamination was throughout the PTO side of the intake, combustion chamber, crankcase and exhaust. No metallic or foreign object material was found on the MAG side of the exhaust system.

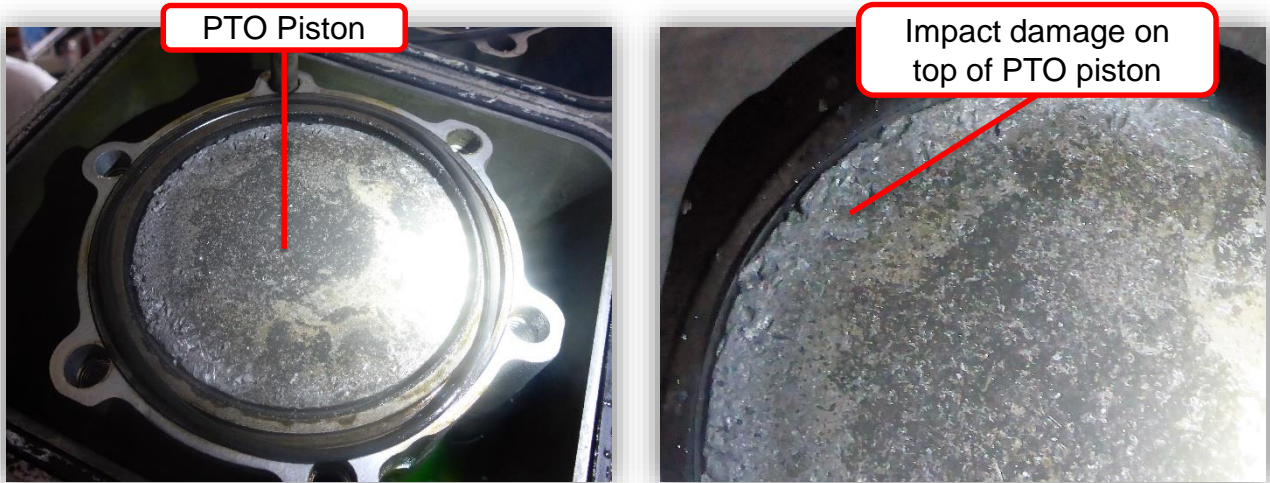
The cylinder head was removed to examine the top of the PTO piston. Impact damage could be seen on the top of the PTO piston. It was determined the impact damage to the piston was caused by the same metallic material found in the intake and exhaust side of the engine.

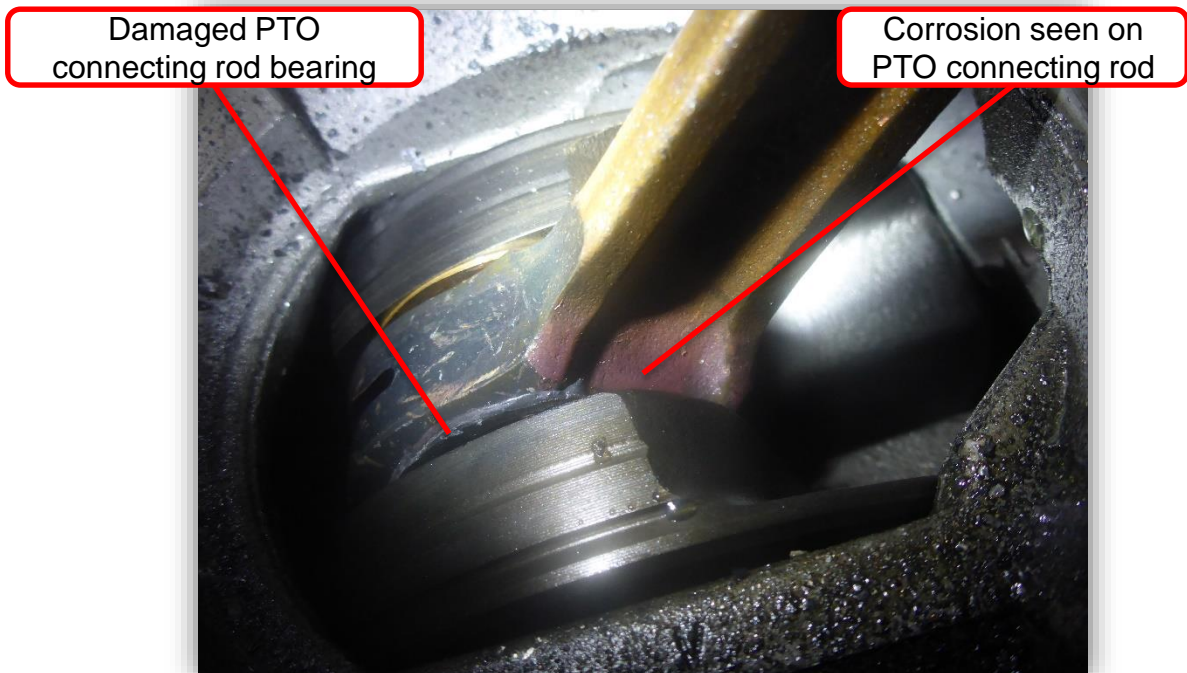
The PTO cylinder was removed to examine the connecting rod, crankshaft and bearings. With the PTO cylinder removed, corrosion and damage could be seen on the connecting rod and the connecting rod bearing. The damaged connecting rod bearing was made up of the same material that was found contained within the PTO intake manifold.

It was discovered that the PTO connecting rod bearing failed and sent metallic shrapnel throughout the PTO side of the engine. It is believed that a piece of this metallic shrapnel made contact and became lodged on the Rotary valve disc, preventing it from rotating and cutting off air and fuel to the engine. This scenario would have caused the engine to lose power and quit running. No other anomalies were found with the engine and installation.

It was concluded the reason for the failed PTO connecting rod bearing was due to corrosion. Evidence of corrosion could be seen on the PTO connecting rod, next to the failed bearing. This engine was required to be overhauled at least 2 times within its operation life span due to calendar time (300 hours or 5 years). An overhaul consists of (but not limited to) a complete tear down of the engine, as well as replacement of all bearings, seals, gaskets crankshaft and piston rings.
