INVESTIGATION REPORT

Date of accident:	02/28/2016	NTSB file number:	ERA16LA120
Location of accident:	Atlanta, GA	FAA Inspector:	Andre Cummings
Location of Investigation:	Atlanta, GA	Law Enforcement:	Unknown
Investigator In charge:	Leah D Read	Corner/Medical Examiner	None

Aircraft Make:	Czech Aircraft Works	Aircraft registration:	N187SF
Aircraft Model:	SportCruiser SRO	Aircraft S/N	08SC190
Propeller make, model & S/N	Sensenich 3 blade

Engine Type:	Rotax 912 ULS	Engine TTSN	Unknown
Engine Serial Number:	6779682	Engine TTSOH	Unknown
Engine Manufacture date:	01/26/2012	Engine position:	Tractor

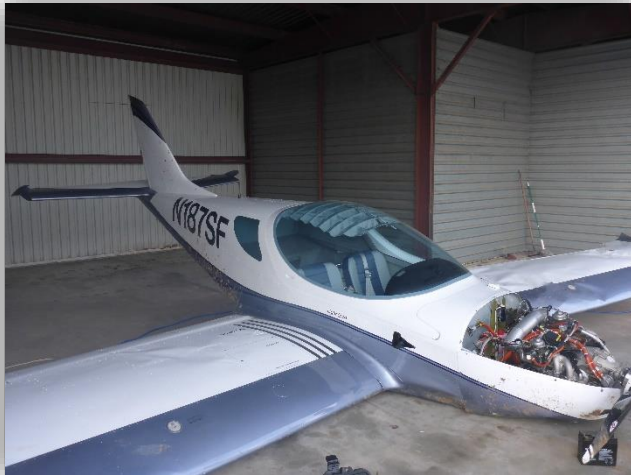
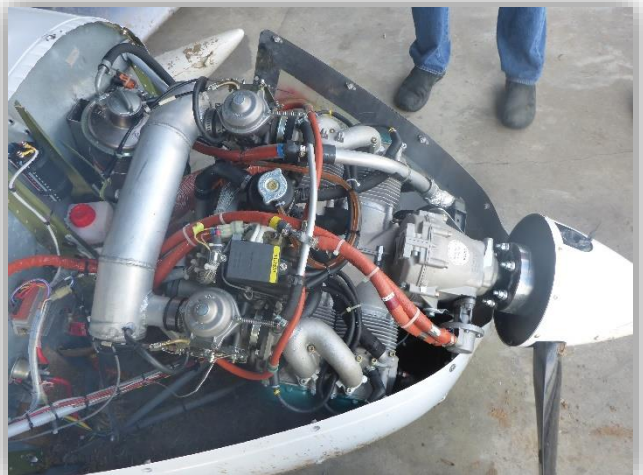
The aircraft sustained minor impact damage and two of the three propeller blades were broken off at the hub. The Rotax 912 ULS, S/N 6779682 engine suffered no impact damage and was still attached to the airframe and engine mount. Both carburetors were found displaced from there respective carburetor sockets and the gascolator bowl was displaced from its mounting location due to impact. The coolant and oil radiators were still in good physical condition and had not been breached.

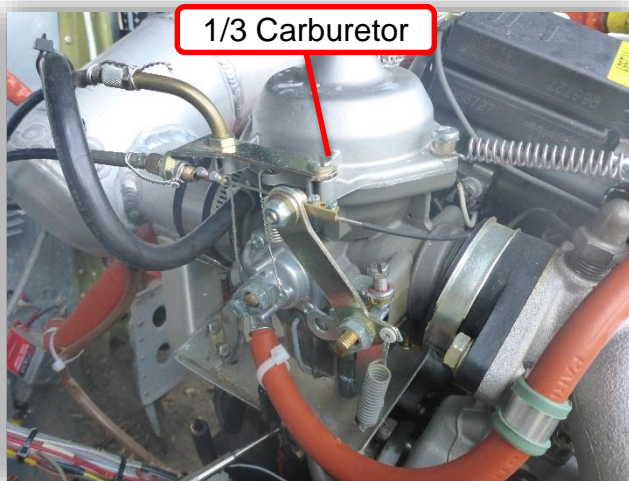
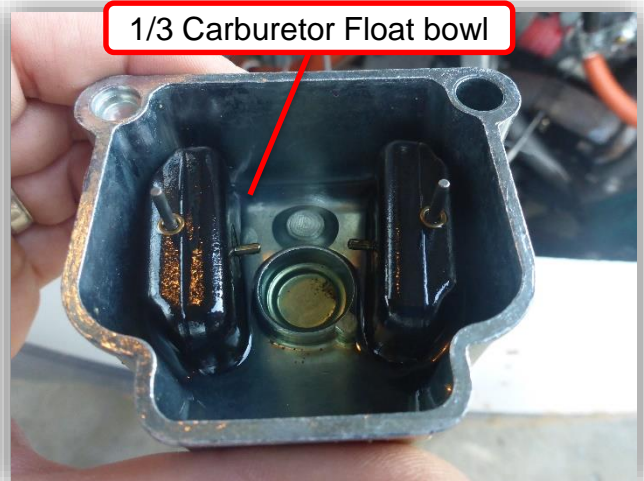
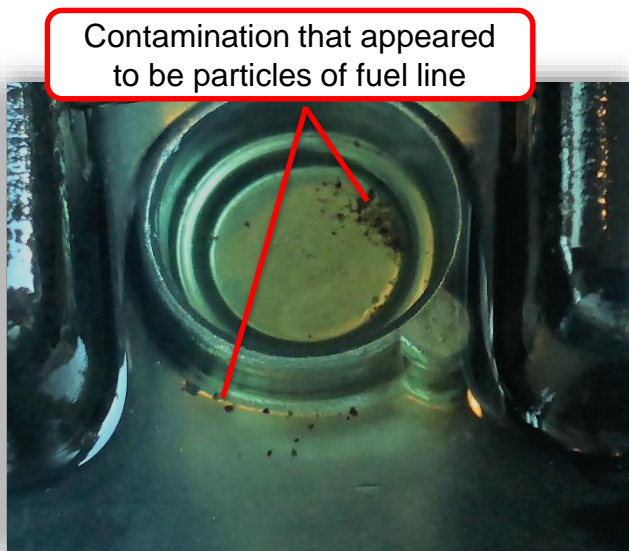
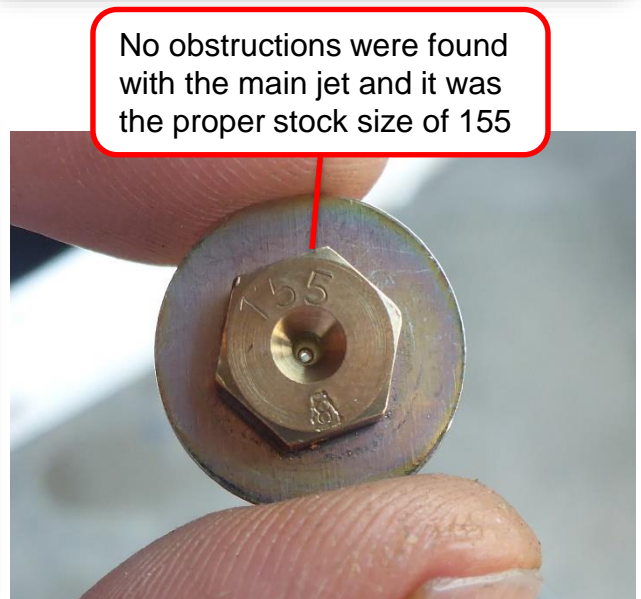
1/3 Carburetor: The carburetor float bowl was removed for inspection and contained a small amount of liquid that was consistent with fuel. Contamination could be seen at the bottom of the 1/3 carburetor float bowl that appeared to be particles of fuel line. The Main jet was removed and inspected for obstructions and proper size. No obstructions were found with the main jet and it was the proper stock size of 155. No further anomalies were found with the 1/3 Carburetor.

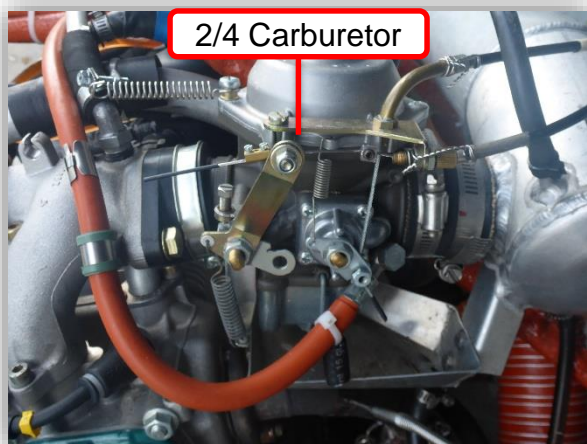
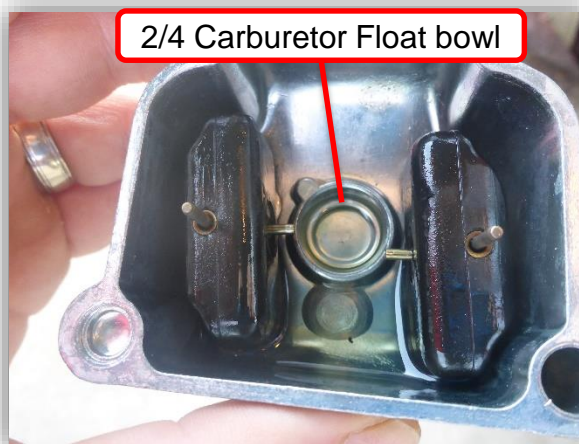
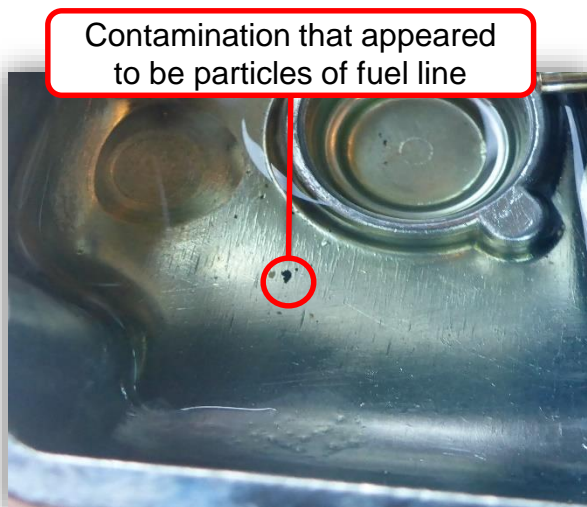
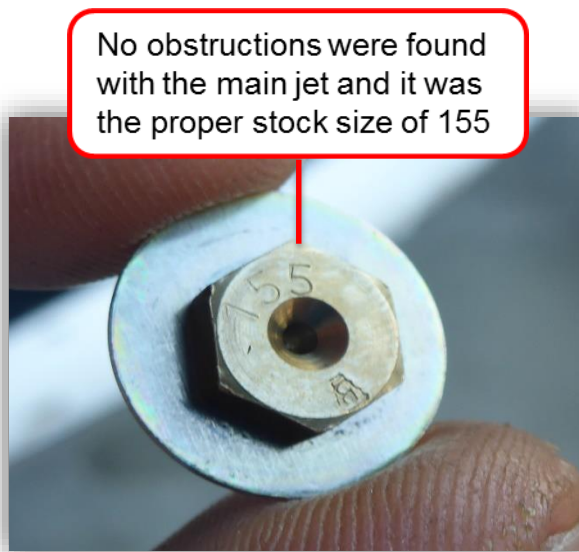
2/4 Carburetor: The carburetor float bowl was removed for inspection and contained a small amount of liquid that was consistent with fuel. Small amounts of contamination could be seen at the bottom of the 2/4 carburetor float bowl that appeared to be a small particle of fuel line. The Main jet was removed and inspected for obstructions and proper size. No obstructions were found with the main jet and it was the proper stock size of 155. No further anomalies were found with the 2/4 Carburetor.

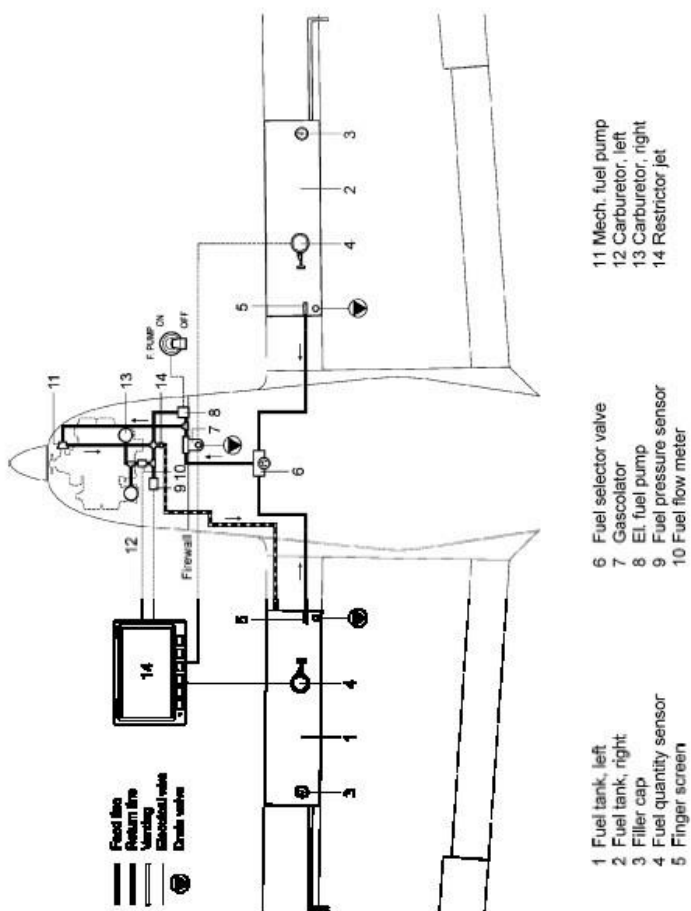
Fig. 9-1: Fuel system layout

The Airframe Maintenance Manual with an issue date of 2011-03-08 (See Appendix C on page 10) , shows the aircrafts fuel system design layout with a fuel return line installed. This CzechSport Cruiser aircraft was manufactured in 2008 and based on the information provided by the NTSB Investigator in charge, no Czech SportCruiser aircraft that was manufactured prior to 2010 had a fuel return line installed. The fuel return line was made standard in September 2010 as the design modification no. S - K - 0084 and a change to the MM Revision 6, aircraft Sport Cruiser was made in January 2011. There is no SB to retrofit older models with a fuel return line
