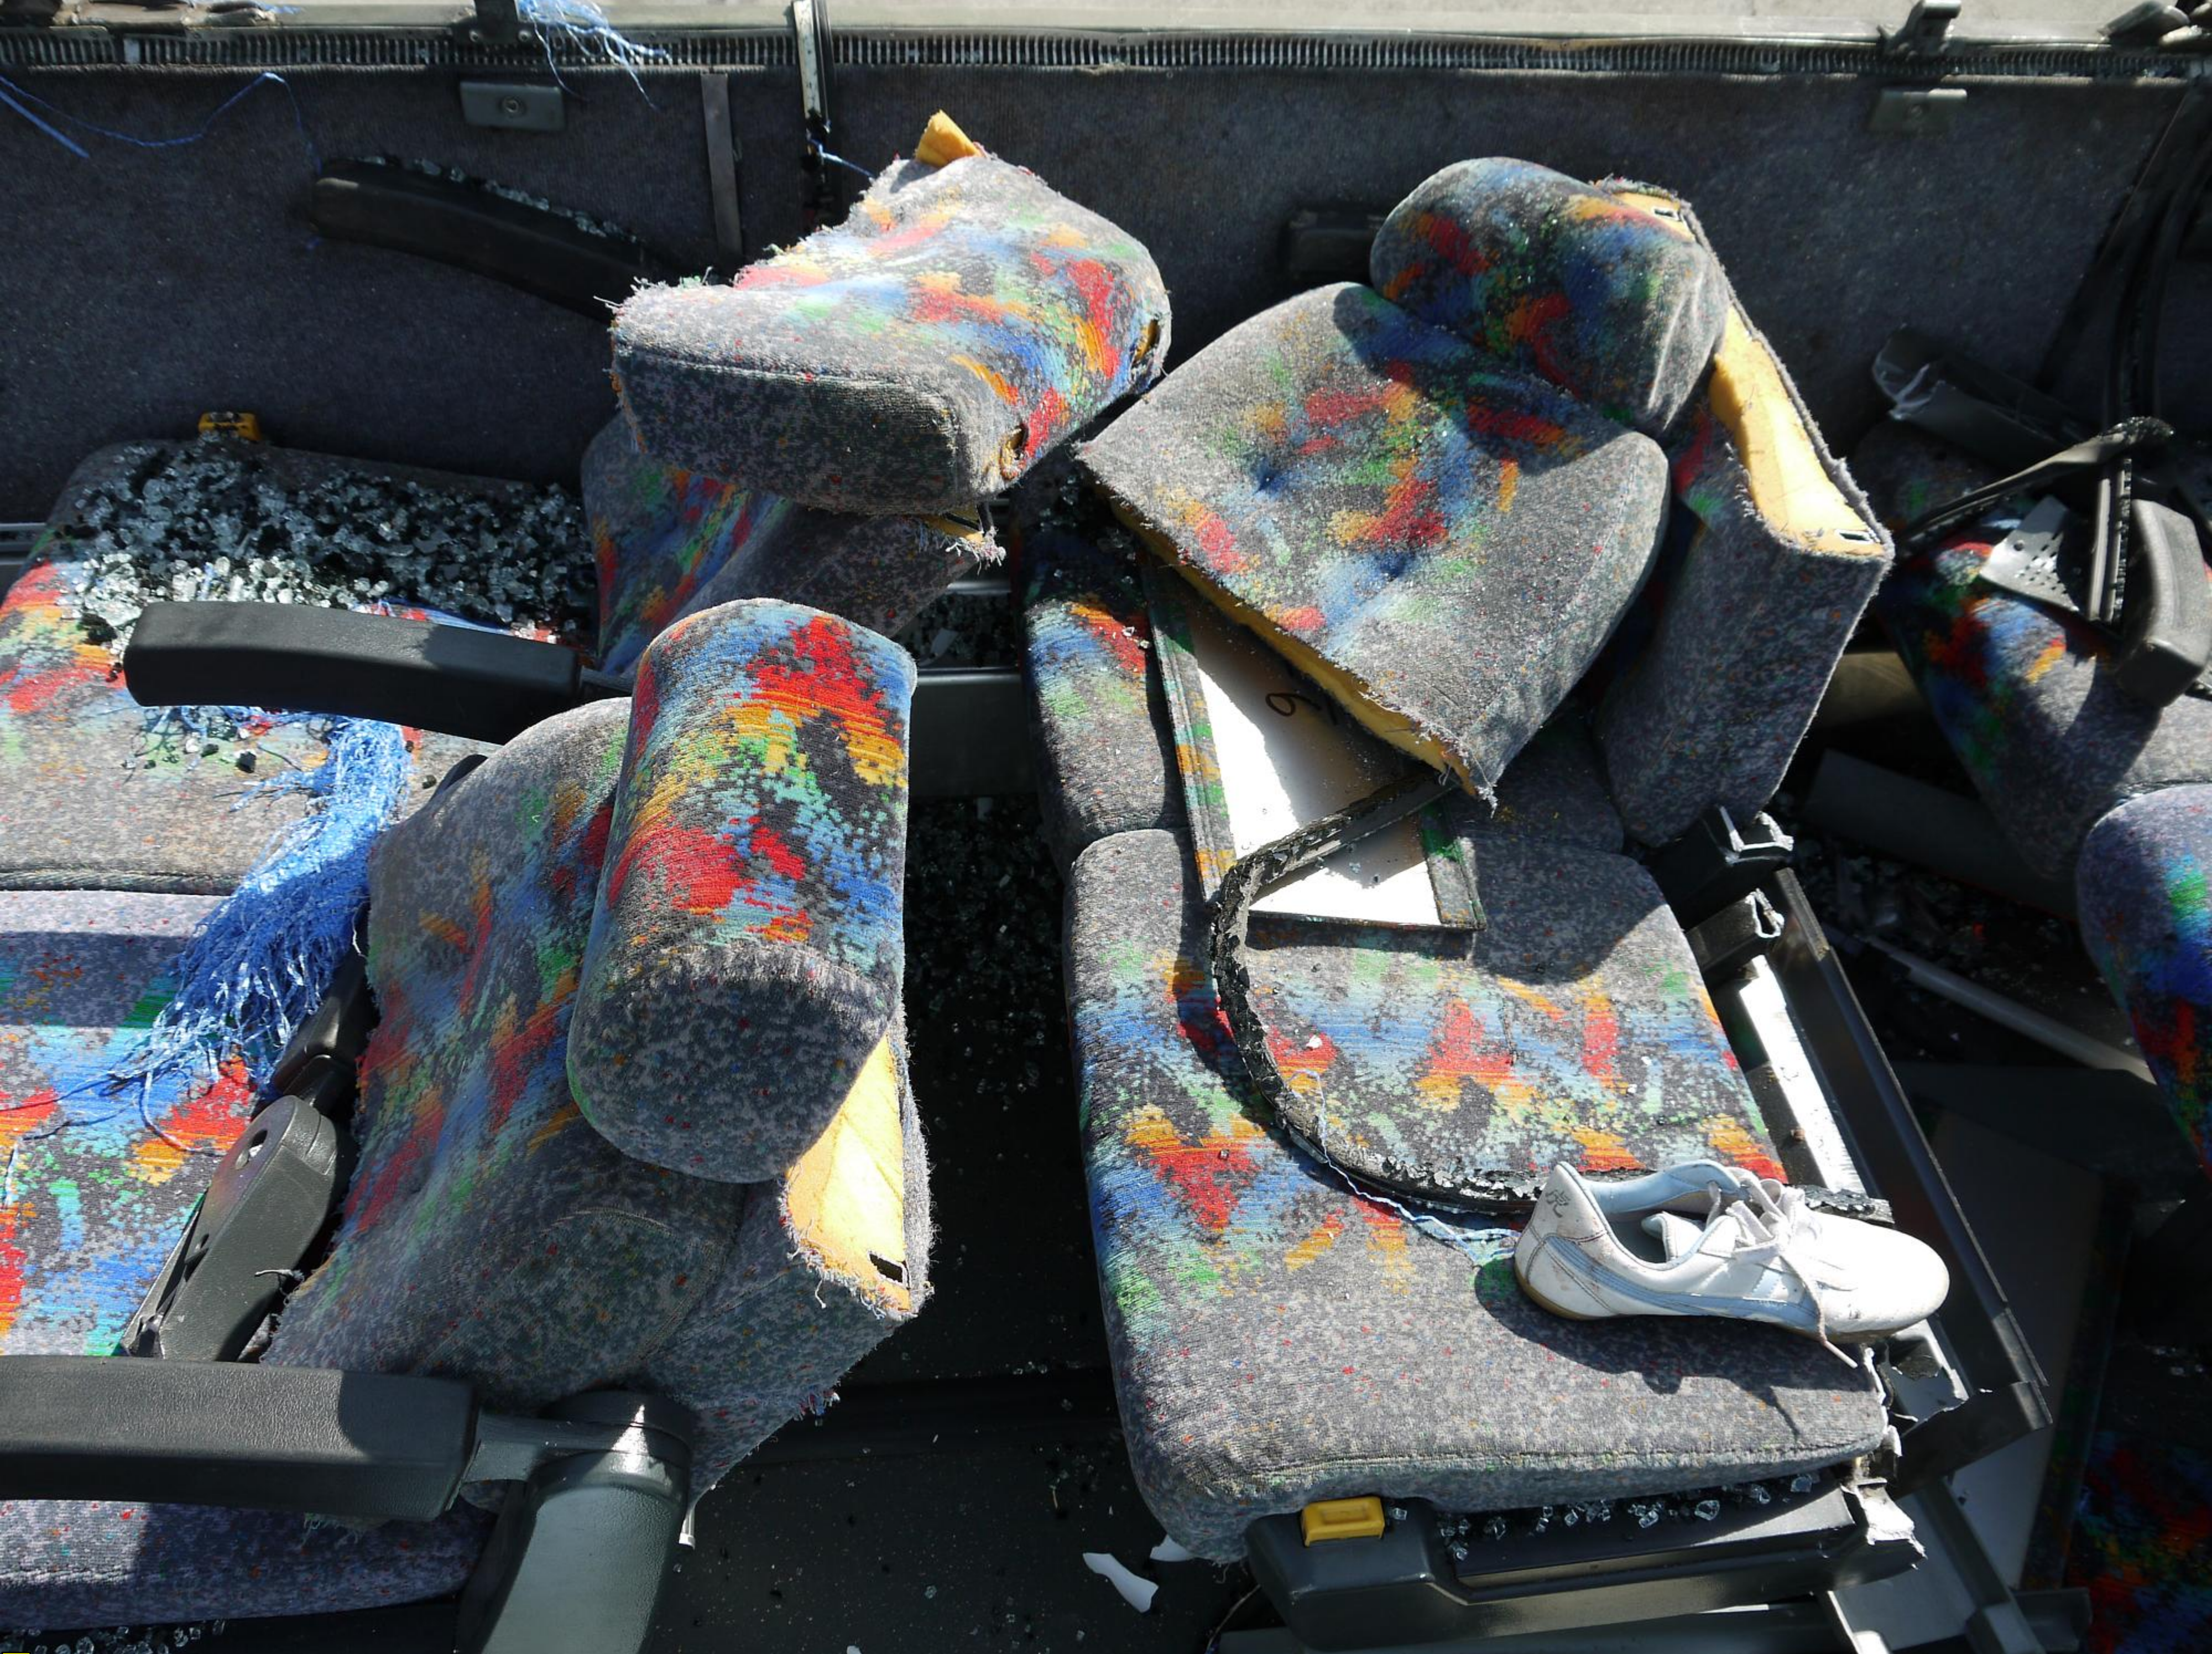
Photo 6 View of Seatbacks Cut During Extrication
