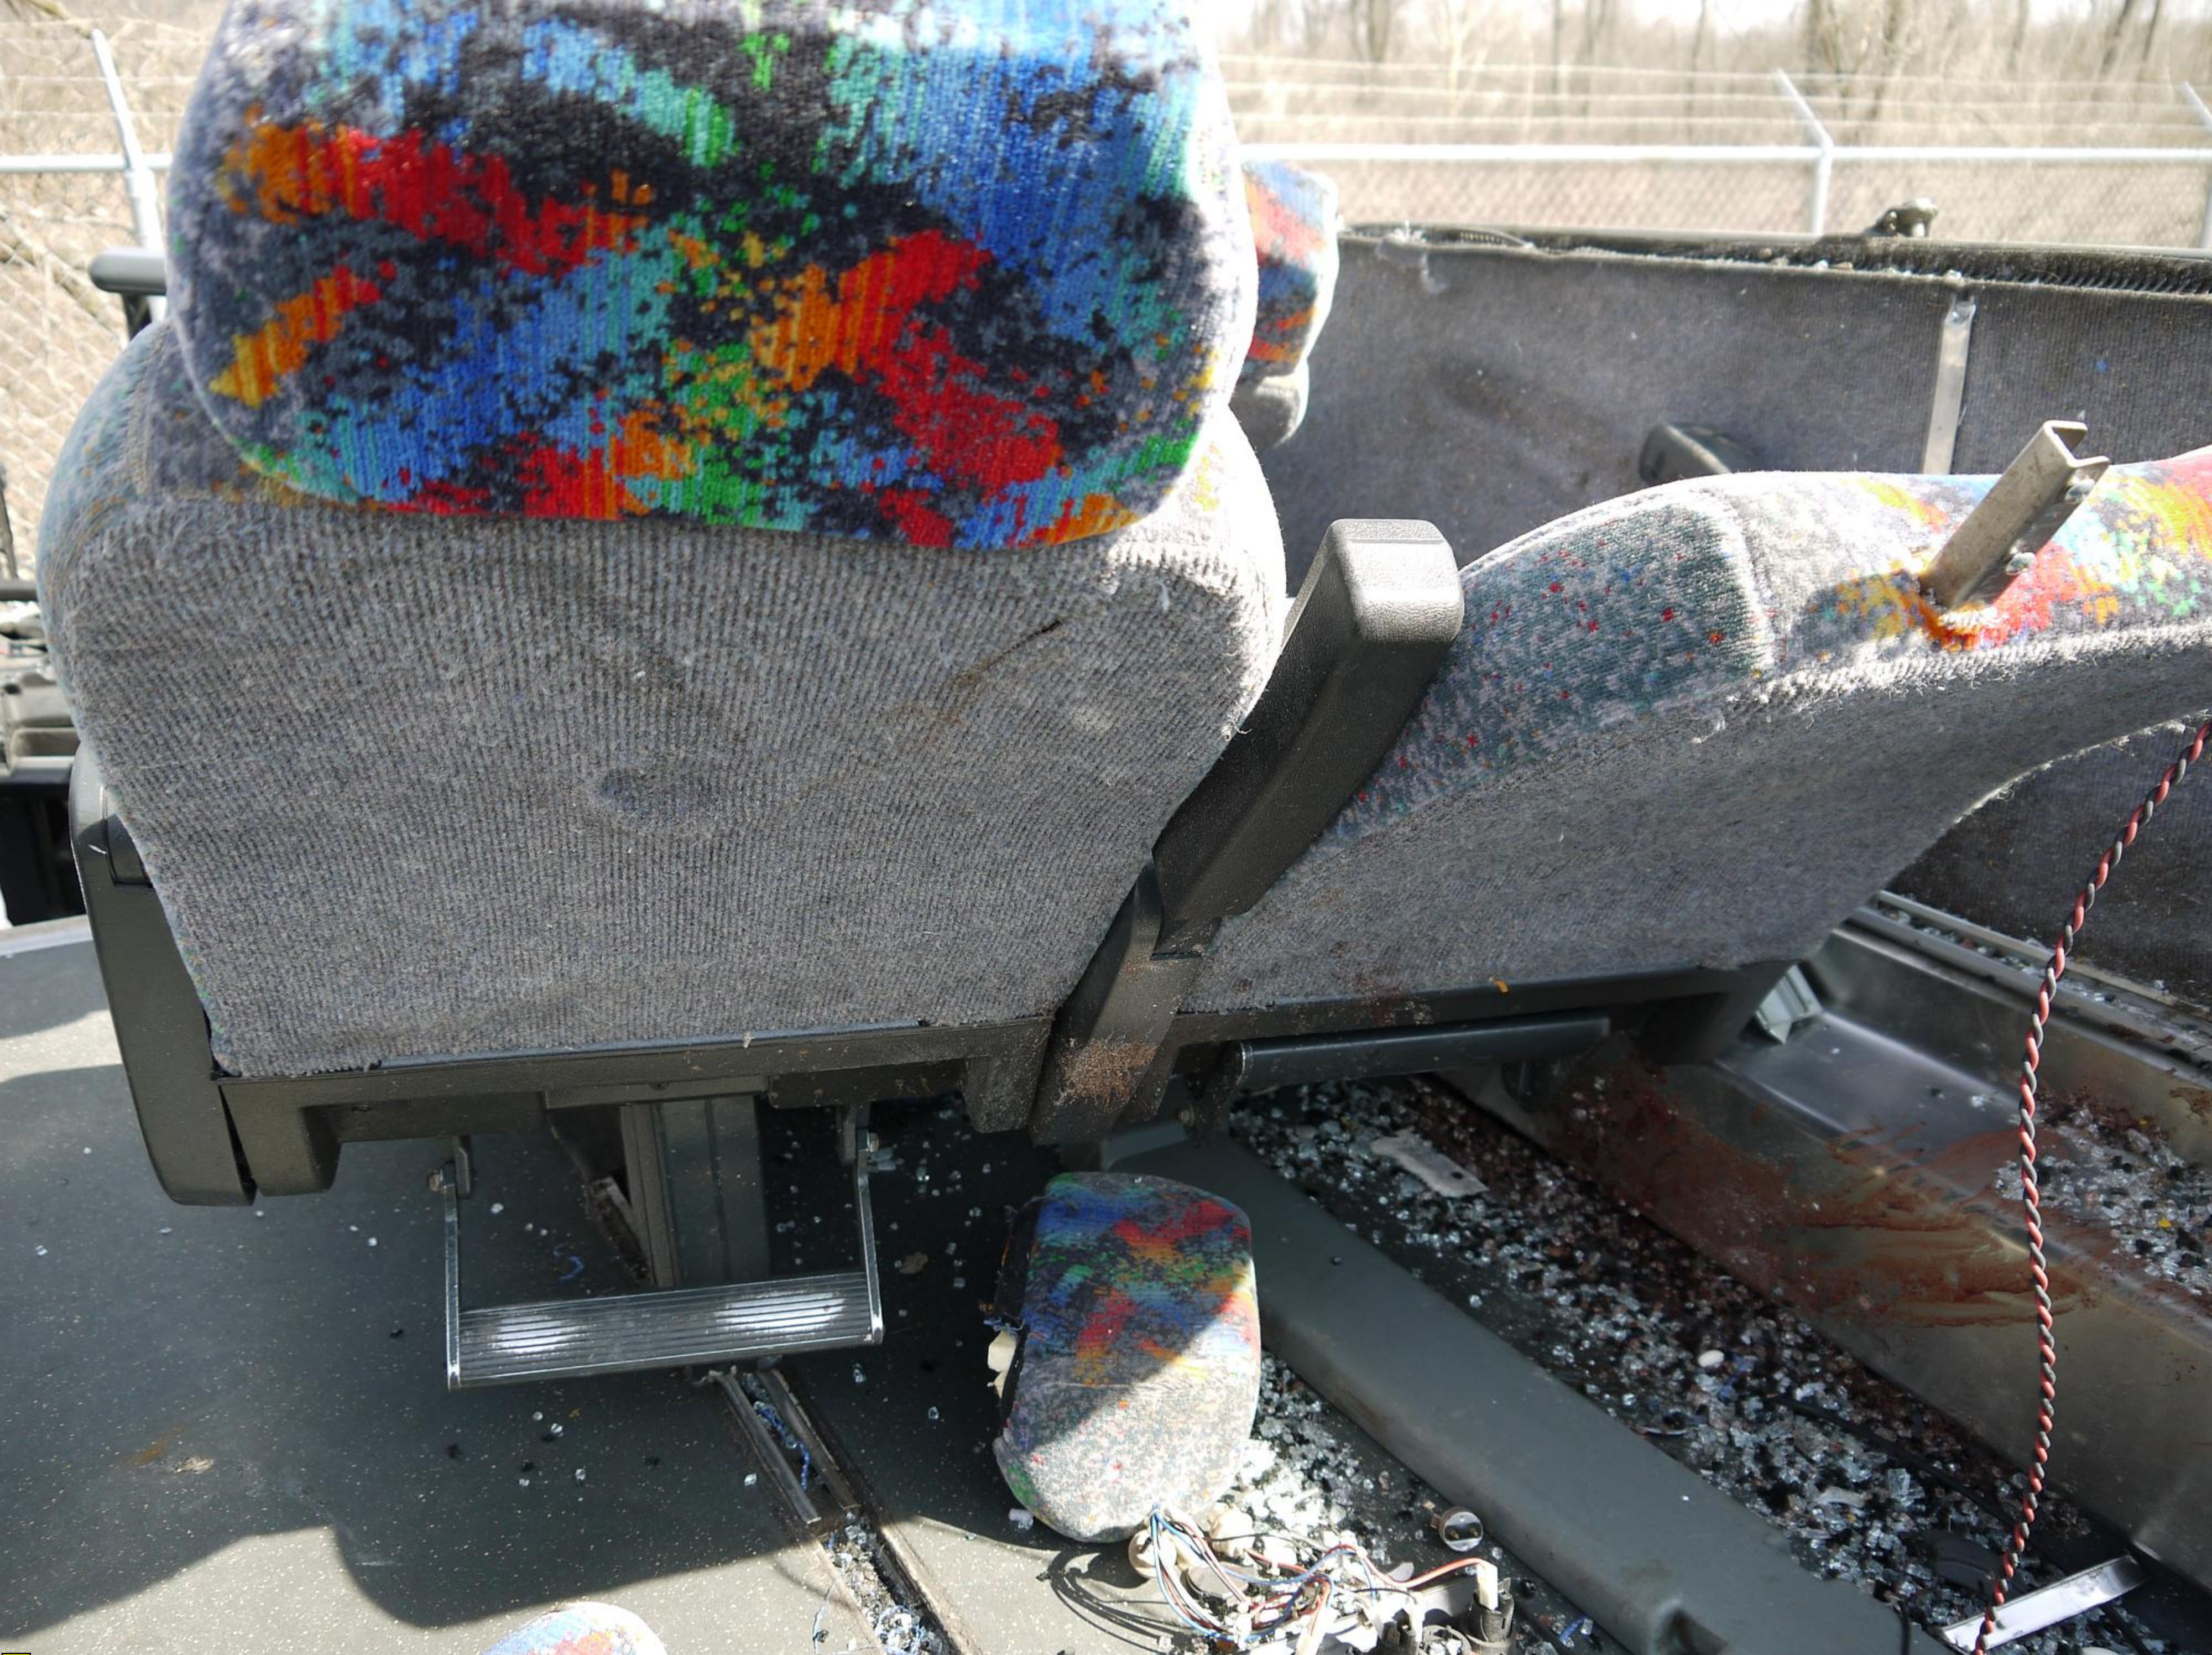
Photo 8 View of Row 2 Passenger Side with Occupant Impact Mark
