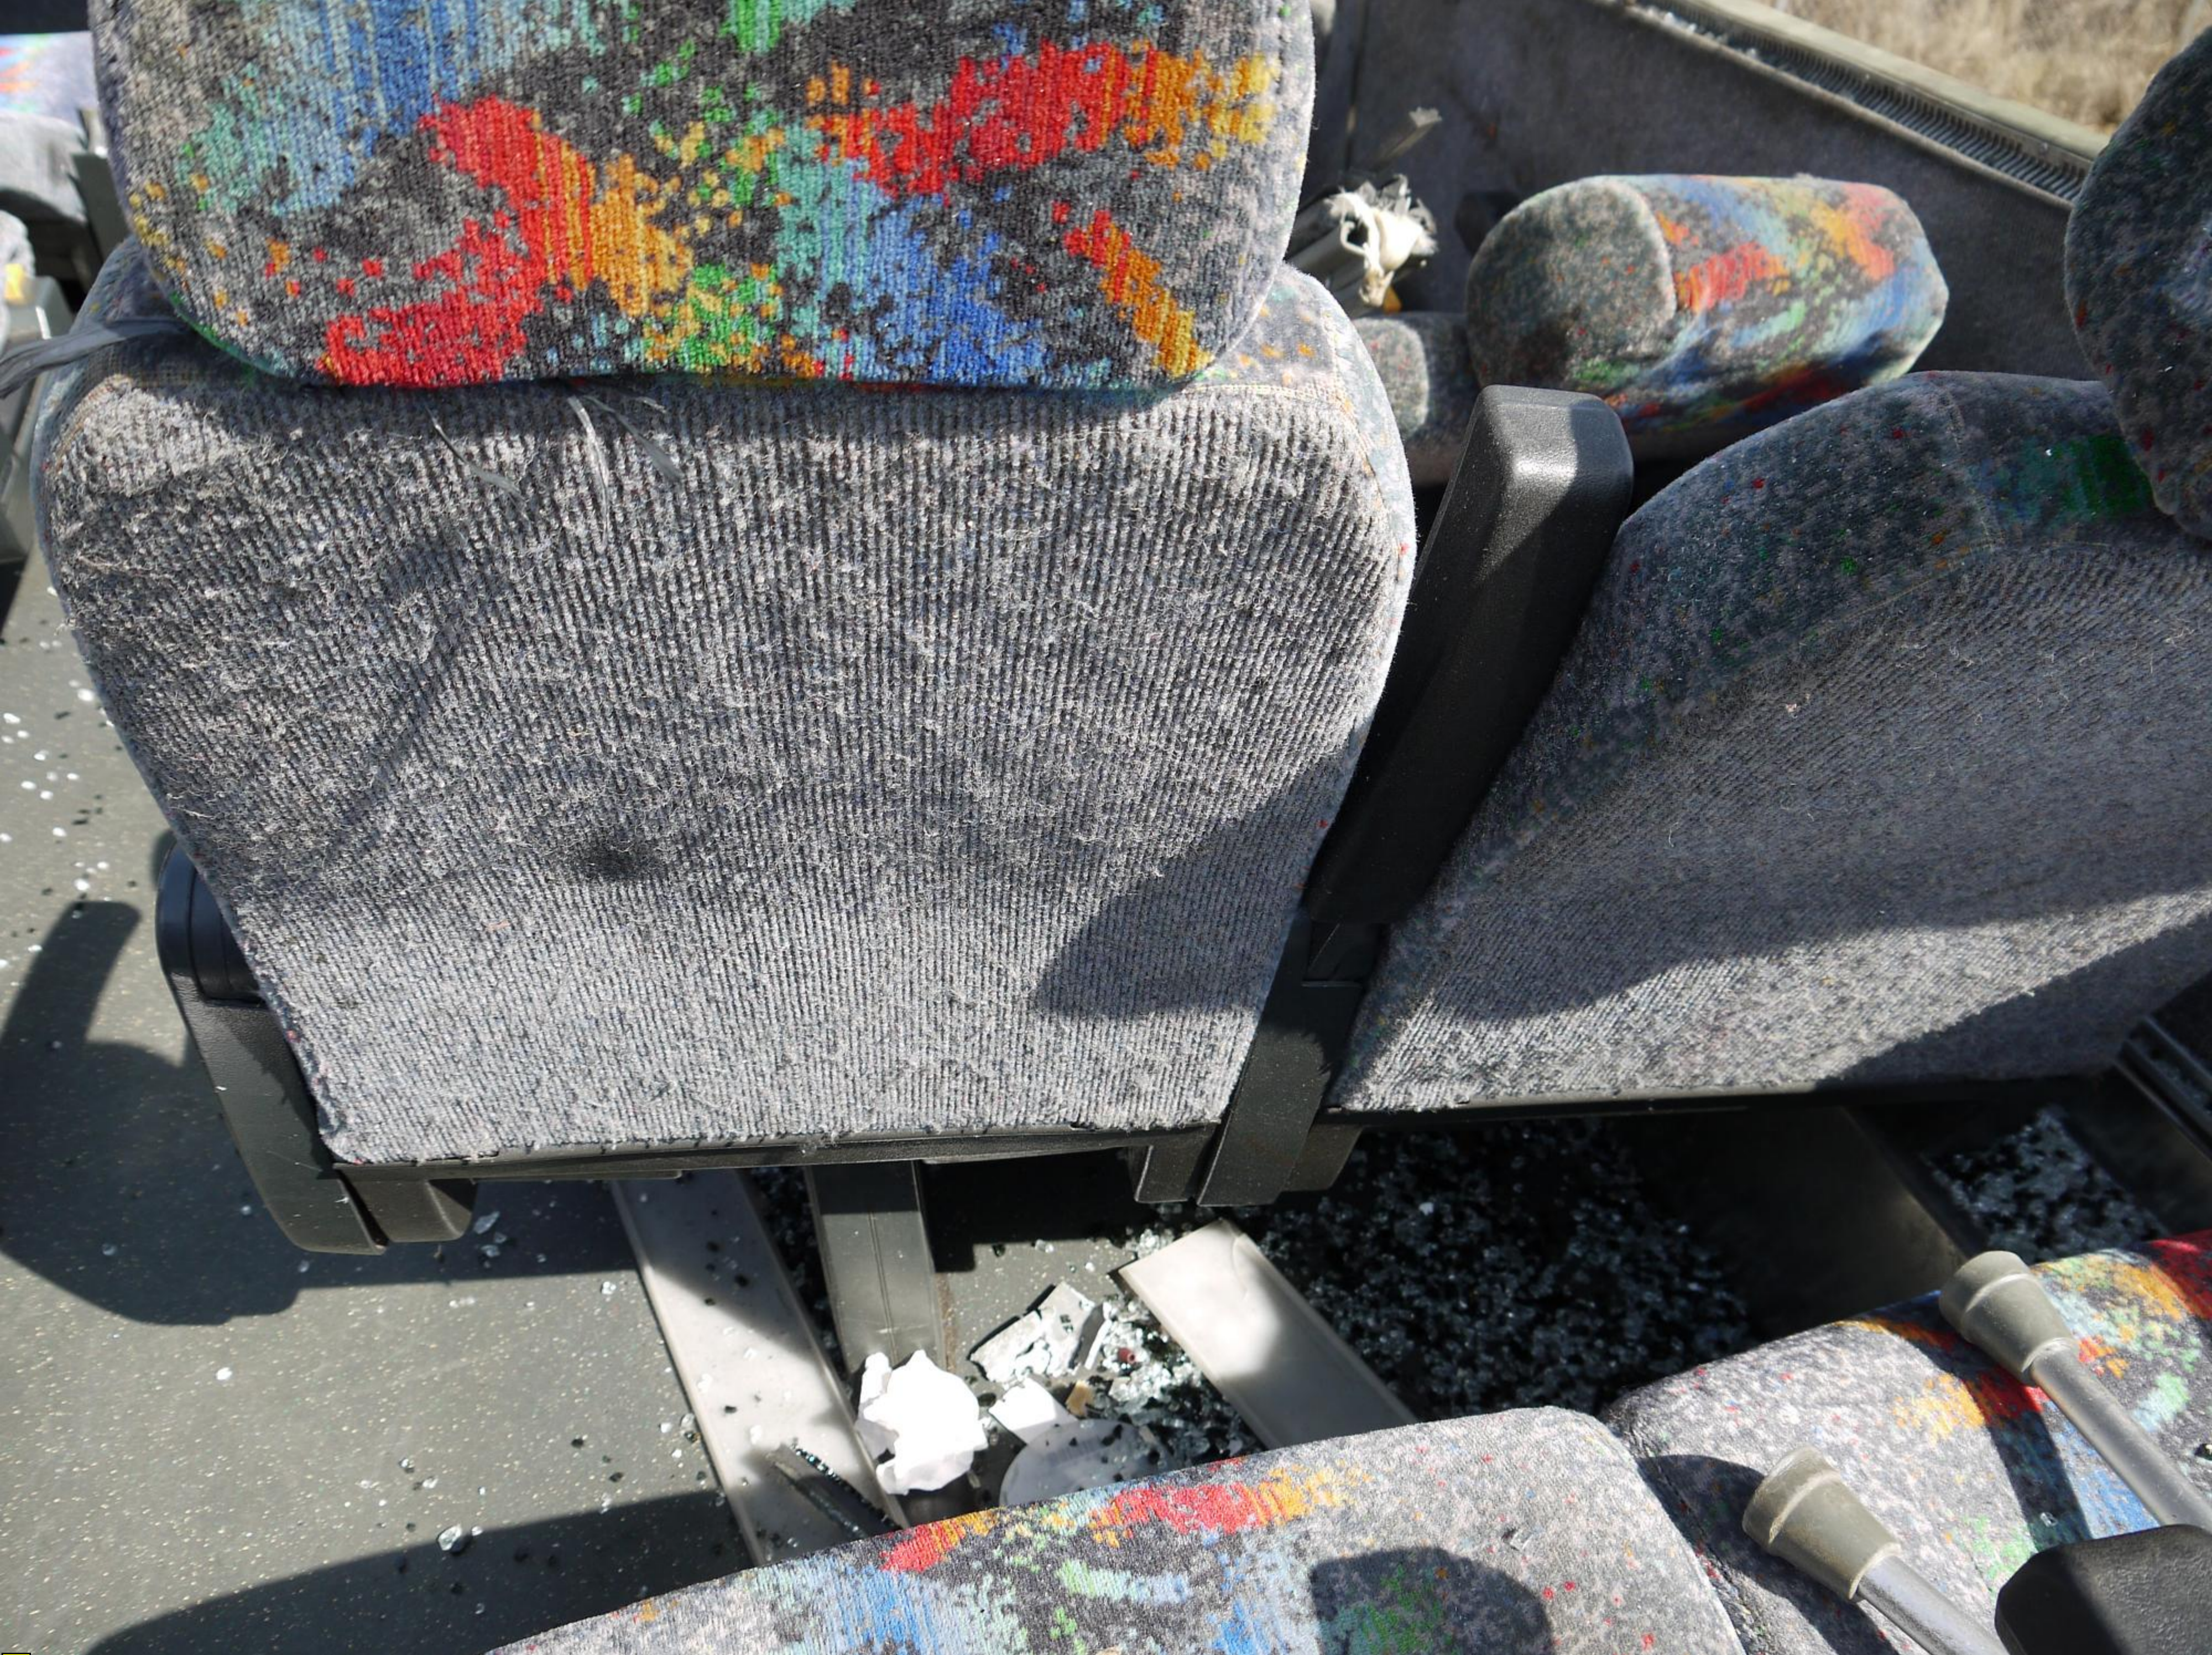
Photo 9 View of Row 6 Passenger Side with Occupant Impact Mark
