**SURVIVAL FACTORS
GROUP CHAIRMAN'S FACTUAL REPORT**

**Multiple Fatality Motorcoach Collision
With Vertical Poles Supporting an Overhead Bridge Sign
New York, NY; 03/12/2011**

**HWY-11-MH-005
(27 Pages)**

**NATIONAL TRANSPORTATION SAFETY BOARD
OFFICE OF HIGHWAY SAFETY
WASHINGTON, D.C. 20594**

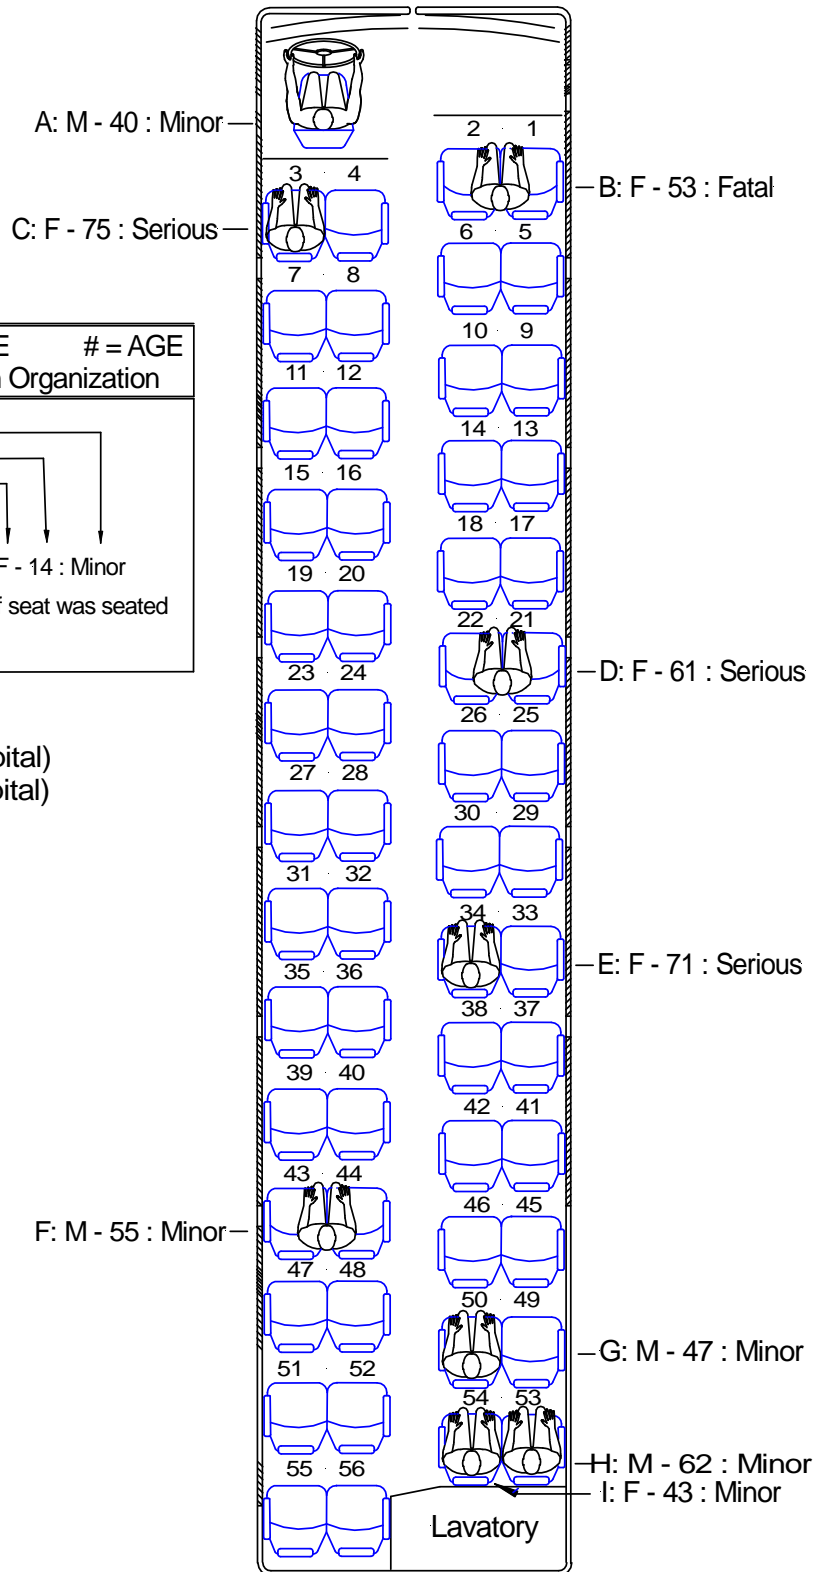
Identification of each seat occupant was not possible due to several factors including: lack of a seating manifest or assigned seats, fatalities, inability for some survivors to communicate due to injury severity, inability to locate some survivors for post accident interviews, language barriers, and lack of passenger seat belts. The partial seating chart provided below contains the known seating locations of bus occupants. All occupants have been assigned a letter designation for reference. The large number of occupants whose seat position prior to the crash could not be identified is listed in the chart according to their letter designation and severity of injury. Section 5 provides occupant information and injury tables organized by known seating positions, survivors, and fatalities.
