MECHANICS: Be Wary of Worn Fuel Selectors

Worn components can lead to fuel starvation and sudden loss of engine power

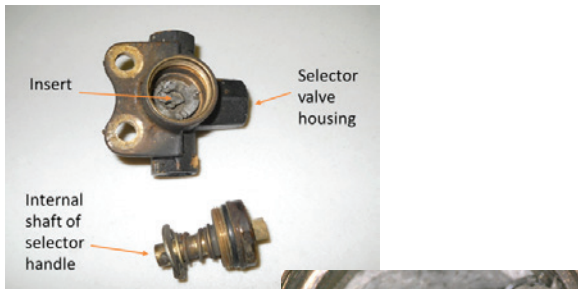
The failure of the fuel selector valve in a position that

restricted fuel flow to the engine led to the total loss of engine power due to fuel starvation. The operator failed to detect and resolve the wear of the fuel selector valve. (ERA17FA112)

Figure 2. Fuel selector valve housing and section of selector handle (above) and fuel selector insert with fractured pieces (right).

- **Inspect fuel selectors according to the airplane maintenance manual, checking the operation, condition, and security of the fuel selector.**
- **Ensure that stops or detents for the fuel selector valve position the valve properly.**
- **Service or replace any worn components, as necessary, according to the airplane maintenance manual and check your work to ensure accuracy.**
- **Be informed and review and comply with any applicable airworthiness directives and service bulletins regarding the fuel selector and components.**
