National Transportation Safety Board

Safety Recommendation

In reply refer to: R-15-25

We urge the Washington Metropolitan Area Transit Authority (WMATA) to take action on the safety recommendation issued in this letter. This recommendation is derived from our ongoing investigation of the electrical arcing and smoke accident near the WMATA L'Enfant Plaza station in Washington, D.C., on January 12, 2015, and supported by evidence from the February 11, 2015, electrical arcing and smoke incident at the Court House station. Although our investigation is not yet completed, this recommendation addresses a safety issue requiring immediate action. Information supporting this recommendation is discussed below.

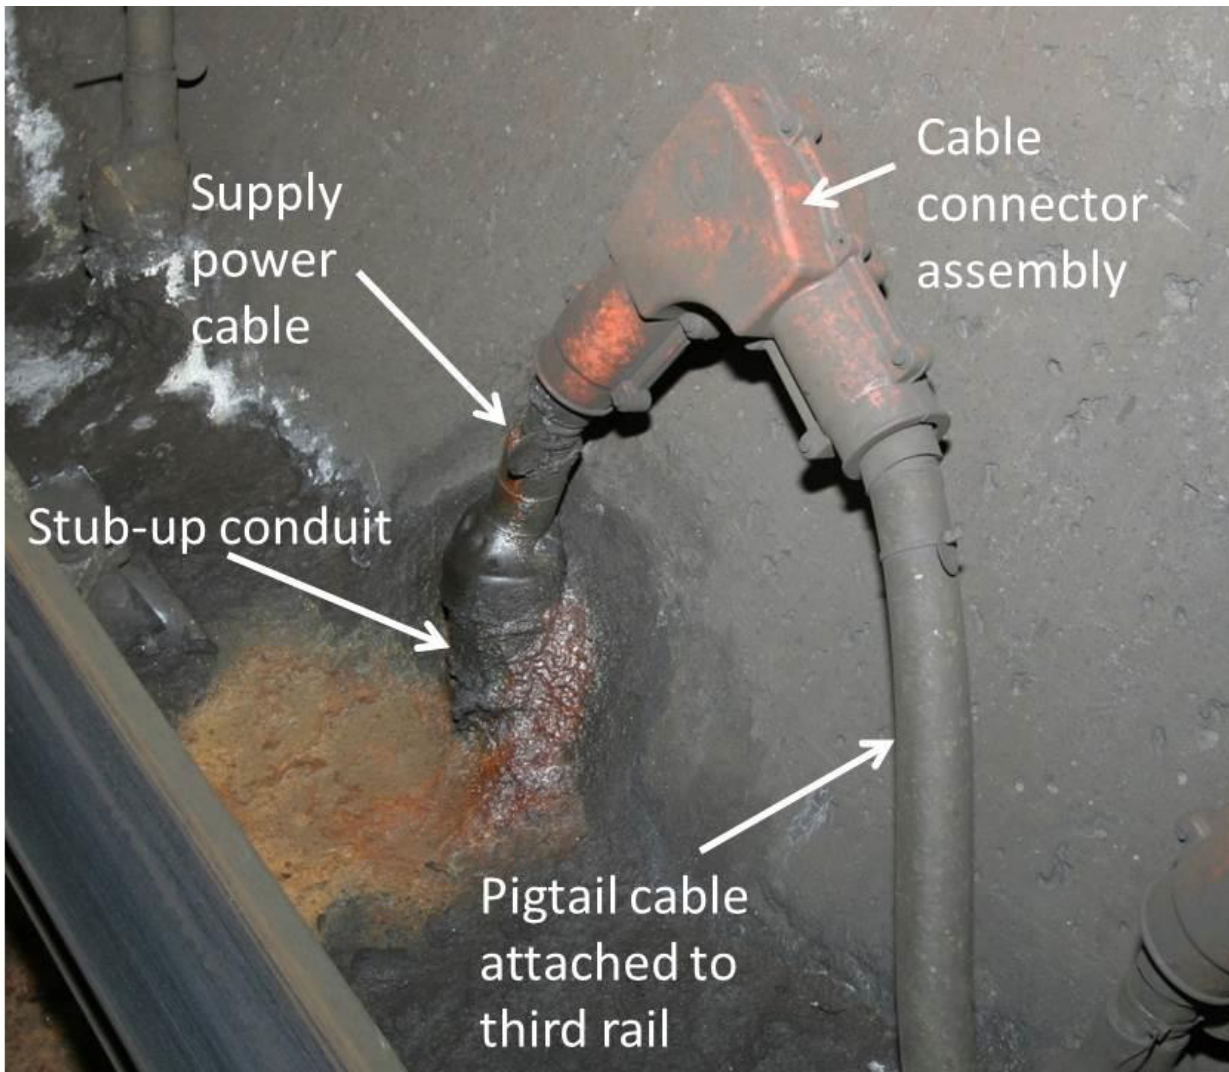
Figure 1 shows the typical arrangement of a supply power cable connected to a pigtail cable, which is welded to the third rail (a cable connector assembly protects the bolted terminal lugs).⁵ The supply power cable is brought to the surface of the tunnel through a stub-up conduit.⁶ In figure 2, the two upper images show the thermally damaged connector cover from the Court House station incident; in the lower image, the thermal damage is identified along the length of the pigtail cable.

Figure 1. A typical stub-up conduit with supply power cable, cable connector assembly, and pigtail cable.

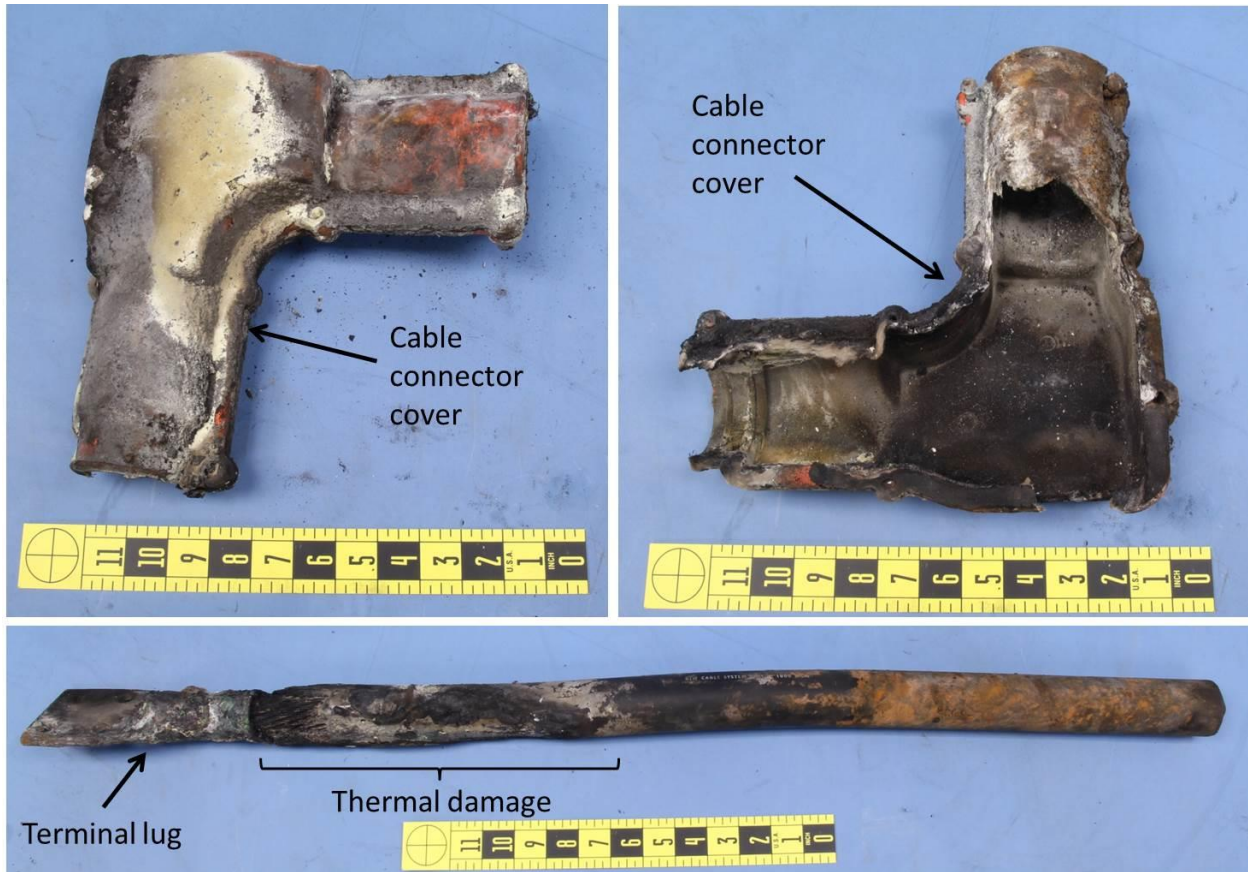
The laboratory evaluation of evidence recovered from the Court House station incident revealed that smoke in the tunnel was generated by thermal damage to about 11 inches of power cable insulation and a portion of the fiberglass cable connector cover. The signatures on the damaged power cable were consistent with a short circuit due to electrical arc tracking. The arc tracking occurred between a terminal lug inside a cable connector assembly and extended along the surface of a section of the pigtail cable leading to the third rail.⁴ The terminal lug was inside a connector cover at the time of the arc tracking, and the cable was lying on the tunnel floor. Inspection revealed no evidence of cable insulation chafing or direct contact between the lug and a grounding medium.

Figure 2. Section of electrical power cable from Court House station incident exhibiting thermal damage. The two upper images show the connector cover from the Court House station incident; in the lower image, the thermal damage is identified on the cable insulation.

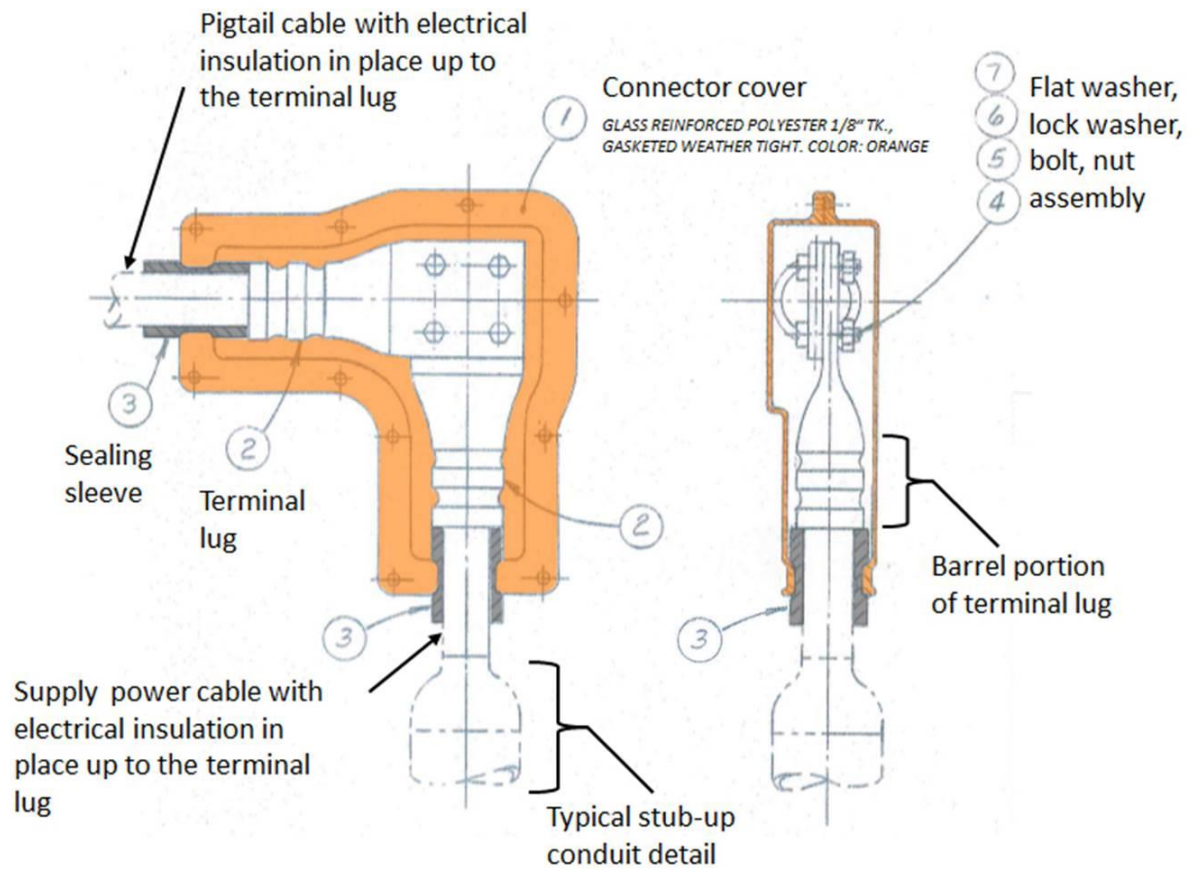
Figure 3 shows the correct cable connector assembly in accordance with WMATA's engineering design specifications. According to WMATA engineering and procurement documents and discussions with engineering personnel, the power cable connector covers are designed to be weather tight when installed with all sealing sleeves (see figure 3).⁷ However, investigators found that the failed power cable connector assembly at the Court House station incident location was missing its sealing sleeves. Figure 4 shows an in-service assembly without the sealing sleeves. NTSB investigators have found a number of other power cable connector assemblies throughout the WMATA Metrorail system constructed without sealing sleeves; often with heat shrink tubing or electrical tape used in place of the sealing sleeves; and with different types of terminal lugs, some of which are not specified for use with their connector covers.⁸

Figure 3. Cable connector assembly showing the correct arrangement of the terminal lugs, connector cover, and sealing sleeves. The typical arrangement of electrical power cables is identified.

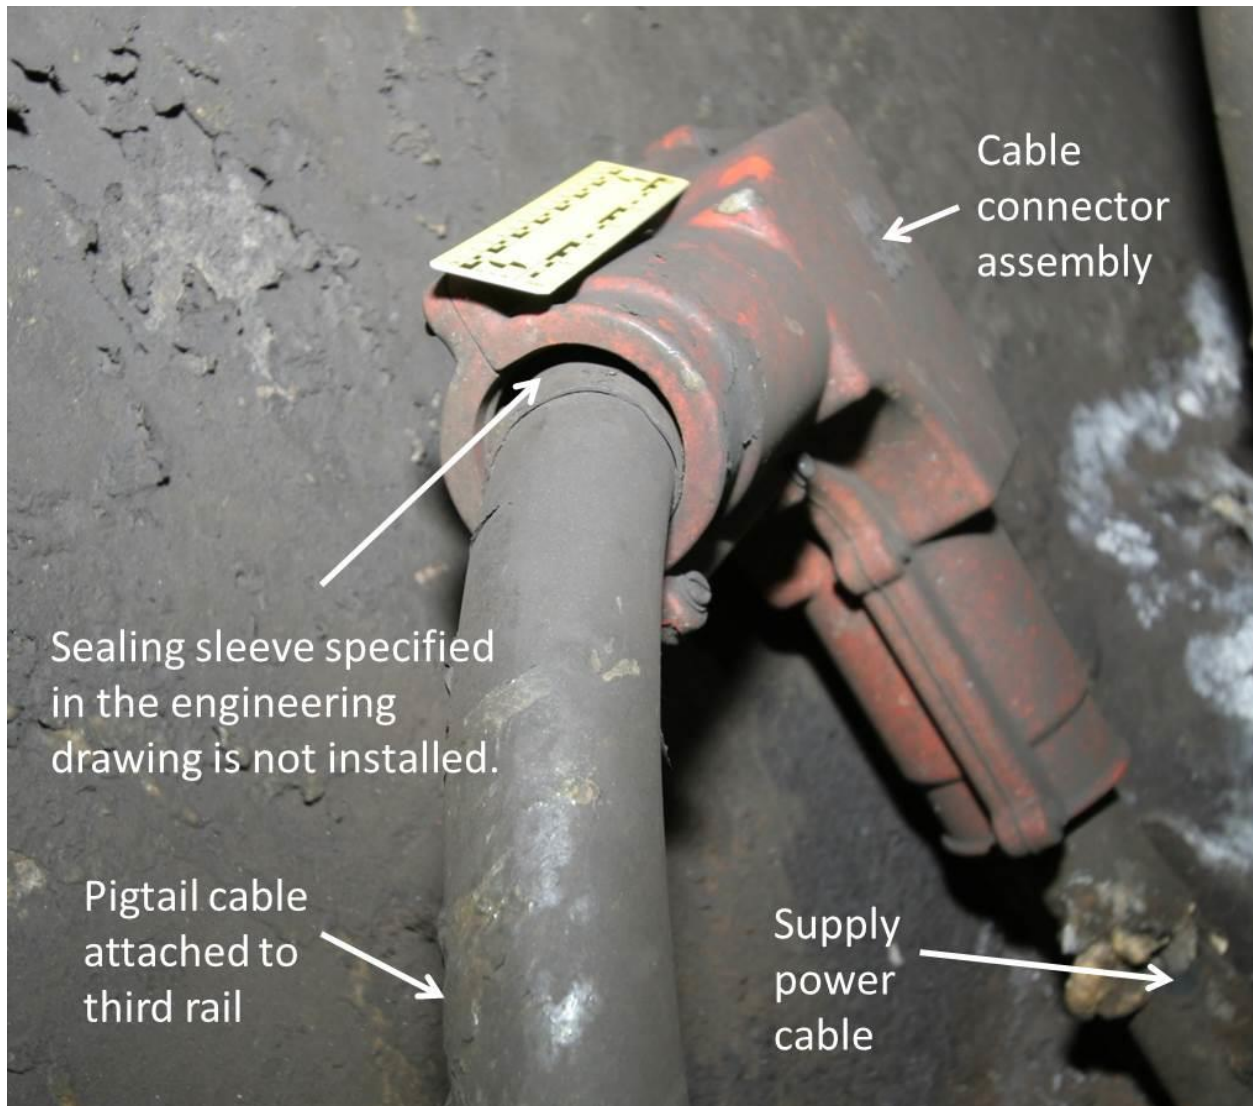
These power cable connector assemblies were not in accordance with WMATA's engineering design specifications.

Figure 4. Installed cable connector assembly without required sealing sleeve.

According to discussions with WMATA, it does not have a program to ensure that power cable connector assemblies are installed in accordance with its engineering design specifications. The specified cable connector covers are installed; however, WMATA has allowed maintenance crews and contractors to use various types of terminal lugs and sealing methods. In what should be identical assemblies throughout the system, NTSB investigators have found numerous power cable connector assemblies that are not in accordance with WMATA's engineering design specifications. These assemblies are frequently missing sealing sleeves and use a variety of different terminal lugs. Even the postaccident repairs made to the power cable connector assembly at L'Enfant Plaza did not include the sealing sleeves indicated in the WMATA engineering design specifications. Although the investigation of the L'Enfant Plaza accident is ongoing and additional analysis is needed before the cause can be determined, the damaged power cable in the Court House station incident is consistent with electrical arc tracking due to contaminants and moisture on the power cable surface. The NTSB concludes that WMATA's third rail electrical power cable systems are susceptible to electrical arc tracking at improperly constructed power cable connector assemblies, which can lead to short circuits that can generate fire and smoke in tunnels.

Promptly develop and implement a program to ensure that all power cable connector assemblies are properly constructed and installed in accordance with your engineering design specifications, including the weather tight seals that prevent intrusion by contaminants and moisture. (R-15-25)

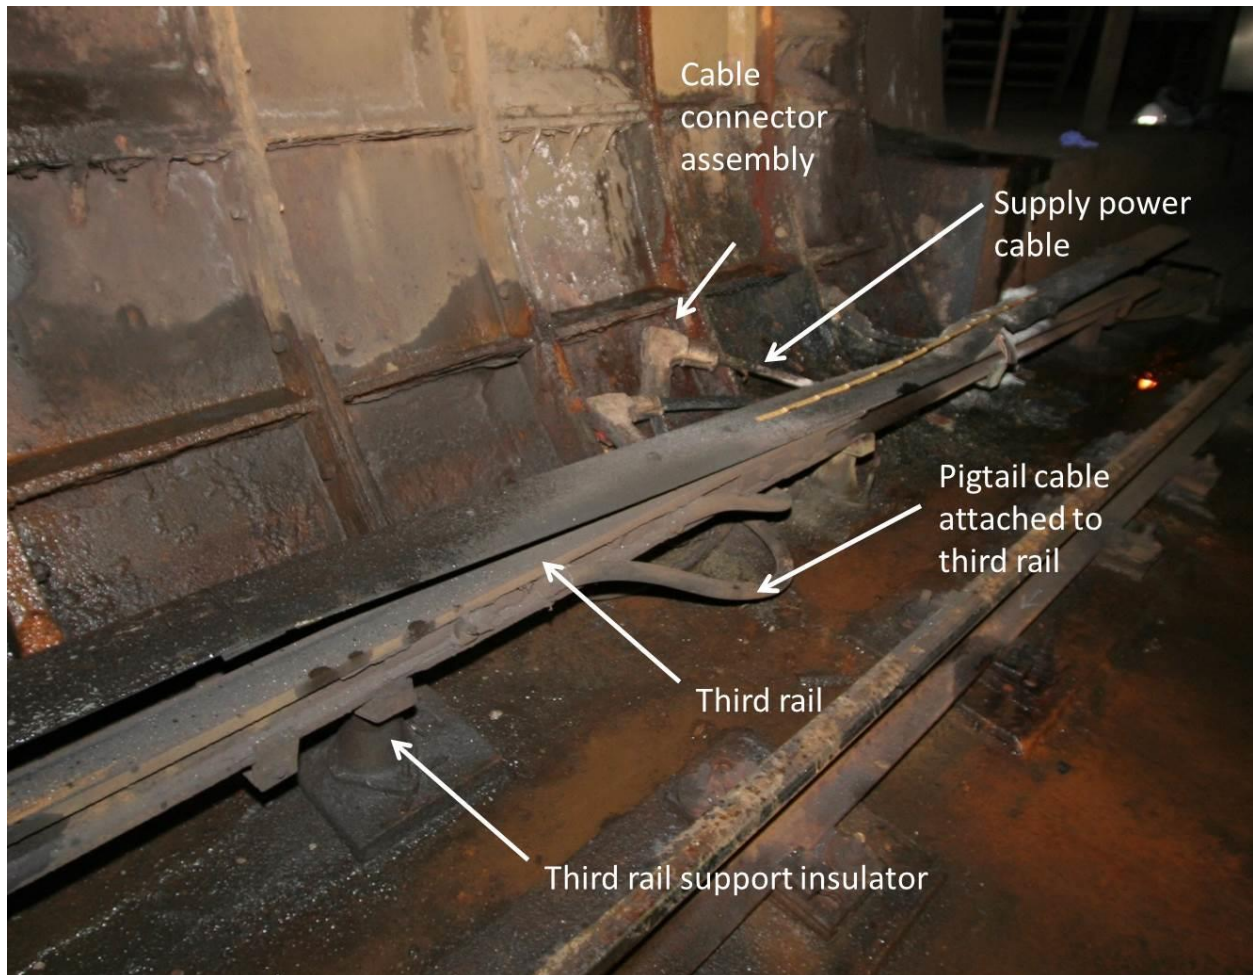
There are many transit systems operating in the United States where the trains are powered by a third rail that is supported on electrical isolation insulators.⁹ Figure 5 shows components of the third rail power distribution system at the L'Enfant Plaza accident location. There are three primary areas where electrical arc tracking can occur:

1. Along the surface of the third rail support insulators, between the third rail and the floor of the tunnel.
2. Along the insulated surface of the pigtail cable, between the terminal lug in the connector assembly and the floor of the tunnel (or along the insulated surface of the cable, between the third rail end of the pigtail cable and the floor of the tunnel).
3. Along the insulated surface of the supply power cable, between the terminal lug in the connector assembly and the floor of the tunnel.

Figure 5. Third rail components with insulating surfaces susceptible to electrical arc tracking at L'Enfant Plaza accident location.

WMATA surveys revealed that the vast majority of the third rail support insulators that annually experienced electrical arc tracking occurred within tunnels.¹⁰ Tunnels have particulate contaminants such as brake dust; rust particles; rail grinding swarf; rail and wheel wear debris; carbon motor brush dust; deicing salt dust; dirt particles; and calcareous deposits from minerals from ground water, which leaks or drips in tunnels.¹¹ Unlike open track, train tunnels can concentrate particulate contaminants, which can coat all surfaces, including support insulators and electrical power cable insulation. For these reasons, power cable connector assemblies need to be sealed to prevent moisture or contaminants from entering the assemblies and creating the path to ground necessary for electrical arc tracking to occur.
