NATIONAL TRANSPORTATION SAFETY BOARD
Vehicle Recorder Division
Washington, D.C. 20594

Sandel SN3500 Study Report

Location: Bloomington, Illinois
Date: April 7, 2015
Aircraft: Cessna 414A
Registration: N789UP
Operator: Make It Happen Aviation, LLC
NTSB Number: CEN15FA190

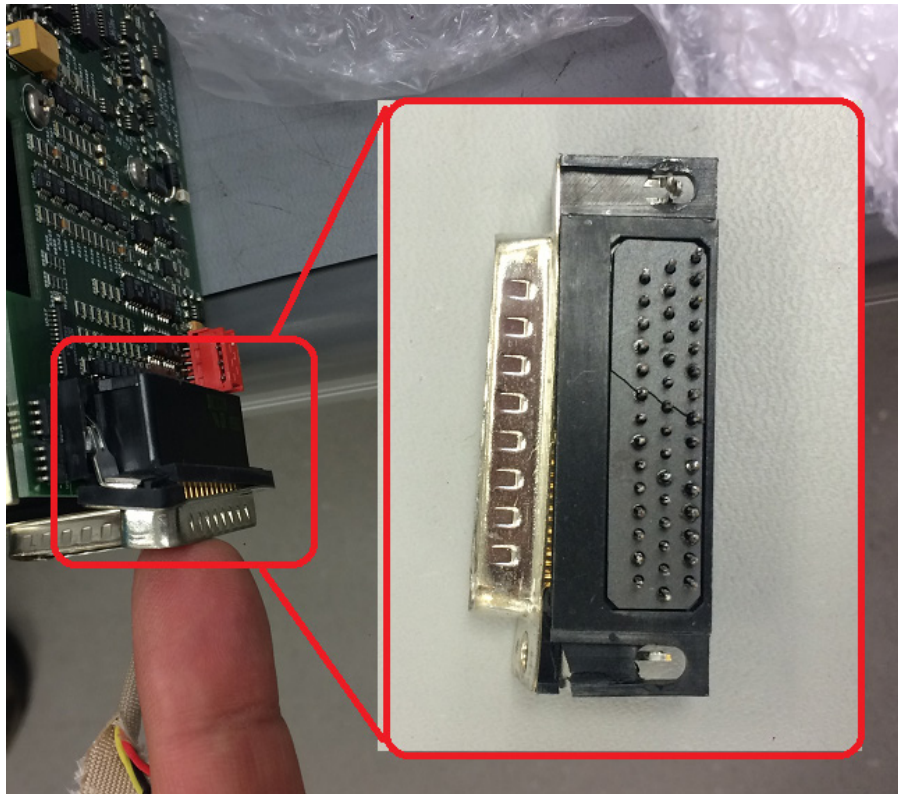
Two items were not working on the accident unit: the cooling fan and the P2 serial connector. The cooling fan was not repaired; rather, an external fan was setup next to the unit while it was running the tests. The P2 serial connector, shown in figure 1, was removed and a new P2 serial connector was soldered in place.

Figure 1. Damaged P2 connector (inset shows close-up of damage after removal).

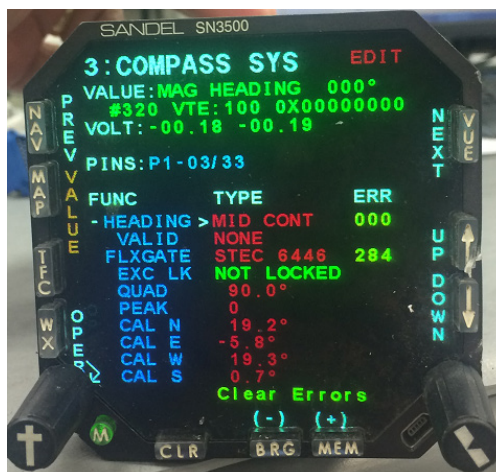
- **Magnetic Heading.** The Sandel SN3500 supports various interfaces for magnetic heading. The accident unit was configured to receive two elemental inputs supporting magnetic heading: (a) gyro values from a Mid Continent gyro and (b) flux gate values from an S-TEC 6446 flux gate (see configuration screen shown in figure 2). The Sandel SN3500 combined these values in real time to produce the displayed magnetic heading. Values from the Mid Continent gyro, S-TEC flux gate, and resulting displayed heading were recorded at 1 Hz.

Figure 2. Accident unit original gyro configuration screen.

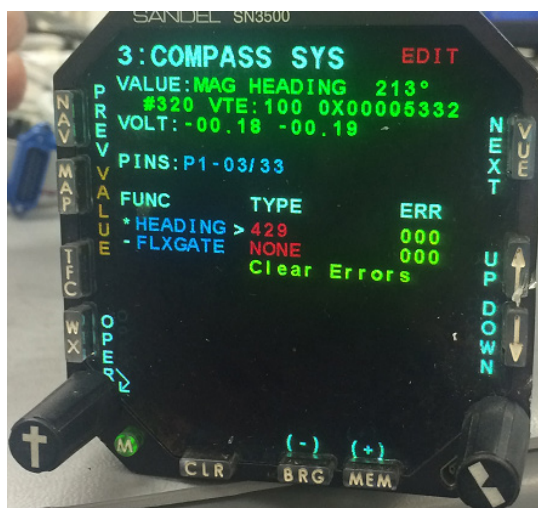
The replay framework was not capable of sending the gyro and flux gate values to the Sandel unit for re-composition to displayed magnetic heading. Therefore, the accident unit gyro configuration was changed to receive an ARINC 429 magnetic heading, as shown in figure 3. The replay framework then sent the recorded, originally displayed magnetic heading to the unit, as if the source was ARINC 429 heading from an external source.

Figure 3. Accident unit with updated gyro configuration for replay.

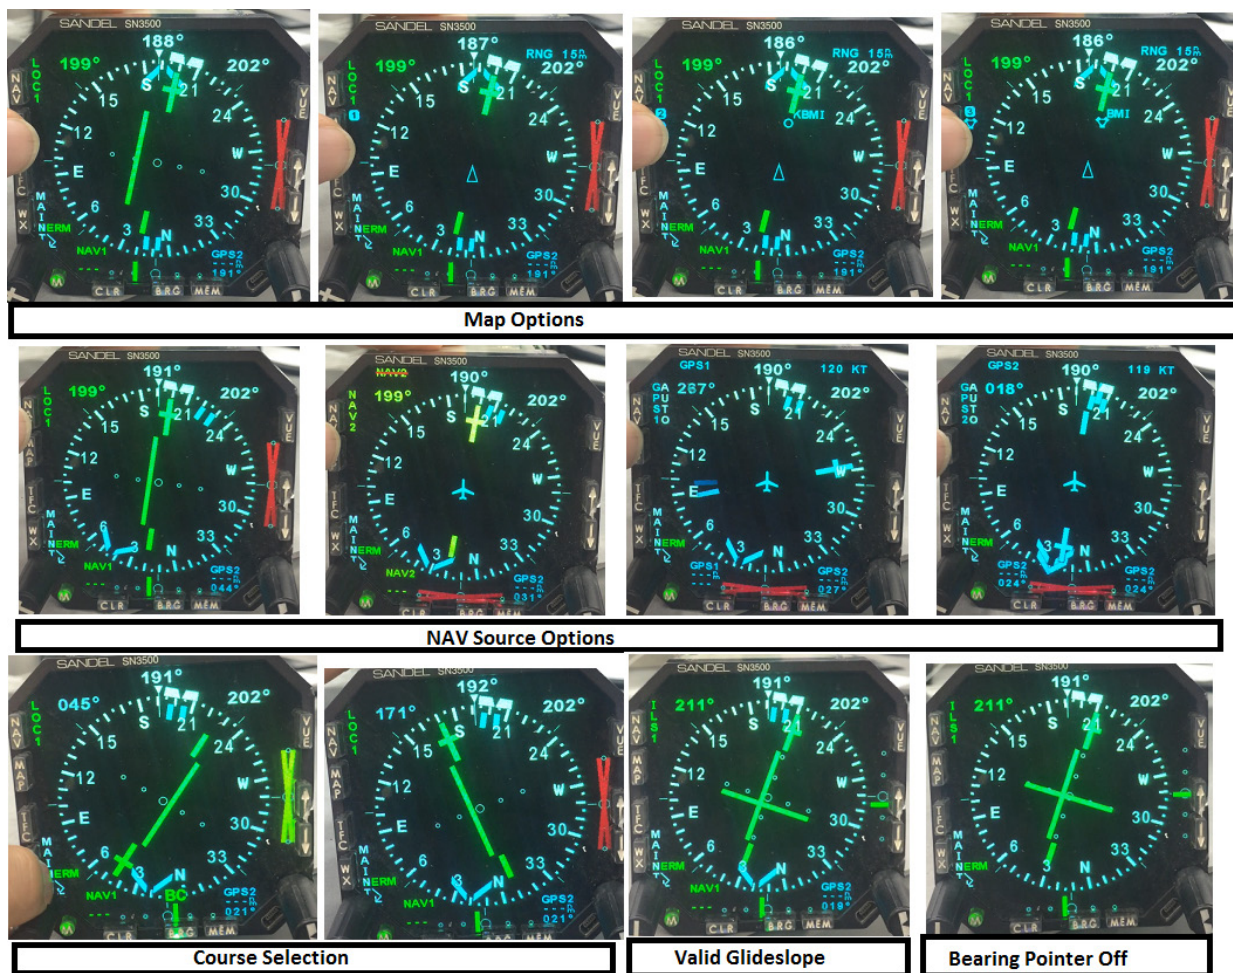
Before beginning the replay of recorded data, possible screen displays presented to the pilot were explored. Figure 4 shows a sample of select screen displays. The top row shows possible map options which may be selected. The second row shows various navigation source selections; from left to right: Nav 1, Nav 2, GPS 1, and GPS 2.

The first two images of the third row show the course selection for the localizer. In the examples, the localizer course was likely the ILS 20 at BMI. The images show the course selected to 045 degrees and 171 degrees. Because the selected course was not recorded, the replay had to assume what course to select during the replay.

The third row shows how a valid glideslope signal is presented on the SN3500. The last image in the third row shows the bearing pointer turned off.

Figure 4. Sample of screen configurations.

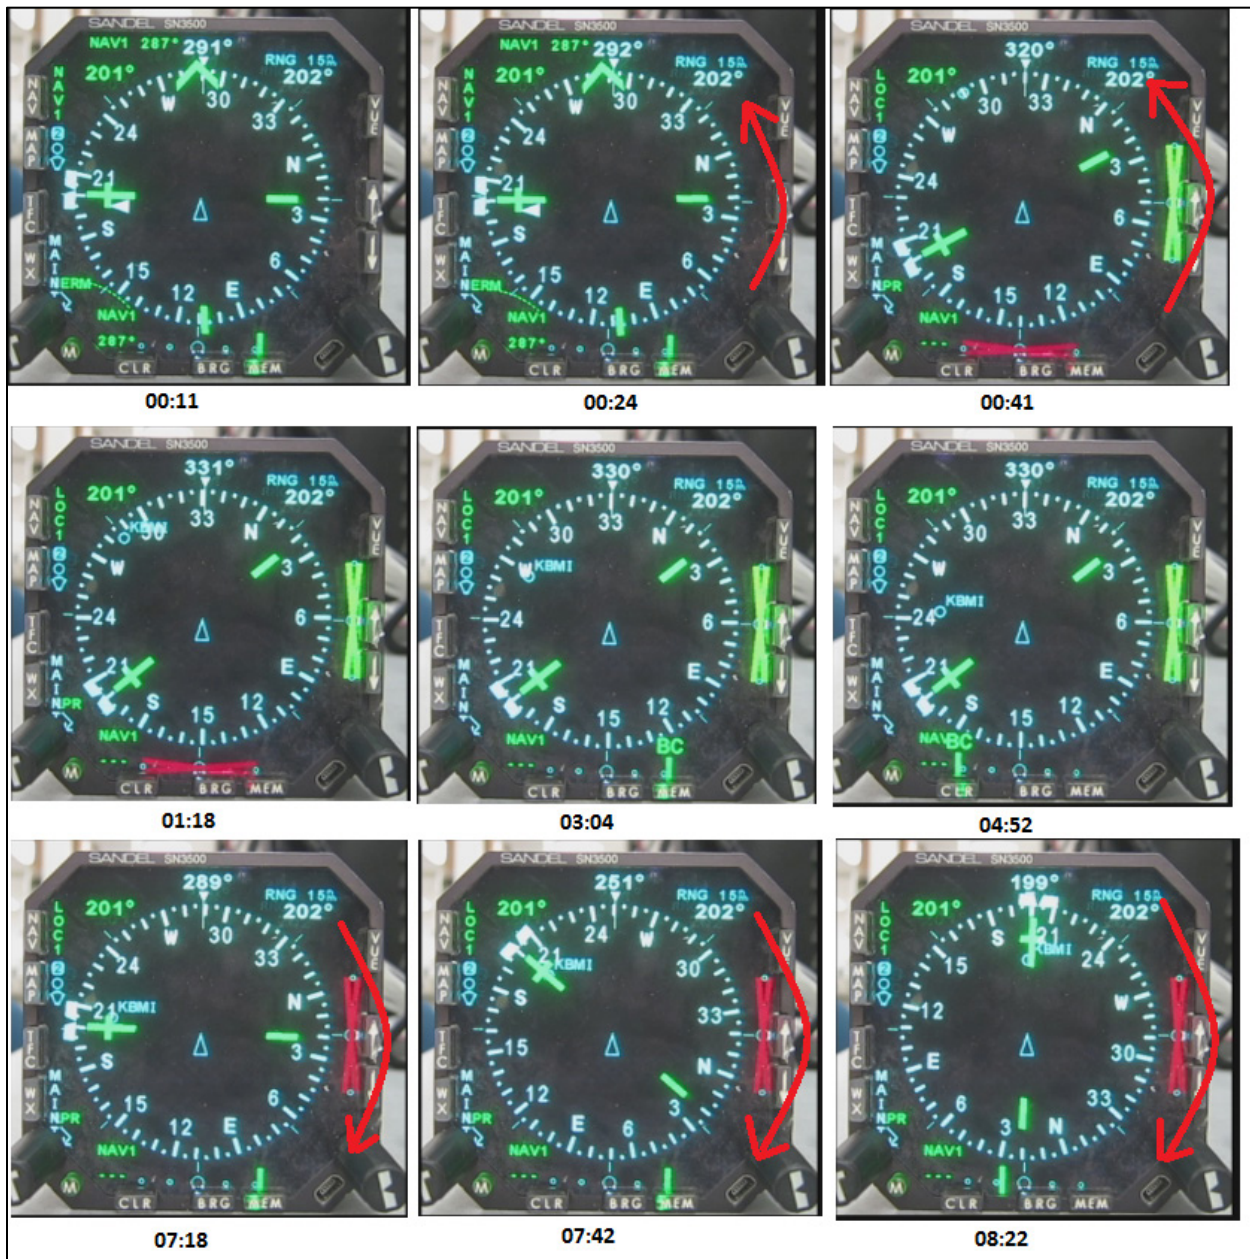
During the accident flight, the glideslope never became valid on Channel 1 or 2. On other flights, the glideslope was valid, but later than would be expected.⁵ Figure 5 shows select frames from the accident replay (log_00) for Channel 1, replayed on the accident unit. Times used in figure 5 correspond to elapsed times of the video recording of the playback from attachment 1. When red arrows are used to annotate a heading change, the red arrows show the direction of movement of the compass card.

At 00:41, while in the turn to 330°, navigation radio 1 tuned to a localizer frequency that was flagged invalid for the localizer and glideslope. The glideslope invalid "X" was yellow⁶.

At 03:04, while still on a 330° heading, the localizer first became valid. The localizer scale displayed a “BC” annunciation, indicating a back course condition. The BC annunciation is expected behavior of the SN3500 when the aircraft heading is more than 90 degrees offset from the selected inbound course. The localizer needle was full scale to the right.

By 07:18, the aircraft was in a left turn towards about 200°. As the aircraft passed through 289°, the BC annunciation extinguished and the localizer needle moved from full scale left to full scale right. The glideslope invalid “X” changed from yellow to red and remained red until aircraft heading changed significantly later in the approach (the change to a yellow “X” was accompanied by the “BC” annunciation⁷).

Throughout the recording, the glideslope needle always displayed an “X,” indicating it was never valid. After 04:52, the localizer needle remained valid until the end of the recording. By about 10:39, the localizer needle was full scale left. Thereafter, heading and localizer fluctuated until the end of the recording.

Figure 5. Select frames from accident flight (log_00, channel 1)
