NATIONAL TRANSPORTATION SAFETY BOARD

Security Video

Group Chairman's Factual Report
By Bill Tuccio, Ph.D.

Location: Queens Village, New York
Date: June 10, 2017
Operator: Long Island Rail Road (LIRR)
NTSB Number: DCA17FR009

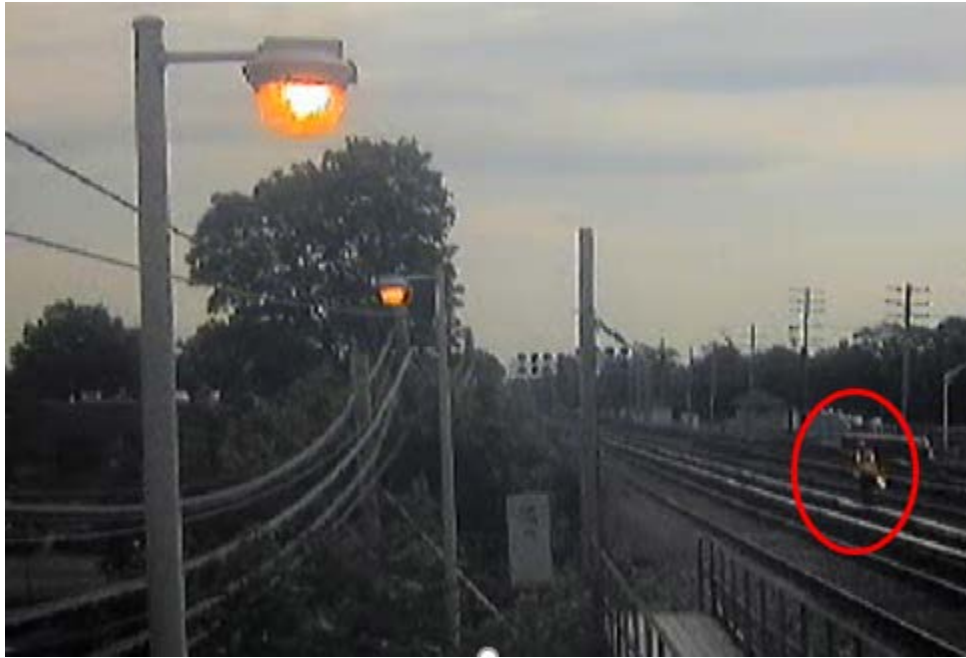
Figure 3. Image at 10:09:05.

At 10:09:05, the last roadway worker, who appeared to be holding a watchman's disc, began to exit the field of view of the camera as he walked westbound in the foul of ML1, as shown in figure 3.

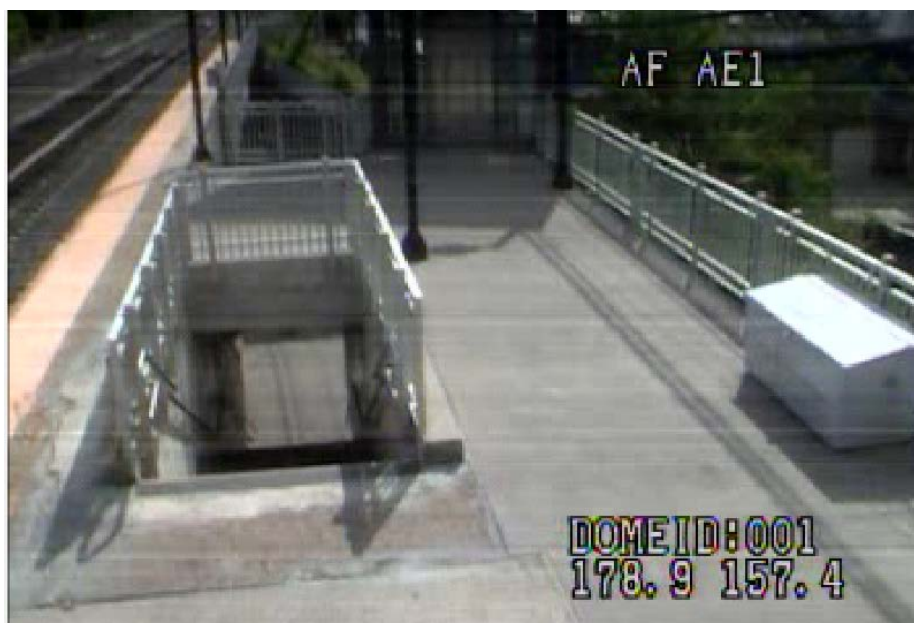
Figure 4. Camera 01-01-01 vantage point.

At 10:13:06, the westbound electric train (incident train) on ML3 came into view without stopping. As the train entered the field of view, a small low-resolution pixelated image, consistent with at least two persons, was barely discernible. One of the persons was struck by the train.

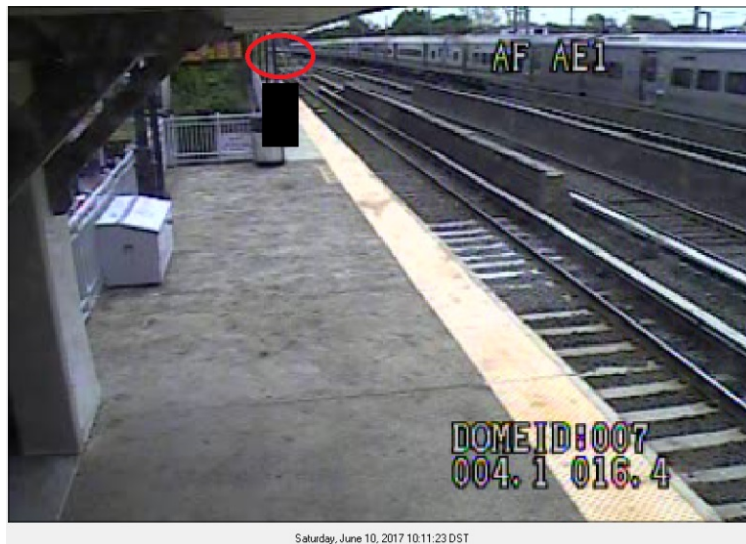
Figure 7. Image at 10:11:23.

At 10:10:45, an eastbound electric train, on track ML4 entered the field of view of the camera, moving slowly (about 15 mph). At 10:11:23, persons were visible north of the passing eastbound train (east of where the roadway worker was eventually struck), and they appeared to remain in the foul of adjacent tracks, as shown in figure 7. By 10:11:55, the eastbound train had moved far enough east, that a person on the south ROW became visible ("Person A"); Person A was moving west on the ROW. By 10:12:22, this train had further slowed and entered the Belmont Wye. The persons (in the foul of the adjacent tracks) moved westbound towards the Queens Village Station.
