NATIONAL TRANSPORTATION SAFETY BOARD

Security Videos

Specialist's Factual Report
By Bill Tuccio, Ph.D.

Location:	San Juan, Puerto Rico
Date:	June 3, 2017
Aircraft:	Piper PA-23-250, N21WW
Operator:	Air America Inc.
NTSB Number:	ERA17FA195

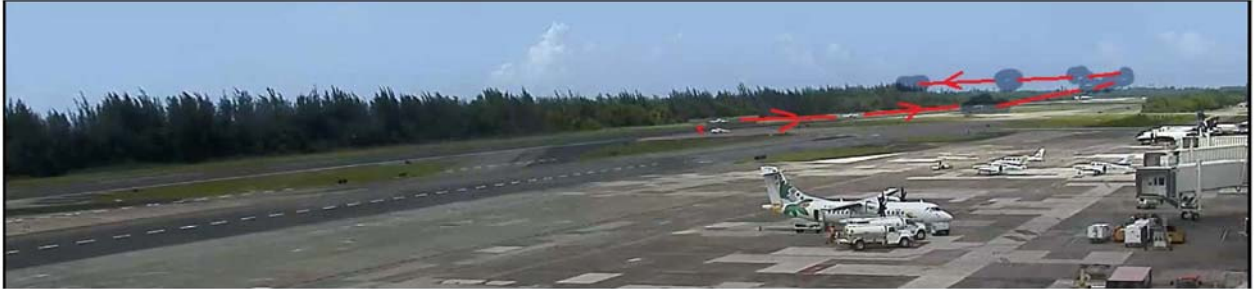
Figure 1. Camera 2 time-lapse imagery of accident flight.

- At 14:14:18, N21WW entered the field of view taxiing towards the departure runway.
- At 14:14:49, N21WW entered the runway from the taxiway without stopping.
- By 14:15:02, N21WW had begun a rolling takeoff (that is, a rolling transition from taxi to takeoff) from the intersecting taxiway.
- By 14:15:40, N21WW had lifted off the runway; due to the video resolution and distance from the camera, an exact time of liftoff could not be determined.
- For additional details refer to other cameras.

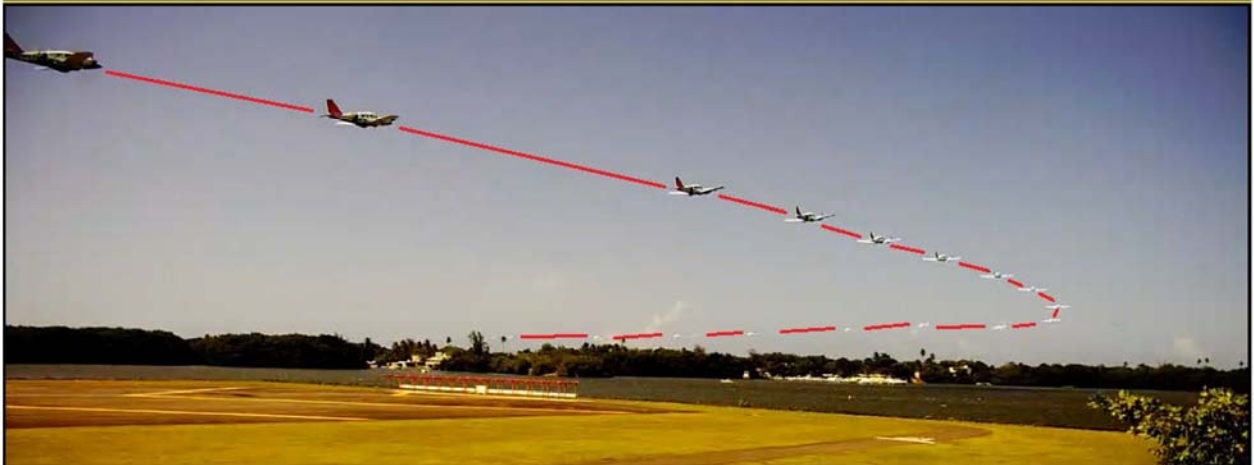
Figure 2. Camera 4 time-lapse imagery of accident flight.

- At 14:16:01, N21WW was over the end of the runway, about 3 to 4 wingspans above the ground. The gear appeared retracted and the flap position could not be determined.

- By 14:16:06, it was evident N21WW was not gaining altitude and may have been losing altitude.
- By 14:16:17, N21WW entered a shallow left turn, while still not gaining altitude and possibly losing altitude.

- By 14:16:39, N21WW had circled to a position consistent with a left downwind from the departure runway at a low altitude, lower than earlier parts of Camera 4's recording. During the turn from crosswind to downwind, the video recording appeared to have shown white emissions from the back of the plane (such as smoke or vapor trails/condensation) from behind the aircraft; however, these apparent emissions may have been video distortion from a cloud behind the plane (and thus may not have been real).

- At 14:16:43, N21WW was no longer visible, as its distance and low altitude put it below the field of view of the camera.

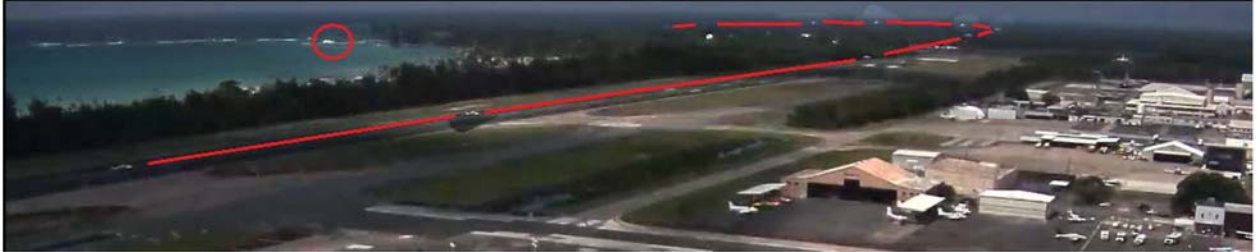
Figure 3. Camera 5 time-lapse imagery of accident flight.

- At 14:15:00, the aircraft was aligned with runway and began its takeoff roll.
- At 14:15:58, the aircraft appeared to be over the yellow chevron pavement markings that are visible in Camera 4.¹
- At 14:16:42, the aircraft was flying at a low altitude, in the vicinity of a left downwind for runway 8.
- At about 14:16:45, the aircraft position became obscured by trees relative to the vantage point of Camera 5.
- At 14:17:07, a plume of water was visible in the water, followed by fire and smoke.
