**CALIFORNIA HIGHWAY PATROL CRASH REPORT**

**PALM SPRINGS, CA**

**HWY17MH005**

**MULTIDISCIPLINARY ACCIDENT INVESTIGATION TEAM NARRATIVE/DIAGRAM**

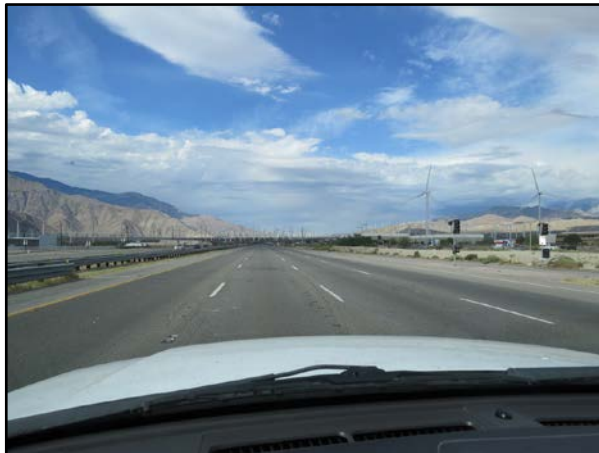
Figure 2. View of Interstate 10 westbound (looking west), approximately 2,505 feet east of the MCI.

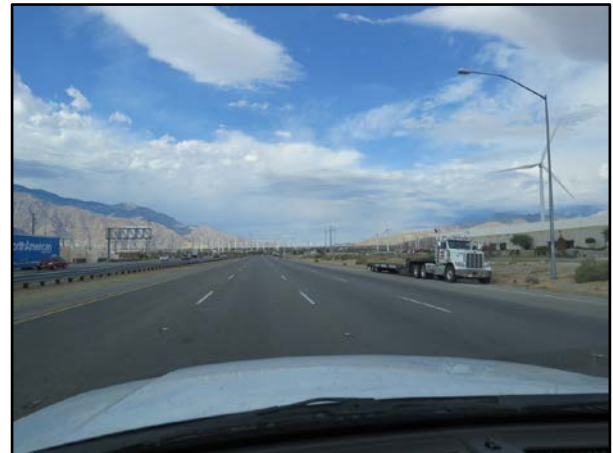
Figure 3. View of Interstate 10 westbound (looking west), approximately 1,658 feet east of the MCI.

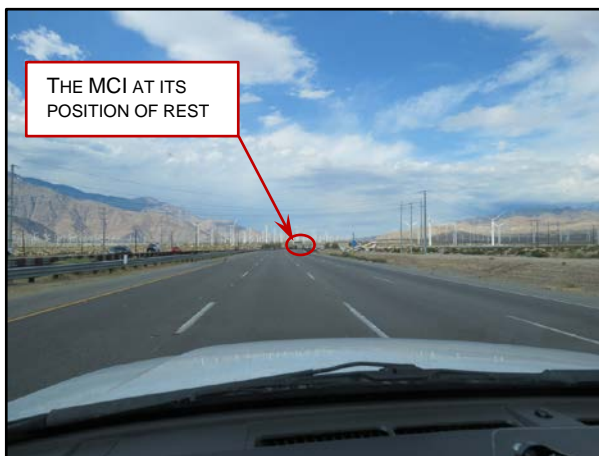
Figure 4. View of Interstate 10 westbound (looking west), approximately 1,009 feet east of the MCI.

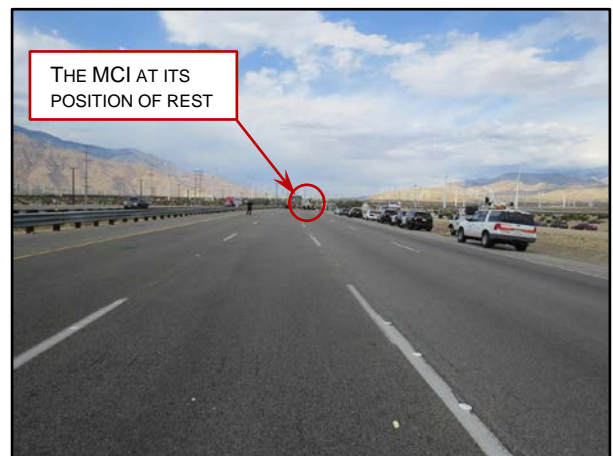
Figure 5. View of Interstate 10 westbound (looking west), approximately 449 feet east of the MCI.

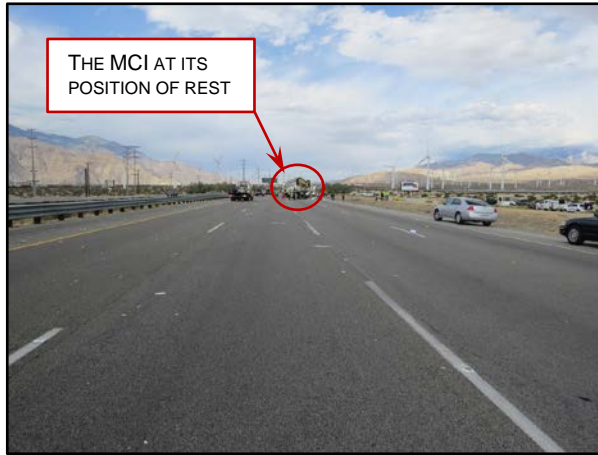
Figure 6. View of Interstate 10 westbound (looking west), approximately 220 feet east of the MCI.

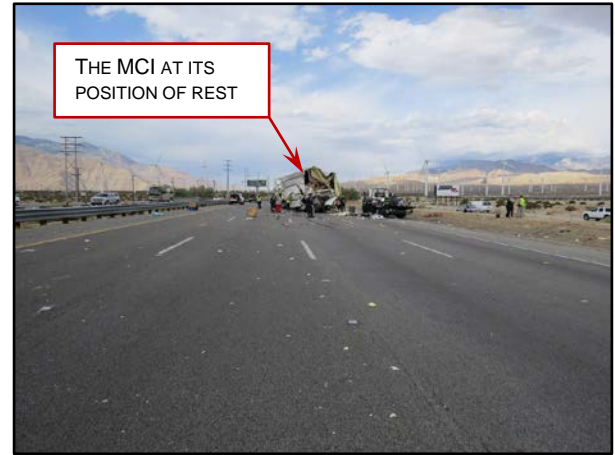
Figure 7. View of Interstate 10 westbound (looking west), approximately 115 feet east of the MCI.

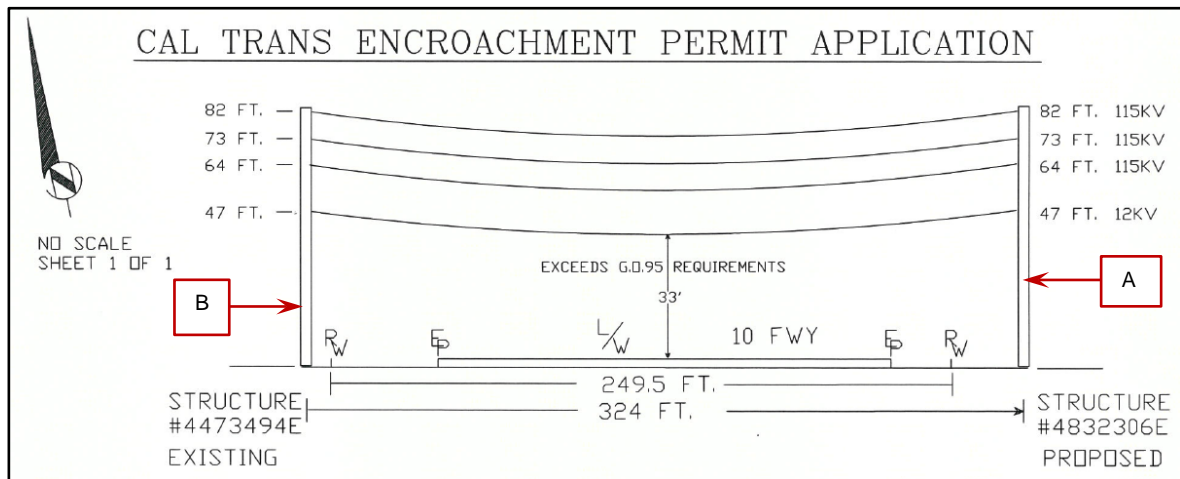
At the time of this collision, there was an encroachment work permit, Permit Number 08-16-6-UF-0832<sup>6</sup>, performed by Southern California Edison (SCE) utility company to transfer six existing overhead transmission conductors<sup>7</sup> from the existing two-pole wood structure (also called “H” frame wood structure) to a new tubular steel pole structure (Figure 18: A). Both pole structures were located outside of the Caltrans right-of-way, north of Interstate 10 and 20th Avenue/ Diablo Road. The existing transmission conductor was suspended across the state right-of-way and Interstate 10 between the existing tubular steel pole structure, which was located on the south side of Interstate 10 (Figure 18: B), and the existing two-pole wood structure on the north side of Interstate 10. There was no conductor relocation work on the south side of Interstate 10 referenced in the encroachment permit. The location of utility work was approximately 1.4 miles west of the collision location (Figure 1).

Figure 18. A portion of SCE Encroachment Permit drawing detail

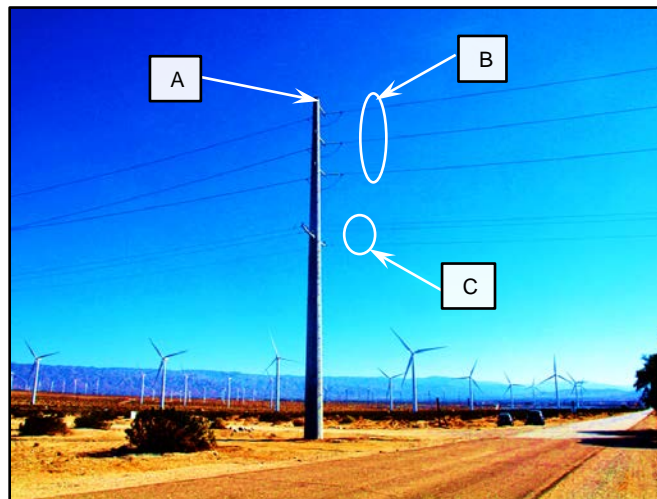
- The top three transmission conductors were transferred by two-man crews working from elevated buckets during the one traffic break completed before the collision, which lasted approximately 8 minutes. The relocation of remaining lower three transmission conductors was completed without additional traffic breaks due to the temporary traffic hold up at the traffic collision location.
- SCE would email a 100 percent completion notice to CT representative to close out the permit. CT representative Ebrahim provided the “100% Completion Notice” to MAIT Engineer Tran on May 31, 2017.

Figure 19. New tubular steel pole structure [A] with the relocated top three [B] and lower three [C] overhead transmission conductors
