Selected Non-Proprietary  
Correspondence from Boeing to Captain S. Kelada and Engr. Hamdy of EgyptAir

Split Elevator Failure Scenarios  
Effect of High Rate Column Inputs  
Dynamic Analysis  
Autopilot Disconnects on DFDR  
Action Items

9 June 2000 thru 15 December 2000

Subject: Split Elevator Failure Scenarios - Egyptair 767-300ER SU-GAP,  
Accident Off Nantucket, Massachusetts – 31 October, 1999

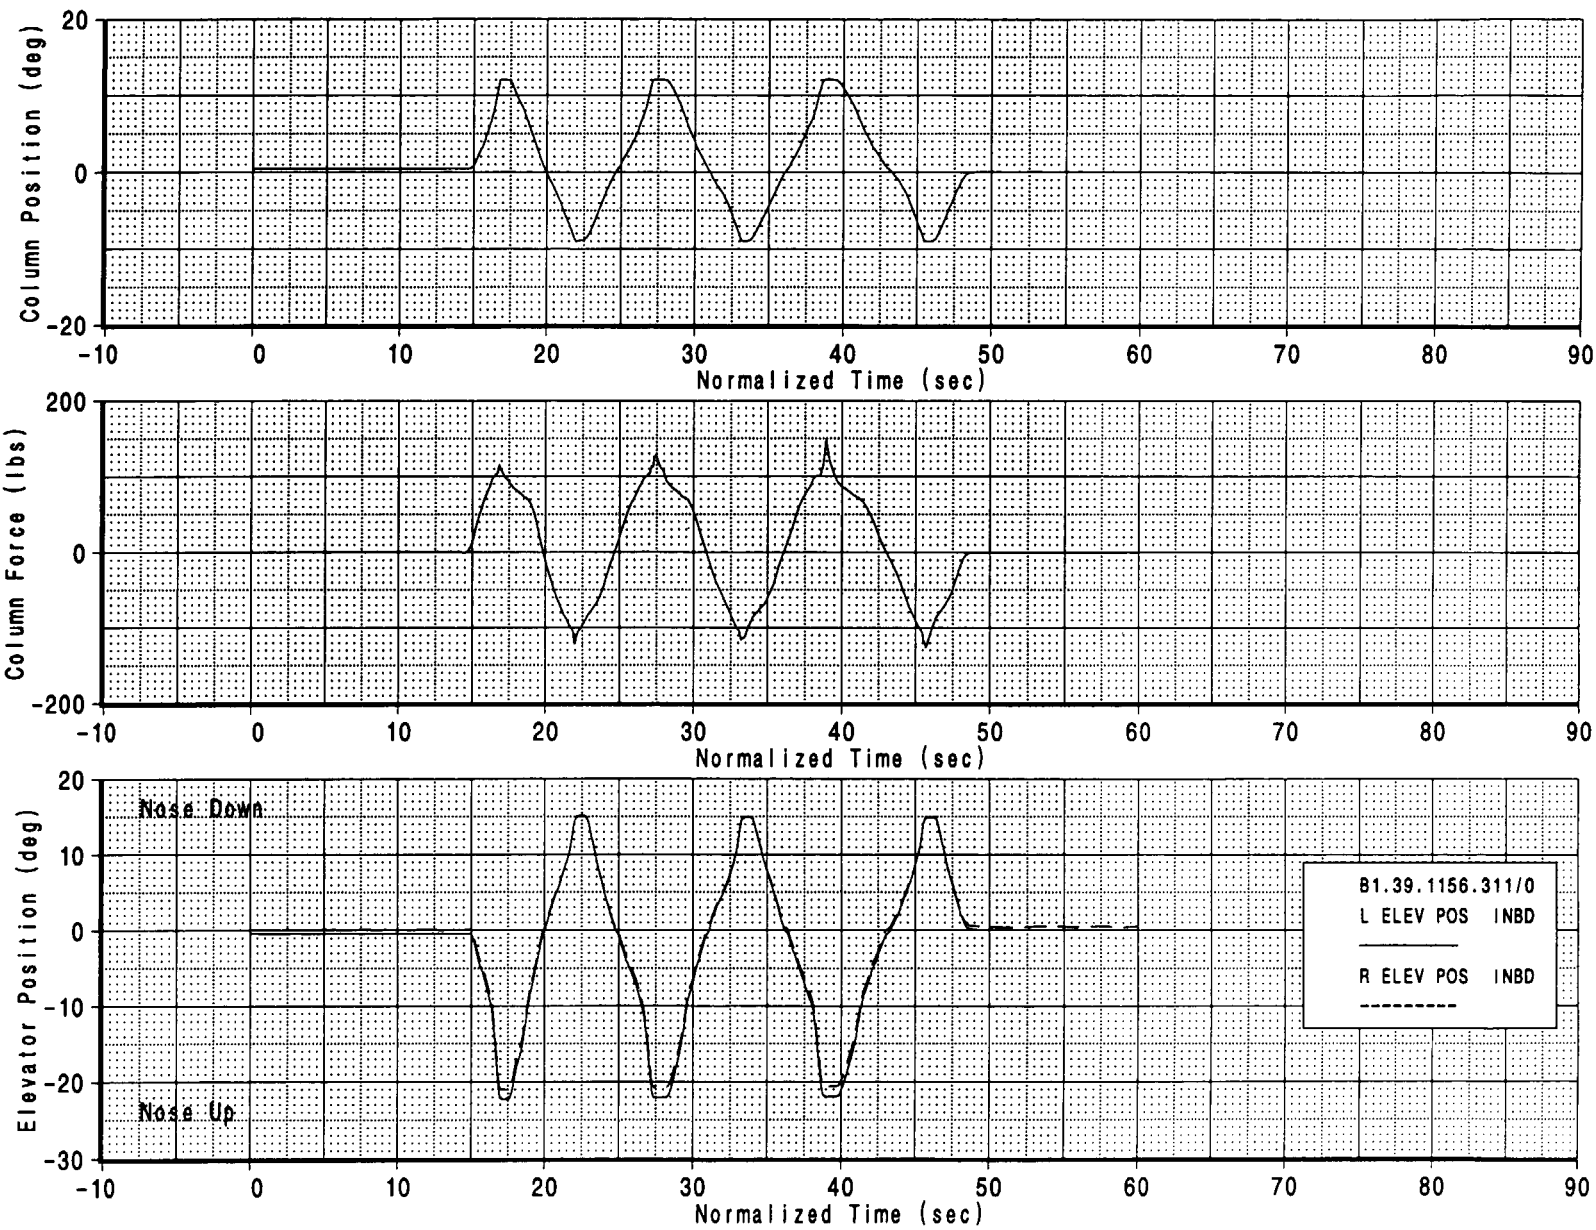
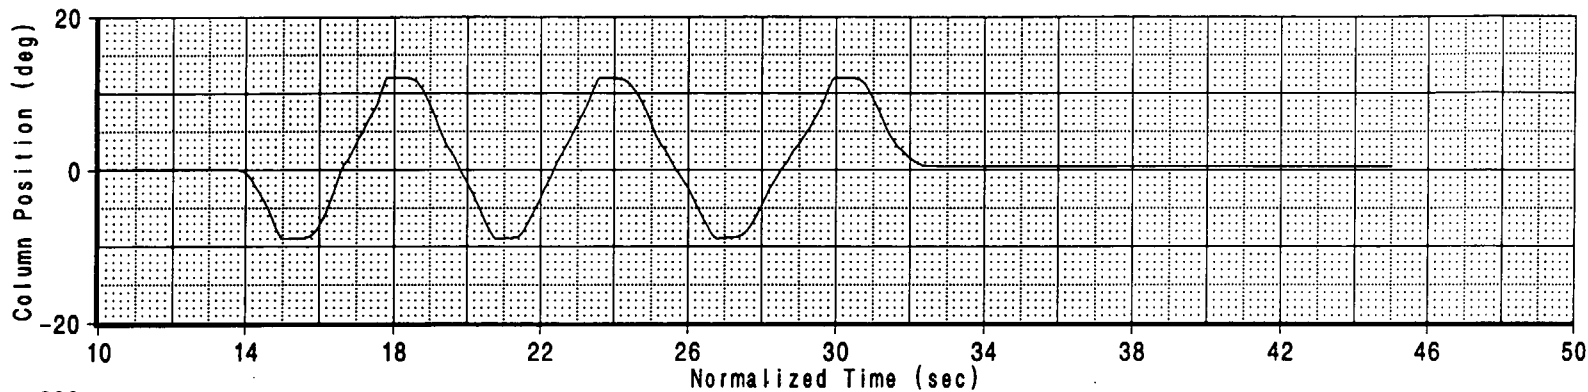
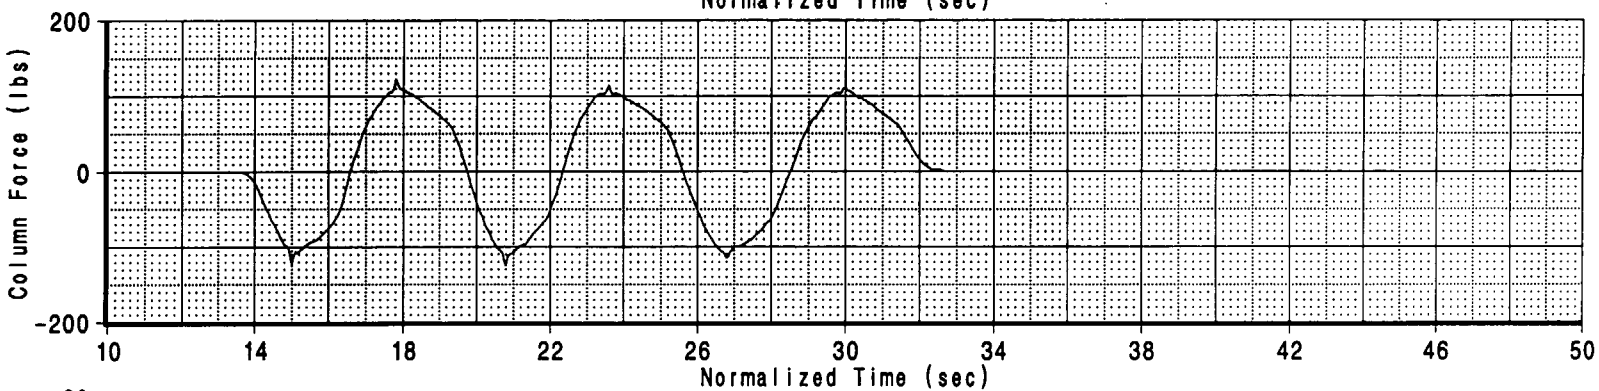
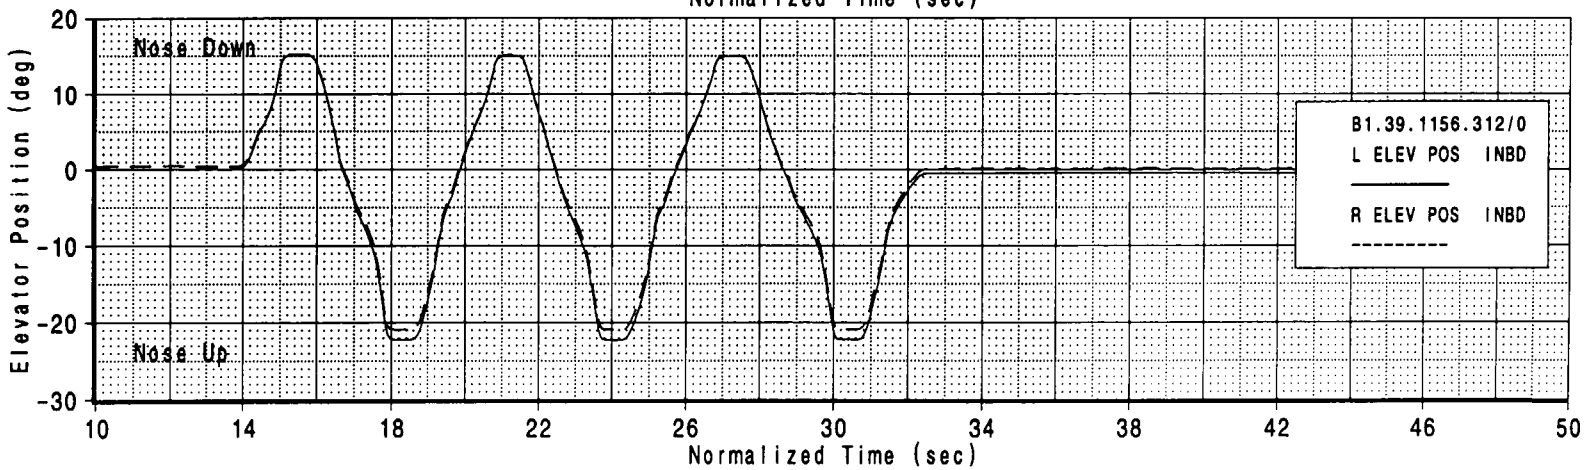
Column Sweeps at Feel Pressure of 900 psi  
Time History of 3 High Rate Column Sweeps

A slightly higher column force is required to obtain the same elevator deflection when the column is experiencing rapid pull motion. This slight increase in column force increases with rate and acts as a resistive damping force in the elevator control system. This damping effect is best demonstrated using aircraft test data. The effect of column rates on the elevator system was measured during a ground test on the same 767-400 aircraft utilized for the dual PCA failure demonstrations, VQ001. For this ground test, the elevator feel pressure was set to 900 psi and three column sweeps were conducted at three different rates. Figure 1 presents time history data of the elevator system for three slow rate column sweeps that were conducted over the course of 120 seconds. Figure 2 presents time history data of the elevator system for three medium rate column sweeps that were conducted over the course of about 33 seconds. Figure 3 presents time history data of the elevator system for three high rate column sweeps that conducted over the course of about 18 seconds. The time histories of figures 1, 2, and 3 show that the tracking of the two elevators is not affected by the rate of column input. In all cases, the two elevators track just as well dynamically as they did statically. The slight increase in column force with column rate is difficult to see from the time history data. Cross-plots of column force versus elevator position are ideal for showing the increase in column force with column rate. Figure 4 shows a cross-plot of the column force versus elevator position for the slow rate column sweeps (solid lines) and the medium rate column sweeps (dashed lines). Figure 4 shows that the medium rate column sweeps have a larger force hysteresis than the slow rate column sweeps. This

increase in force hysteresis is caused by damping forces in the elevator control system, which resist increases in column rate. Pulling the control column aft of zero at a medium rate took about 2 to 5 pounds of additional column force relative to the slow column sweeps in order to achieve the same elevator deflection. Figure 5 shows a cross-plot of the column force versus elevator position for the slow rate column sweeps (solid lines) and the high rate column sweeps (dashed lines). Figure 5 shows that the high rate column sweeps have an even larger force hysteresis than was present during either the slow rate or medium rate column sweeps. Pulling the control column aft zero at a high rate took about 5 to 10 pounds of additional column force relative to the slow sweep in order to achieve the same elevator deflection.

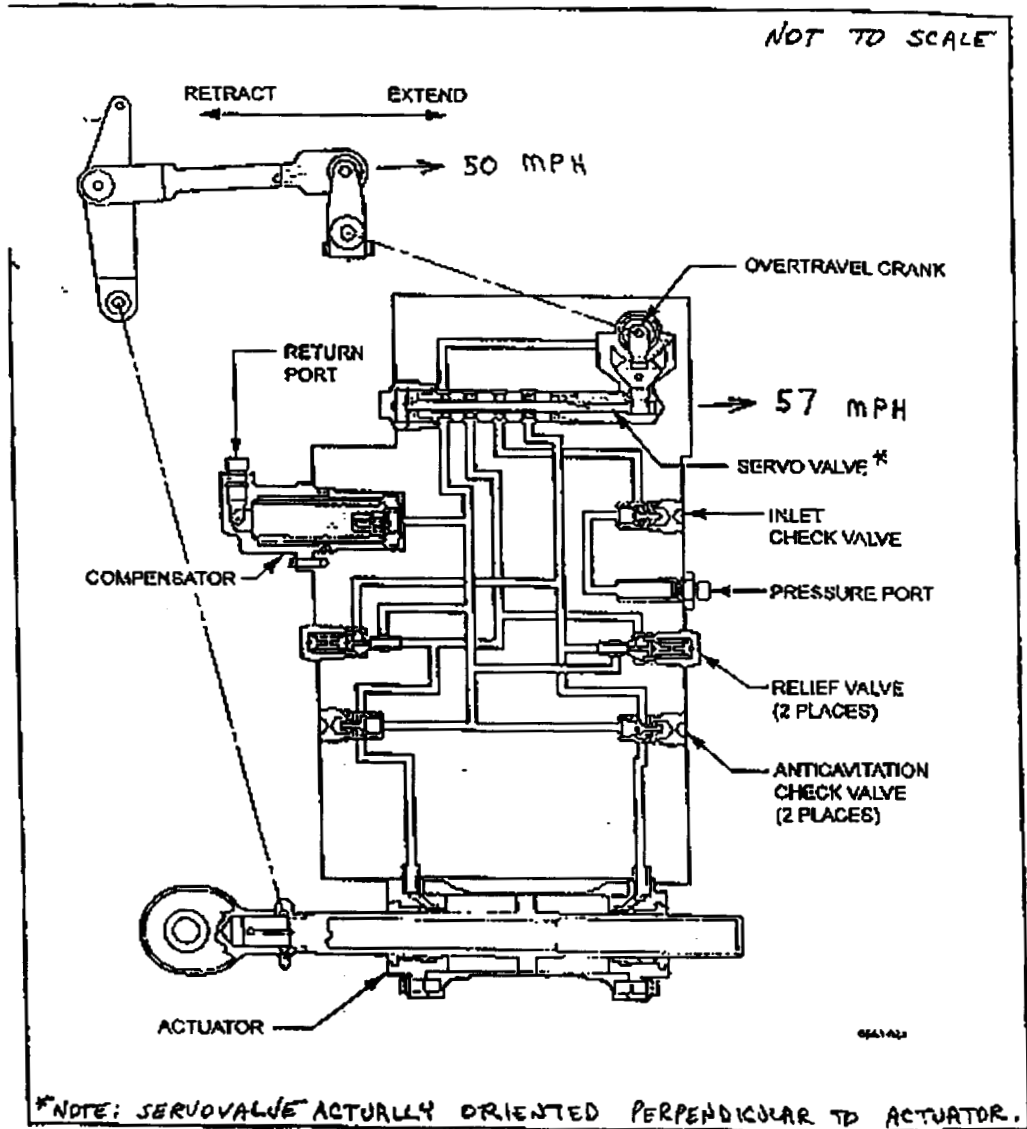
Figure 1

During the accident impact, system/structural buckling and/or the inertia of the external elevator PCA linkages and pogo provided an extremely rapid extend input to the servovalve slide (see attached Figure 1). The accelerations involved caused a mismatch of the spring to the spring guide (this acceleration has not been directly calculated). Once the internal linkage reached the overtravel region, the item 355 overtravel cam, item 315 servo slide, and item 310 spring guide continued to travel in the extend direction until the item 355 overtravel cam “bottomed” against the manifold (see attached Figure 2, positions 1 and 2). When the item 355 overtravel cam and item 325 servo slide “bottomed” (and would have even “bounced back”), the inertia of the item 310 spring guide provided enough energy to shear the item 305 pin (see attached Figure 2, position 3). The velocity necessary for sufficient spring guide inertia to shear the pin is calculated to be ~57 mph (see attached calculations, note that the spring mass was not included). Subsequently, the item 315 spring pushed the item 310 spring guide off the end of the item 325 servo slide. The item 310 spring guide was then unconstrained and could move off center relative to the item 325 servo slide. Subsequent retract input commands from the external linkage (either during impact or during recovery or subsequent mishandling), would force the end of the item 325 servo slide against the item 310 spring guide. The off-center contact would result in the item 310 spring guide and the mismatched item 315 spring being “scraped” along the inner side and end of the item 290 servo cap. This “scraping” resulted in partial removal of the anodize layer on the item 290 servo cap and resulted in the observed corrosion (after submersion in salt water and subsequent exposure to air).

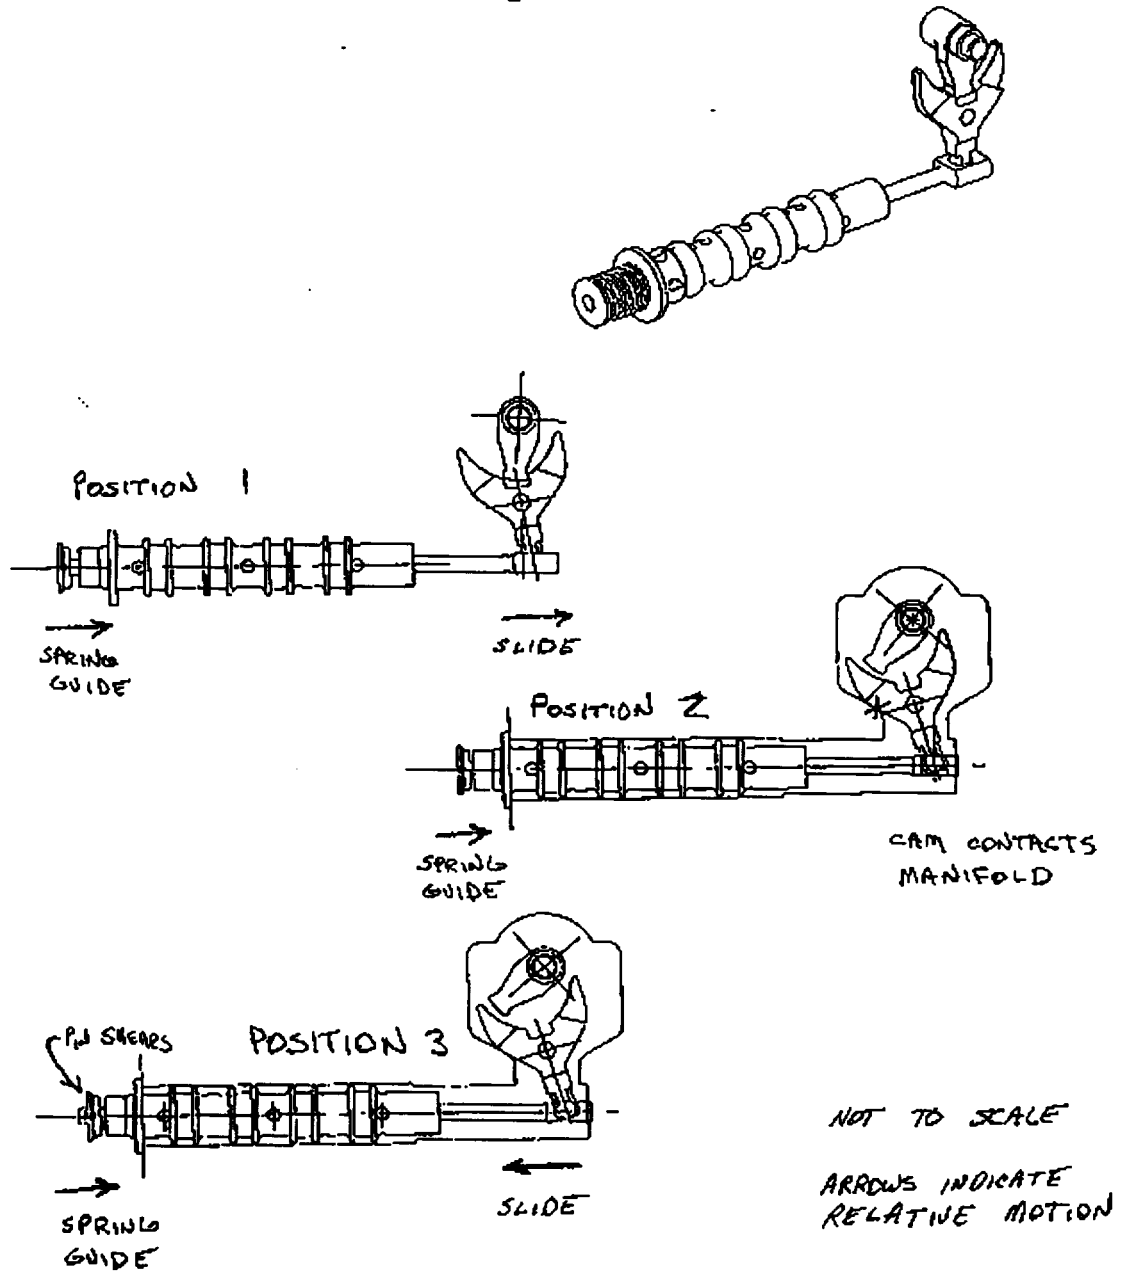
Figure 2

During the accident investigation it was discovered that the rolled pin C/T the PCA bias spring guide/retainer and the slide fractured in double shear action. This analysis is to determine the dynamic load due to the acceleration of spring guide/retainer that would be physically high enough to sever the pin.

- Slide + guide + spring moving in the PCA extend input direction
- Slide bottomed out
- Inertia of guide plus portion of rolled pin (embedded in the guide) reacted on the pin caused it to shear out.

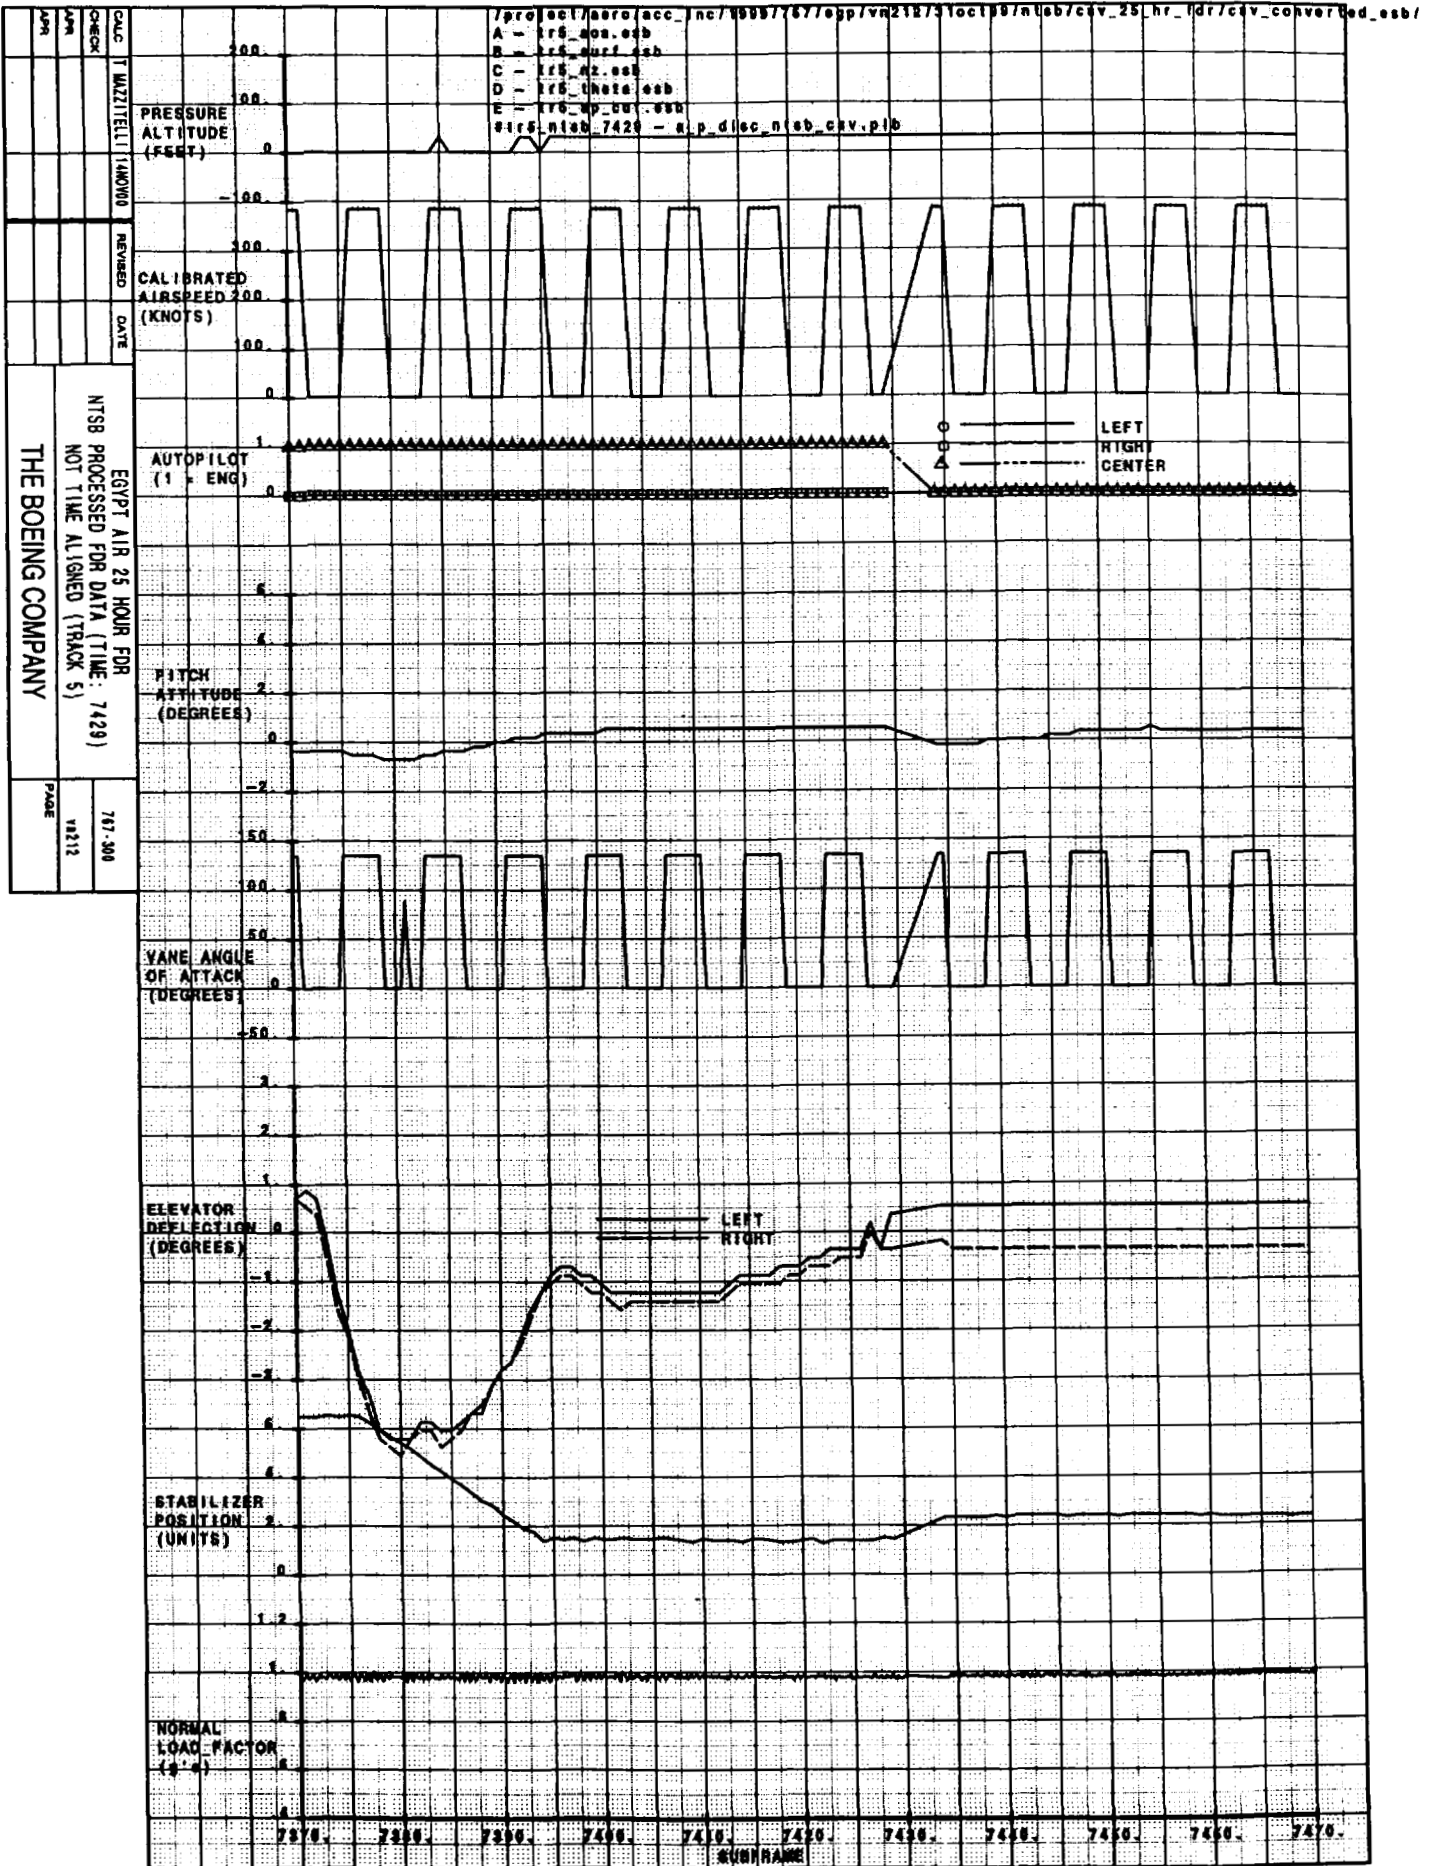
The NTSB method of processing the DFDR data from this event resulted in the sub-frame numbers getting incremented four times (7430, 7431, 7432, and 7433) when no data was actually recorded in order to complete the data frames that existed before and after the DFDR power cycling. Figure 2 in the original version of this document contained Boeing processed FDR data. The data file that Boeing used to compute sub-frame information was missing these incomplete data frames and as a result the original version (reference (a)) of figure 2 appeared to have continuous data. Now that this letter uses only the NTSB processed DFDR data and its associated definition of a sub-frame, it is clear that figure 2 is missing data for four sub-frames.

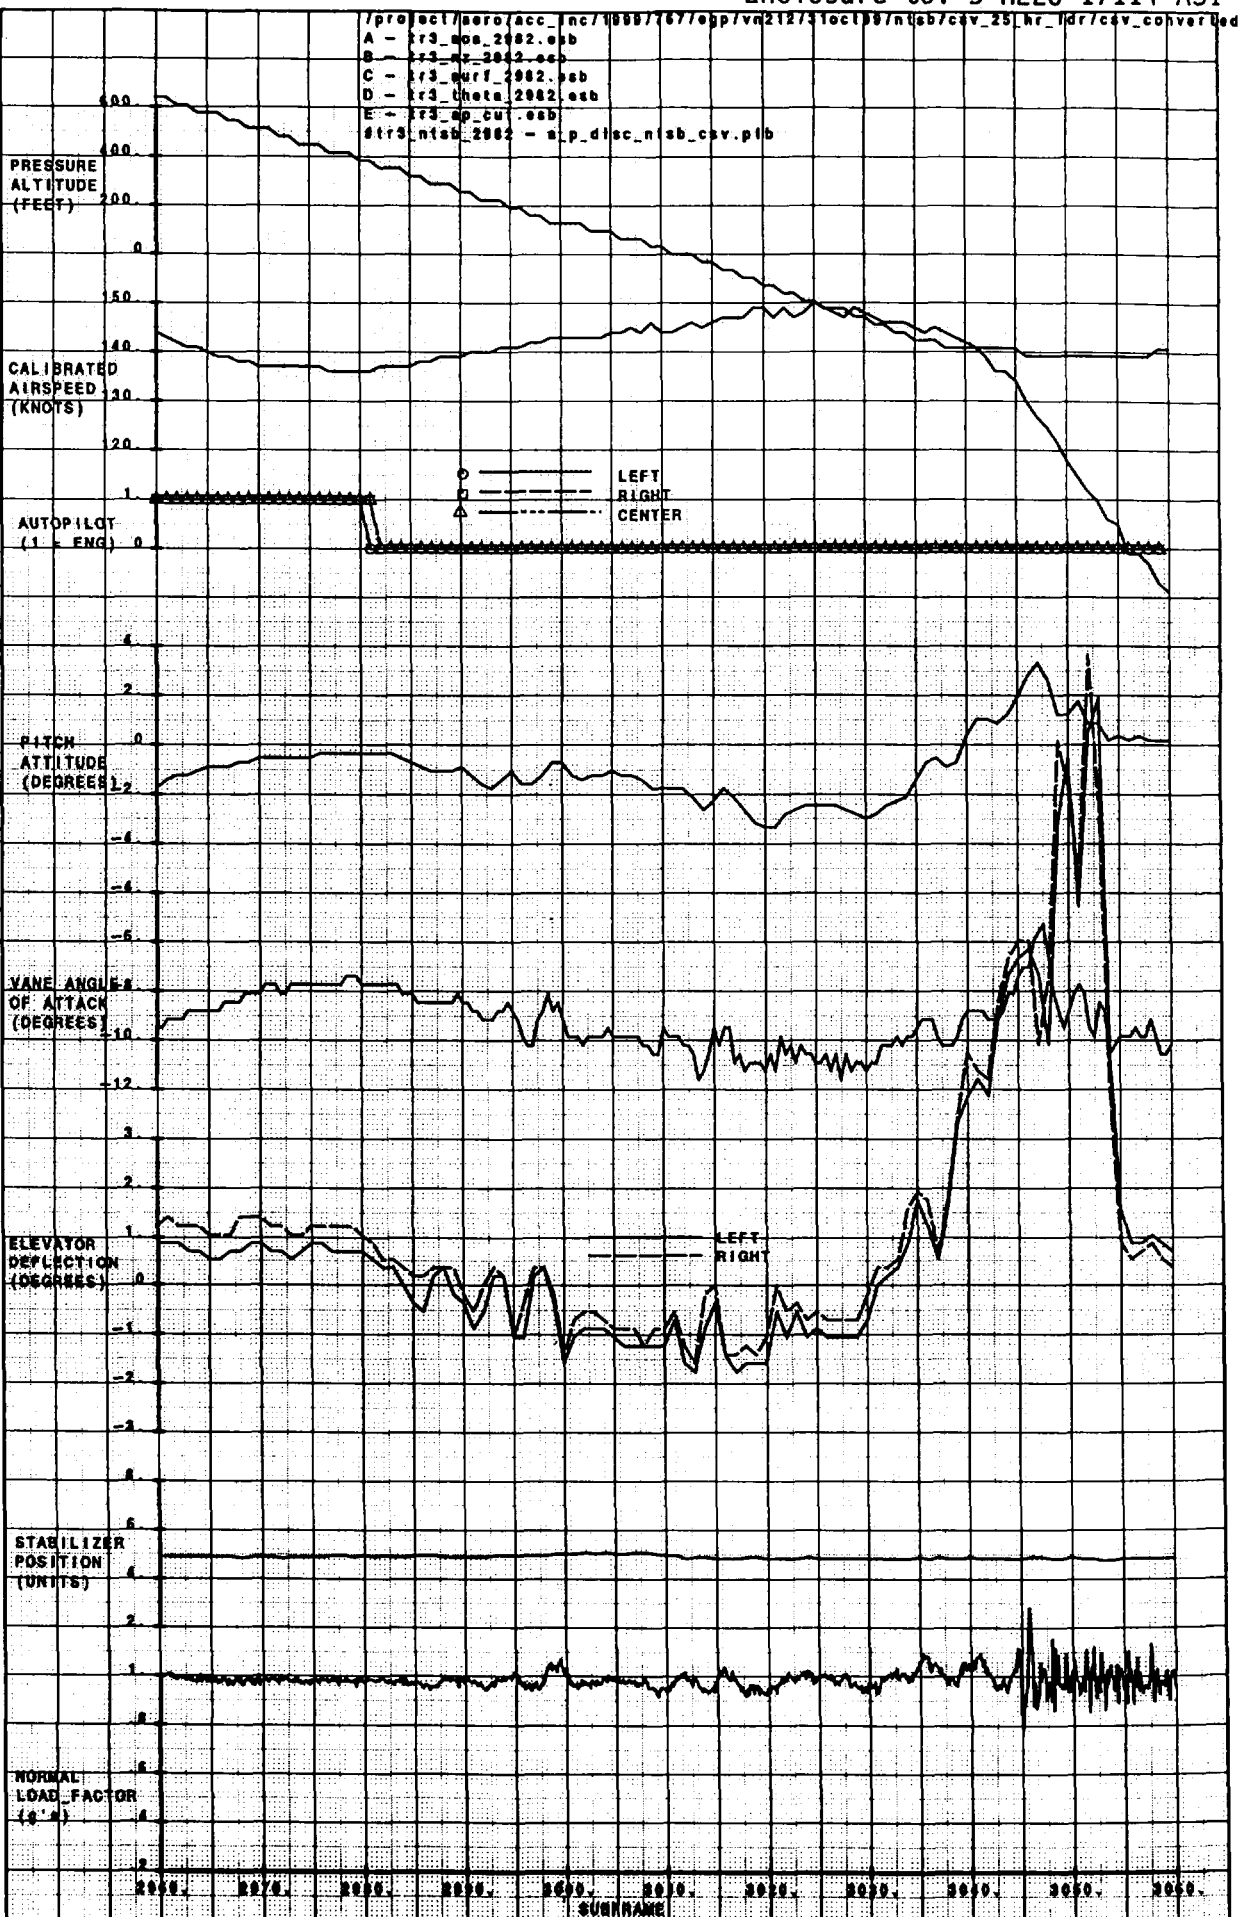
Figure 4 presents the DFDR data from a triple channel autopilot disconnect that occurred on approach. The autopilot disconnect event occurred at a sub-frame of about 2982 in figure 4 which was one minute prior to touchdown. Between the autopilot disconnect and touchdown, the pilots are actively controlling the elevators. Due to the non-stop elevator motion after the autopilot disconnect, it is impossible to determine from this DFDR data what part if any of the elevator motion was caused by the act of disconnecting the autopilot.

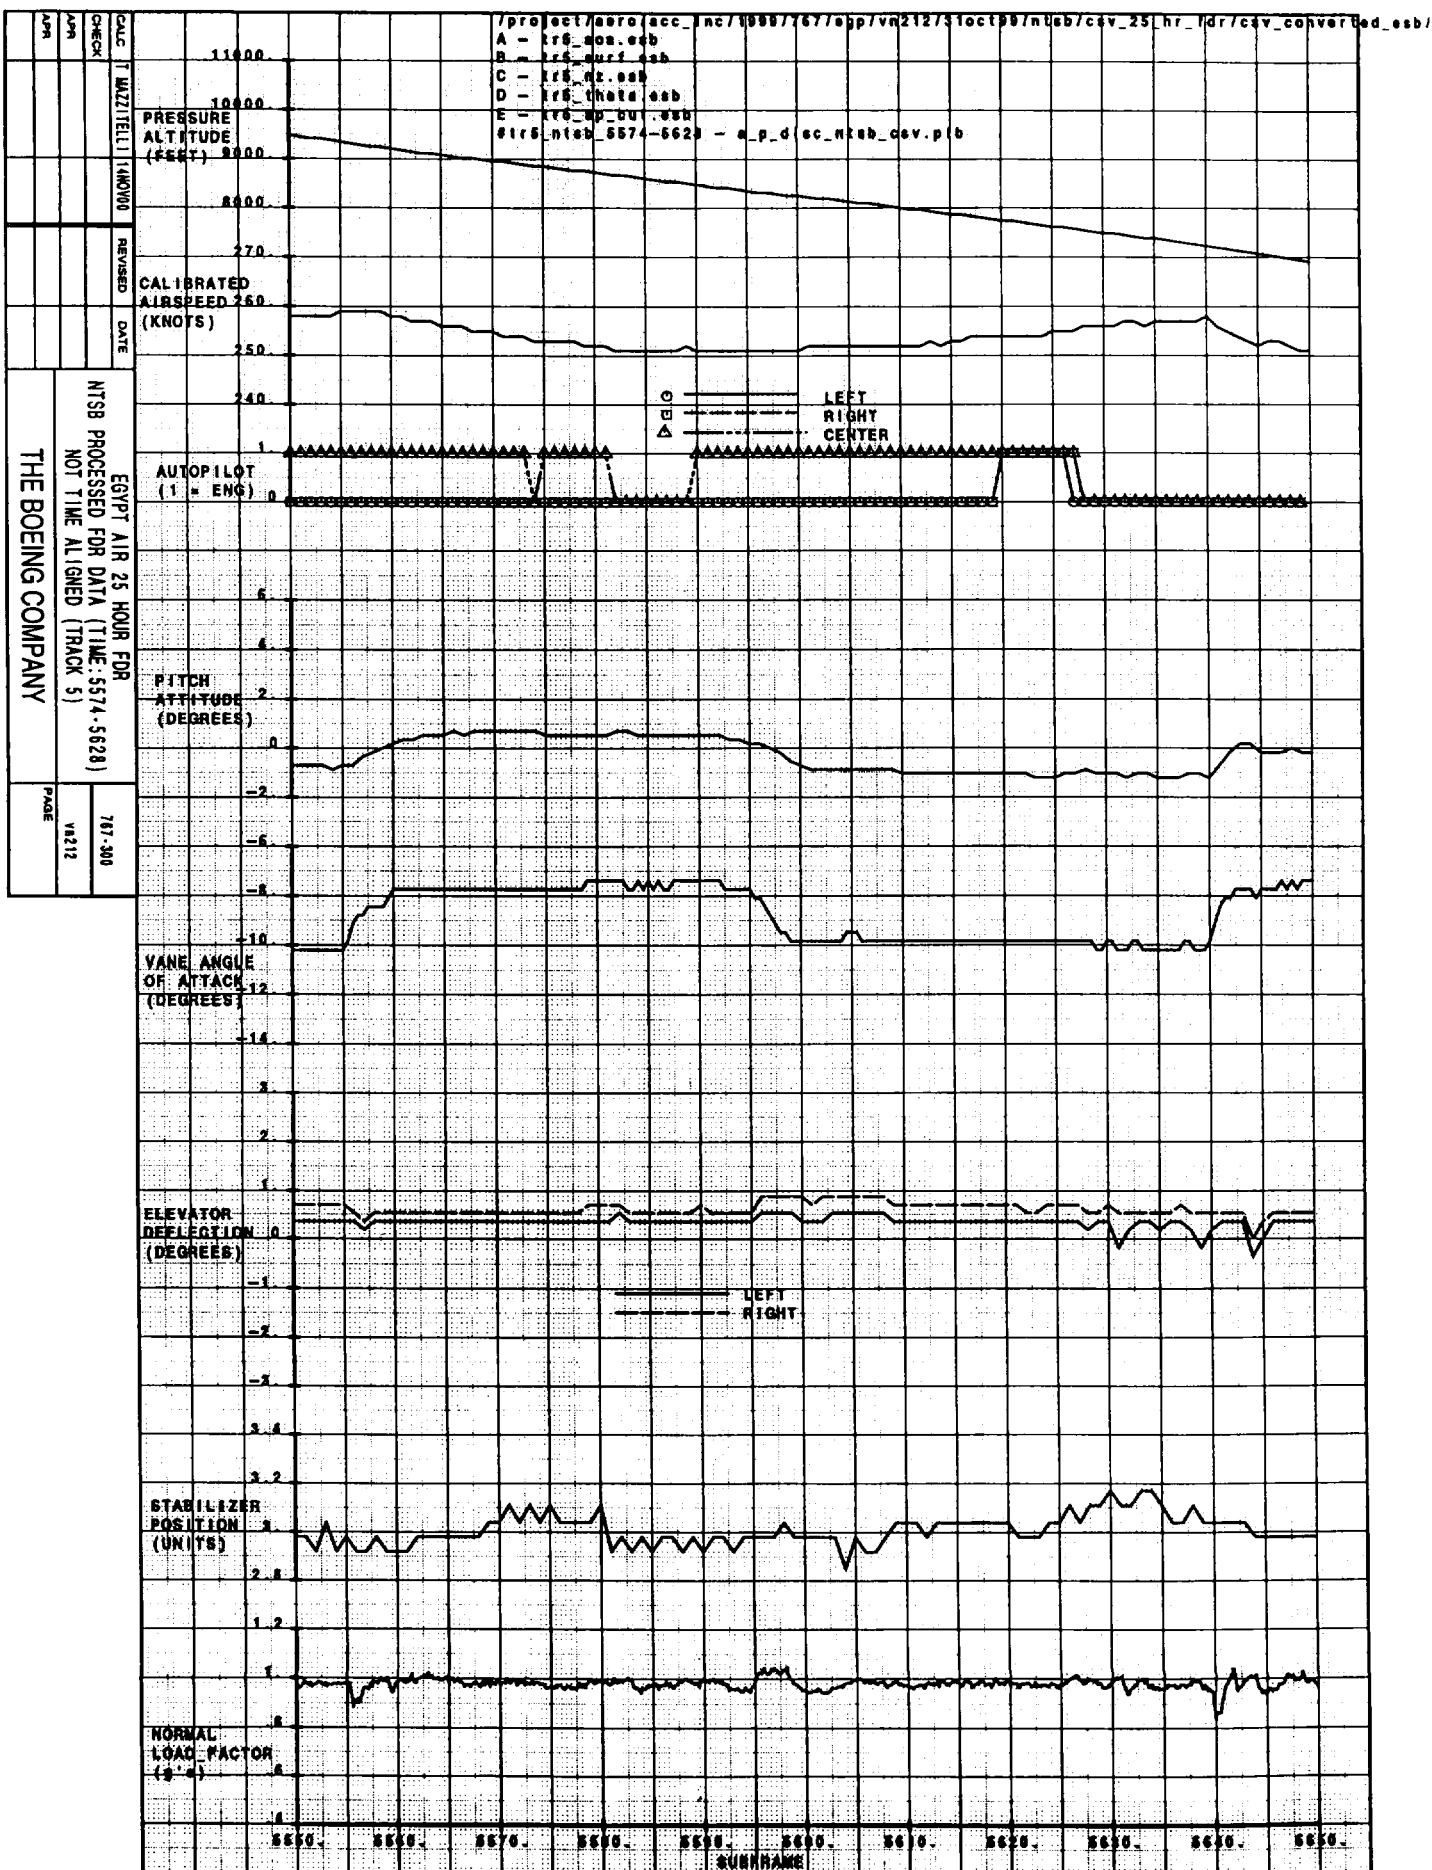
Figure 7

The second autopilot disconnect event on figure 7 occurs at a sub-frame of 5582. The center autopilot was disconnected for about 6 to 7 seconds during this event. When the autopilot is disconnected, both elevators may have moved as much as 0.17 degrees (1 LSB) in the nose down direction. It is possible that the elevators didn't really move at all during the time period of 5560 to 5595 seconds and that the small changes in recorded elevator position are just due to toggling of the LSB due to electrical signal noise. Whatever the cause of the recorded elevator motion during this event, the magnitude is very small and well within the range allowed by the autopilot trim threshold.

The third autopilot disconnect event on figure 7 is a triple channel disconnect that occurs at a sub-frame of about 5628. When the autopilot disconnect occurs, both elevators appear to move about 0.17 degrees (1 LSB) in the nose down direction. Following this initial nose down motion, the elevators quickly reverse direction and move in the nose up direction, which indicates that pilot forces are probably present. One can only speculate as to whether pilot forces also caused the small amount of nose down elevator motion at the time of the autopilot disconnect. The small amount of elevator motion that occurred when the autopilot disconnected is well within the range allowed by the autopilot trim threshold.
