**Selected Non-Proprietary
Correspondence from Boeing to Powerplants Group Chairman**

**Engine Fuel Flow FDR Data
11 February 2000**

**Thrust Management System
25 April 2000**

Subject: Engine Fuel Flow FDR Data – Egyptair 767-300ER SU-GAP,
Accident Off Nantucket, Massachusetts – 31 October, 1999

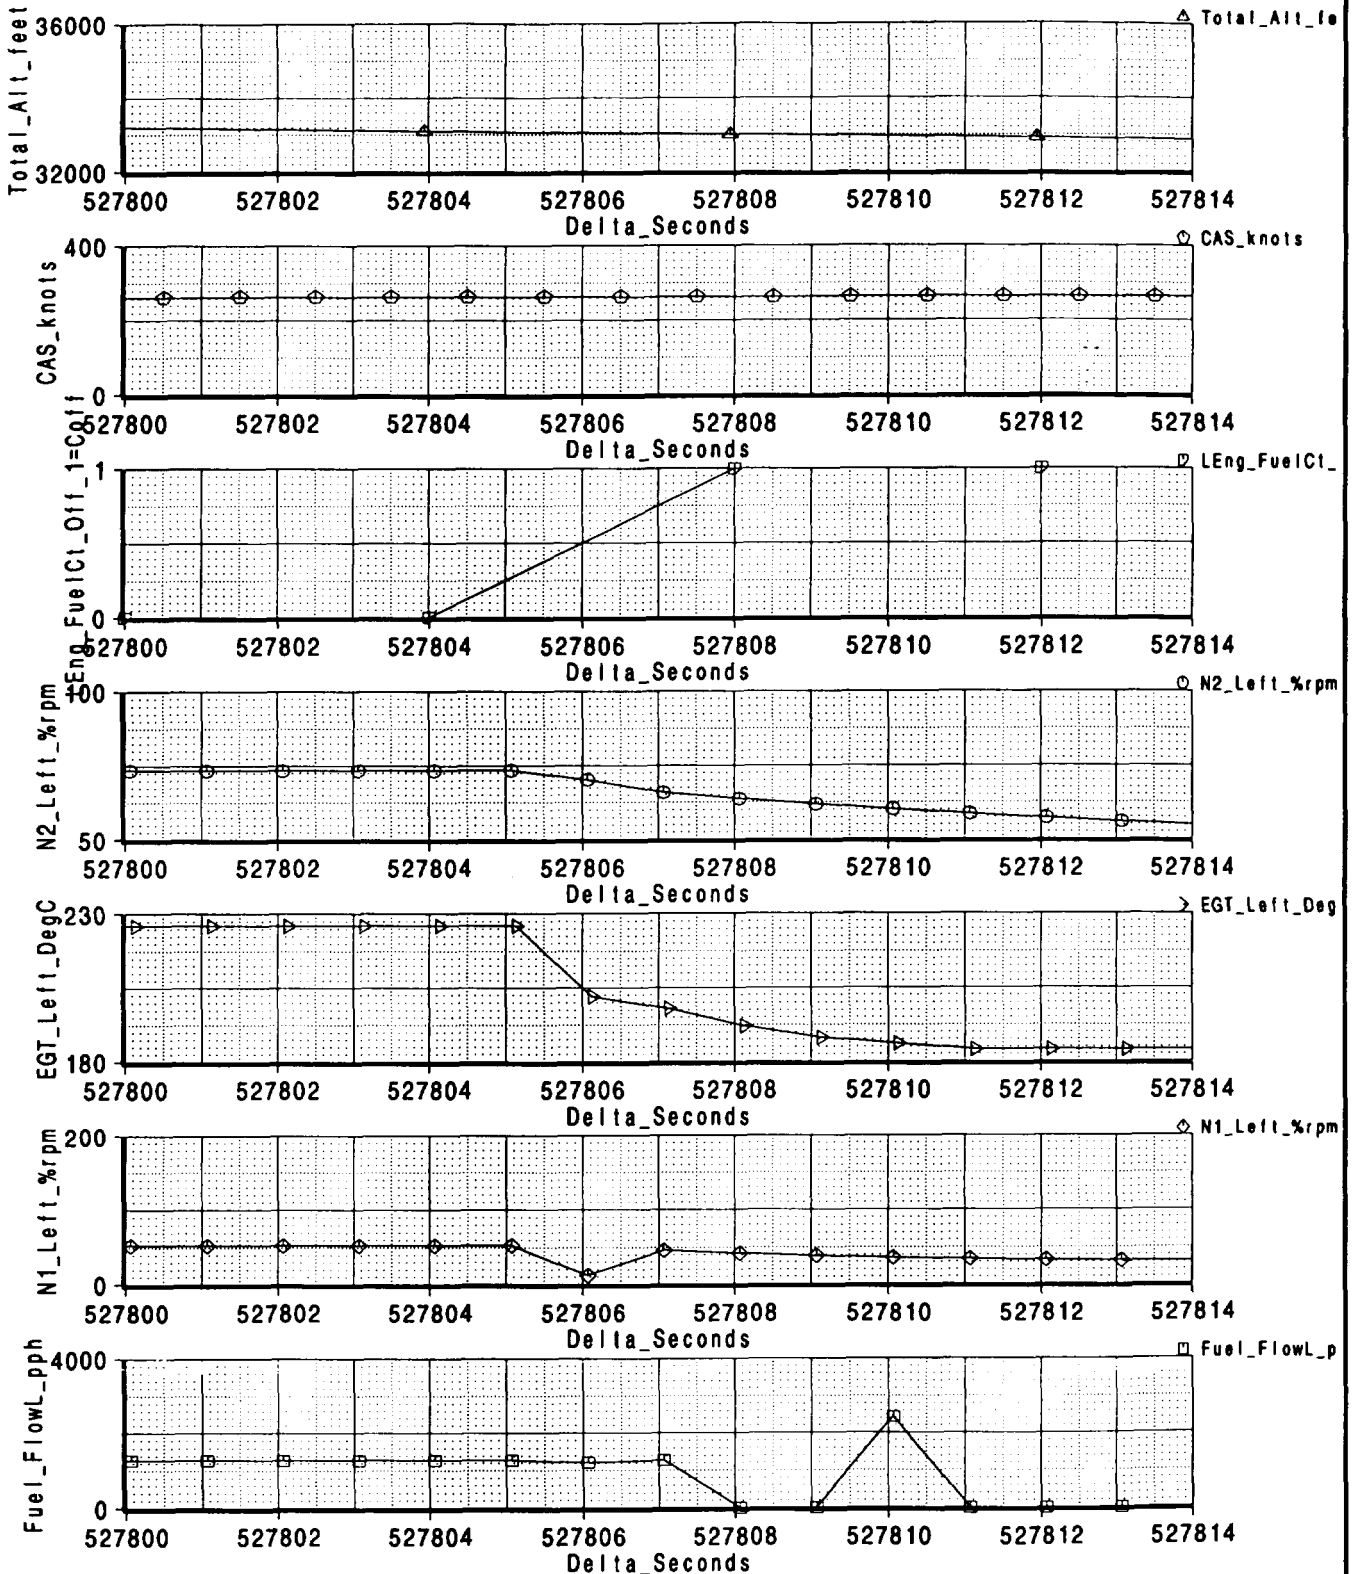
CALC		12Jan00	REVISED	DATE	CHECK					APPD.					APPD.					767 / PW4000 / AMETEK FLOW METERS LEFT ENGINE SHUTDOWN B1 FLIGHT, 1-11-2000				
CALC		12Jan00	REVISED	DATE																					
CHECK																									
APPD.																									
APPD.																									
BOEING					PAGE

3. Following "fuel shutoff" (as defined by the initial decay in engine parameters), the left engine fuel flow remained at idle flow for 2 - 3 seconds, then showed a flow of zero. Five seconds after fuel shutoff, the left engine fuel flow showed a spike to 2400 lbs./hr (1100 kg/hr) for one data point, then back to a steady flow of zero.

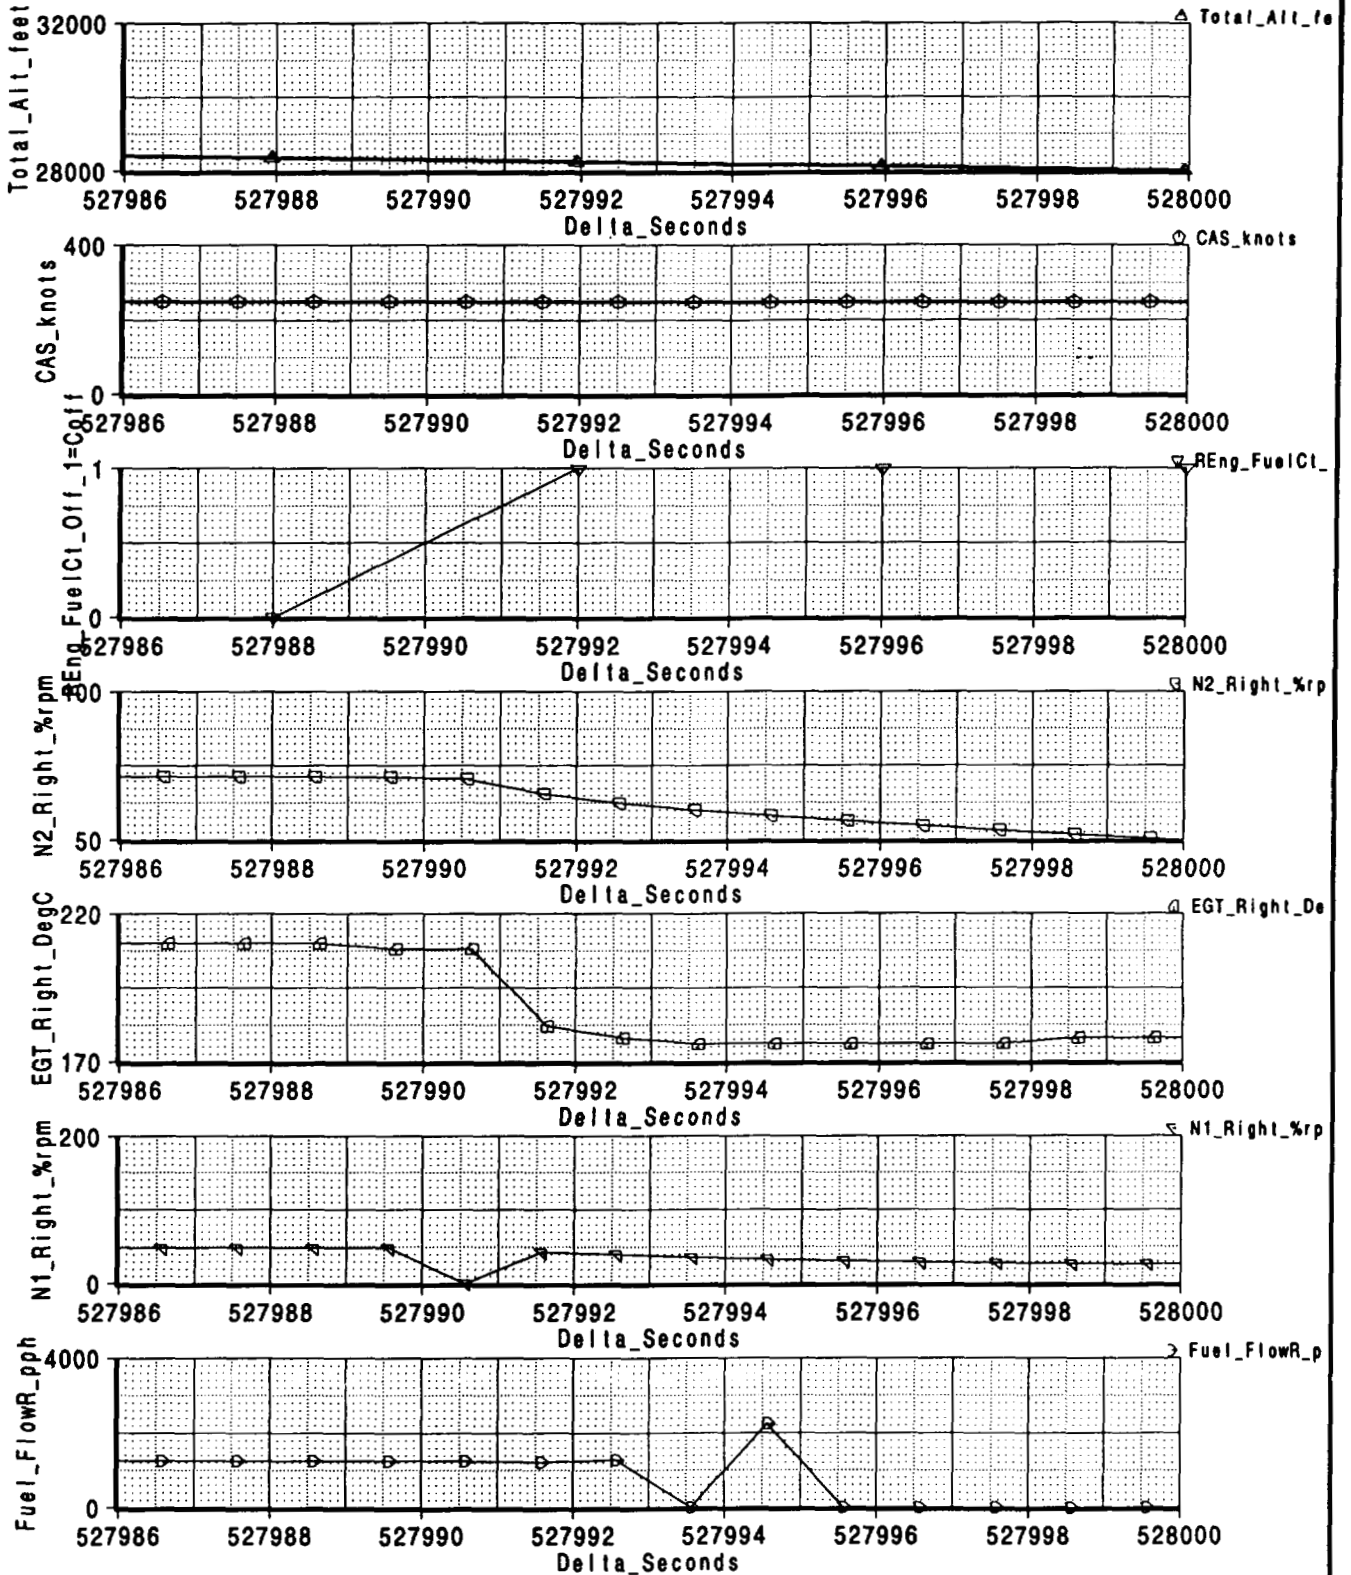
CALC	12Jan00	REVISED	DATE	767 / PW4000/ AMETEK FLOW METERS RIGHT ENGINE SHUTDOWN B1 FLIGHT, 1-11-2000	
CHECK					
APPD.					
APPD.					
				BOEING	PAGE

4. Following "fuel shutoff", the right engine fuel flow remained at idle flow for 2 - 3 seconds, then showed a flow of zero. Four seconds after fuel shutoff, the right engine fuel flow showed a spike to 2200 lbs./hr (1000 kg/hr) for one data point, then back to a steady flow of zero.
