**Selected Non-Proprietary
Correspondence from Boeing to Systems Group Chairman**

**Autopilot Disconnect Warning
Stick Nudger operation
Dual Elevator PCA Jam Ground Test
Split Elevator Failure Scenario, 21 July 2000
Split Elevator Failure Scenario, Effects of Airloads
Split Elevator Failure Scenario, 29 Sep 2000
Elevator System Response to Hydraulic Power On
CG and Elevator Position Data
Potential Elevator System Failure Scenarios**

18 December 1999 to 27 June 2001

Subject: Autopilot Disconnect Warning - Egyptair 767-300ER SU-GAP,
Accident Off Nantucket, Massachusetts – 31 October, 1999

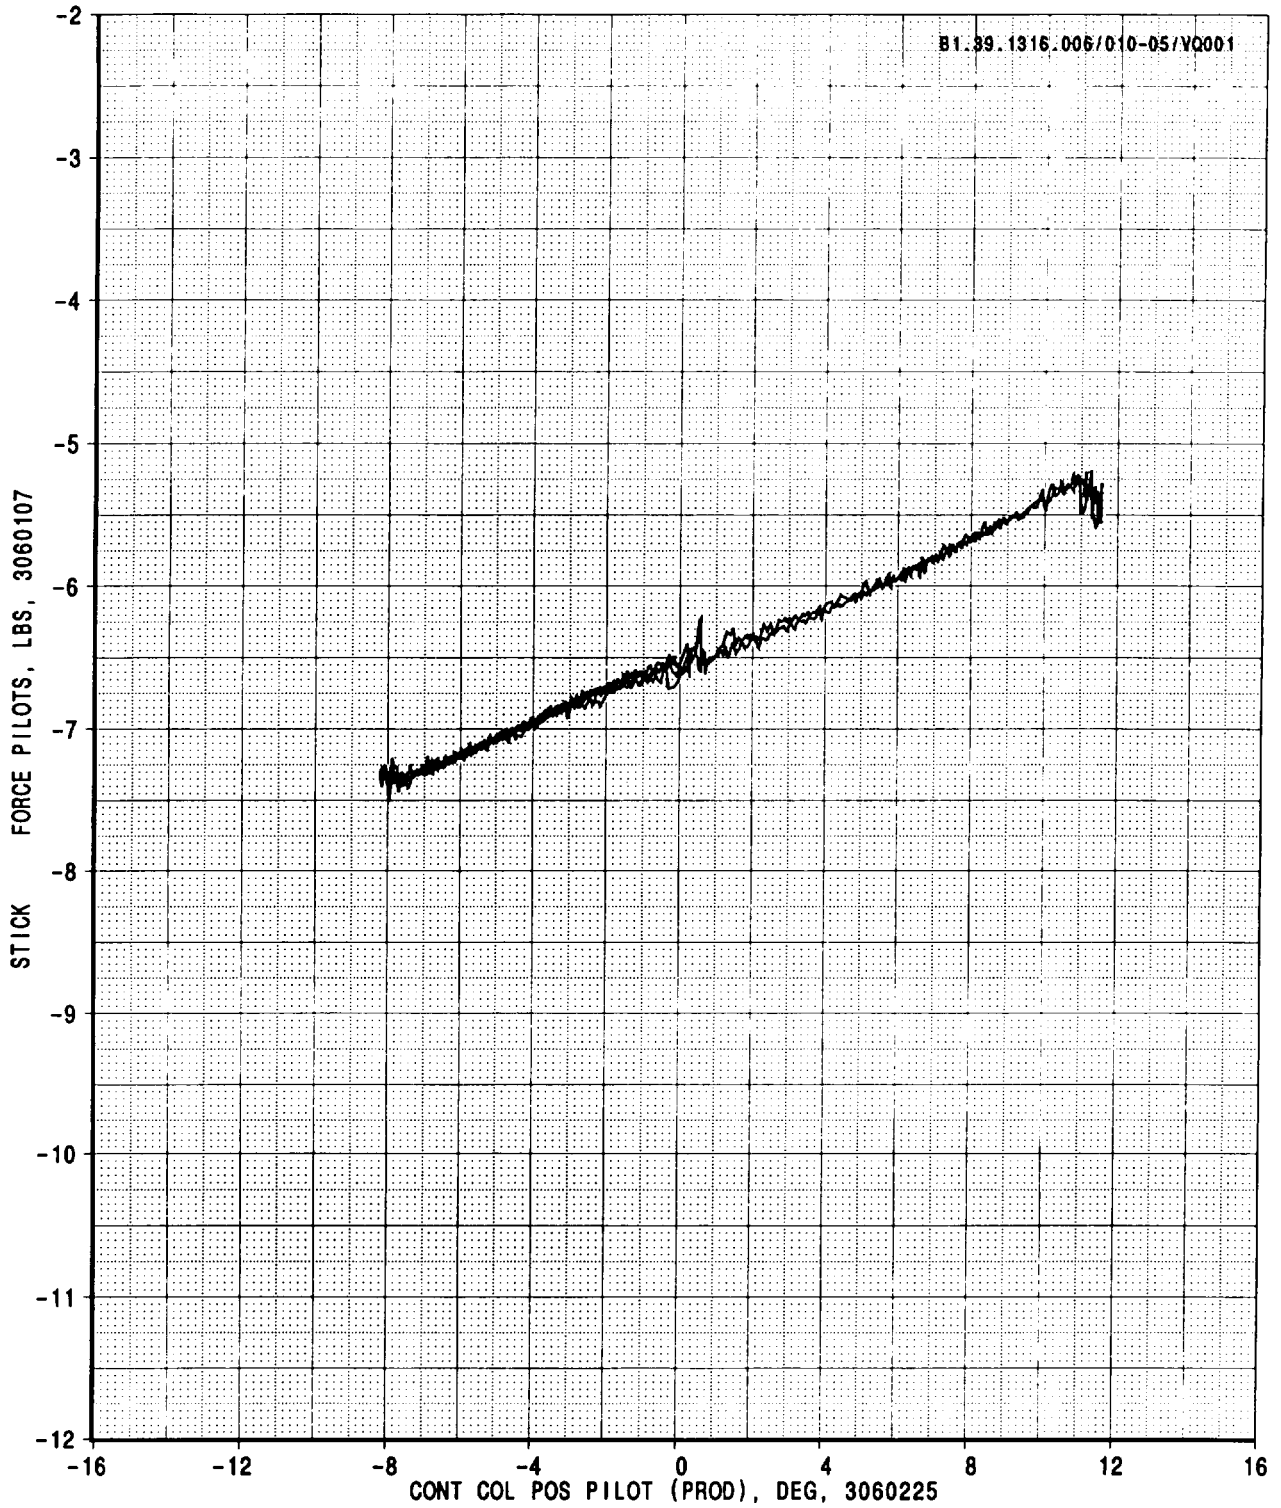
Figure 3 shows a plot of the captain's column force versus the captain's column position for a typical test condition in which the first officer alone made the column inputs. Since no pilot force was being applied to the captain's column during this condition, this plot shows the captain's column force bias directly.

The positive slope characteristic on the column force bias of figure 3 is caused by the effect of gravity on the column mass located above the strain gage. Since our column force instrumentation derives "applied column force" based on a measurement of the total strain at the base of the control column, it is unable to distinguish between the applied pilot forces and the column mass unbalance forces. Since the magnitude of the column mass unbalance forces are roughly only +/- 1 pound of column force relative to those at zero degrees of column, they can be ignored without introducing any significant error. If greater accuracy is desired, the column mass unbalance forces could be accounted for in any computations because they are simply a function of the column angle.

There is very little hysteresis on the column force bias of figure 3. This minimal hysteresis is to be expected for slow column sweeps since there are no friction elements between the strain gage and the top of the control column. The fact that there is no hysteresis shows that the instrumented column force readings are repeatable during a test condition. Some hysteresis could occur on the column force bias trace as a result of either something bumping into the column or due to sudden changes in column velocity. Sudden changes in column velocity produce an inertial force that is sensed by the strain gage at the base of the column. Since most of our testing involved slow column

CALC	B. Cook	17Ju100	REVISED	DATE	Captain's Column Force Bias During Test Condition 006 of Test 10-05	767-400ER VQ001
CHECK						Figure 3
APPD.						
APPD.						
						PAGE 10 of 16

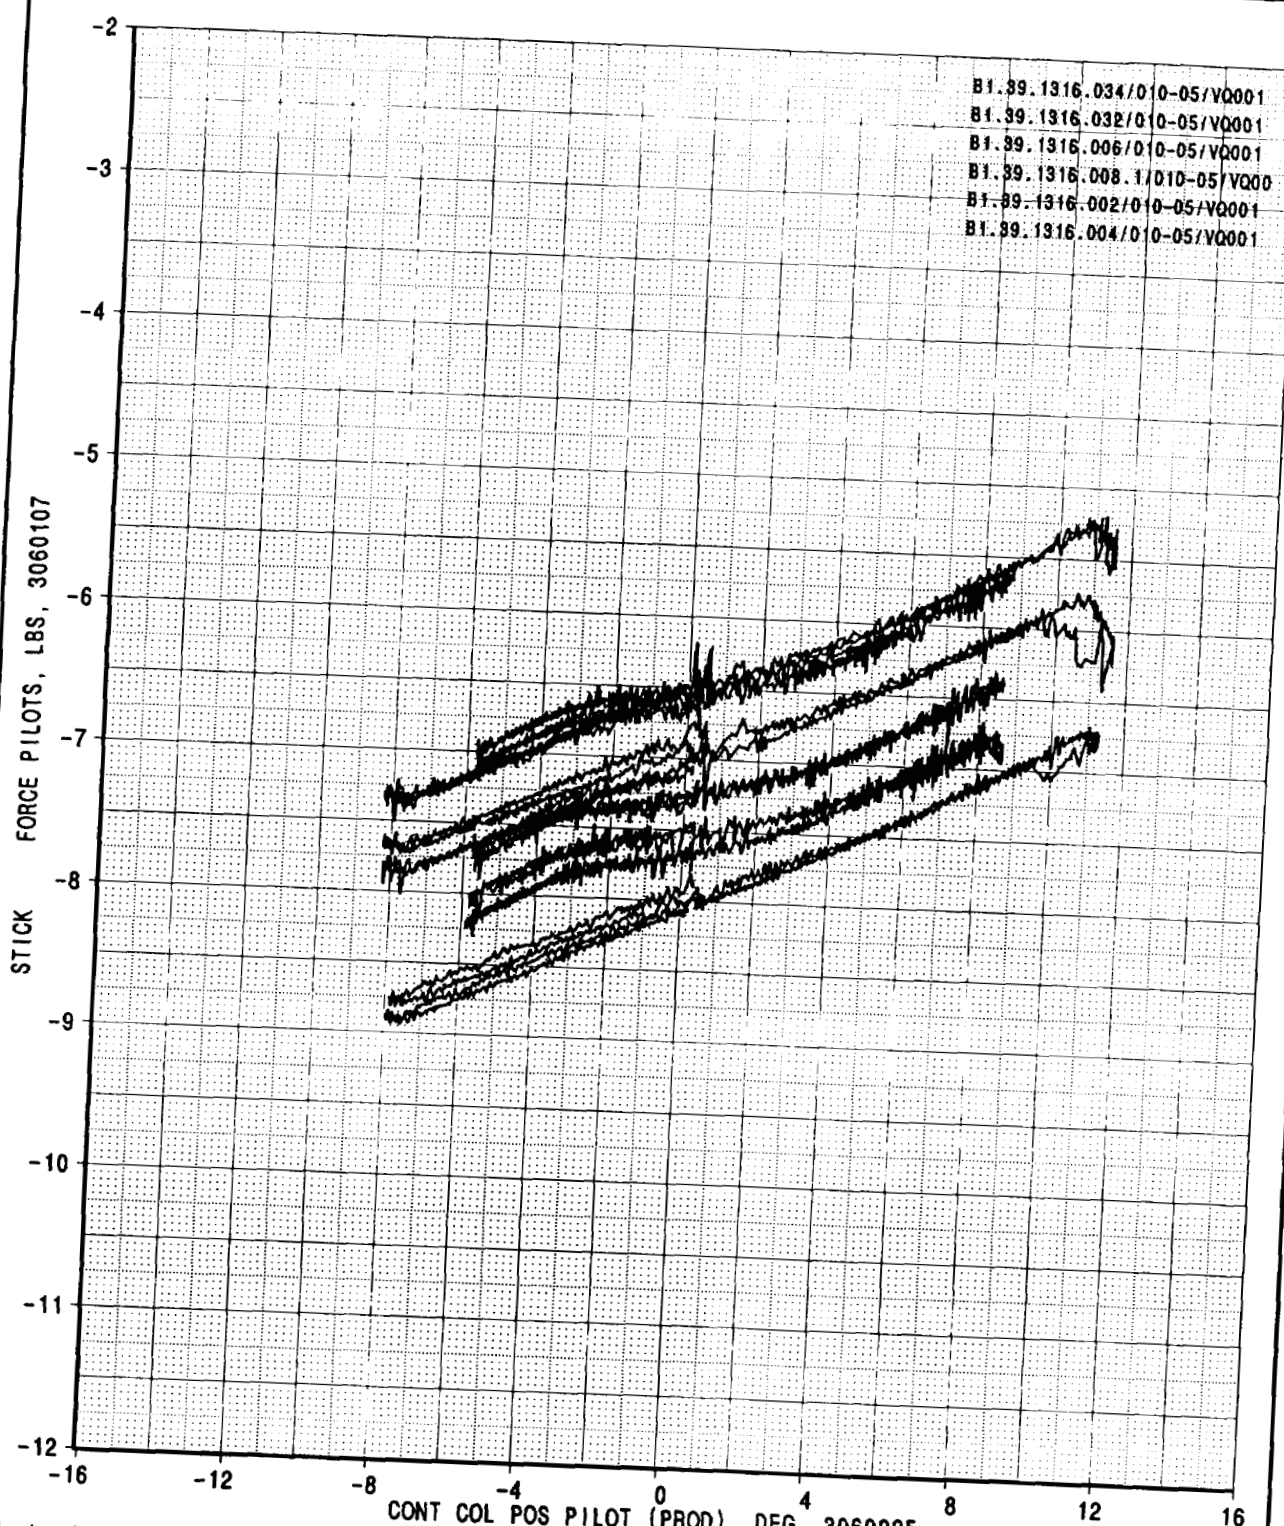
The captain's column force biases during test 010-05 are shown in figure 4. Figure 4 was created by plotting the captain's column force versus the captain's column position for all test conditions in which the first officer alone made the column inputs. Figure 4 is the same as figure 3 except that the column force biases were measured at different times throughout the day. Figure 4 shows a bunch of parallel lines. The fact that the lines in figure 4 don't lay right on top of each other shows that the column force instrumentation bias at zero degrees of column shifted during the course of the day within the range of -6.5 to -8.0 pounds of column force. The fact that these lines are parallel to each other demonstrates that even though the bias shifted throughout the course of the testing as a result of temperature changes, the gain of the instrumented column force was unaffected. Since the same mass unbalance force caused the characteristic slope of these lines, any change to the gain of the instrumented column force would have resulted in non-parallel lines.

Examination of figures 4, 5, 6, and 7 reveals that the column force instrumentation biases all shifted during the course of the day's testing. The cause of this shifting is changes in temperature during the course of the testing. During the design of the strain gage simulator circuits, no attempt was made to produce biases that were constant with respect to temperature. For figures 4, 5, and 6, the shift in the column force instrumentation bias is less

CALC	B. Cook	17Jul00	REVISED	DATE	Captain's Column Force Biases During Test 10-05	767-400ER VQ001
CHECK						Figure 4
APPD.						
APPD.						
						PAGE 10 of 16

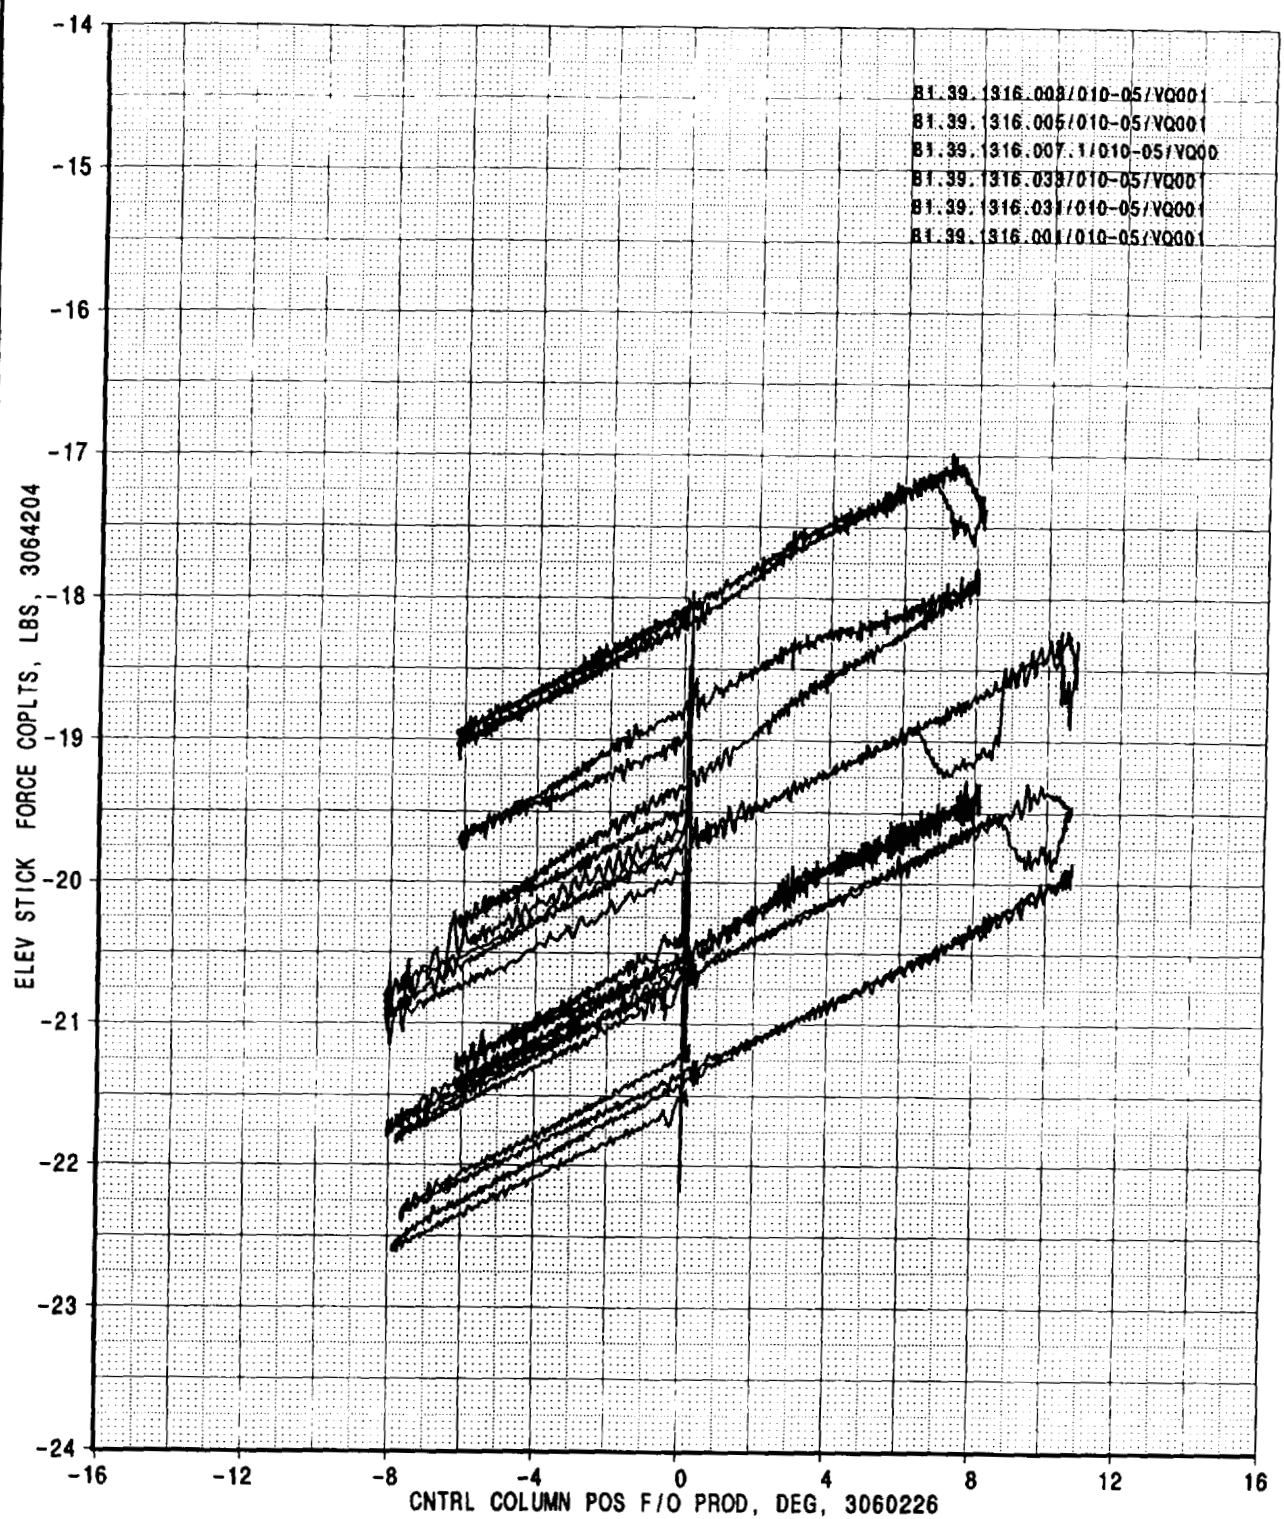
The First Officer's column force biases during test 010-05 are shown in figure 5. Figure 5 was created by plotting the first officer's column force versus first officer's column position for all test conditions where the captain alone made the column inputs.

CALC	B. Cook	17Jul00	REVISED	DATE	First Officer's Column Force Biases During Test 10-05	767-400ER VQ001
CHECK						Figure 5
APPD.						PAGE
APPD.						12 of 16

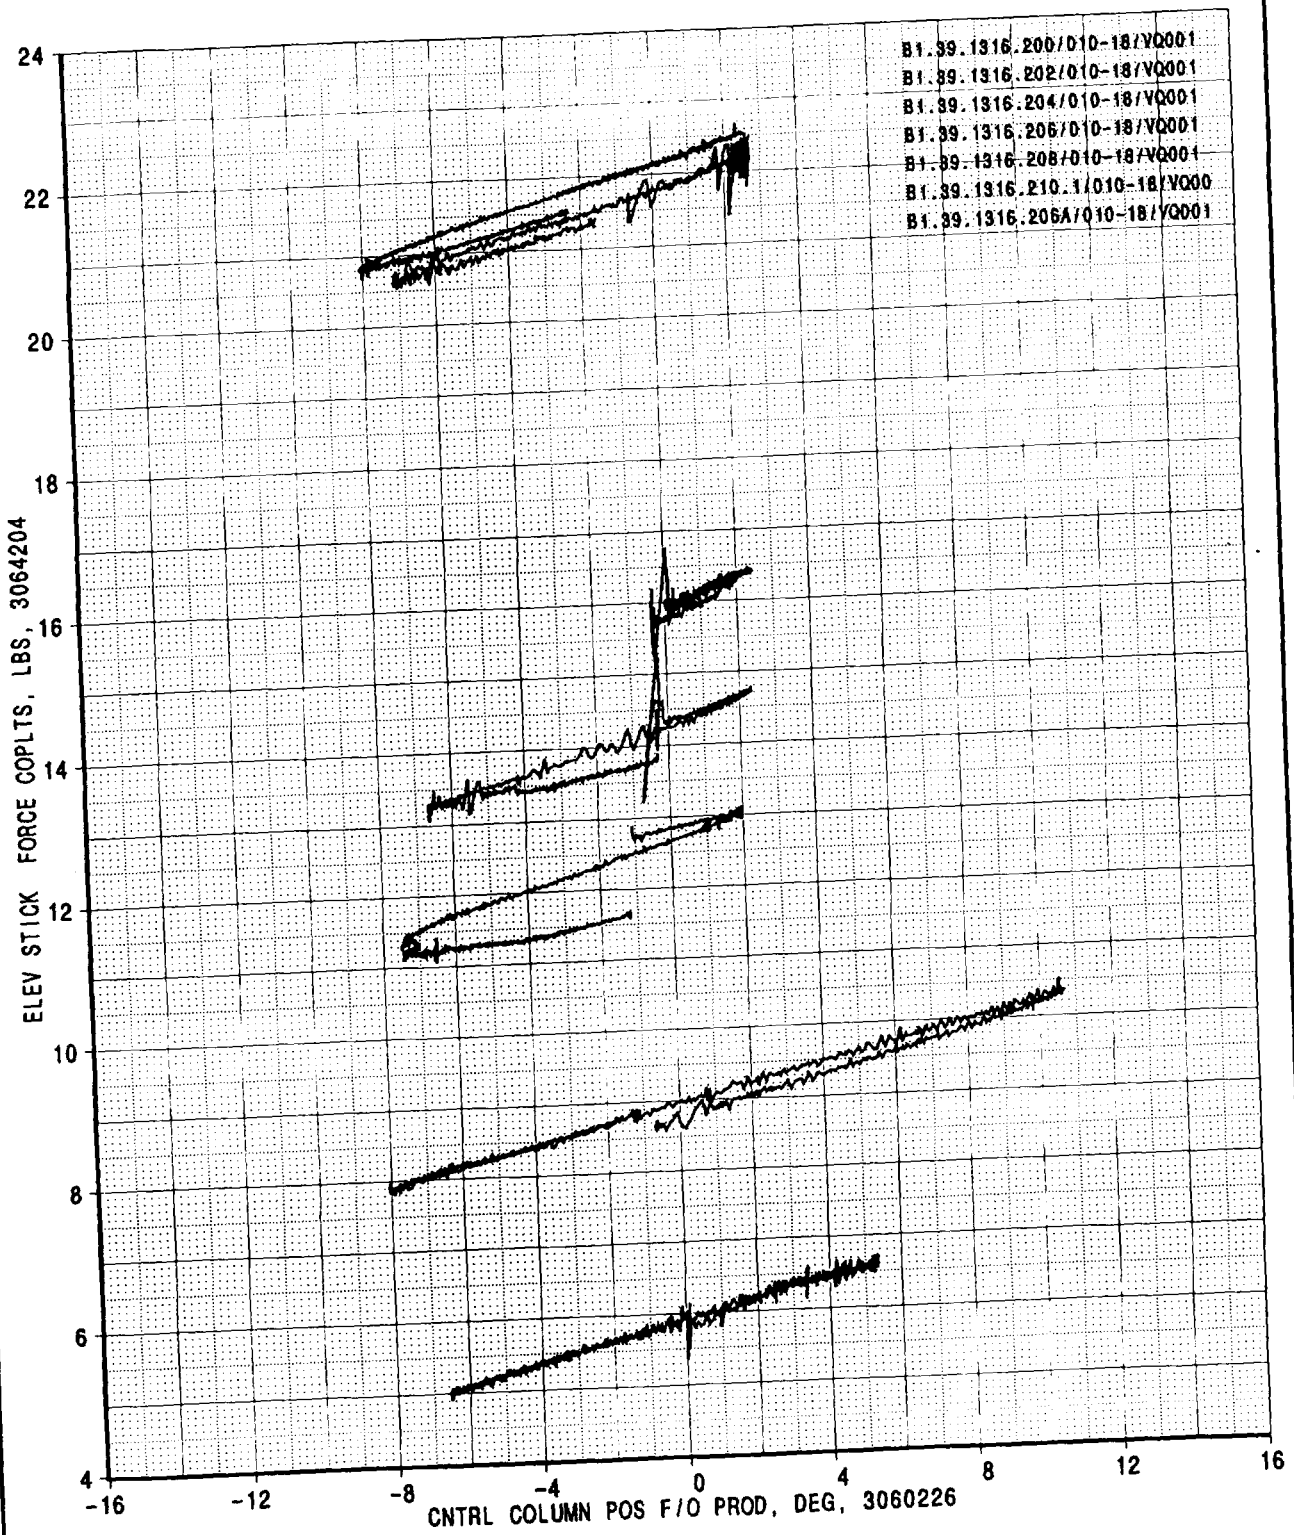
For figure 7, the column force instrumentation bias on the first officer's column during test 010-18 varied from 6 lbs to 22 lbs. This is significantly more shift in the bias than that observed during any other test. Test 010-18 was conducted with 3 main test configurations: (1) single input jams, (2) single input jam plus a single disconnect, and (3) dual input jams. Switching between test configurations during test 010-18 required significant amounts of time because elevator PCAs had to be removed and replaced to produce an input jam. A review of the test conditions completed in each of these three test configurations shows that the column force bias values didn't shift more than a few pounds for the test conditions within a single configuration. The major shifts occurred between main test configurations when large temperature shifts occurred while the airplane configuration was changed.

First Officer's Column Force Biases During Test 10-18					767-400ER VQ001
					Figure 7
CALC	B. Cook	17Jul00	REVISED	DATE	BOEING® PAGE 14 of 16
CHECK					
APPD.					
APPD.

While the column force instrumentation biases were observed to shift some during the course of a full day of testing, the biases remained constant during each test condition. For this reason, the column force instrumentation biases should be removed by subtracting the force necessary to make the initial hands-off column force equal to zero prior to each test condition.

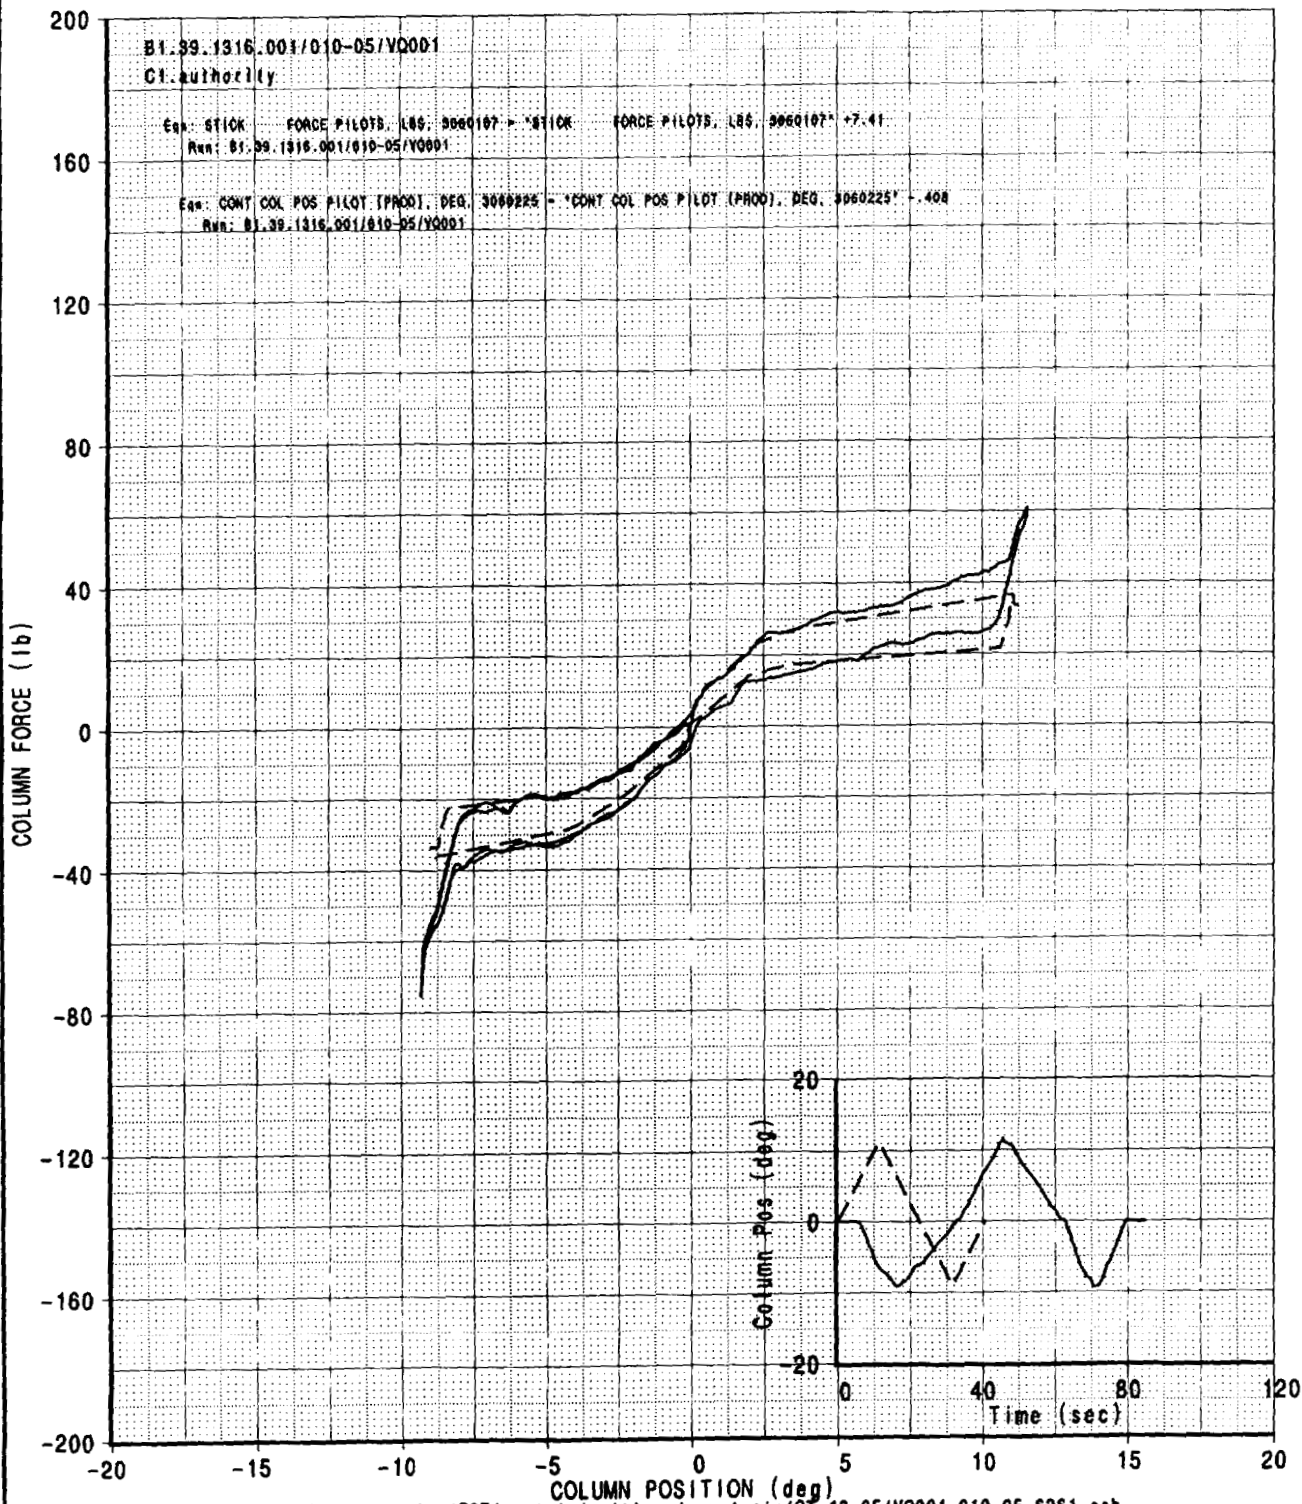
CALC	B. Richardson	17 Jul 00	REVISED	DATE	Ground Test/Simulation Proof of Match Base Feel Sweep with Biases Removed	767-400ER VQ001
CHECK						Figure 8
APPD.						
APPD.						
						PAGE 15 of 16

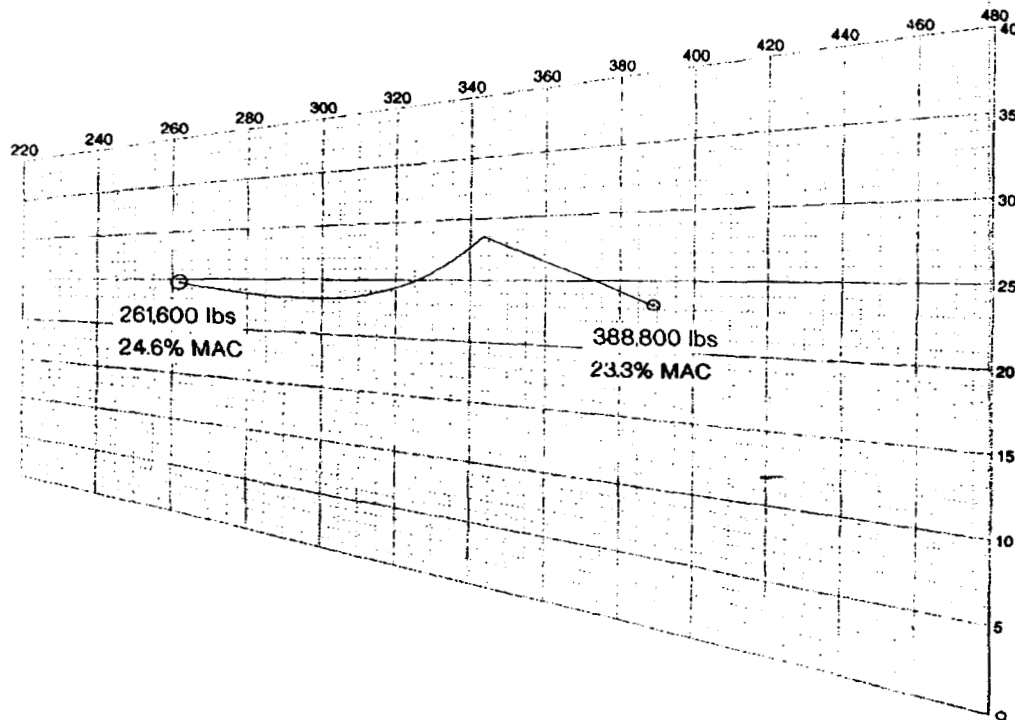
Figure 1, CG Change due to Fuel Burn

To calculate the change in center of gravity as fuel is burned, we started with the total fuel load recorded on the FDR just prior to the initial upset. For these conditions (gross weight 388,800 lbs and total fuel 127,200 lbs), Boeing's recommended operating procedure is to have the wing tanks nominally full with the engines supplied from the center tank. When operated according to Boeing's recommended procedure, the change in CG due to fuel burn is shown in Figure 1, CG Change due to Fuel Burn. Starting from the point labeled 388,800 lbs, the airplane gross weight and CG move along the straight line segment until the center tank fuel is exhausted. At that point, the engines begin to burn fuel from the wing tanks, as represented by the kink in the curve and subsequent curved segment. At the point of the initial upset, Figure 1 shows that the trend in CG due to fuel burn alone is rearward.
