**NATIONAL TRANSPORTATION SAFETY BOARD
WASHINGTON, D.C**

**METALLURGY / STRUCTURES SEQUENCING GROUP
CHAIRMAN'S
REPORT OF INVESTIGATION**

**Supporting Documentation for
OVERALL BREAKUP SEQUENCE
Materials Laboratory Report No. 97-38**

Appendix B: Detailed Rationale

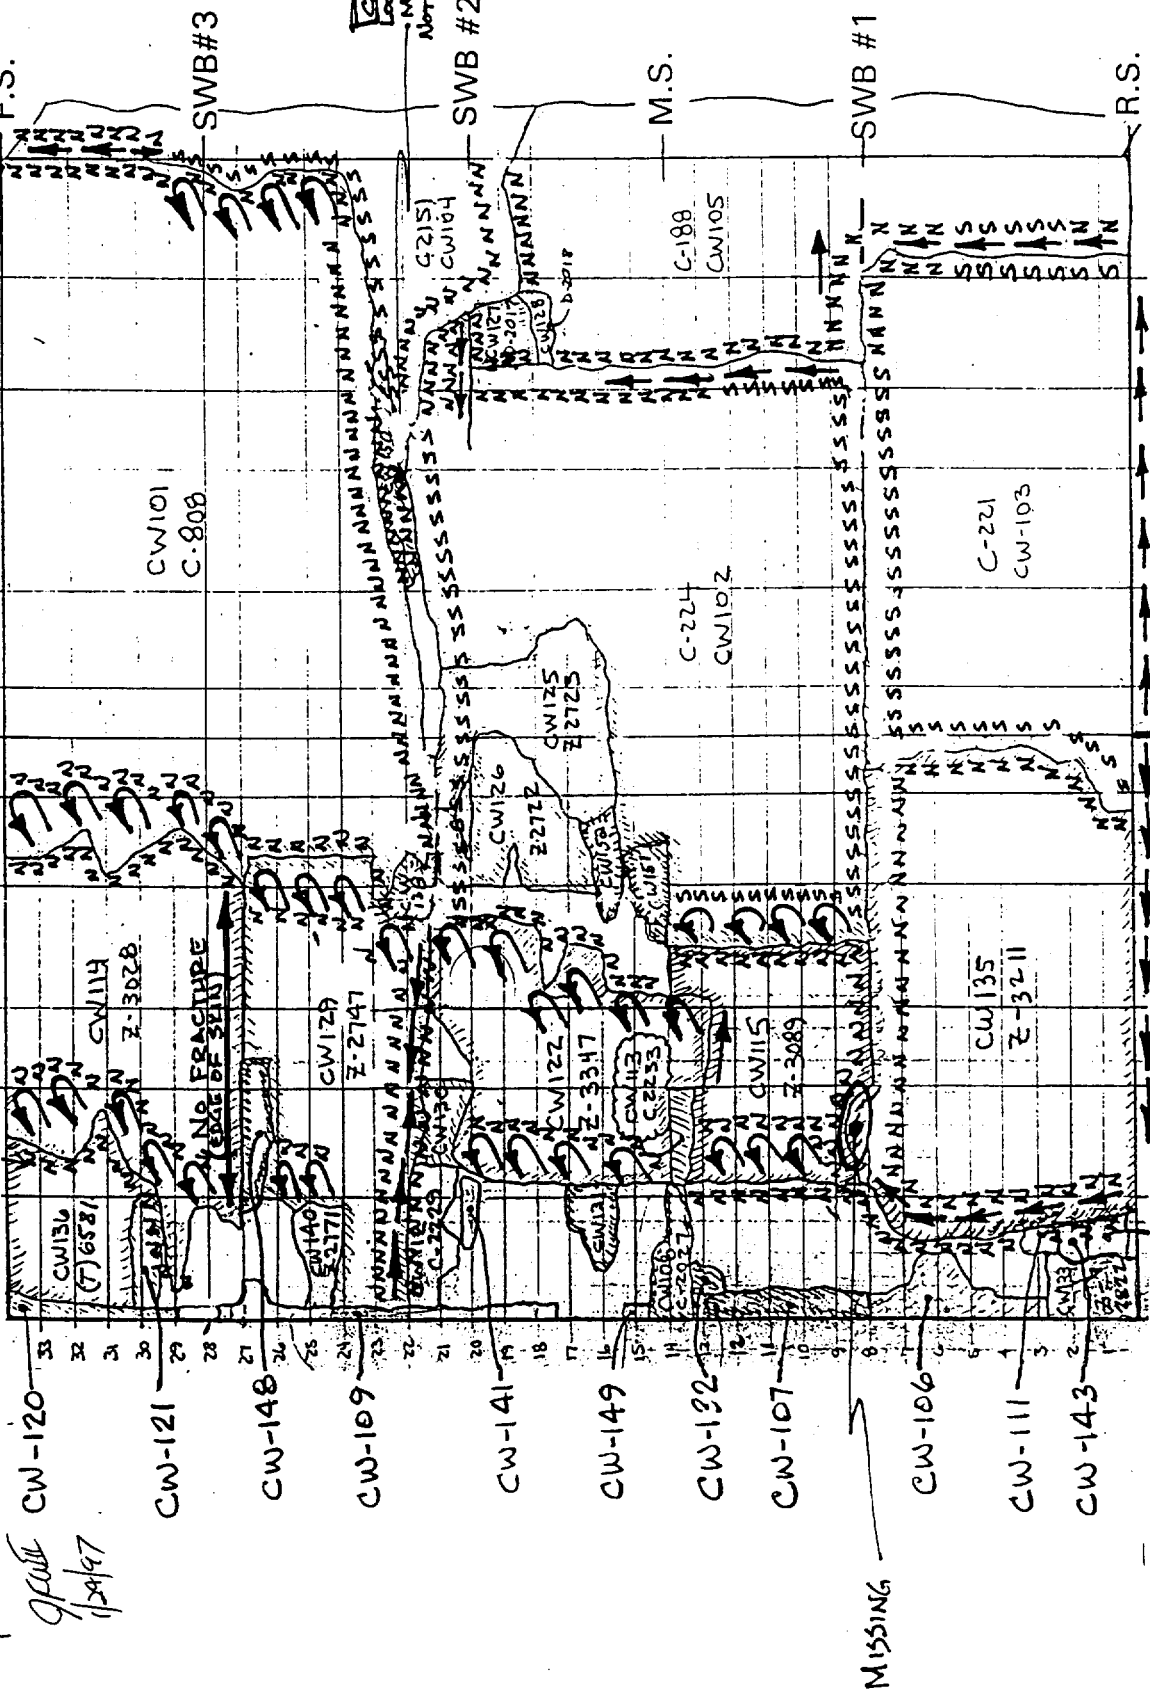
FIGURE B-1

DESCRIPTION OF POSSIBLE SEQUENCE	SUPPORTING OBSERVATIONS	NON-SUPPORTING OBSERVATIONS	Confidence Level
The loss of the front spar and spanwise beam #3 attachment to the upper skin panel would result in some loss of compression stability of the upper skin panel.			High
If the structure sustains thermal damage from fire, it will result in decreased structural capability.			High
Buckling of the upper skin is potentially initiated between the midspar and the rear spar and restraint would be provided by the BL 0 rib which is consistent with an inflection in the curvature at BL 0.	Upper skin panel has residual deflection of an upward bow to the left of BL 0 and slight upward curvature to the right of BL 0 with the inflection point at BL 0.		Medium
The initial fracture consistent with upper panel buckling is potentially along the attachment to spanwise beam #1. This fracture runs primarily through the single fastener row common to the upper chord of the spanwise beam.	<ol style="list-style-type: none">1. Bending fracture in the skin panel at SWB #1 is through the fastener row and the fracture exhibits upward bending both fwd and aft of the fastener row.2. Fore/aft fractures are not continuous forward or aft of the fracture running along SWB#1 suggesting that the fracture along SWB#1 existed prior to the fractures occurring at LBL 40, LBL 5, RBL 76, and RBL 100. (see figure B-1)		Medium

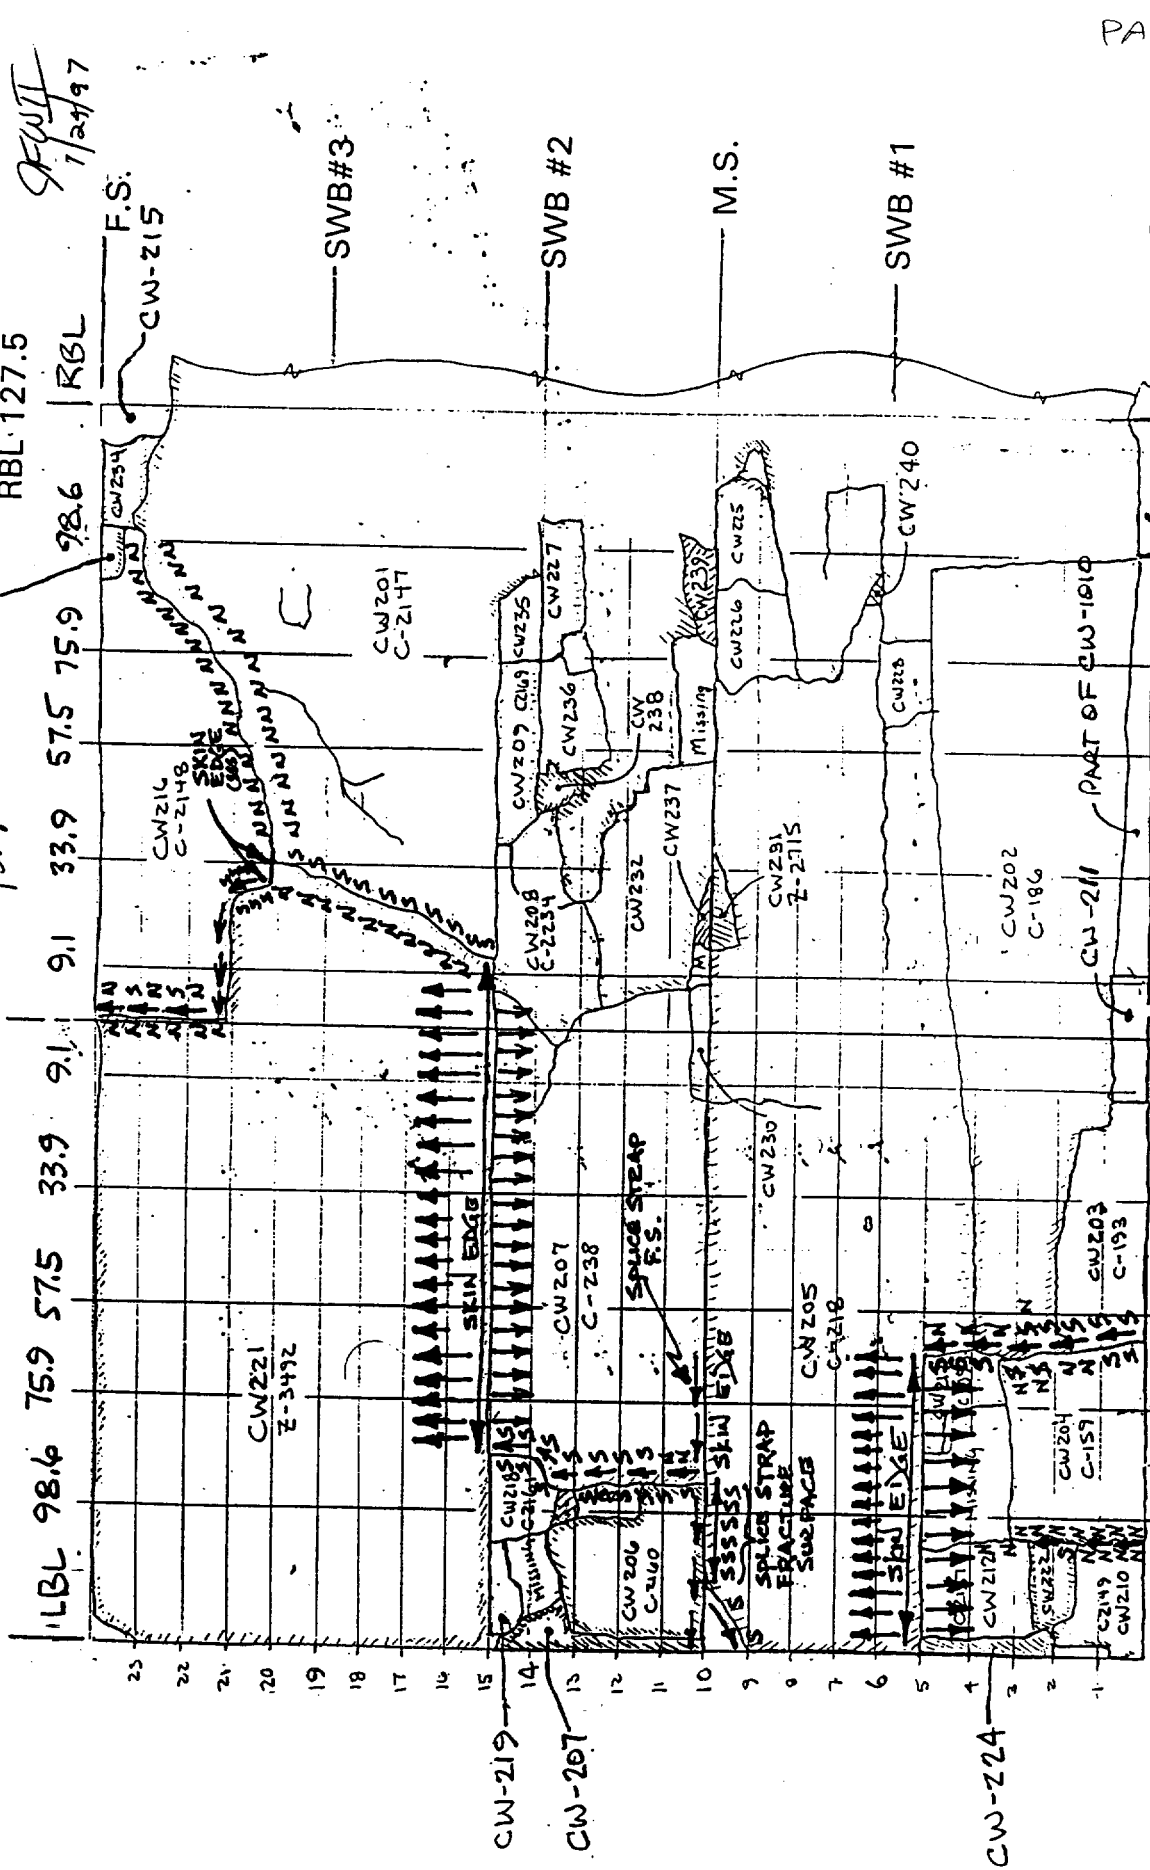
FIGURE B-2

DESCRIPTION OF POSSIBLE SEQUENCE	SUPPORTING OBSERVATIONS	NON-SUPPORTING OBSERVATIONS	Confidence Level
<p>As a result of the wing breakup, the lower skin apparently separates into 2 major sections.</p> <ol style="list-style-type: none"> The aft left corner (LBL 100 to LBL 127 and R.S. to S-5) including CW-210, CW-222, CW-212, and CW-224 remain with the left wing. The section from LBL 90 to the S.O.B. from the midspar to S-15 including CW-206, CW-229, CW-219, AND CW-218 stays with the left wing. CW-221 also stays with the left wing. A potential additional secondary failure occurs between CW-203 and CW-204 but CW-204 remains attached to the right wing portion through partial attachment to CW-202 and lower panel stringers 1,2, and 3. The remainder of the lower panel remains with the right wing. <p>Additional mating clean fracture faces are consistent with water impact or are at least apparently subsequent to the primary wing breakup.</p>	<ol style="list-style-type: none"> Sooted fracture faces on the panels that potentially remain attached to the right wing and unsooted fracture faces on those segments that potentially remain attached to the left wing. Exterior surface of CW-210, CW-212, CW-224, and CW-222 are more heavily sooted in comparison to segments fwd and more inbd of them. 	<ol style="list-style-type: none"> Exterior soot comparison between CW-221 fwd of stringer S-15 has much lower soot deposits than CW-218 and CW-219 aft of S-15 which could suggest that CW-221 did not remain with left wing. Outbd wing lower skin at the side of body has sooted portions of the side of body interface that are not sooted on CW-221. 	Medium

<p>Additional mating clean fracture faces are consistent with water impact or are at least apparently subsequent to the primary wing breakup.</p>		Some local indications of partially sooted fractures exist within areas of clean fracture faces.	Medium

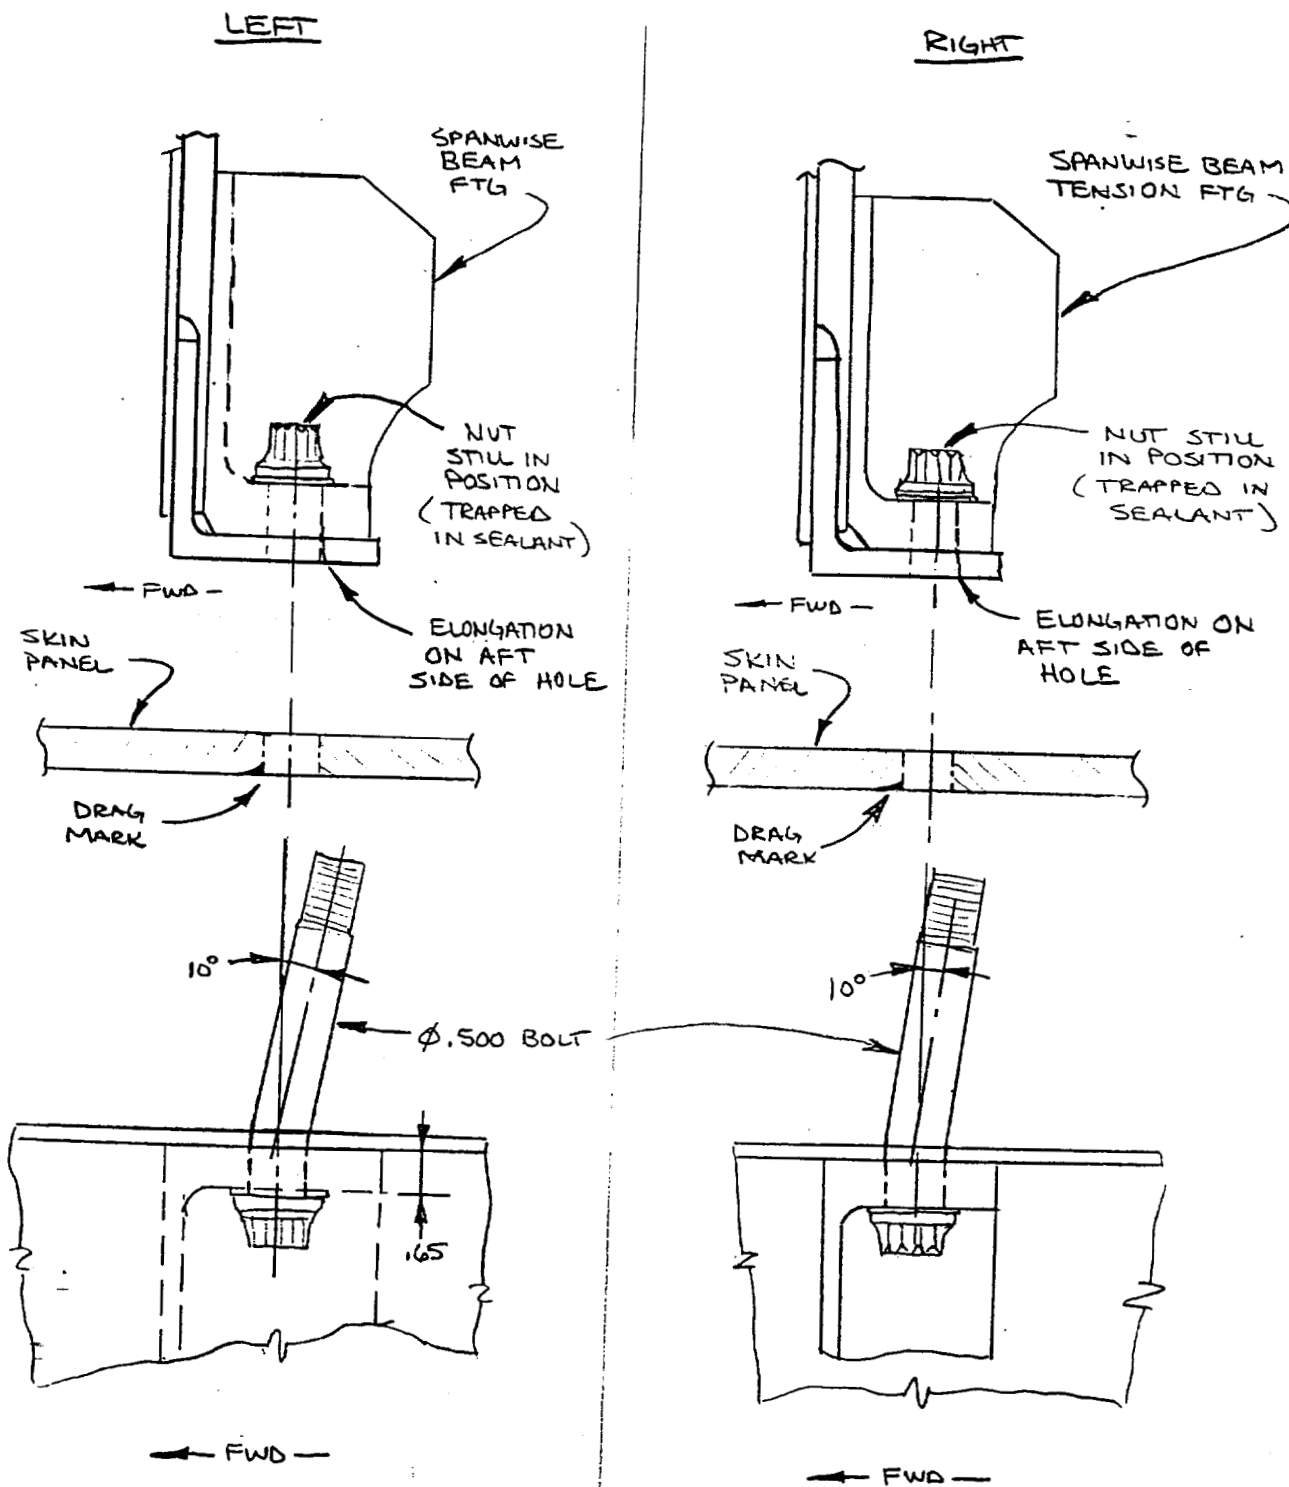
FIGURE B-4

DESCRIPTION OF POSSIBLE SEQUENCE	SUPPORTING OBSERVATIONS	NON-SUPPORTING OBSERVATIONS	Confidence Level
Spanwise beam is possibly intact prior to the keel beam tension bolt fracture. The condition of the related parts is shown in figure B-4.	Keel beam tension fasteners failed by stripping threads out of the nut indicating relatively pure tension loading with low bending forces.	Structure from left side of SWB#2 not recovered or identified	Medium
Resultant web shear from the keel beam loads induced while fracturing the keel beam tension bolts is consistent with initiating shear failure of the access door fasteners common to stiffeners and surround structure shown in zone A on figure B-5. This could also be as a result of overpressure in the WCS.	<ol style="list-style-type: none"> 1. Shear failure of fasteners common to the stiffeners, surround structure, and the manufacturing access door. Examination of the sheared rivets in the stiffener shows the door attach structure moving down relative to the access door. 2. Indication of early shear tie failure at the upper panel attachment of stiffener at RBL 17.2 due to partially sooted fracture on skin flange of the upper chord. 		Medium

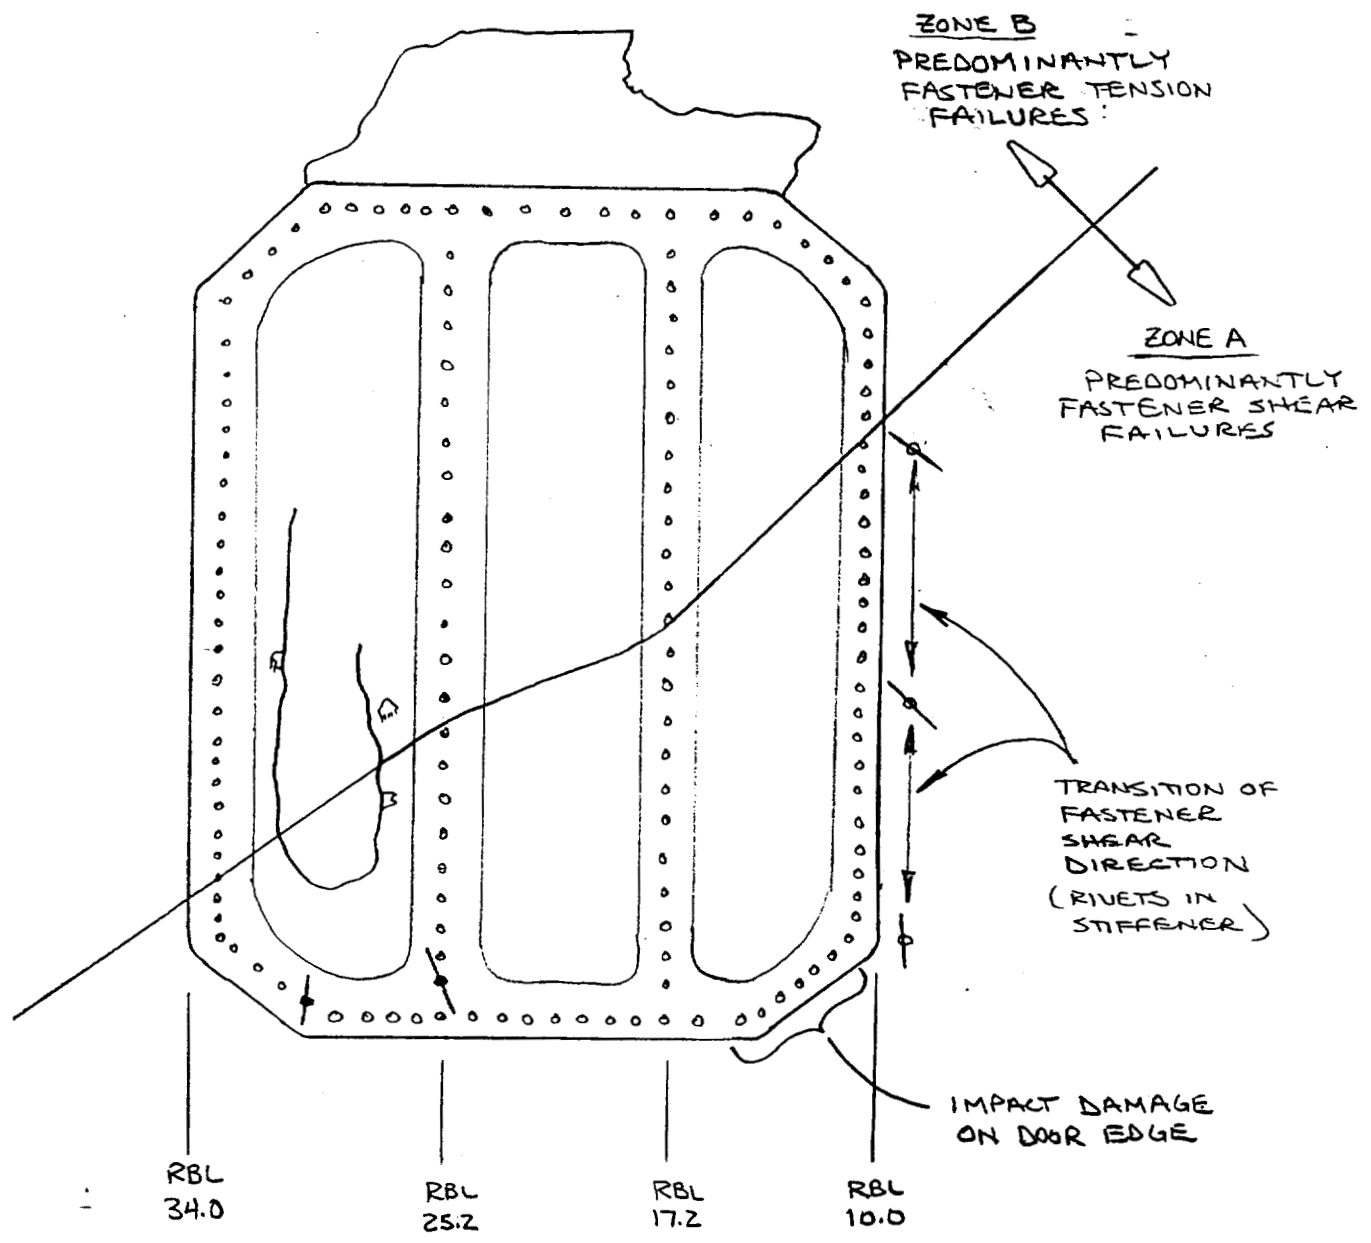
FIGURE B-5

SPANWISE BEAM # 2
MANUFACTURING
ACCESS
DOOR
(CW703)

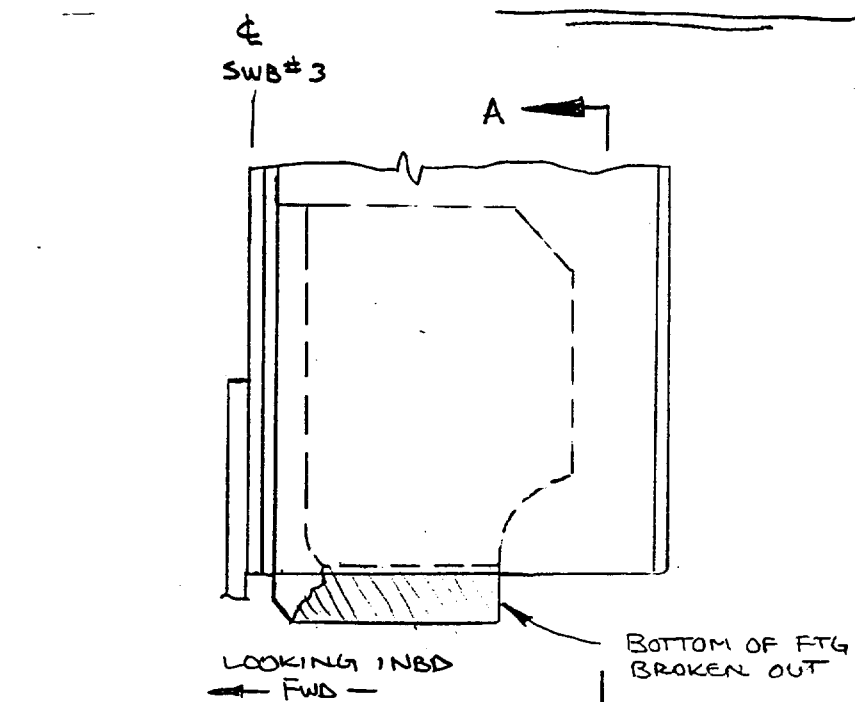
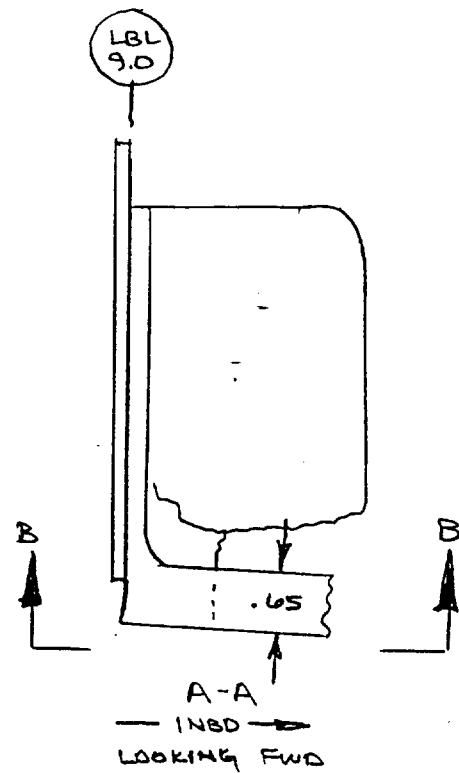
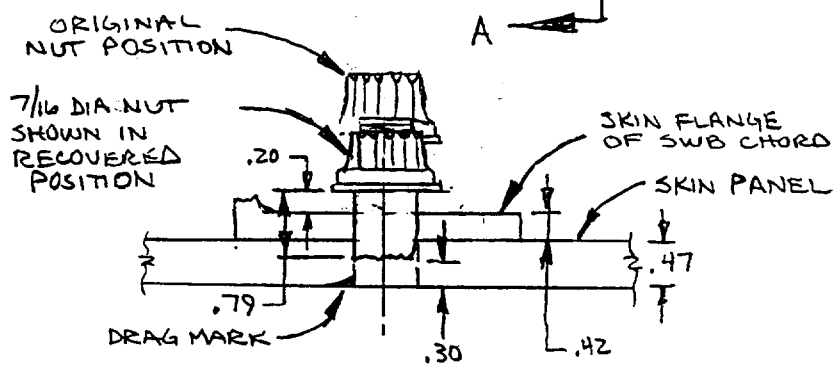
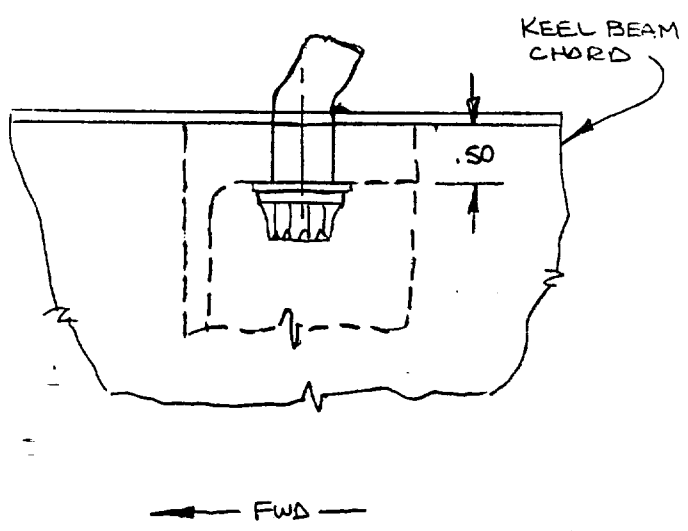
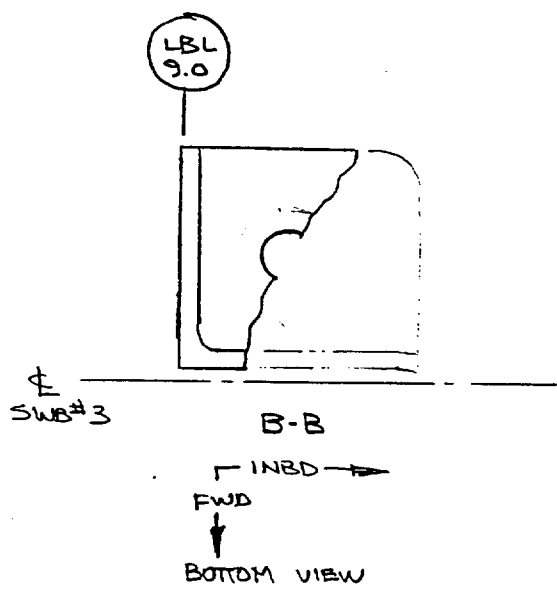
FIGURE B-6

SWB #3 - LEFT FTG.

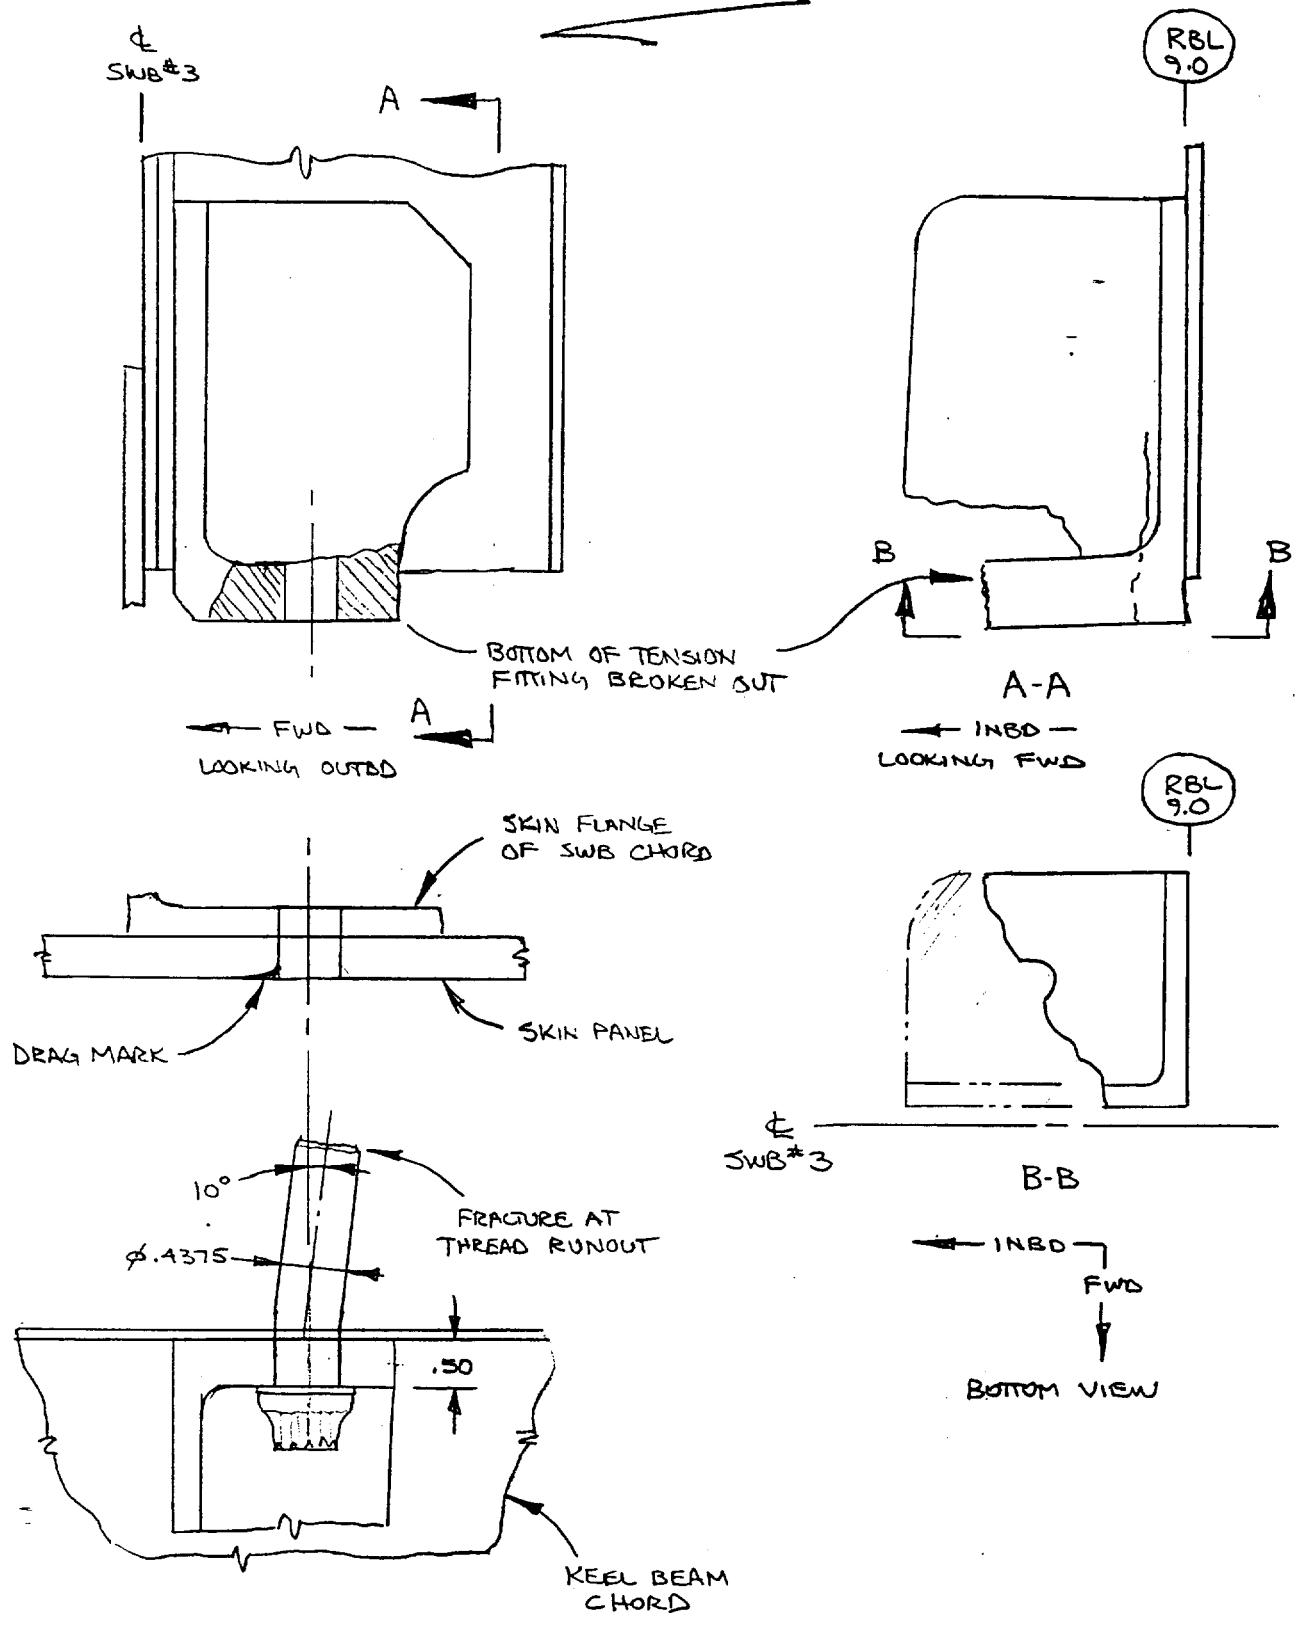
FIGURE B-7

DESCRIPTION OF POSSIBLE SEQUENCE	SUPPORTING OBSERVATIONS	NON-SUPPORTING OBSERVATIONS	Confidence Level
<p>As segment CW-603 rotates fwd, the lower tension fittings common to the keel beam may fracture through the pad of the tension fitting but not failing the tension bolts. Since there are no lower intercostals fwd of the spanwise beam in this section, this segment may rotate about the lower chord.</p> <p>Tension fitting fracture results in loss of tension bolt clamp-up and .65 freeplay in the joint to the keel beam.</p>	<ol style="list-style-type: none"> 1. The tension bolt common to the left tension fitting has a portion that remains in the skin panel and a portion that remains in the keel beam. Based on the length of the remaining bolt segments, the tension fitting had to fracture prior to the tension bolt failure for the bolt to be able to remain in the hole and then be pulled down further into the hole as compared with it's original position when the SWB#3 tension fitting was intact. 2. The lower chord fracture (just above the chord fillet radius) originates near the left and right keel tension fittings and propagates outward from those locations. 3. The tension bolt common to the tension fitting at RBL 9.0 is fractured at the transition of the shank into the threads. 4. Fracture of tension fitting end pad is consistent with bending of tension fitting around the lower SWB chord. <p>(See figures B-6 and B-7 to clarify supporting observations) Review of structural features.</p>		High

SWB#3 - RIGHT FTG

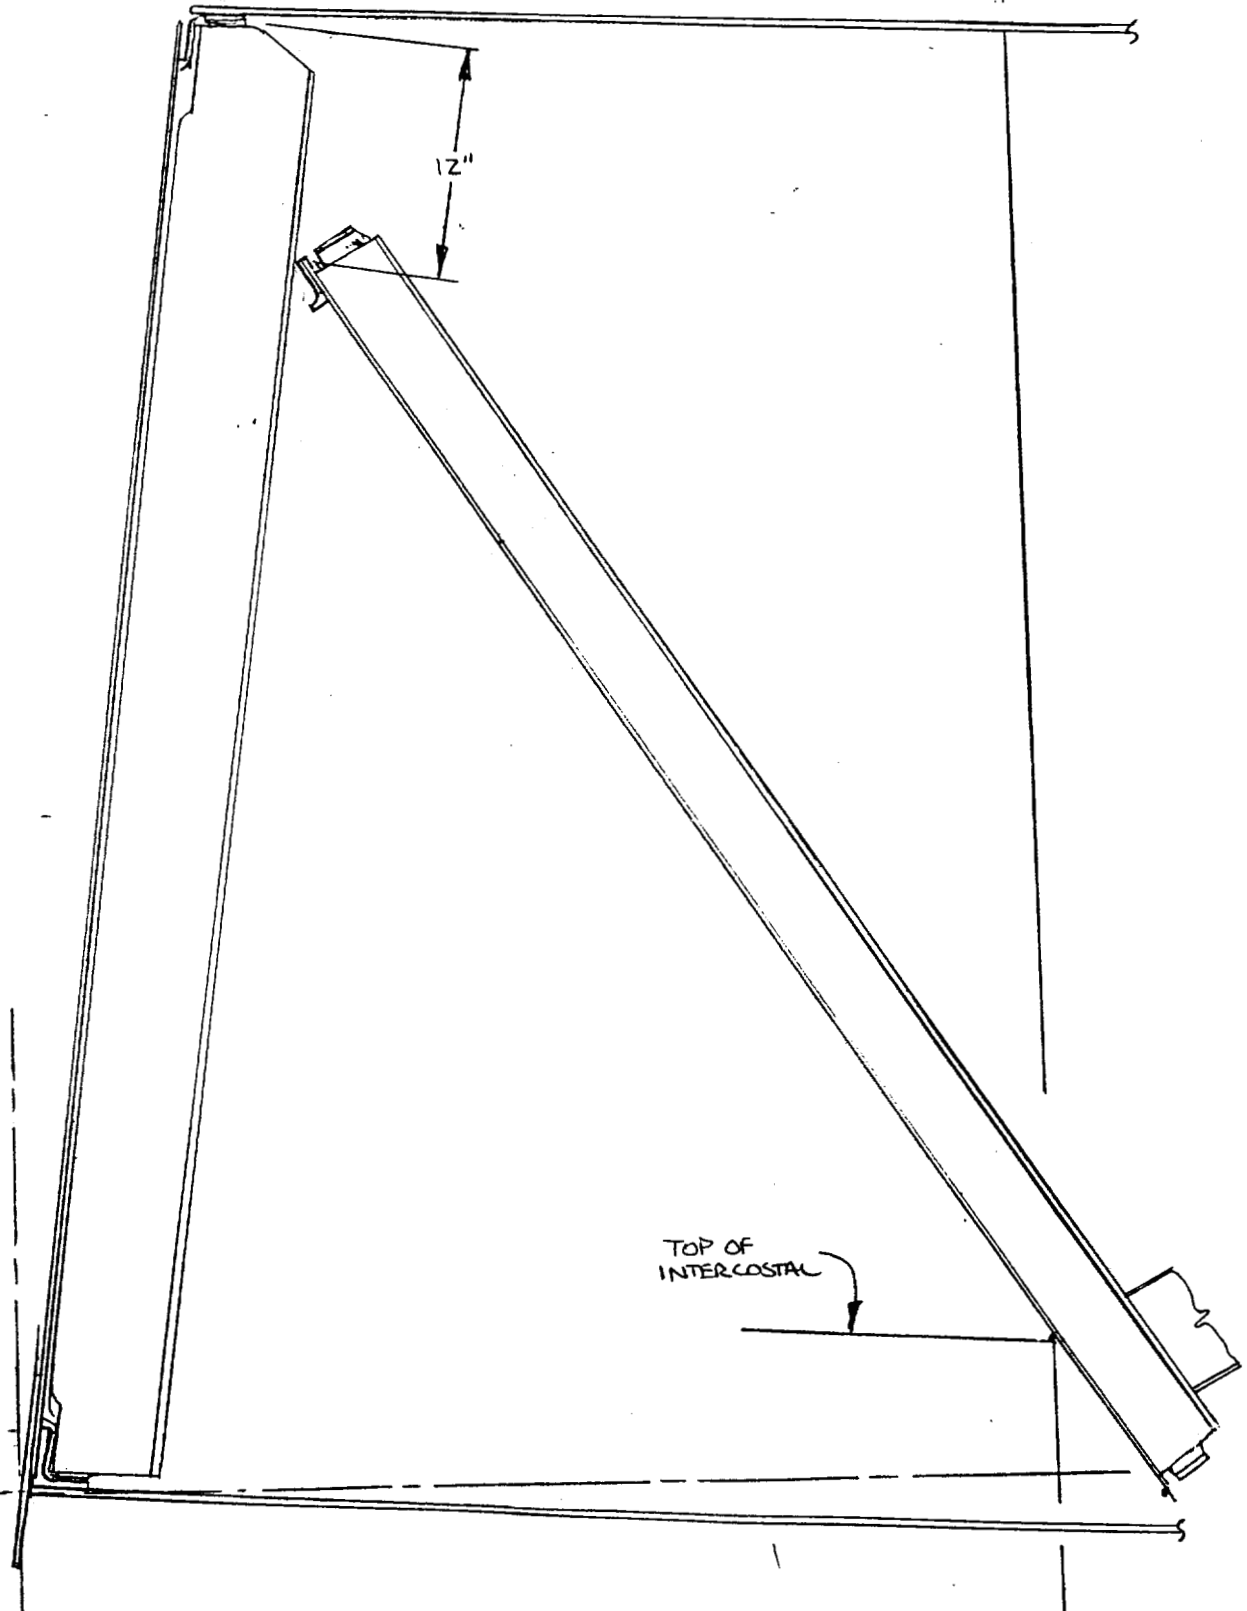
FIGURE B-8

INITIAL ROTATION OF SWB#3
PRODUCES IMPACT ON FRONT
SPAR IN A ZONE 12" BELOW
THE UPPER SPAR CHORD.

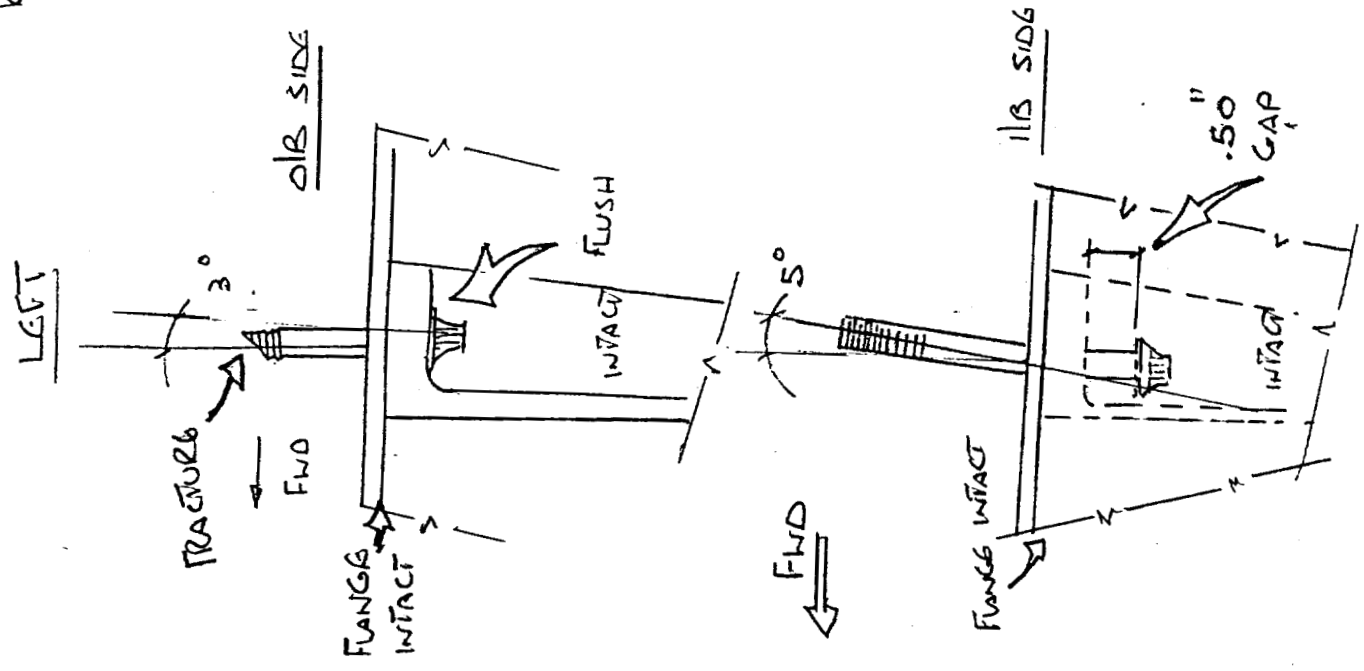
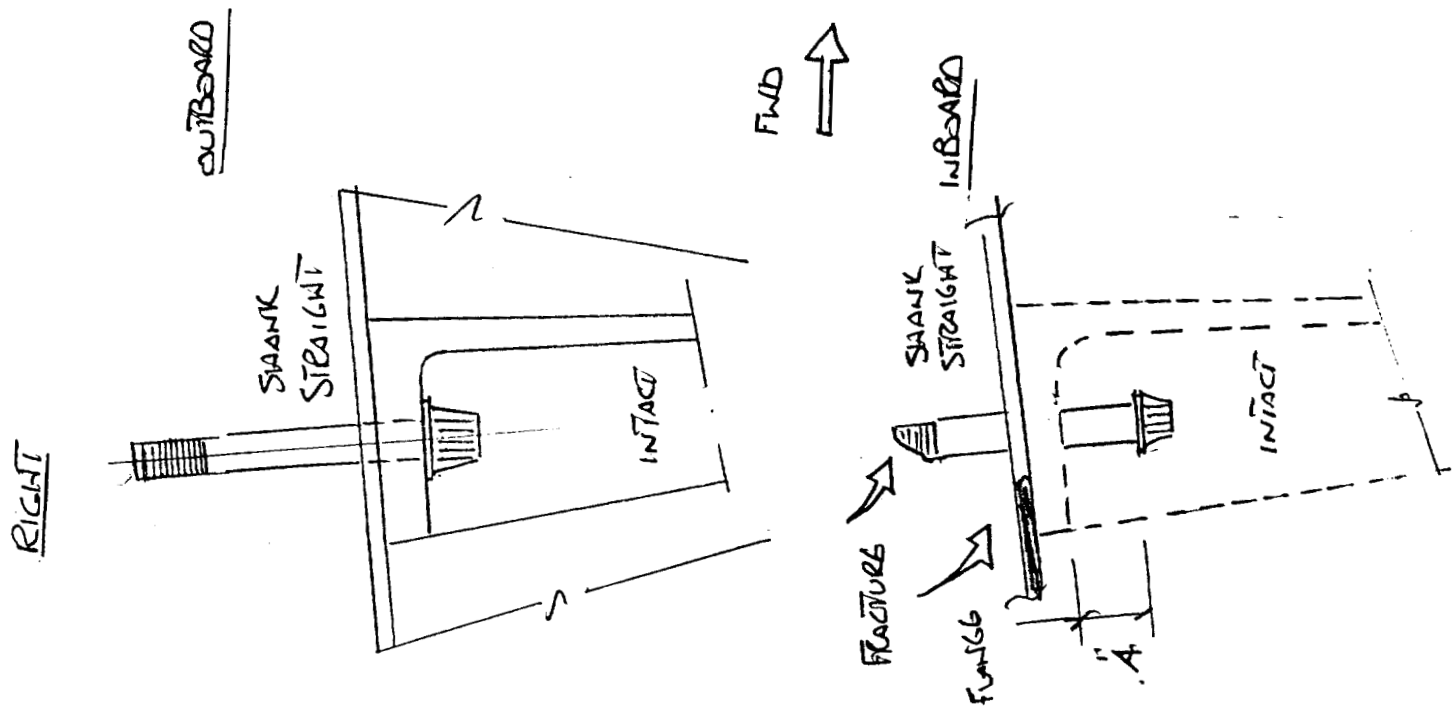
FIGURE B-10

FRONT SPAR AND KEEL BEAM INTERFACE

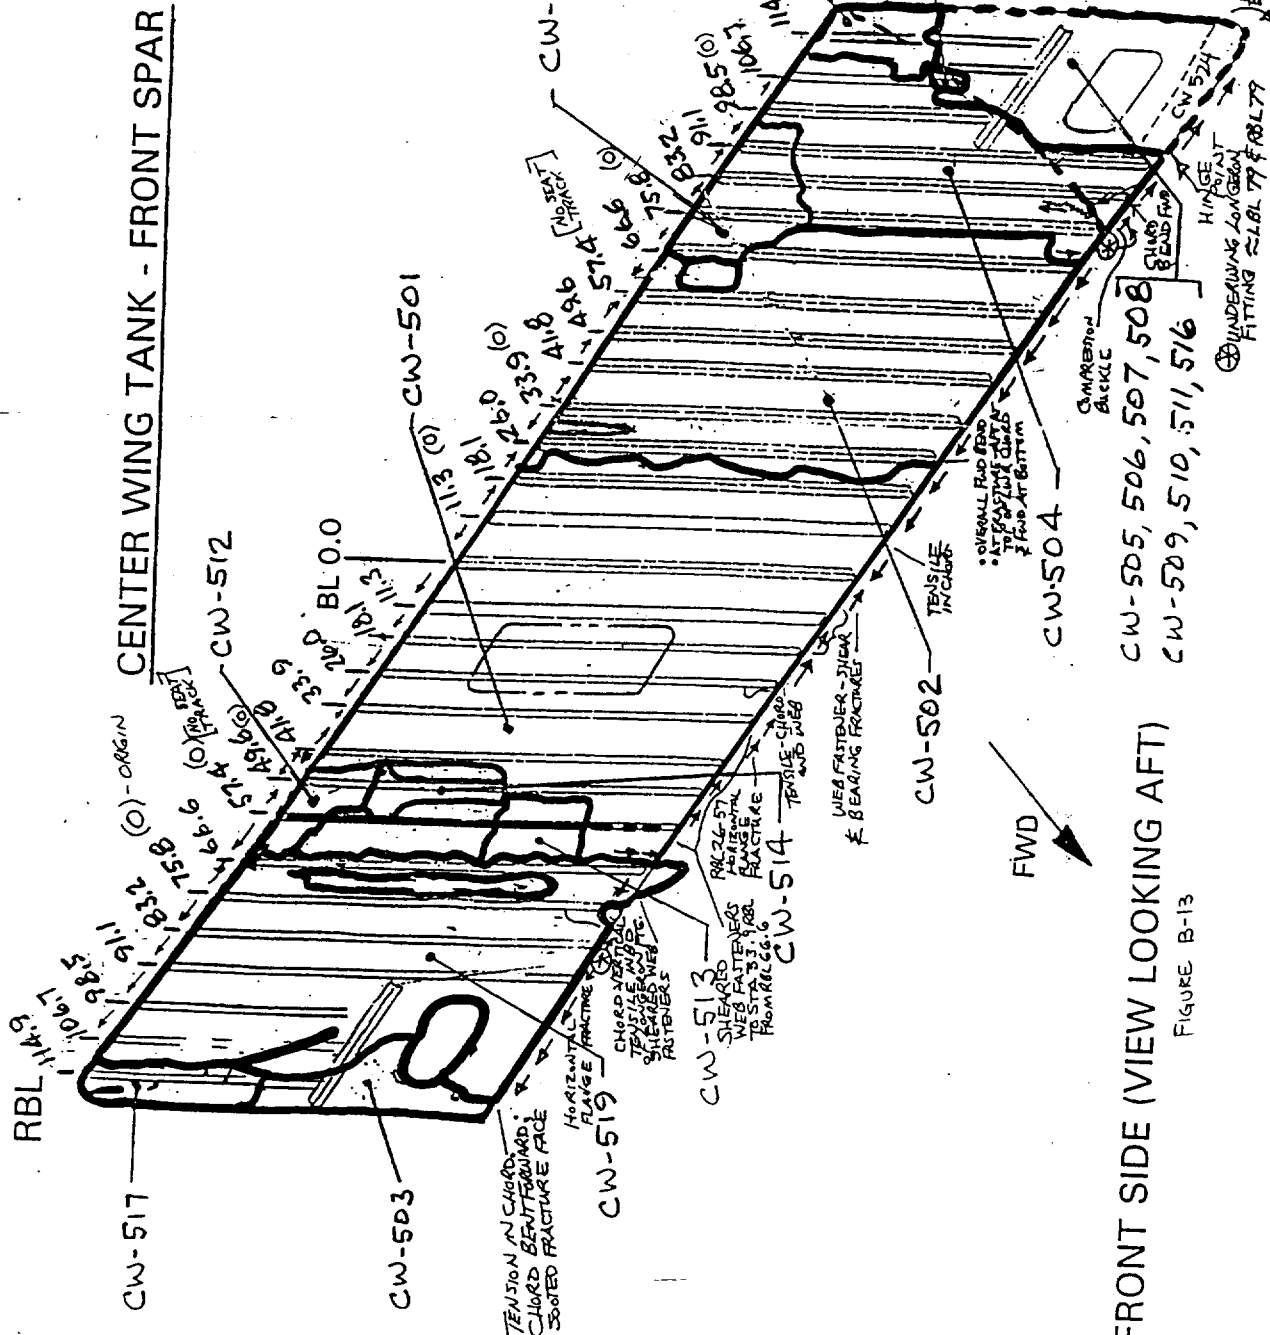
FIGURE B-13

DESCRIPTION OF POSSIBLE SEQUENCE	SUPPORTING OBSERVATIONS	NON-SUPPORTING OBSERVATIONS	Confidence Level
<p>As a result of spanwise beam #3 rotating fwd, the upper chord of the spanwise beam impacts the aft side of the front spar stiffeners. This results in crushing of the aft side of the stiffeners at a location shown in figure B-8.</p>	<p>Impact marks and damage on the aft side of the front spar stiffeners at a distance of approx. 12" below the upper stiffener shear ties. The damage on the aft side of some of the stiffeners shows two distinct impact marks with 3" vertical separation that equals the chord height of the spanwise beam upper chord.</p>		High
<p>The applied impact force on the aft side of the stiffeners and local buckling of the stiffeners at the impact zone results in bending of the upper spar chord between the vertical and horizontal flange. Overpressure loads may also contribute. This bending moment results in a fracture in the fillet radius of the upper spar chord.</p>	<p>Multiple initiation sites of the upper spar chord fracture coincident with the floor beam locations at RBL 75 and 57.5, and LBL 11, 33, 75, and 98. These fractures are a bending type fracture with the lower edge of the chord moving fwd relative to the skin flange of the chord. At all of these locations, the chord has a slight residual deformation indicative of an inbd/outbd bowing of the vertical flange of the chord. See figure B-13.</p>		High

SLIGHT BOWING OF FLANGE NOTED AT ORIGINAL SITES ASSOCIATED WITH FLOOR BEAMS AT RBL 91, RBL 75, RBL 57, LBL 11, LBL 33, LBL 57, LBL 75 AND LBL 98. INITIATION SITES IN UPPER CHORD CO-LOCATED AT FLOOR BEAM AT RBL 75, RBL 57, LBL 11, LBL 33, LBL 75, AND LBL 98.
 ONE ABDL INITIATION SITE BETWEEN RBL 41 AND RBL 45 WAS ASSOCIATED WITH WATER FRACTURE DOVE DOWN IN THE VERTICAL FLANGE.

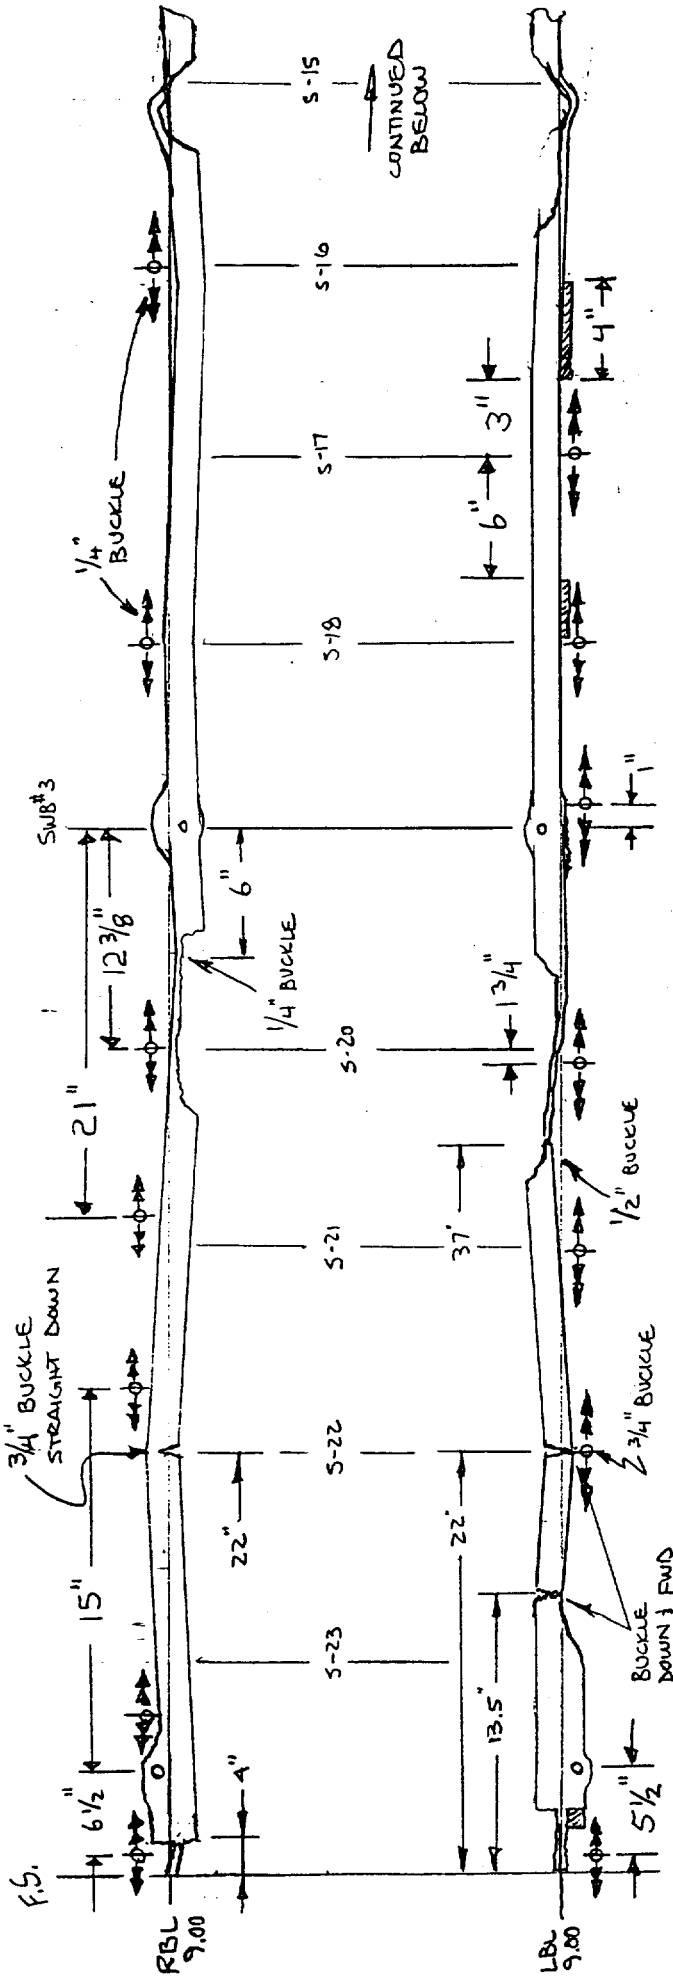
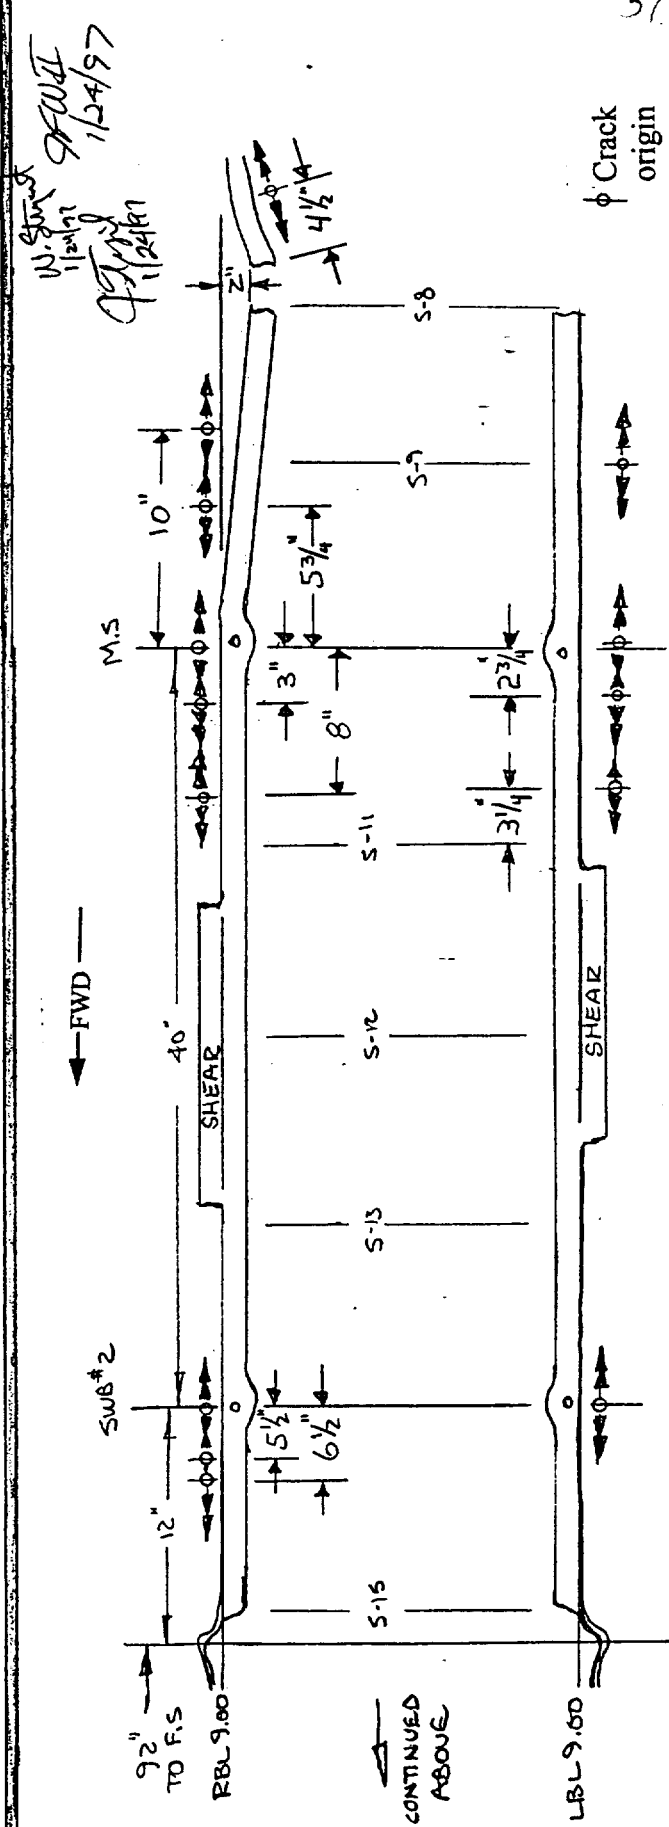
FIGURE B-14

UPPER CHC S OF KEEL BEAM
