**NATIONAL TRANSPORTATION SAFETY BOARD
WASHINGTON, D.C**

**METALLURGY / STRUCTURES SEQUENCING GROUP
CHAIRMAN'S
REPORT OF INVESTIGATION**

**Supporting Documentation for
OVERALL BREAKUP SEQUENCE
Materials Laboratory Report No. 97-38**

Appendix B: Detailed Rationale

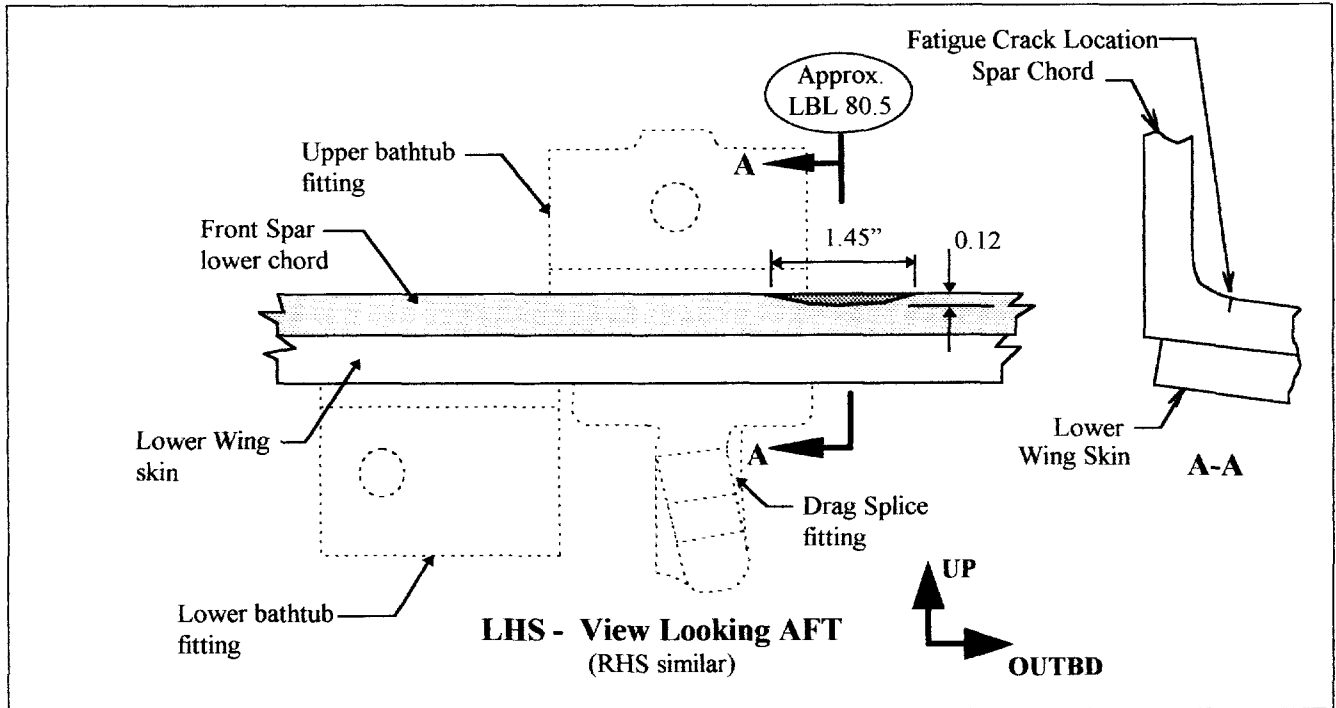
C.1 Front Spar lower horizontal chord - existing fatigue cracking (continued)

Finally, the structural breakup pattern of the front spar has been discussed in Sections 4.11 and 4.12. The fracture of the lower chord through the fillet radius is consistent with the impact of SWB #3 on the front spar and the subsequent overpressure acting on the front spar rotating it forward about the lower chord. A similar fracture occurred in the fillet radius of the upper chords of the front spar and SWB #3 as well as through part of the lower chord of SWB #3. It should be noted that it is the propagation of the fracture at the fillet radius which has coincidentally exposed the two areas of localized, pre-existing fatigue cracking near RBL and LBL 80 in the lower chord.

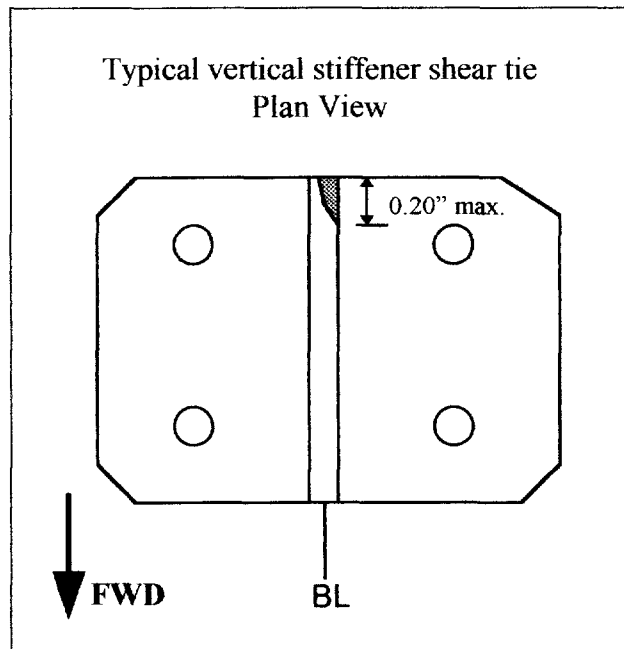
C.2 Front Spar vertical stiffener shear ties - existing fatigue cracking

Small existing fatigue cracks were found in the vertical stiffener shear ties at RBL 83.24 (lower), RBL 75.92 (upper and lower), LBL 75.92 (upper and lower), and LBL 83.24 (lower).

The cracks were all in the shear tie radius near the base of the leg that attaches to the vertical stiffener at the aft edge. This cracking is the subject of SB 747-57-2249. The Service Bulletin was issued in 1989 after reports of in-service cracking. The maximum crack length on the subject airplane was 0.20 inch long. In service, operators have reported cracks ranging from 0.50 inch to 1.5 inch long without complete part fracture, demonstrating the capability of these shear ties to withstand cracking well in excess of the 0.20 inch detected cracking under normal operating conditions. Furthermore examination of the area of fatigue cracking and adjacent material on the fracture face indicates an abrupt transition from slow crack growth to a sudden ductile fracture. This provides further confirmation that the cracking did not propagate to failure due to fatigue but rather was the result of a one time static overload associated with structural breakup.

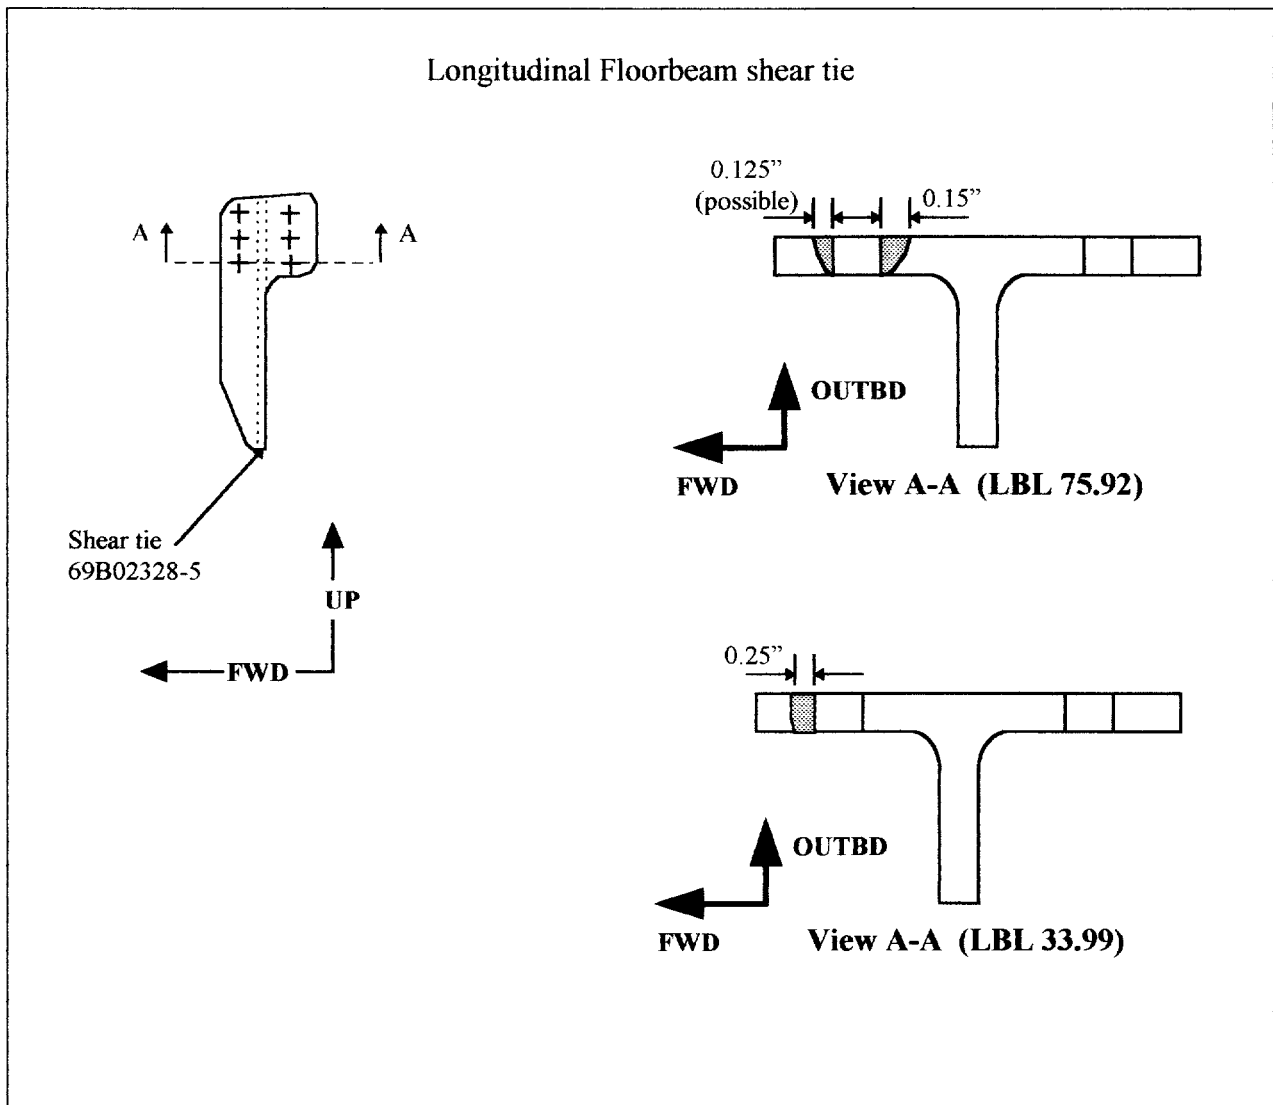
C.3 Longitudinal Floorbeam at Front Spar - existing fatigue cracking

The component is a secondary attachment for floor structure and does not contribute to carrying primary airframe loads.

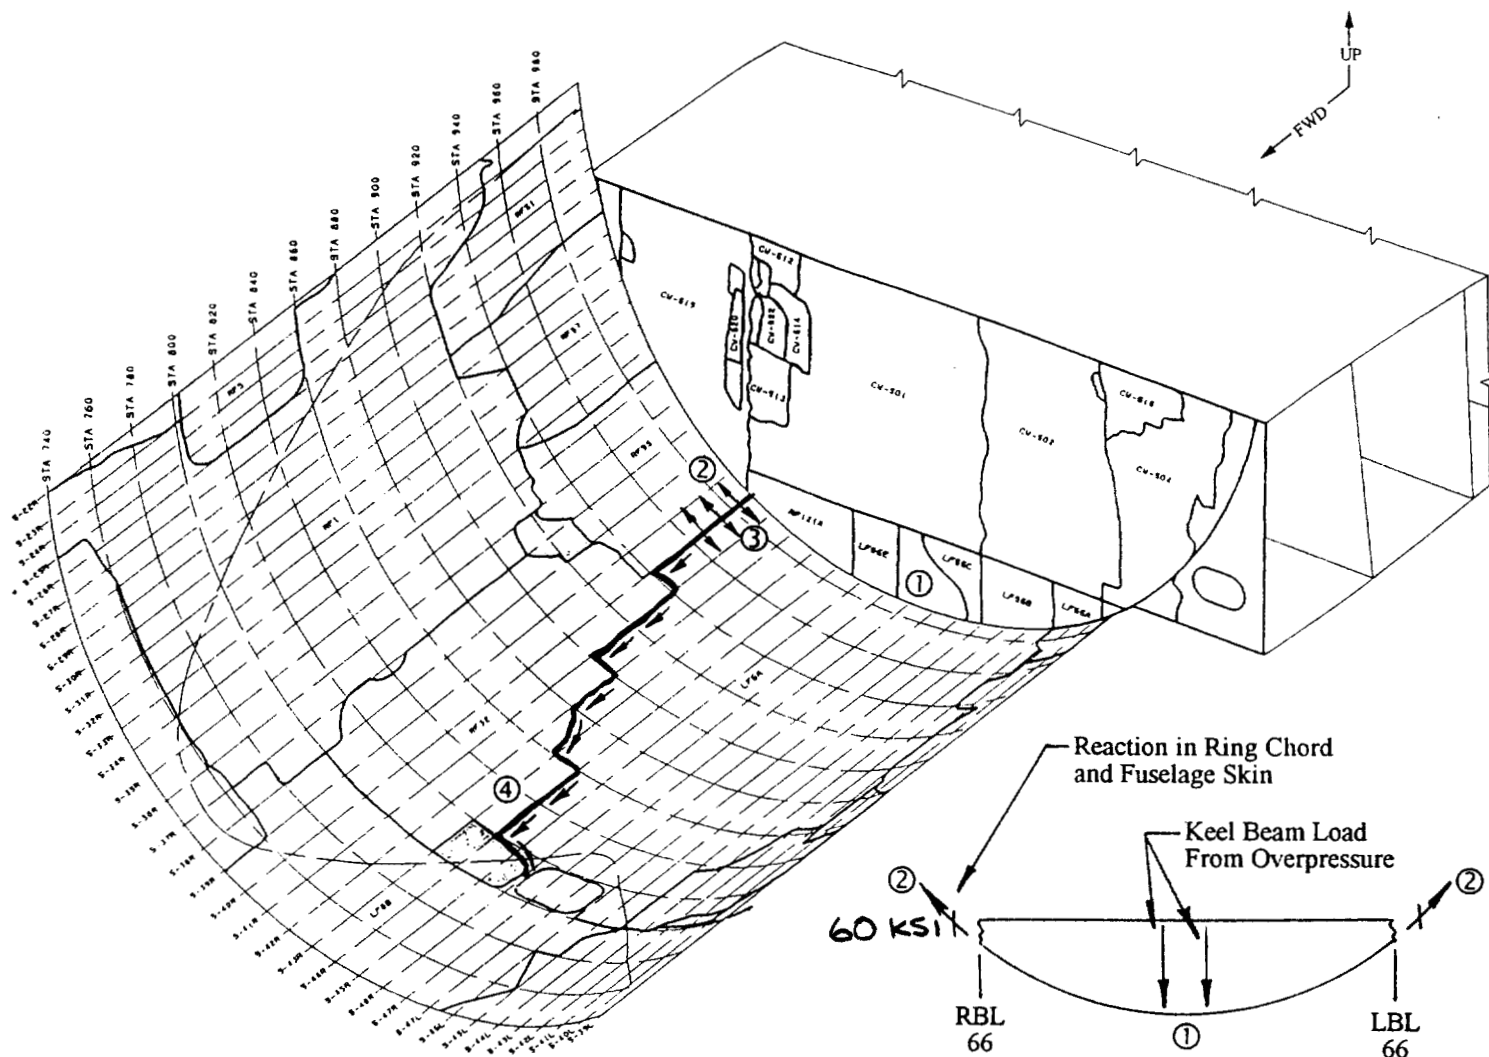
FIGURE E-1

- ① Keel Beam overpressure related loading still present in lower pressure bulkhead (RELATED TO ASSUMED 25 PSI)
- ② Load reaction is concentrated in ring chord and adjacent fuselage skin at RBL 66 and LBL 66 where web has failed
- ③ Ring chord and adjacent fuselage fail in net tension at RBL 66 (S-40R) 60 KSI PREDICTED 55 KSI ALLOWABLE
- ④ Fuselage crack propagates forward to access door opening at STA 810
