APPENDIX A

CENTER WING TANK - GENERAL CONFIGURATION

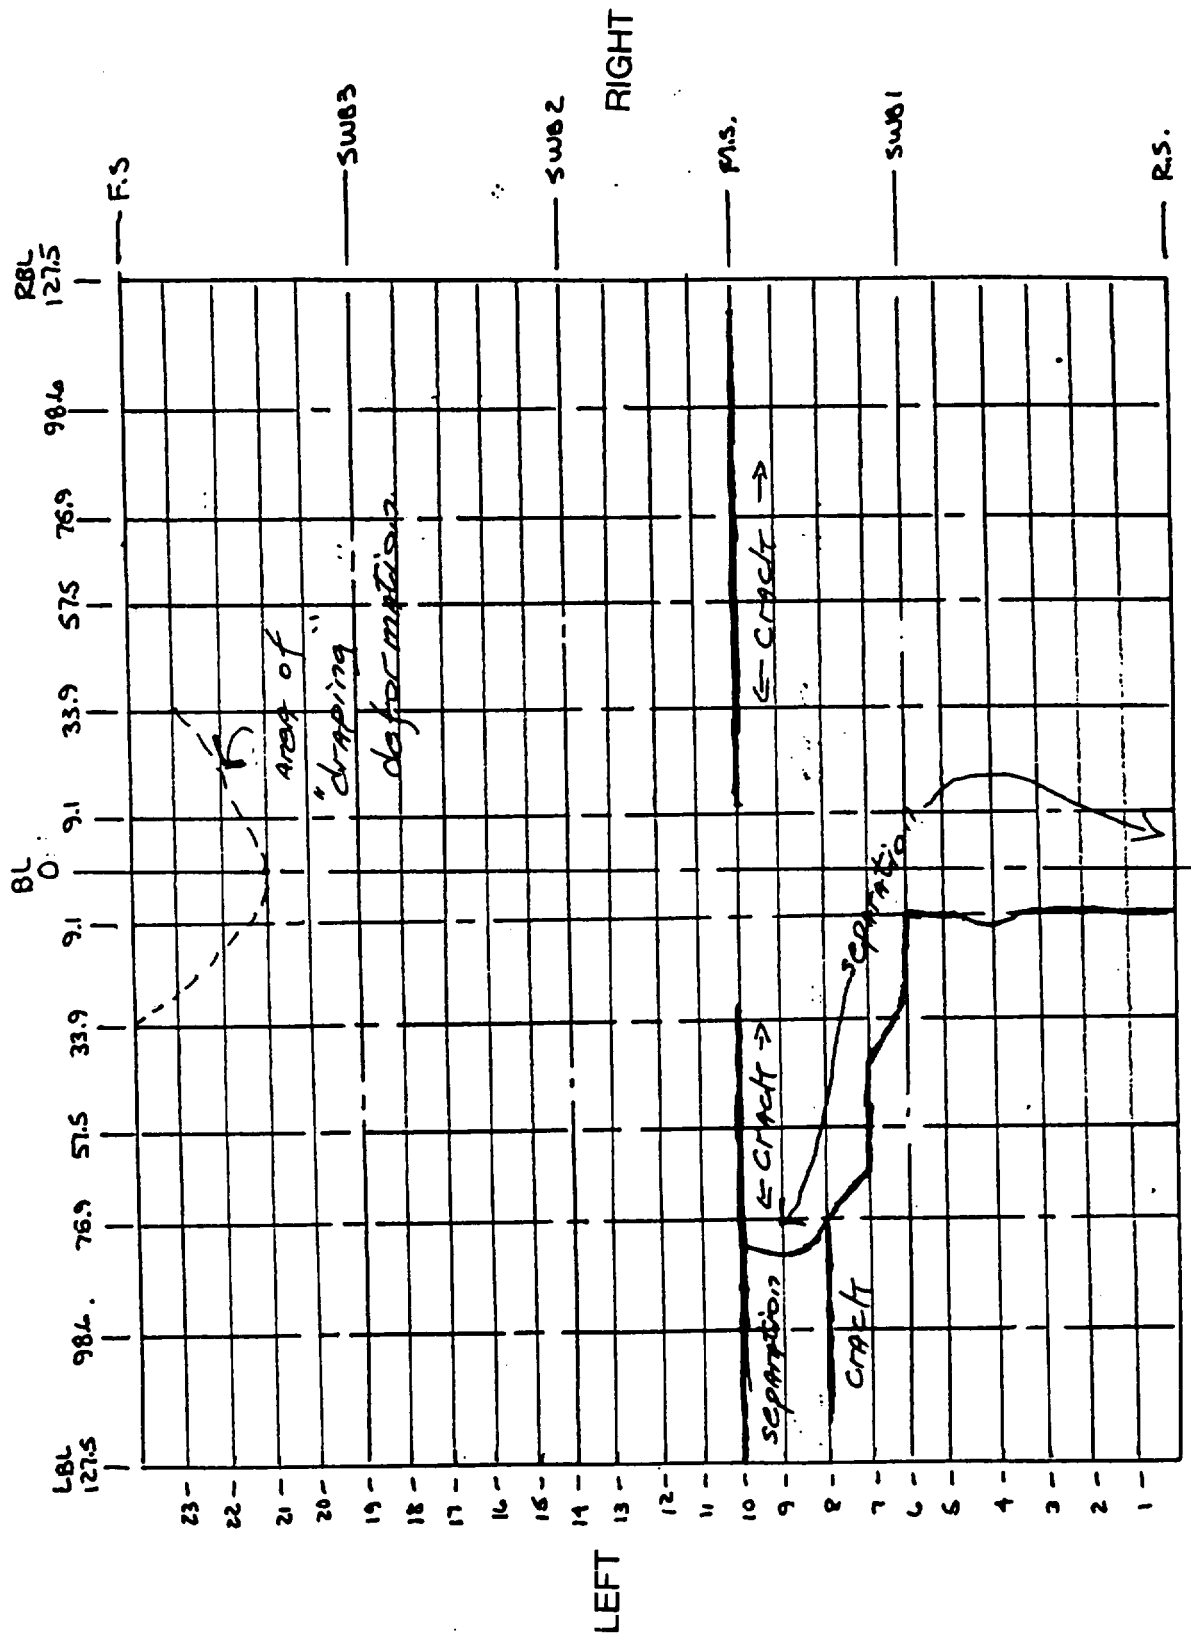
LOWER PANEL

TOP ATTACH POINT END OF WEB CRACK

TOP MOVED 0/B 3 INCHES

WEB MOVED 3 INCHES

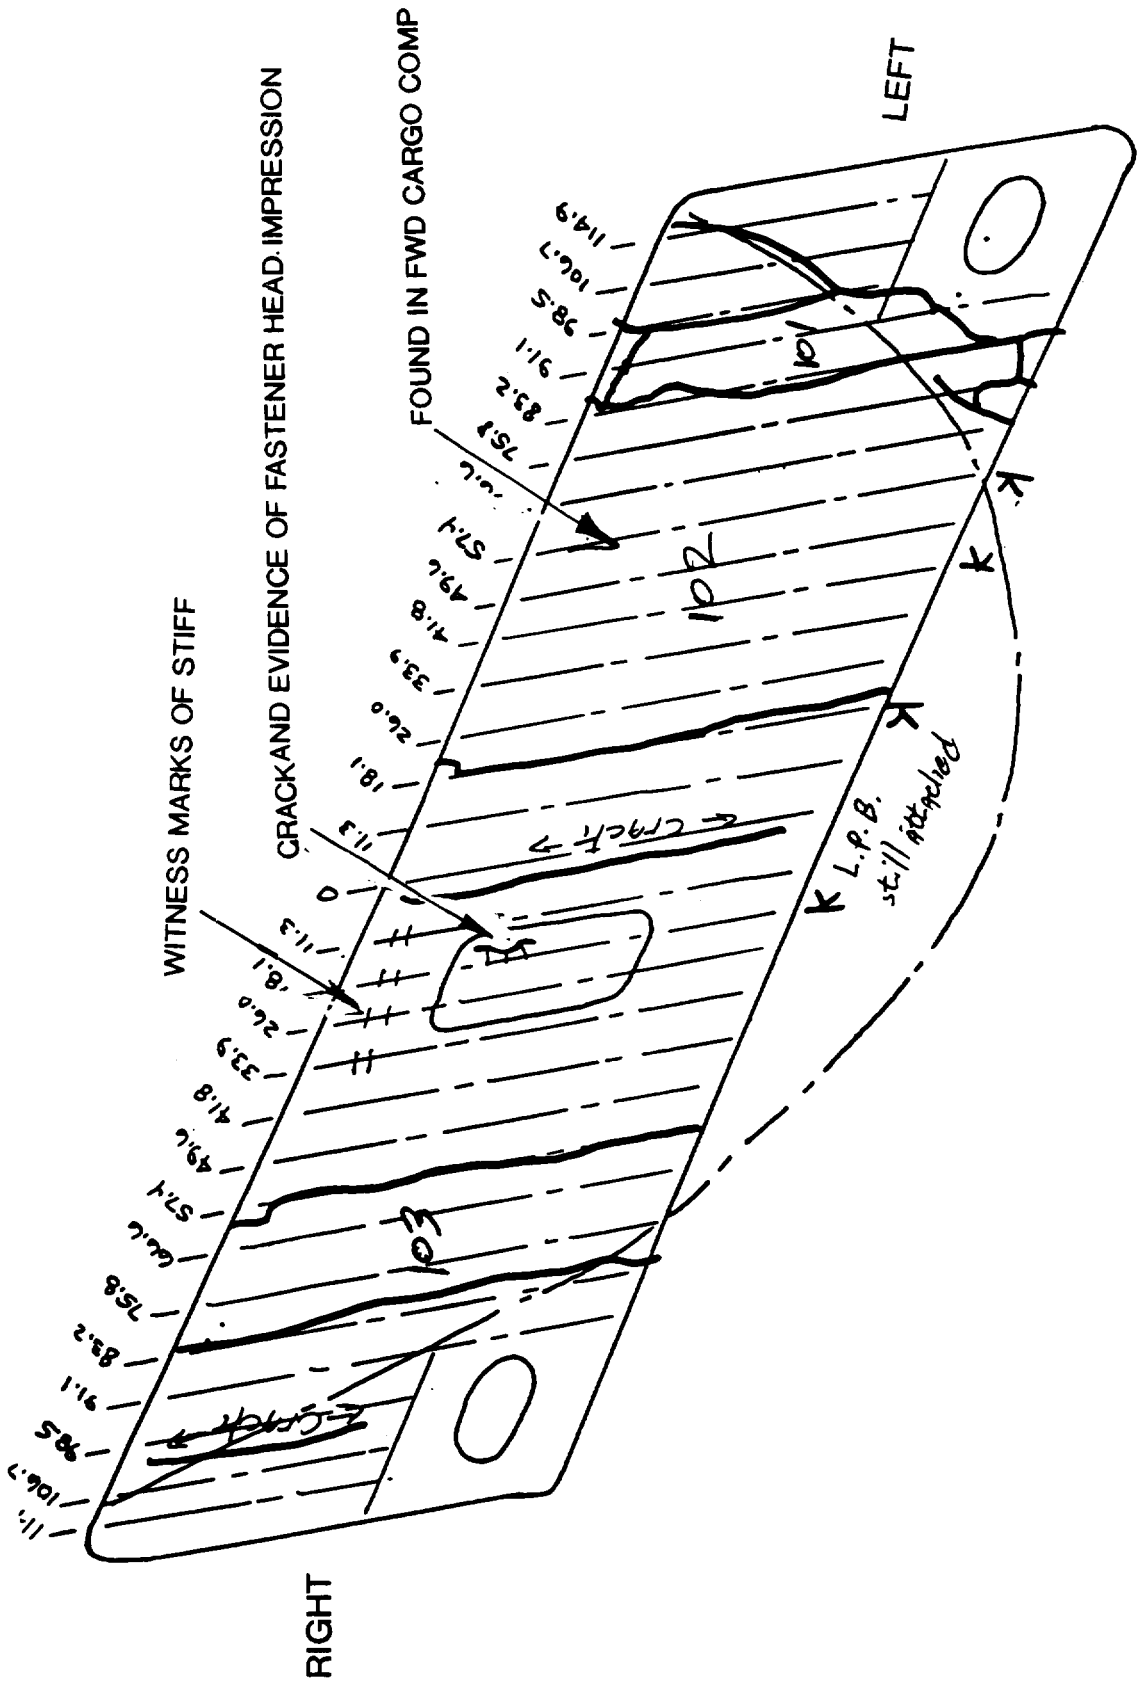
FRONT SPAR

CHORD FAILED

WEB FAILED

FAILURE ZONE

WEB FAILED + UPPER CHORD

MULTIPLE CRACKS IN WEB

CRACK IN CHORD

24" x 20" FAILURE

20" FAILURE

FAILURES
