SERVICE No. 1123B BULLETIN

Date: April 20, 2006 (M)

**SUBJECT: PA-34 SERIES AIRCRAFT NOSE GEAR
 INSPECTION AND PRODUCT IMPROVEMENTS**

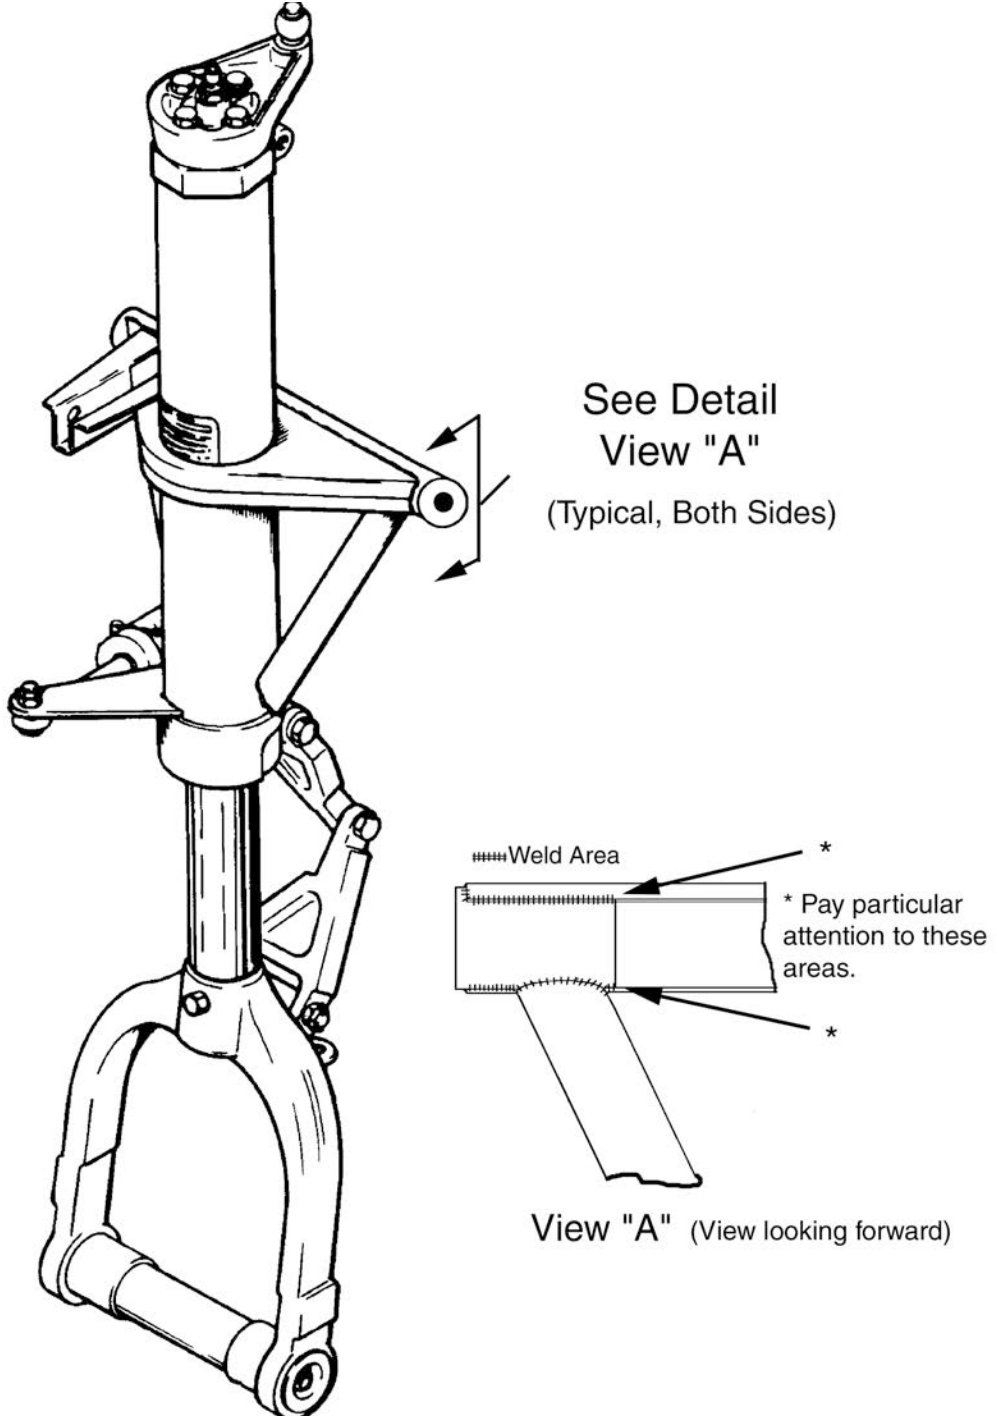
Figure 1
 Trunnion Inspection
 (See Table 1, Item 3)

3. Visually inspect (2000 hrs. initial) the nose gear trunnion (P/N 95723-00, -05, -06) for cracks in the area of attachment to the nose gear mount assembly (See Figure 1) using supplemental lighting and a 10X magnifier				0

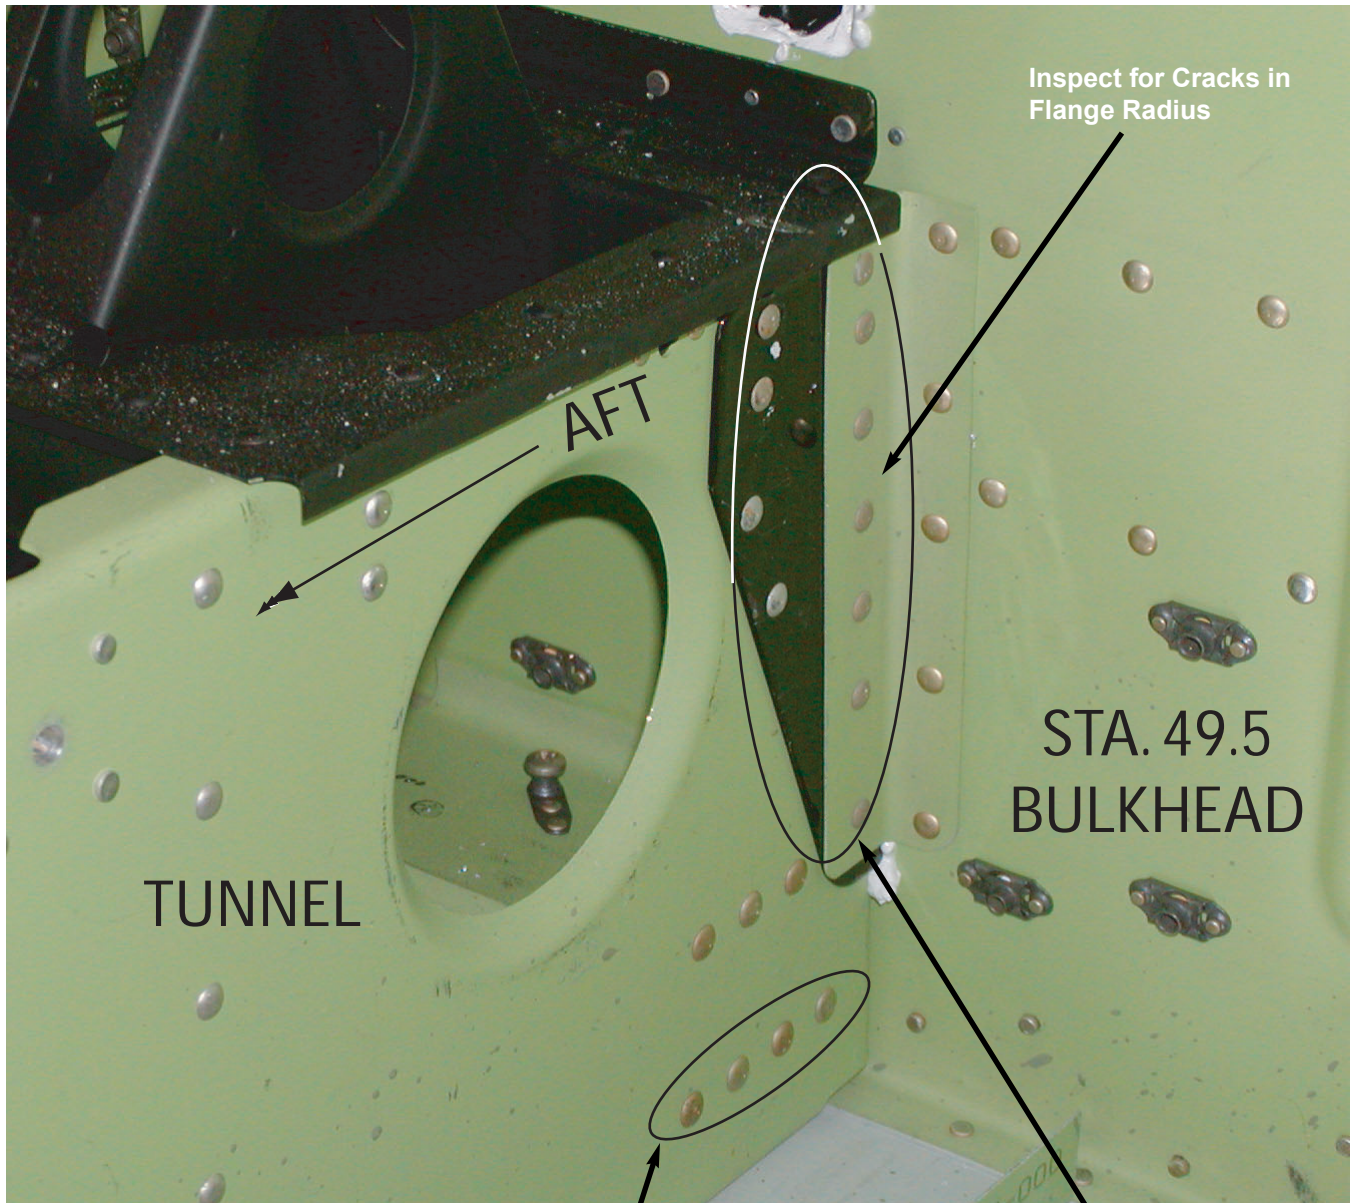
Figure 1A
Actuator Mounting Bracket Rivets

9. Inspect the actuator mounting bracket for cracks, elongation of the .250 dia. holes where the retraction link attaches, and for loose mounting rivets. (Reference Figure 1A for rivet inspection details) See paragraph 2. c. for aluminum -vs- steel mounting bracket inspections. See section 3 of this service bulletin for wear limits. See applicable S/N below. a. 34-7250001 through 34-7570050 b. 34-7570051 and Up For aircraft in category 9.a. that have had the steel mount bracket installed (95724-004 thru -007, as applicable), inspection requirements shall be per category 9.b.	0	0 0	0 0	0 0

<p>14. Inspect the Tunnel Bracket 95554-000 installation for loose attachment rivets to the tunnel and nose gear mount fitting 95555-000 and visually inspect for cracks in the bracket attachment flange adjacent to the fitting. This inspection can be accomplished through an access opening located in the bottom skin at B.L. 00.00, just aft of Sta. 49.5 bulkhead. Inspect for loose rivets by observing the area during the landing gear cycle test performed per Inspection No. 9. (Ref Figure 1A) and looking for any relative motion between riveted components.</p>		0	0	0
--	--	---	---	---

Inspect These (4 Rivets) for Attachment of Tunnel Bracket 95554-000.

Inspect These 11 Rivets

Inspect for loose mounting rivets that attach the actuator mounting bracket to tunnel aft of Sta. 49.5 bulkhead by placing aircraft on jacks, extend and retract landing gear and note any relative motion between the subject bracket and the tunnel. It will be necessary to pull carpet away from the side of tunnel to inspect noted rivets.

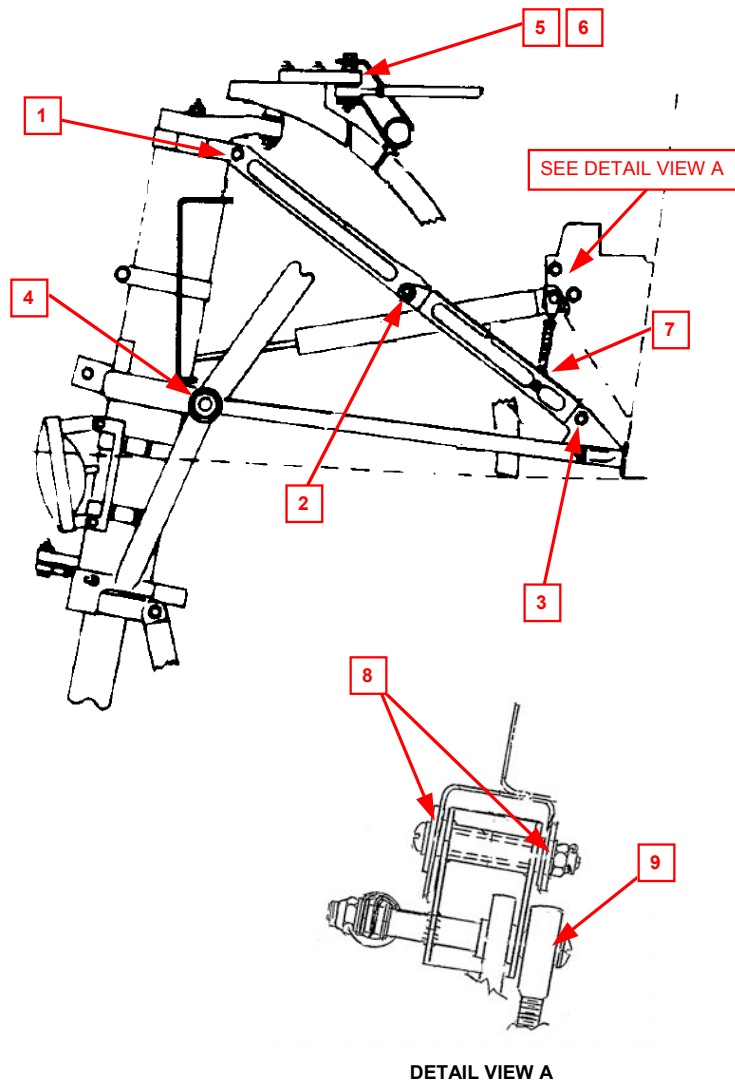
Figure 2
Service Wear Limit Locations

Table 3 is a "Wear Limits Chart" that can be used to determine the acceptable /or replacement condition for the listed parts that were inspected per Instructions Step 1. in this Service Bulletin. Visually inspect all bolts/pins for wear, damage, or corrosion. Replace as required.

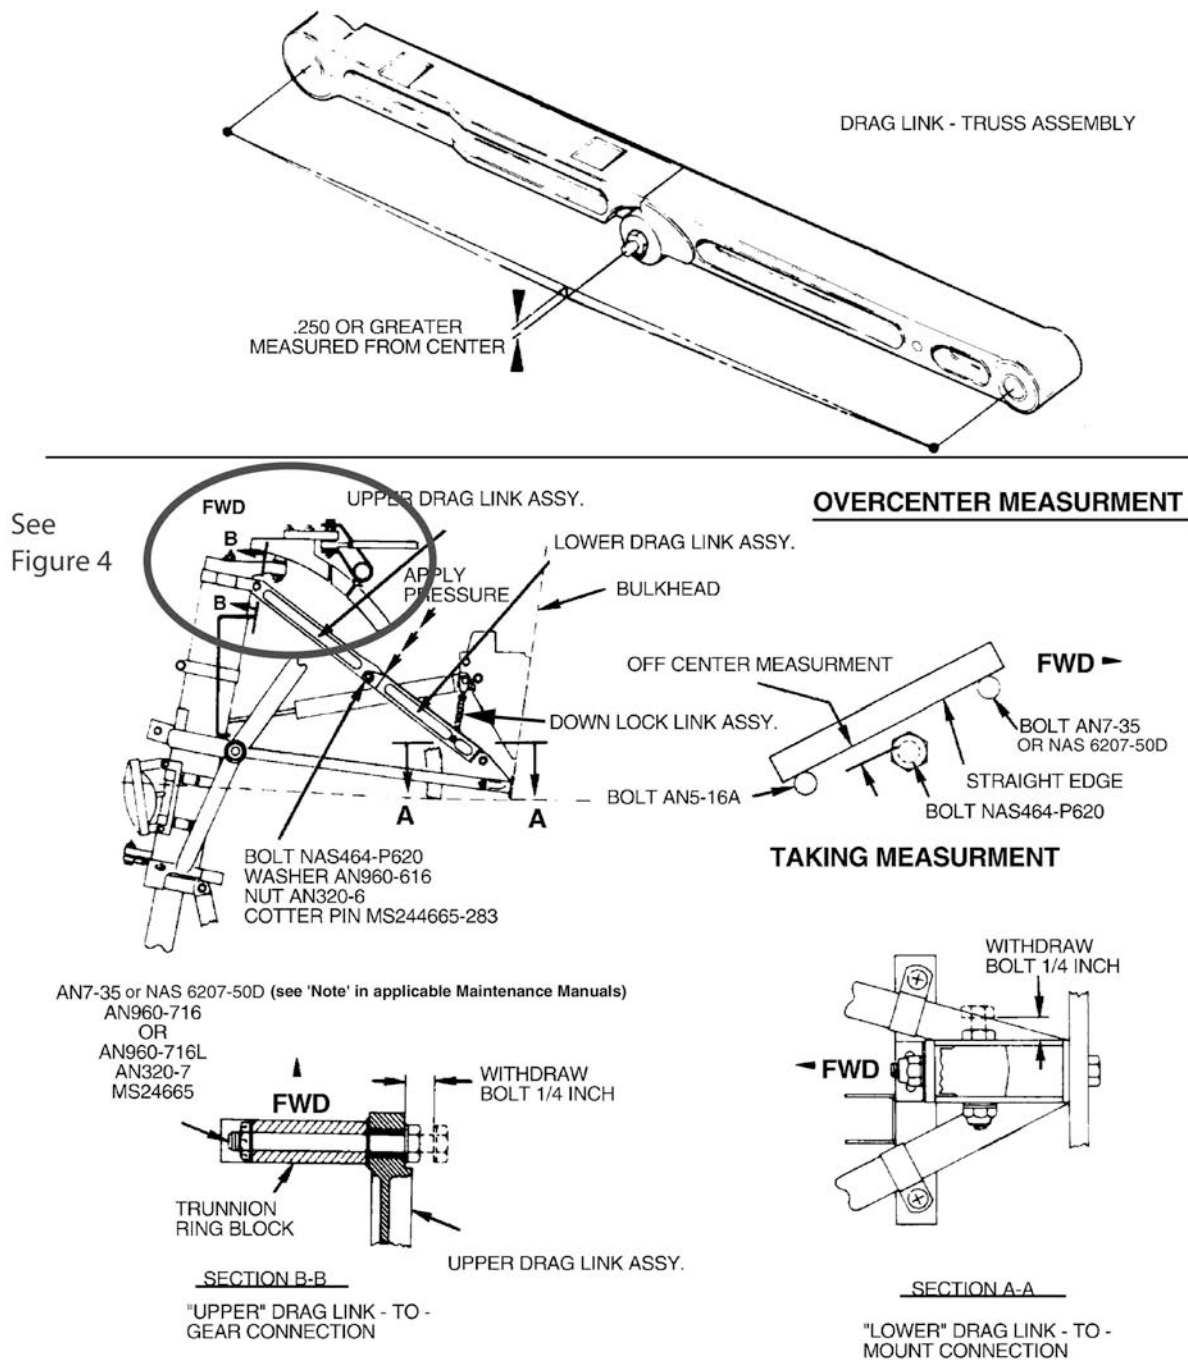
Figure 3
Drag Link Over-Center Measurement
Nose Gear Installation

- a. For Senecas serial numbers 34-7250001 through 34-7450220: Rigging of the nose gear installation (Item 13, Table 1) shall be accomplished per this Service Bulletin. The 'over center' measurement for the Seneca, as for all Senecas, shall be 0.250 or greater as measured from the center (See Figure 3). The Service Manual will be revised to delete reference to Service Bulletin 413. All required measurements are in this service bulletin and will be incorporated into the Service Manual.

- b. For Senecas II through V: Rigging of the nose gear installation (Item 13, Table 1) shall be accomplished per the appropriate Service Manual with the following exception for the Seneca II. The 'over center' measurement for the Seneca II, as for all Senecas, shall be 0.250 or greater as measured from the center (See Figure 3). The 0.250 dimension supersedes the 0.300 dimension which was incorrectly stated in the Seneca II Maintenance Manual. Refer to the Maintenance Manual for the procedure to make the over center measurement. This Service Bulletin supersedes Service Bulletin No. 413, Nose gear Drag Link Dimension Check.

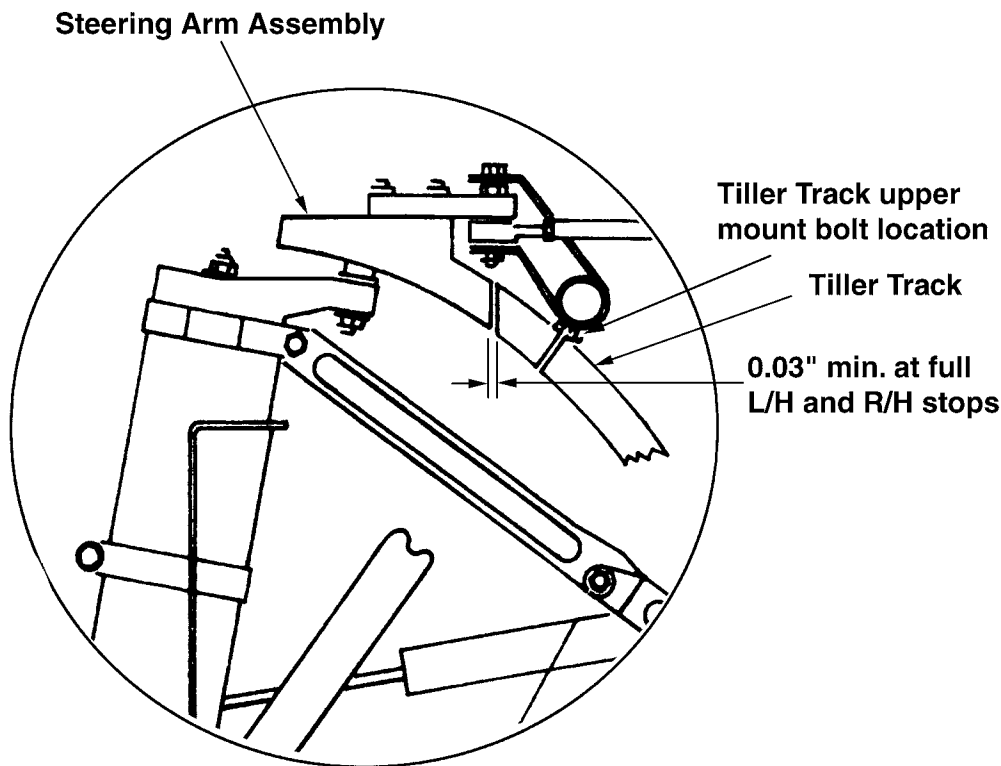
Figure 4
Steering Arm Channel Clearance

- a. Turn the nose gear full travel and make sure the clearance between the steering arm assembly and the tiller track is a minimum 0.03 of an inch at both the left and right stops. (see Figure 4). If insufficient clearance is obtained, loosen the upper mounting bolts for the tiller track and move the track upwards in the slotted holes where the track is attached to the gear mount assembly. Adjust to obtain a minimum clearance of 0.03 of an inch. Tighten the upper mounting bolts.
