"PZL - MIELEC"

MANDATORY SERVICE MANUAL

No. E/02.142/91

Subject: Extension of aircraft service life
up to 6000 flying hours.

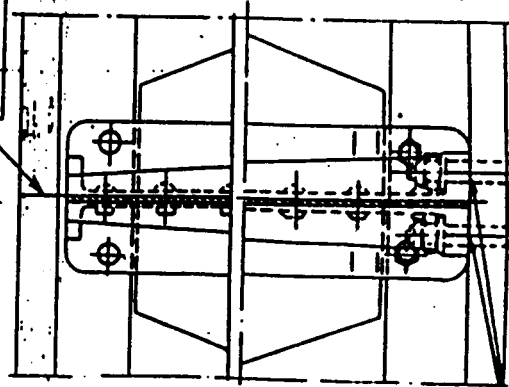
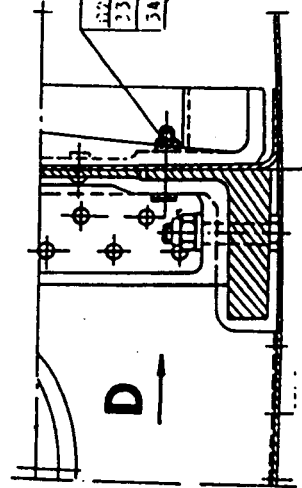
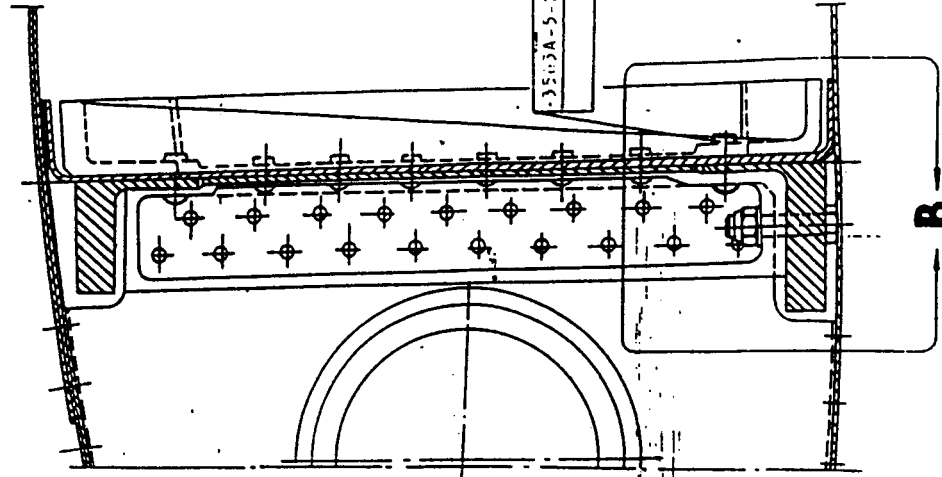
SKETCH No. 3

The bracket mount should rest against
spar flange

3.2.3. Remove 2 rivets (3503A-5-26) located symmetrically on either side of Rib 5A, view "D", both at the LM and RH aircraft side, in the area shown in Sketch No.3.

3.2.7. Connect the spar flange to the wall with D21.200.01.0R repair bolts as shown in Detail 8, Sketch No.3.
