MANDATORY SERVICE BULLETIN No. E/02.152/94

For airplanes: PZL M18, M18A, M18AS DROMADER

Subject: Supplement to Bulletin No. E/02.142/91
extending the airplane service life
up to 6000 fl.hrs.

Subject: Extension of aircraft service life
up to 6000 flying hours.

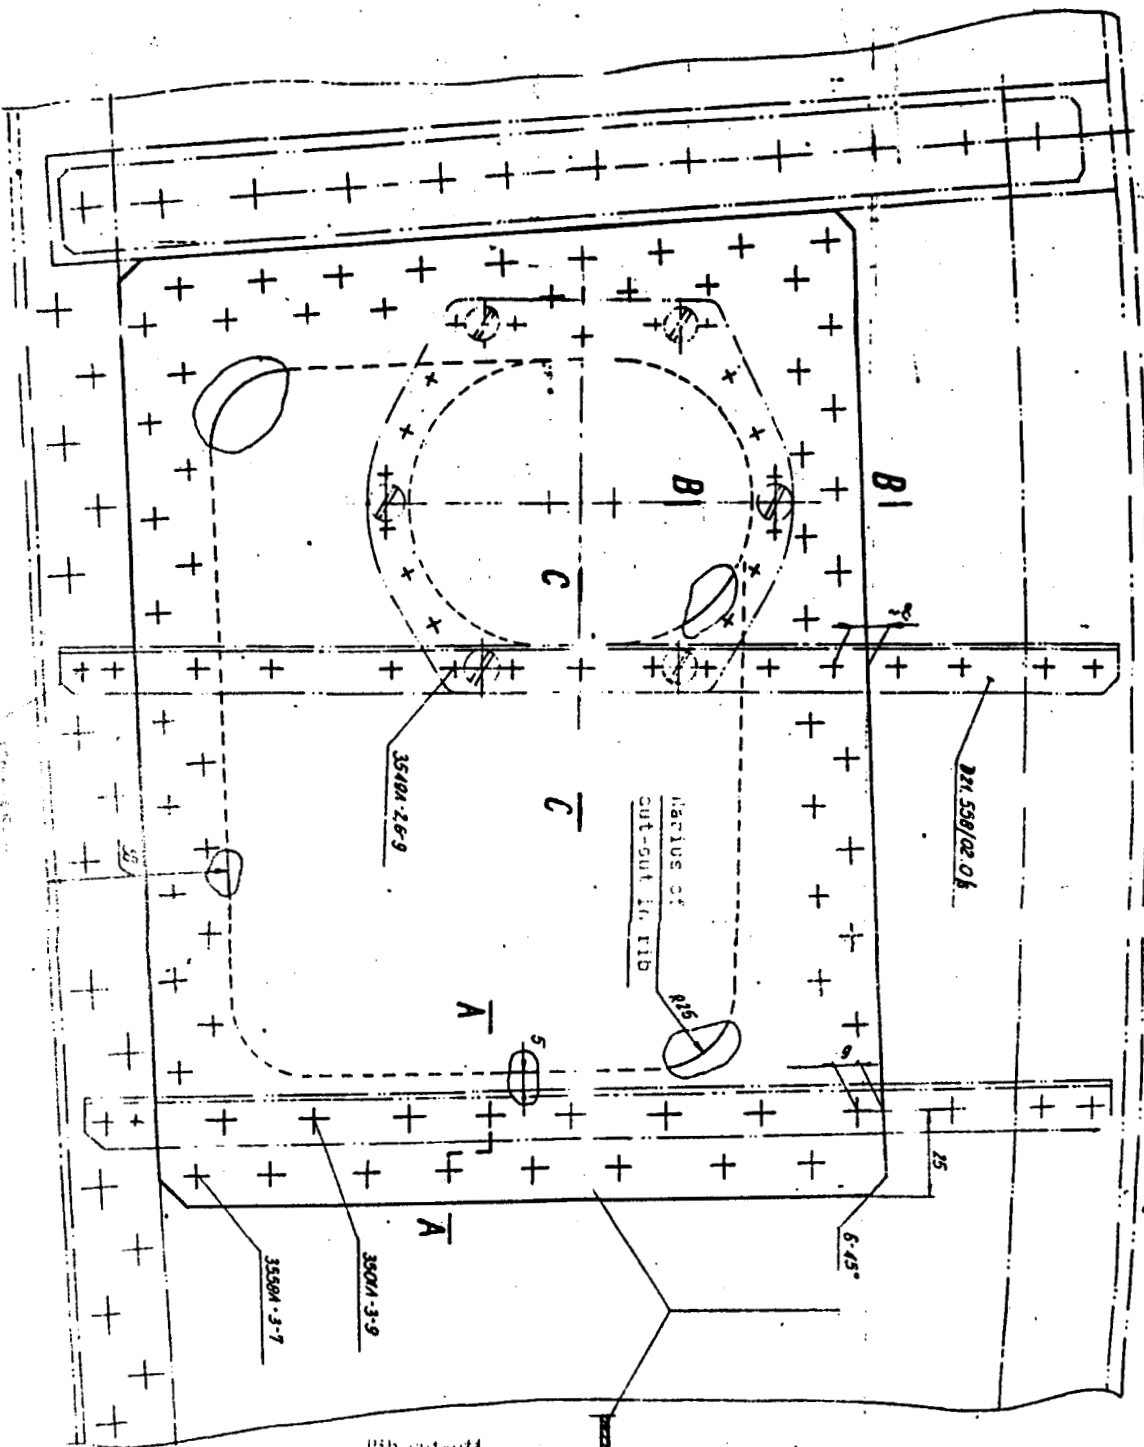
SECTION NO. 2

F.W.D. VIEW OF RIB AT THE SIDE OF CAVITY FOR HOPPER

- 3.2.1. To facilitate work at drilling out rivets and boring holes up to dia. 7H8, repair peepholes shall be made in D21.550.00.0 L/P ribs per Sketch No.2. To this end, proceed as follows:
 - dismantle covers of the existing peep-holes
 - drill out rivets attaching D21.558/02.L/P angle bars and remove them
 - cut out the holes of radius R=25 mm in the ribs.

3.2.9. Rivet the repair cover plate, D21.558/02.0 L/P angle bar and make a peep-hole in the cover plate as shown in Sketch No.2.

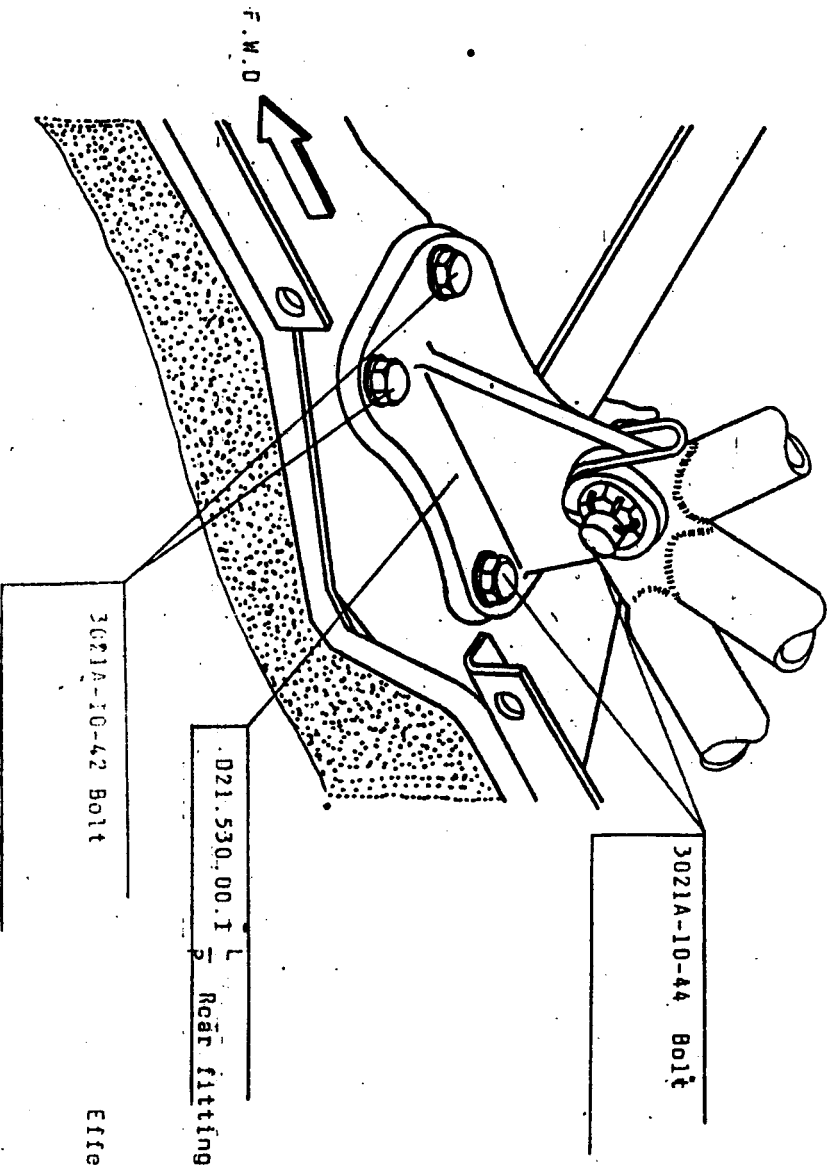
SKETCH NO 1

VIEW OF REAR CENTERING ATTACHMENT FITTING

3.1. Replacement of D21.530.00.0 fittings for the D21.530.00.1 L/P on the aircraft S/N 12019-30 and down.

- 3.1.4. Put the removed fittings into the D21.573.016988 fixture and basing on them set the fixture adjusters so as to trace the holes for the bolts attaching the fitting to the centerwing. After setting the fixture adjusters remove the old (reference) fitting and instead of it affix a new one for drilling out. Safeguard the new fitting against displacement using chucks.
- 3.1.5. Drill four holes of dia. 6 mm. bore then from dia. 6 to dia. 6.7 and then up to dia. 6.986 / $\frac{0.010}{0}$ and 10H8 / $\frac{0.010}{0}$ / using a reamer and finally make chamfers of 0.5/45° on either side.

- 3.1.6. Set shim washers and the bored fitting on the centerwing, securing it in place with two bolts inserted into the holes spaced diagonally, whereas the remaining two holes are to be drilled-out again with a reamer of ϕ 10H8. Insert 2 bolts into the enlarged holes, placing 3405A-0,5-10-18 washers under bolt heads. Next, put 3402A-1,5-10-18 washers over bolts and screw on nuts. Tighten bolts alternately so that uniform screwing can be obtained. Remove two bolts that held the fittings for boring two holes and drill out the remaining two holes with a reamer up to dia. 10H8. Place bolts, washers and nuts. Tighten nuts, screwing the bolts spaced diagonally.

NOTE: 1. Re-boring of holes in fittings and centerwing is aimed at eliminating a slight misalignment of 4 holes of dia. 10H8 for bolts 3021A-10-42 /-44/.

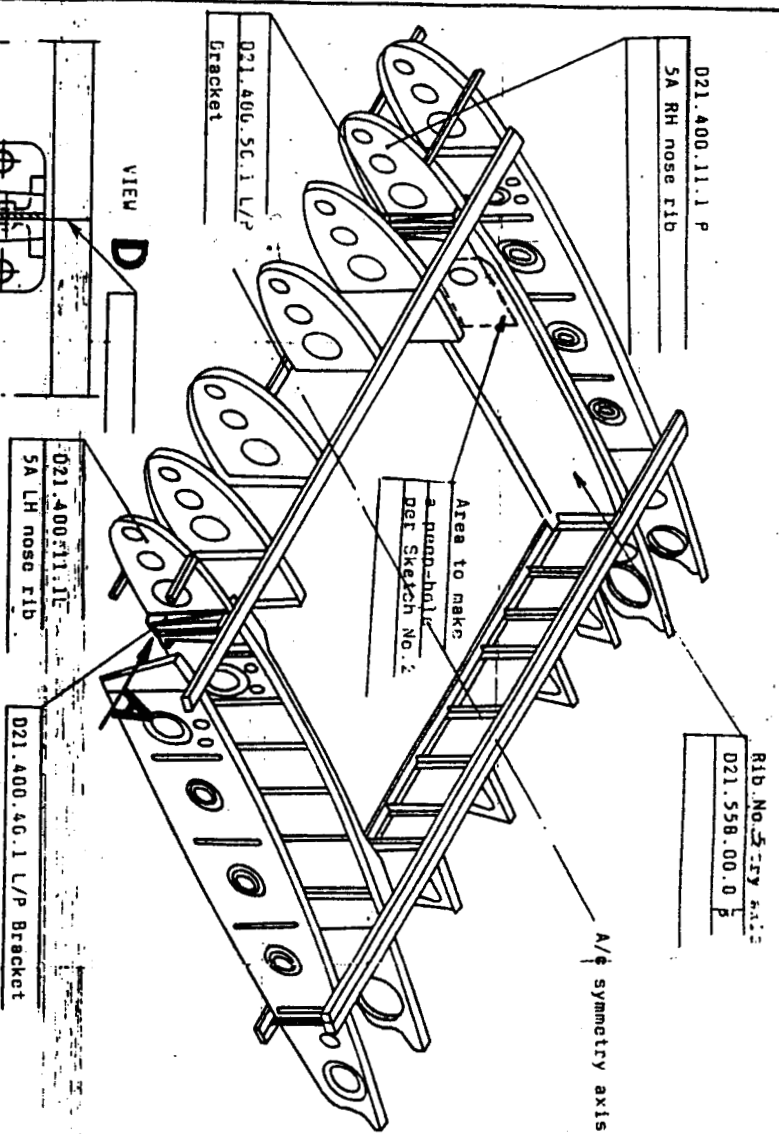
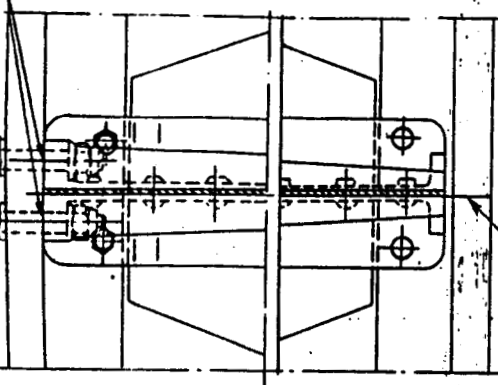
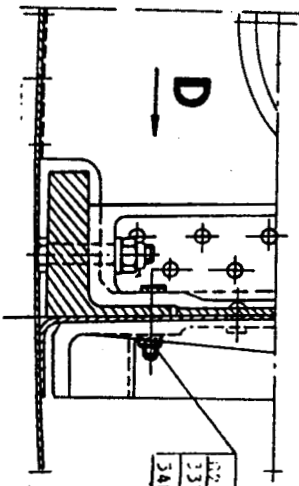
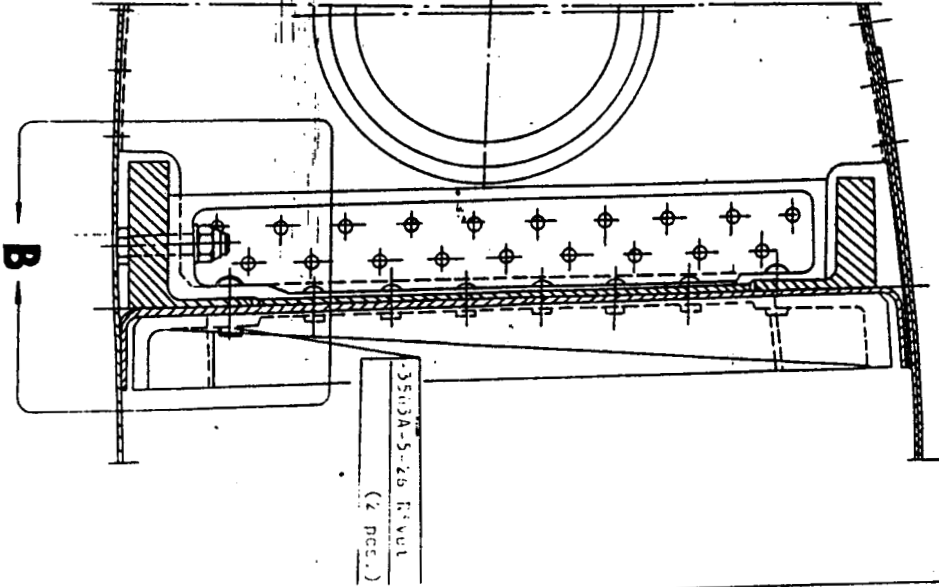
SKETCH NO. 3

The bracket mount should rest against spar flange

3.2.3. Remove 2 rivets (3503A-5-26) located symmetrically on either side of Rib 5A, view "D", both at the LM and RH aircraft side, in the area shown in Sketch No.3.

3.2.7. Connect the spar flange to the wall with D21.200.01.0R repair bolts as shown in Detail 8, Sketch No.3.
