PIAGGIO AERO INDUSTRIES S.p.A.

SERVICE BULLETIN (MANDATORY) N.: SB-80-0262 REV.3 ATA CHAPTER: 55-20

TITLE: P180 - HORIZONTAL STABILIZER TO ELEVATOR HINGE FITTING - INSPECTION AND MODIFICATION

Rev. N. **3** Date: **November 14, 2011**

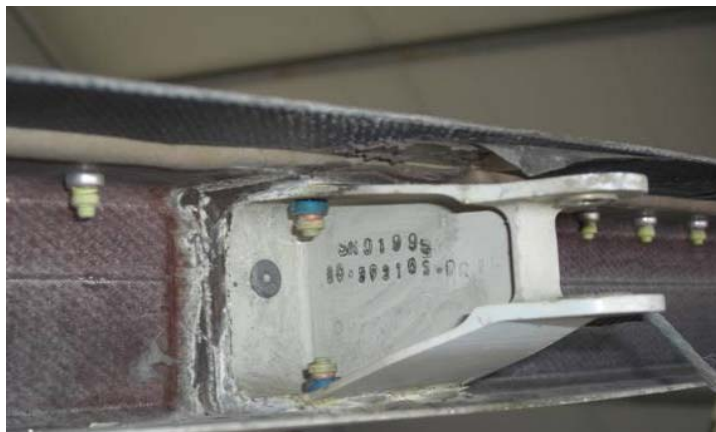
Presence of corrosion was detected on in service P180 aircraft, on the horizontal stabilizer to elevator hinges fittings. Investigation identified the root cause in galvanic corrosion between dissimilar materials (carbon fiber and metallic). A modification was developed to solve this issue on new aircraft, that can be installed also on in service aircraft. It is therefore required to perform a visual inspection and, if necessary, the replacement of the corroded hinges.

Fig.1 – Corroded center fitting without aluminum bonding strips

2. Inspect for presence of corrosion on LH hinge fittings
3. If traces of corrosion are detected (see fig.1) embody part C of this Service Bulletin, otherwise proceed with step 4.
4. AIRCRAFT MSN 1002; 1034-1191: if the aluminum bonding strips are not installed (see fig. 2), embody part C of this Service Bulletin, otherwise go to part D.
AIRCRAFT MSN 1004-1033: embody part C of this Service Bulletin

- 24 Inspect for presence of corrosion on RH hinge fittings
- 25 If traces of corrosion are detected (see fig.1) embody part E of this Service Bulletin, otherwise proceed with step 26.
- 26 AIRCRAFT MSN 1002; 1034-1191: if the aluminum bonding strips are not installed (see fig. 2), embody part E of this Service Bulletin, otherwise go to part F.
AIRCRAFT MSN 1004-1033: embody parts E of this Service Bulletin

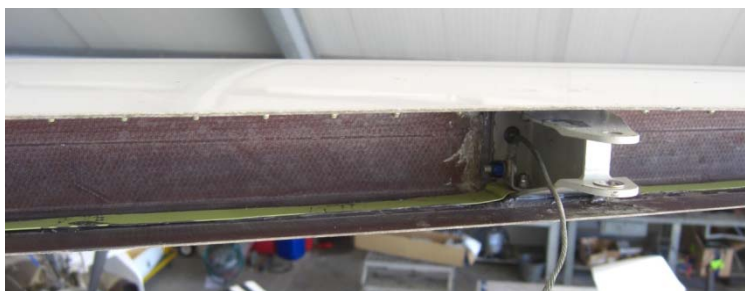
Fig.2 – Center Fitting with aluminum bonding strips installed

Moreover, the improvement of the electrical bonding by adding aluminum strips is required, also if corrosion is not detected.

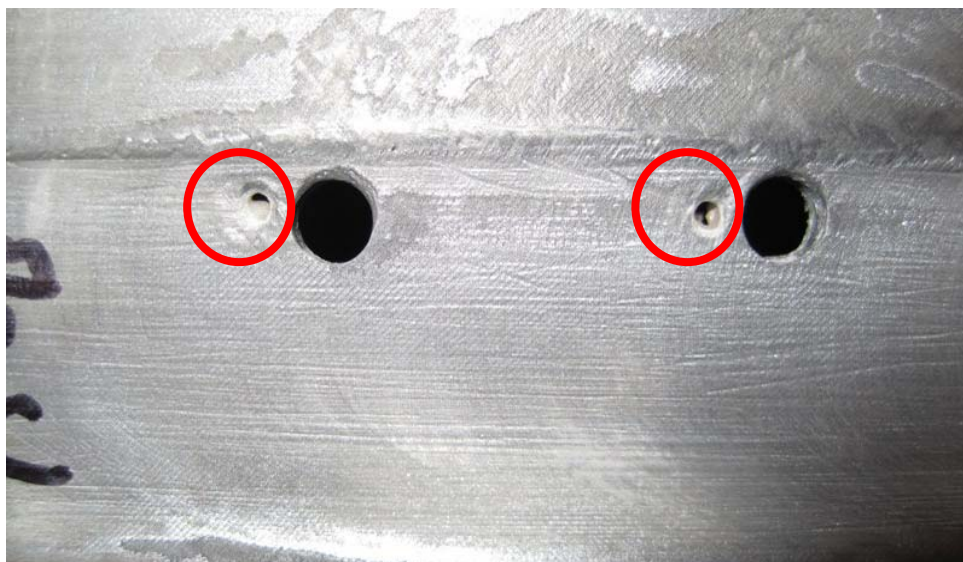
Figure. 3 – Example of wrong holes on Horizontal Stabilizer rear spar

TYPE I: full size holes drilled adjacent to the correct ones, that form an 8-shape

TYPE II: 2.5 mm pilot holes that are drilled in the wrong position (see also figure 3)

NOTE: The pilot holes may be found open or covered with conductive sealant

- 8b If defect (TYPE I or TYPE II) is covered clean it from any residual of sealant and other debris
- 8c Verify there are no other defects around holes in the rear spar flanges (upper and lower flange)

- 8d Only for defect TYPE II, verify that the position of the defects is within 3D from the main holes (D is the diameter of the main holes) . Nominal value of D=.199 - .202 in.

- 8e If the defect is as TYPE I or TYPE II and (for TYPE II only) complies with the previous step 8d, no repair is needed except the cleaning of the defects.

- 8f Take a picture of the holes, measure their dimension (diameter) and position. Fill in the Failure report form as per latest issue of Service Letter 80-0097 latest revision.

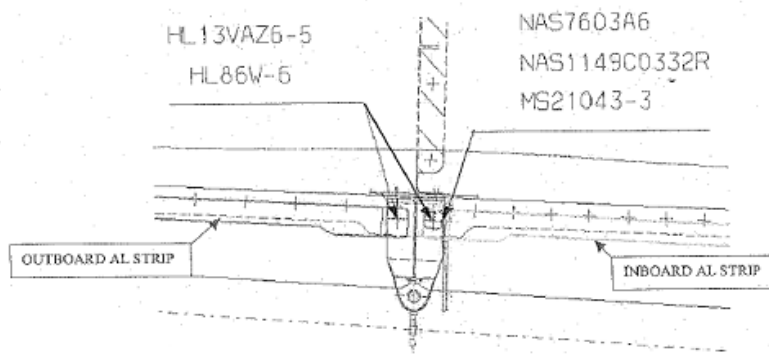
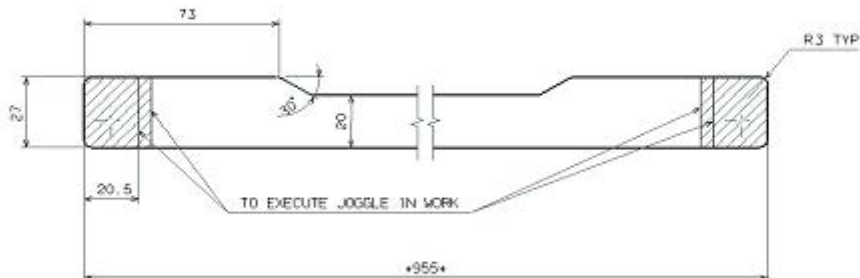
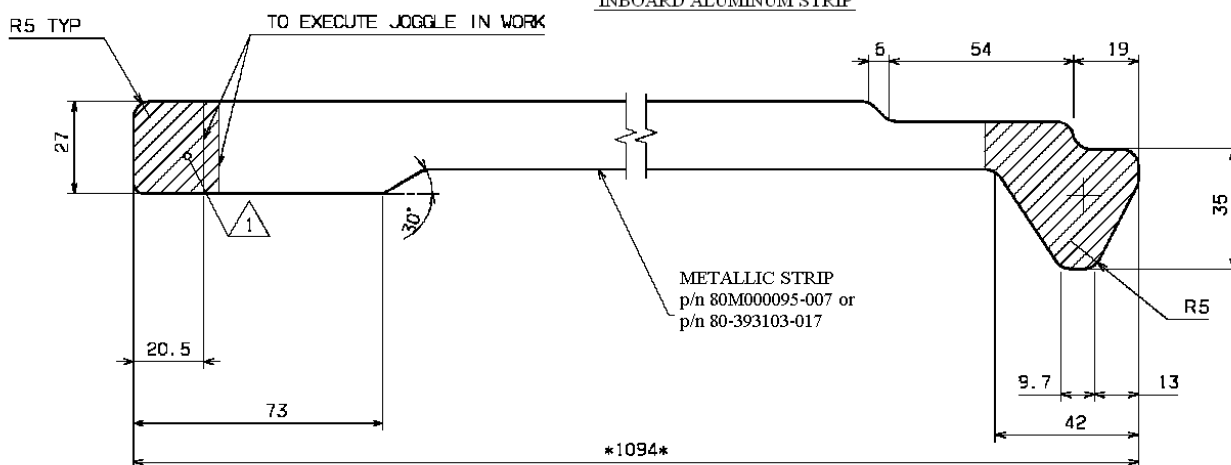
Fig.11 – Electrical Bonding strip upper view (common for LH and RH).

WITH REFERENCE TO FIG.11, REMOVE ANY GREASE, OIL AND PAINT FROM THE DASHED AREA OF THE ALUMINUM STRIP LOWER SURFACE, TO ASSURE PROPER BONDING

- 19 Recover the electrical bonding by applying the aluminum strips. Refer to fig. 11 and to SRM, ATA 51-70-80, Chapter 6 (*Repair Procedure for the Horizontal Stabilizer Hinge Corrosion*), Section B (*Repair*), paragraph 4 (*Aluminum Strip Installation*).

- 22 With reference to fig. 11, apply an ALODINE 1200 protection coat on the dashed area of the aluminum strip - upper surface (Ref. AMM 51-23-00).
- 23 Verify the electrical conductivity by connecting a standard milliohmeter probe at the central end external hinge fitting and at a convenient ground point of the battery. If the resistance value is 20 milliohms or less, the electrical bond is acceptable otherwise inspect the aluminum strips installation. Contact Piaggio Aero Technical Support if additional support is required.

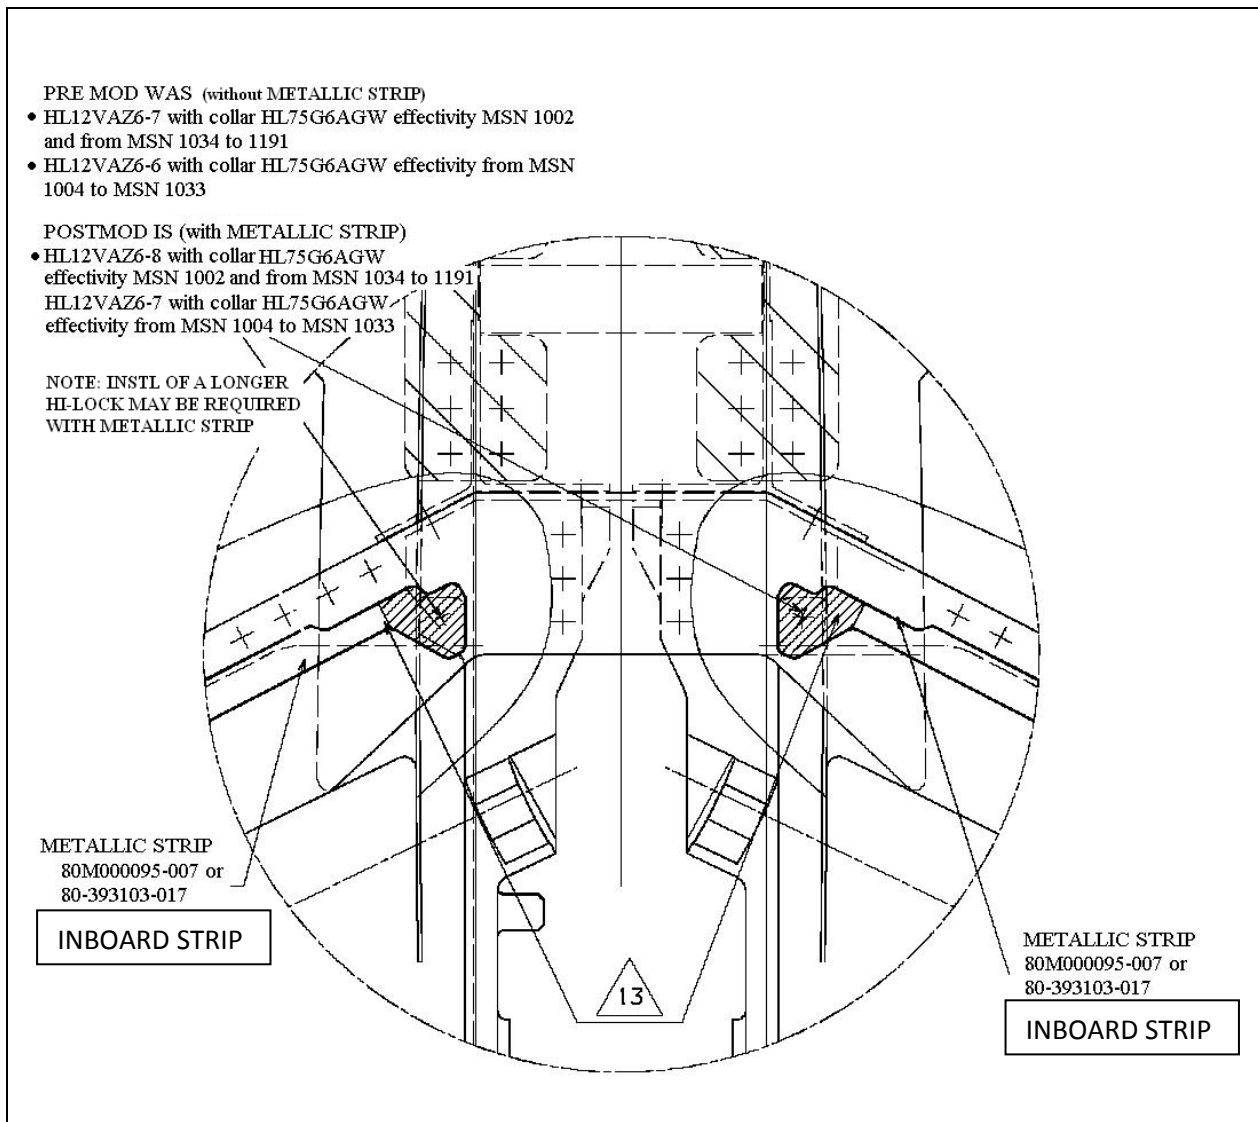
Fig. 12– Detail of inboard strip installation

- 20 With reference to fig. 12:
- a. (effectivity MSN 1002 and from MSN 1034 to MSN 1191) remove the Hi-Lock p/n HL12VAZ-6-7 with relevant collar
 - b. (effectivity from MSN 1004 to MSN 1033 - horizontal stabilizer manufactured by Sikorsky) remove the Hi-Lock p/n HL12VAZ-6-6 with relevant collar

- 21 With reference to fig. 12:
- a. (effectivity MSN 1002 and from MSN 1034 to MSN 1191) install a new Hi-Lock p/n HL12VAZ-6-8, plus collar p/n HL75G6AGW on the aluminum strip in lieu of the Hi-Lock previously removed

- b. (effectivity from MSN 1004 to MSN 1033 - horizontal stabilizer manufactured by Sikorsky) install a new Hi-Lock p/n HL12VAZ-6-7, plus collar p/n HL75G6AGW on the aluminum strip in lieu of the Hi-Lock previously removed

- c. (effectivity: all) reinstall on the aluminum strip the Self-Locking Nut previously removed, using no. 2 rivets p/n NASM20605R3W8 (Ref. AMM, ATA 51-41-00).
