Czech Sport Aircraft a.s.	SERVICE BULLETIN	Czech Sport Aircraft a.s. Na Záhonech 1177/212, 686 04 Kunovice Czech Republic office@czechsportaircraft.com
No. SB-CR-016		Rev.: 6
Date: 2013-10-09		
Page: 1 of 4		Date: 2015-08-31

MODEL AFFECTED:	SportCruiser, PiperSport, PS-28 Cruiser with the NLG SG0270N
SUBJECT:	Inspection of the nose landing gear leg and its replacement (if required)
AIRCRAFT AFFECTED:	All SportCruiser aircraft with the NLG SG0270N installed All PiperSport aircraft with the NLG SG0270N installed All PS-28 Cruiser aircraft with the NLG SG0270N installed
COMPLIANCE:	Before next flight after issue of this bulletin.

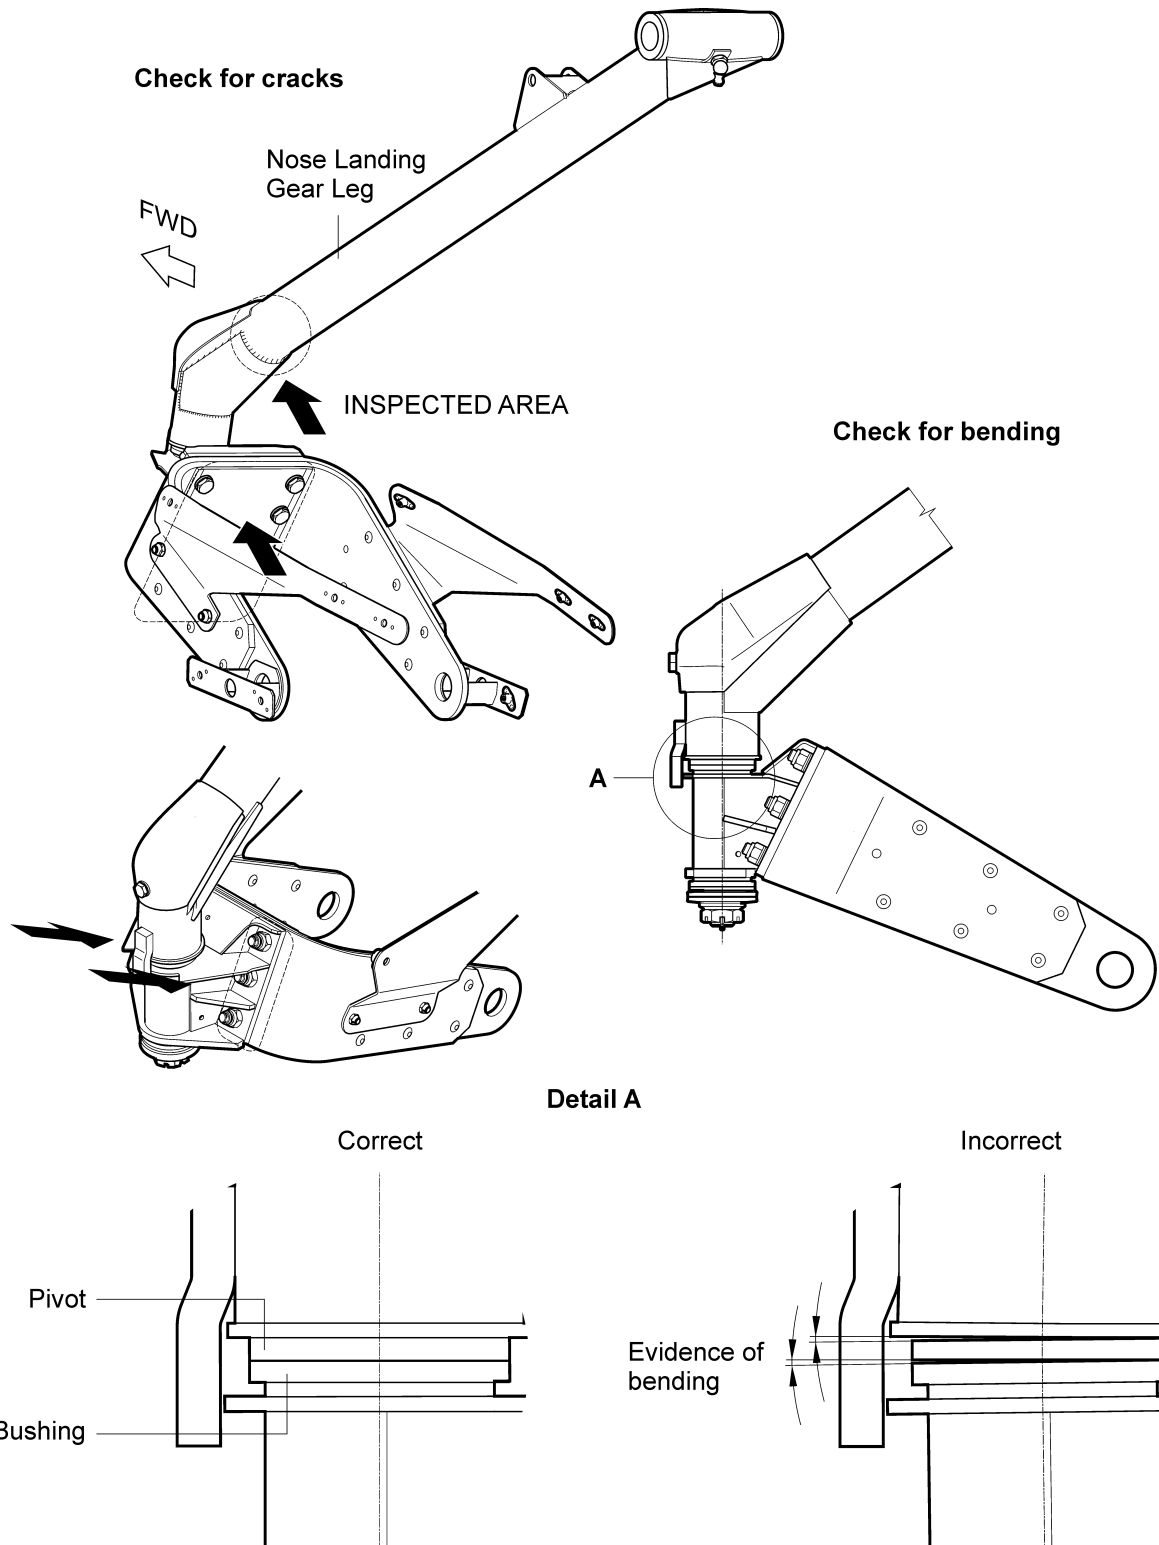
Some SportCruiser / PiperSport / PS-28 Cruiser aircraft have developed cracks in the bottom side of the lower section of the nose landing gear (NLG). The cracks develop on the NLG assembly along the weld of the tube and the bracket. Furthermore, on several aircraft bending of the pivot connecting the fork with leg was discovered and cracks from holes of bolts on the fork. To address this potentially unsafe condition, a repetitive inspection is required of the bottom side of the lower section, in the area of the weld of the tube, the bracket and the pivot and the fork in the place of the bolts mounting the fork to the landing gear.

- A. Before next flight after issue of this bulletin.
- B. Periodically at each 25 FH or 50 cycles whatever occurs first check as described in documents [1] for PS-28 Cruiser and [2] for SportCruiser (see REFERENCES).
- C. During pre-flight check (see POH , Section 4, 4.1 Pre-flight check, Inspection Check List, Point 4 - Nose gear) visually inspect pivot (see the picture on the Page 3 of 4 of this Service Bulletin) and verify that there is no evidence of cracks or bending.
