# National Transportation Safety Board

## **SIDESLIP THRUST and RUDDER STUDY**

CEN15FA034

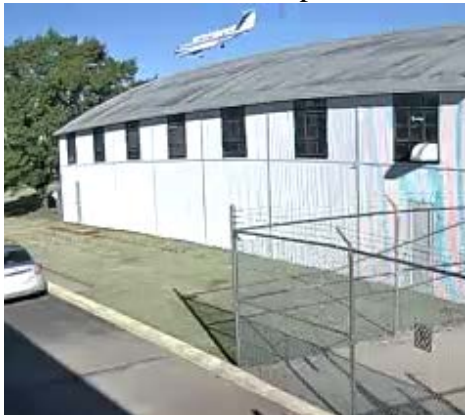
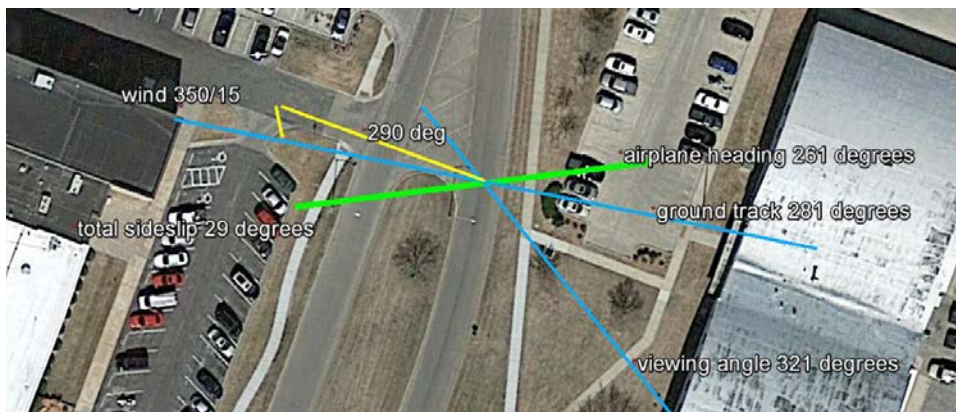
The photo below was extracted from a video camera. The airplane was about one second from impact one second before impact. Data extracted from the surveillance videos show that the ground speed ranged between 80 and 89 knots (KGS), resulting in a calibrated airspeed ranging between 85 and 94 knots (KCAS). The higher speeds were presented in the Wichita Video Study.

A 29-degree airplane nose left (ANL) sideslip was reconstructed from an image recorded moments before the airplane hit the Flight Safety building (see the Sideslip Study).

To achieve greater nose-left sideslip angles as noted in the photograph, a substantial left rudder input is necessary.
