RAILROAD SIGNAL & TRAIN CONTROL GROUP FACTUAL REPORT OF INVESTIGATION

**Head-on Collision between
Eastbound Train S-LACLPC 1-26 and
Westbound BNSF Train Q-CHISBD 6-27**

**In Panhandle, Texas on
June 28, 2016**

DCA16FR008

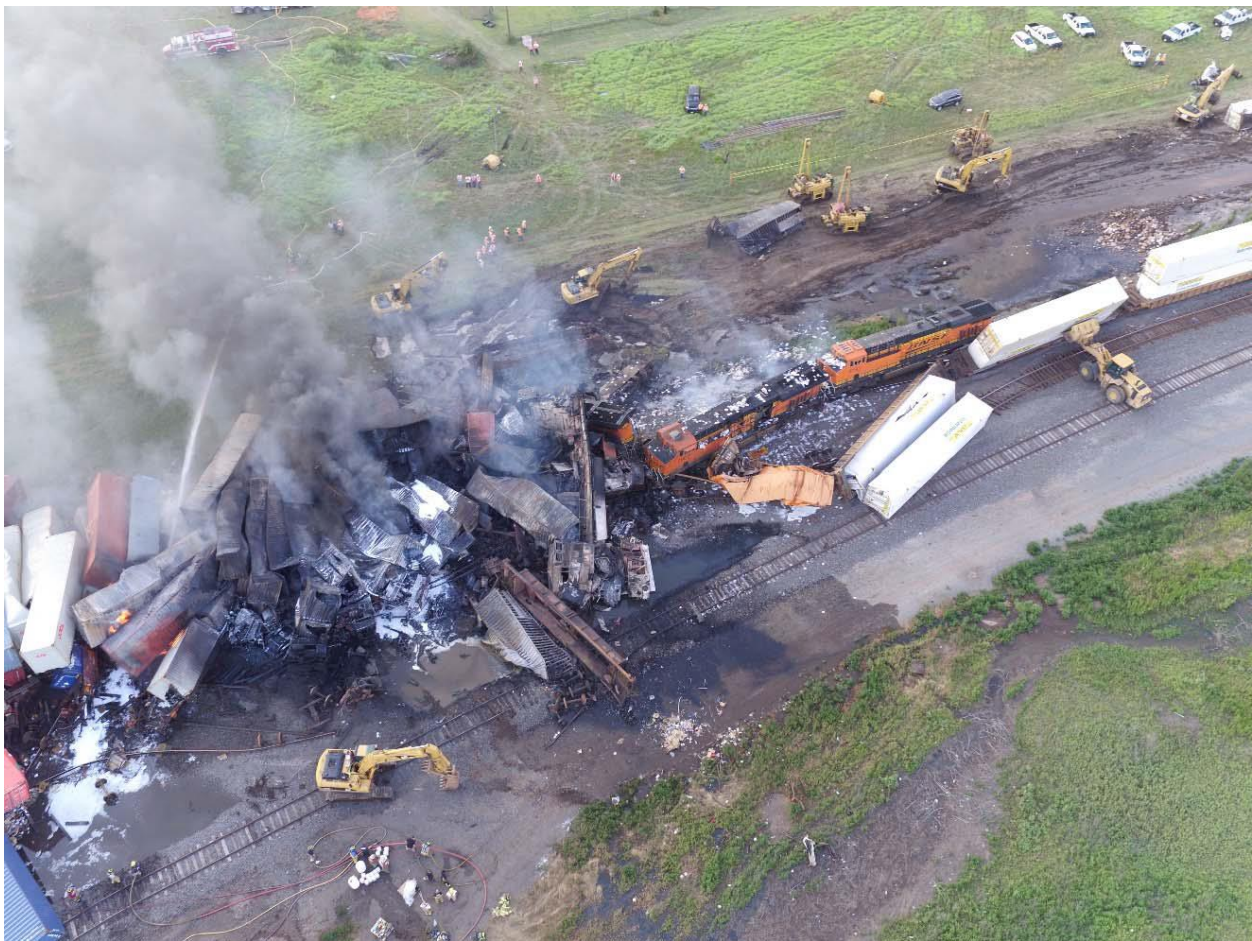
P-1 Aerial view of impact of eastbound BNSF S-LACLPC1-26 and westbound BNSF Q-CHISBD6-27

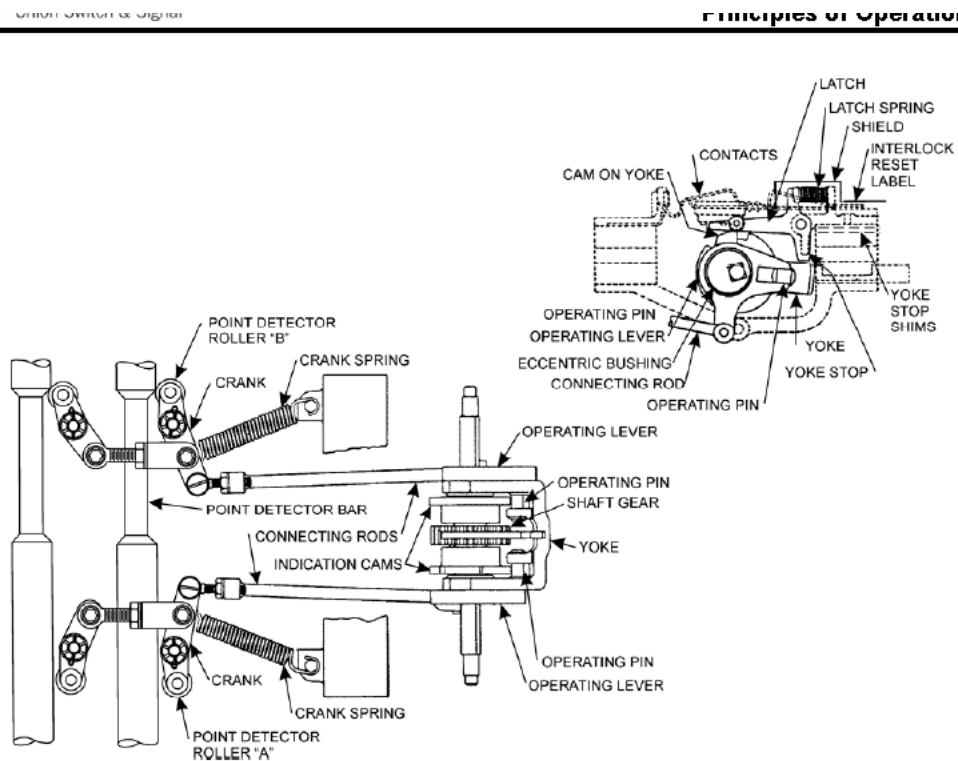
Figure 2-11 - Schematic Diagram of Point Detector – Parts in Reverse Position and Latched-Up

running through the switch improperly while the machine is in the locked-up position. Inspection of the US&S M-23 switch machine revealed that the latch out device was effective and latched up which prevented the switch position indication contacts from closing. This damage along with the other switch damage is indicative of a switch that the reverse point was forcibly opened by a trailing point move.

The following figure 2-11 represents a M-23A switch machine latch out device latched up due to reverse point being forcibly opened while switch is in reverse position.

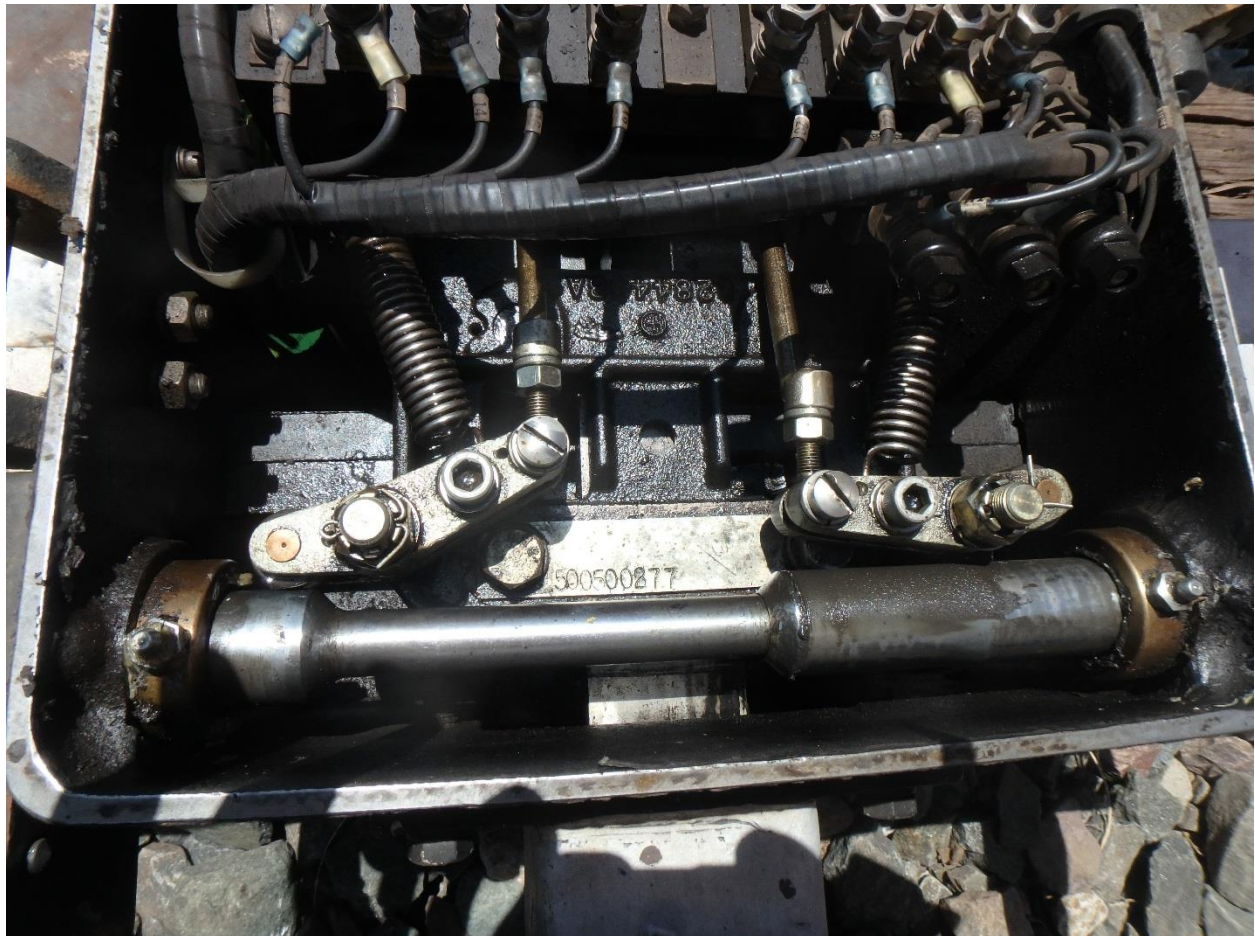
The following photograph is the point detector at CP 526.1 Panhandle TX after the collision.

Following the post-accident investigation, the switch rods and US&S M-23 switch machine were replaced. Although the US&S M-23 machine did not show visible damage, the machine was replaced as a precaution. During the derailment the intermediate signal located at MP 525.89 on Main Track 2 was also damaged.
