National Transportation Safety Board

Signal & Train Control **Factual Report of Investigation –** **Addendum # 1**

*Rear-End Collision of
Washington Metropolitan Area Transit Authority
Metrorail Train No. 112 with
Stopped Metrorail Train No. 214 near the
Fort Totten Station in Washington, DC
On June 22, 2009*

NTSB Accident Number: DCA-09-MR-007

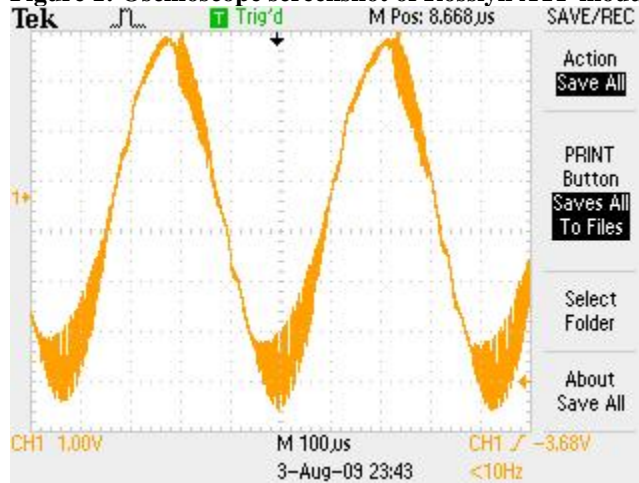
Figure 1: Oscilloscope screenshot of Rosslyn ATP modules

During the Fort Totten investigation, the S&TC group learned that the Rosslyn modules were still stored in the WMATA ATC Systems Engineer's office and requested them for testing in the ATC lab at the Carmen Turner Facilities. On August 3, 2009, the Rosslyn modules were installed on the test rack. The S&TC group, using the same test equipment, observed parasitic oscillations between the transmitter module and the receiver module. A screen shot of the parasitic oscillations was captured and also recorded in the log book that was maintained by the S&TC group (figure 1).

The archived occupancy data indicates that track circuit C2-111 was intermittently indicating vacant during train occupancy going back to 1988. Track circuit C2-111 had GRS/Alstom impedance bonds and GRS/Alstom ATP modules installed at the time it was put in service and at the time of the 2005 Rosslyn incident. Track circuit C2-111 was never set up using equipment from different manufacturers.
