**NATIONAL TRANSPORTATION SAFETY BOARD
OFFICE OF RAILROAD, PIPELINE AND HAZARDOUS
MATERIALS INVESTIGATIONS WASHINGTON, D.C. 20594**

RAILROAD SIGNAL AND TRAIN CONTROL SIGNAL FACTUAL

DCA17FR004

Roadway Worker Employee Fatalities

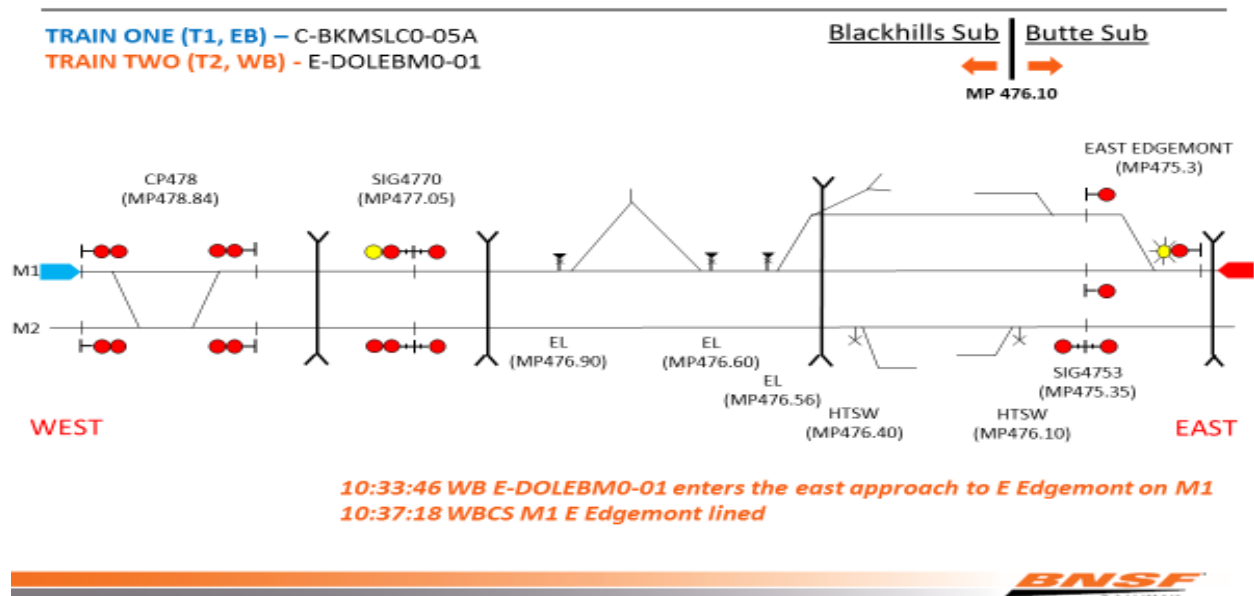
Figure 1. Signal Aspect and Train Movement. (Graphic courtesy of BNSF Railway).

508 Text: *This graphic shows the westbound accident train, E-DOLEBM0-01E, on main track 1 approaching a flashing yellow signal at CP East Edgemont. It also shows the eastbound train, C-BKMSLC0-1 on main track 1 approaching a red signal at CP478.*

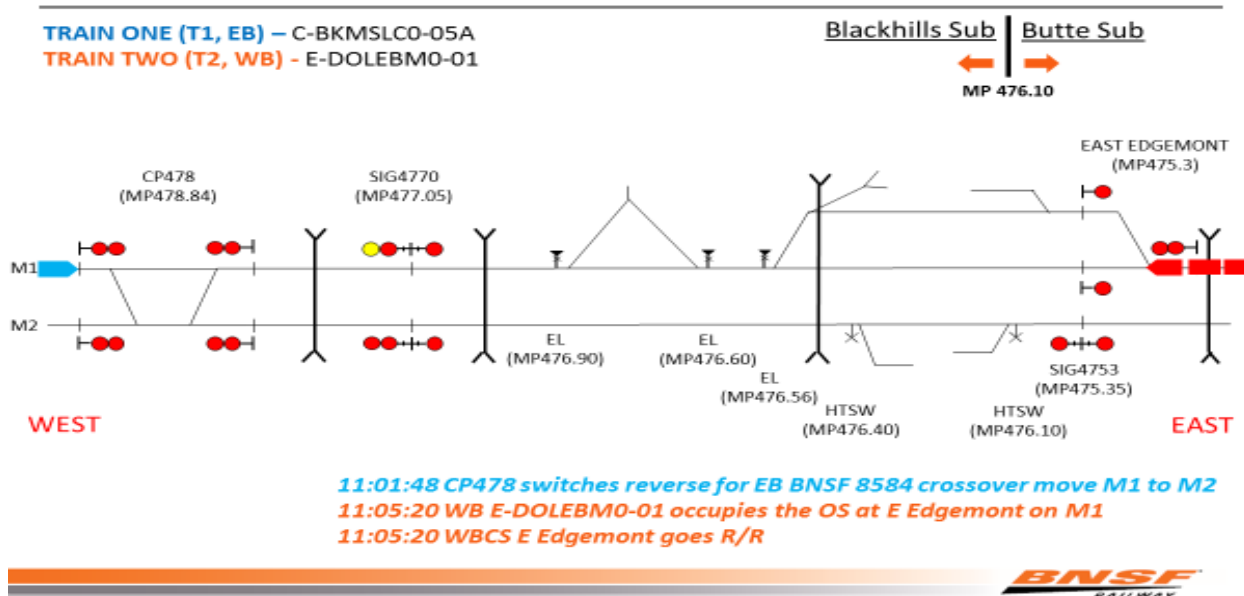
Figure 2. Signal Aspect and Train Movement. (Graphic courtesy of BNSF Railway).
508 Text: This graphic shows the westbound accident train, E-DOLEBM0-01E, on main track 1 entering and occupying the OS track circuit at CP East Edgemont. It also shows the eastbound train, C-BKMSLC0-1, on main track 1 approaching a red signal at CP478.

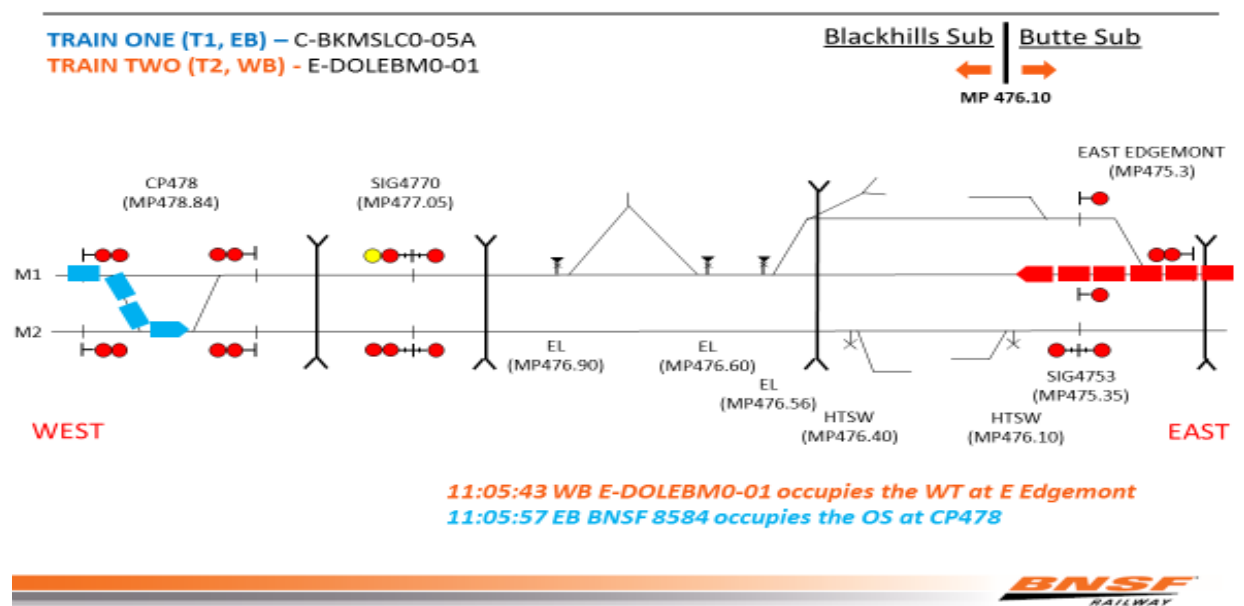
Figure 3. Signal Aspect and Train Movement. (Graphic courtesy of BNSF Railway).
508 Text: This graphic shows the westbound accident train, E-DOLEBM0-01E, on main track 1 occupying the WT track circuit at CP East Edgemont. It also shows the eastbound train, C-BKMSLC0-1, crossing over from main track 1 to main track 2 at CP478.

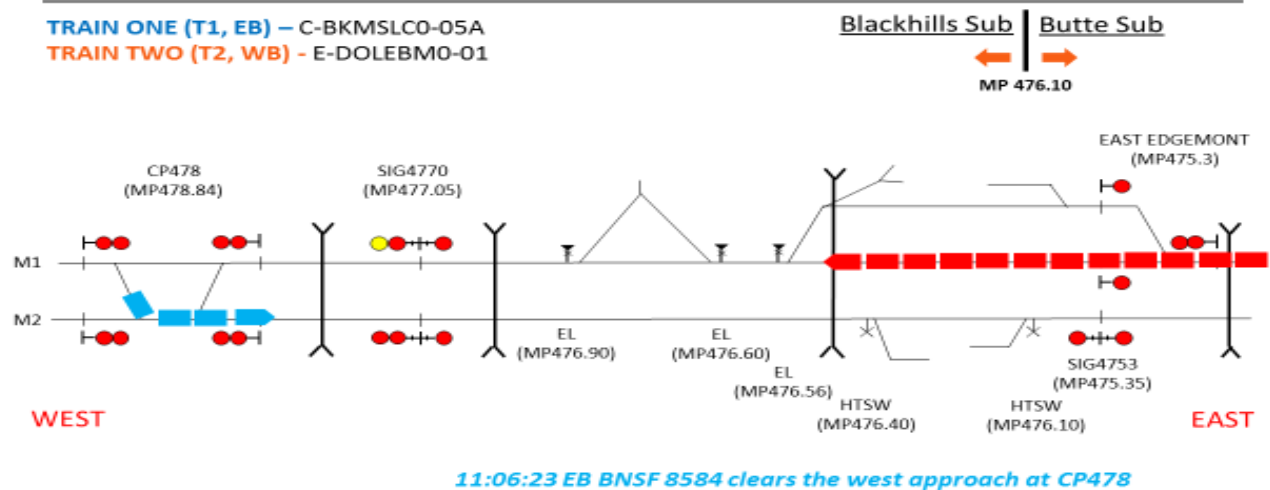
Figure 4. Signal Aspect and Train Movement. (Graphic courtesy of BNSF Railway).
508 Text: This graphic shows the westbound accident train, E-DOLEBM0-01E, on main track 1 occupying the WT track circuit at CP East Edgemont continuing the westbound movement. It also shows the eastbound train, C-BKMSLC0-1, crossing over from main track 1 to main track 2 at CP478 and in the clear of main track 1.

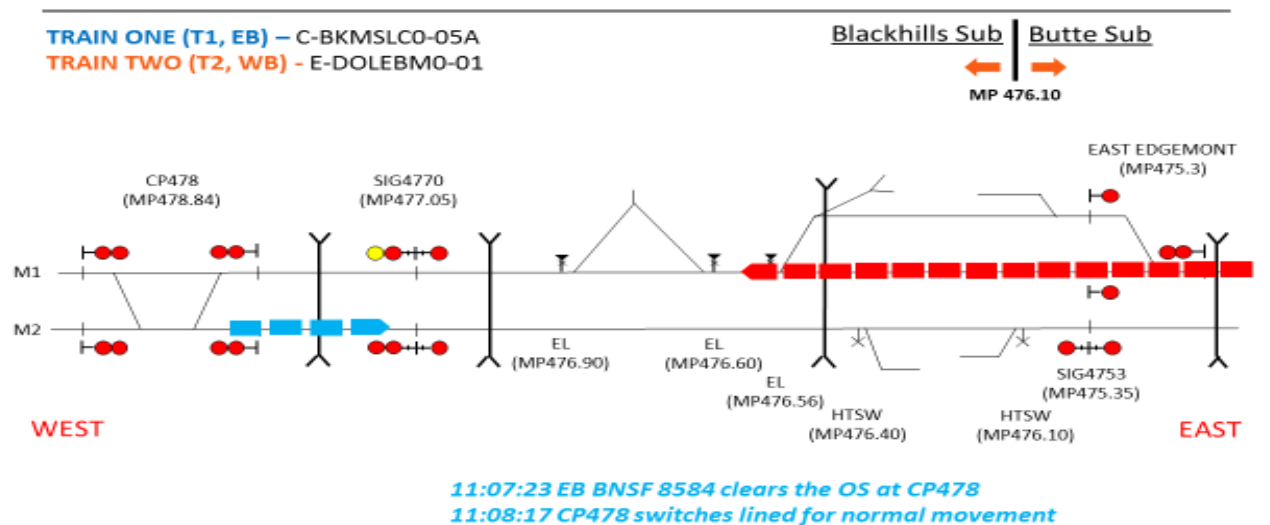
Figure 5. Signal Aspect and Train Movement. (Graphic courtesy of BNSF Railway).
508 Text: This graphic shows the westbound accident train, E-DOLEBM0-01E, on main track 1 occupying the WT track circuit at CP East Edgemont continuing the westbound movement. It also shows the eastbound train, C-BKMSLC0-1, completely on main track 2 continuing the eastbound movement.

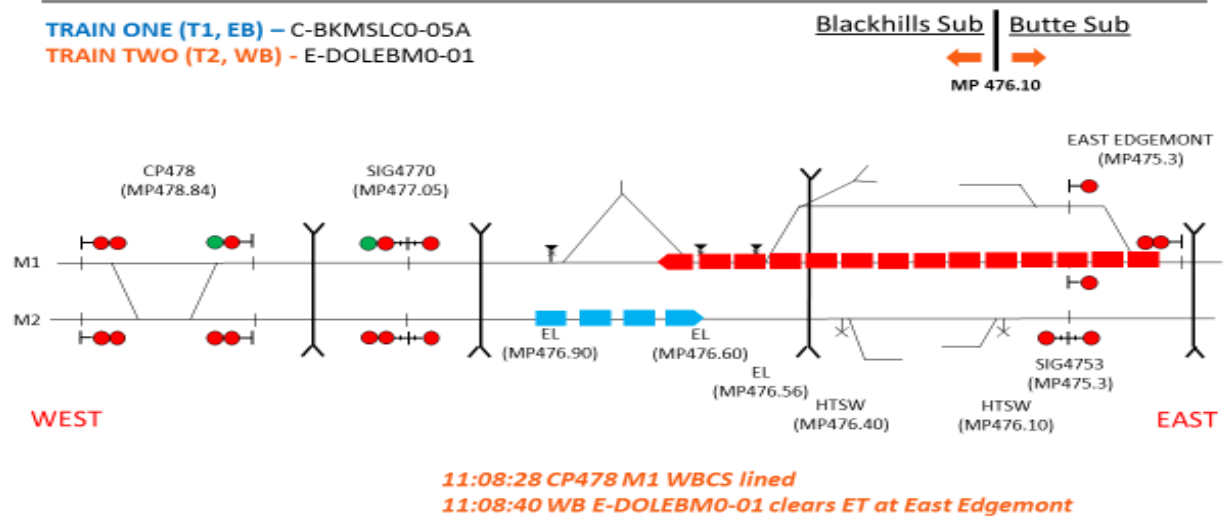
Figure 6. Signal Aspect and Train Movement. (Graphic courtesy of BNSF Railway).
508 Text: This graphic shows the that the last car of the westbound accident train, E-DOLEBM0-01E, on main track 1 clears the eastbound approach track circuit at CP East Edgemont while continuing the westbound movement. It also shows the eastbound train, C-BKMSLC0-1, on main track 2 continuing the eastbound movement.

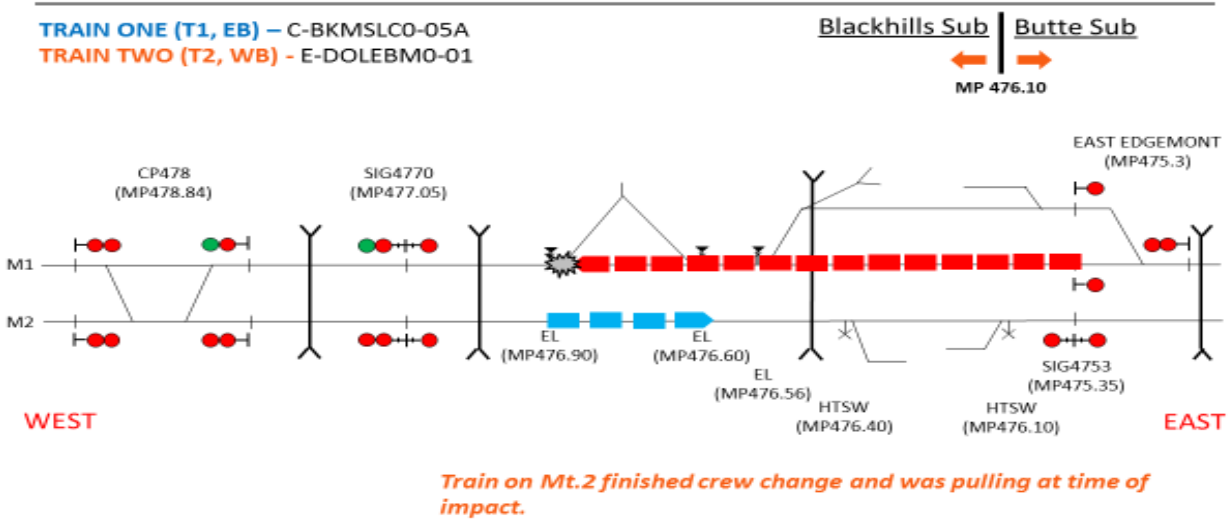
Figure 7. Signal Aspect and Train Movement. (Graphic courtesy of BNSF Railway).
508 Text: This graphic shows where the westbound accident train, E-DOLEBM0-01E, on main track 1 struck the roadway workers at MP 476.90. The rear of the eastbound train, C-BKMSLC0-1, on main track 2 passes the accident location at the same time while continuing the eastbound movement.
