**NATIONAL TRANSPORTATION SAFETY BOARD**

**HWY17MH010**

**CSX TRAIN COLLISION WITH TOUR BUS at MAIN**

**SIGNAL GROUP FACTUAL REPORT**

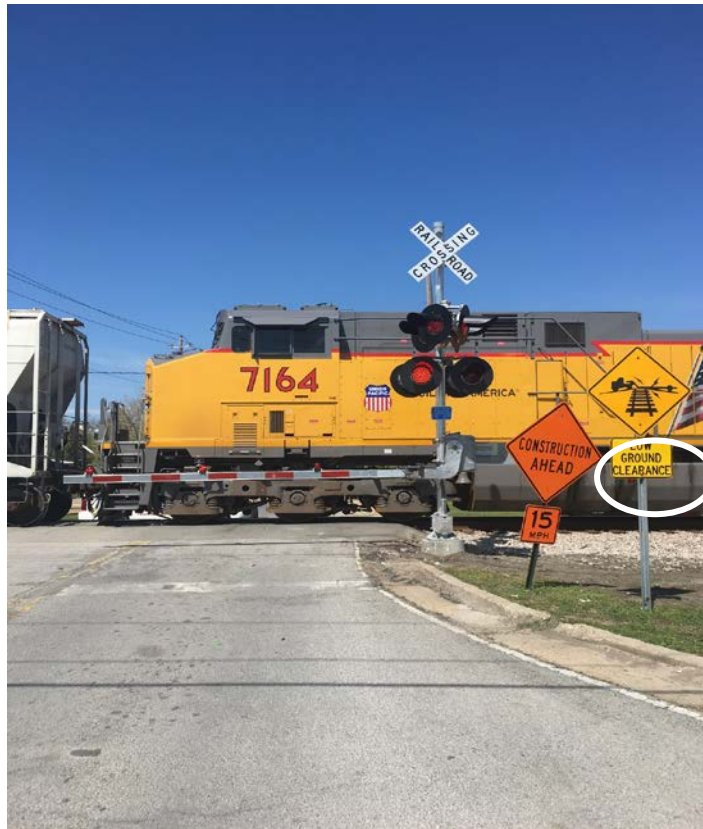
**Figure 2. Photo of the repaired signal gate and flasher. White circle highlights low ground clearance sign.**

Damage was made to the southeast geographical quadrant foundation, mast, gate mechanism, and flasher assembly. The CSX engineering personnel estimated the total grade crossing signal system damage is approximately \$20,000.00.

Signal damage due to the incident included one gate mechanism, including mast, one doll arm, two sets of LED lights, an 18-foot aluminum gate and foundation which cost \$9, 979.90. Straight time man hours equaled 40 hours and overtime man hours equaled 80 hours. A man-hour is fringed at \$65 per hour. Total labor for repairs, tests and inspections is \$10,400.
