HWY15MH006

**METROLINK TRAIN COLLISION and DERAILMENT WITH SERVICE TRUCK AND
TRAILER NEAR RICE AVENUE HIGHWAY/RAIL GRADE CROSSING**

Oxnard, California

SIGNAL FACTUAL REPORT

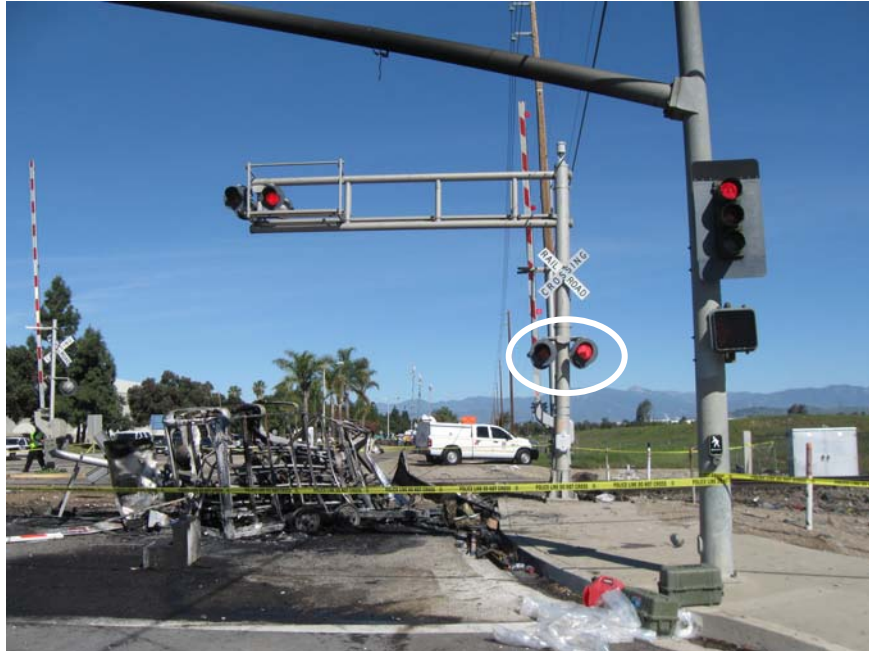
Figure 1. Photo taken, north direction, wreckage of trailer associated with utility truck after impact, & warning system devices operating after island gate knock down. The plastic covers for the LED flashers were burned on the cantilever.

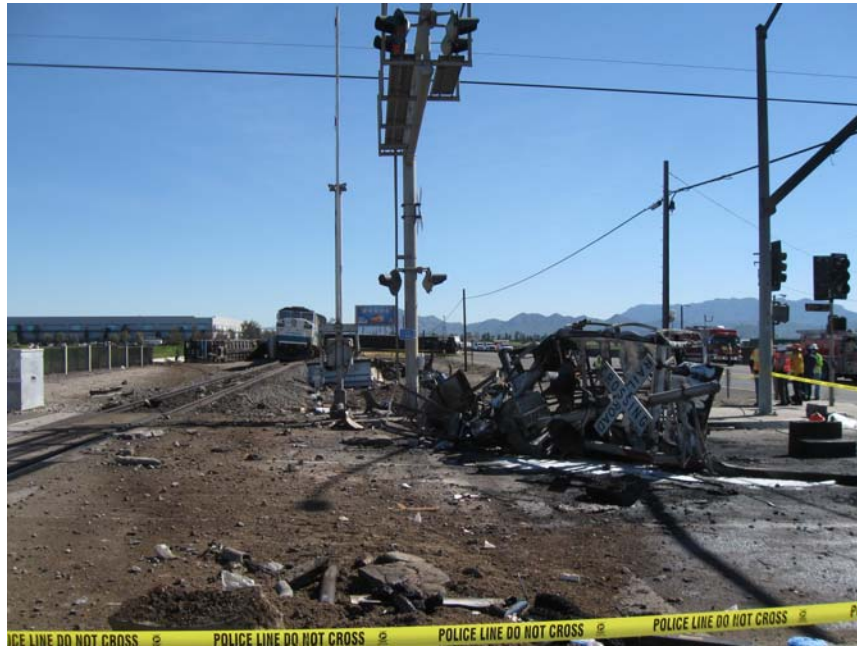
Figure 2. Photo taken, east direction, shows wreckage of trailer with island mechanism tangled together.

Damage was made to the 'B' island foundation, mast, gate mechanism, and flasher assembly. Damage also sustained to the 'A' cantilever base. The UP engineering personnel estimated the total grade crossing signal system damage is approximately \$40,000.
