**RAILROAD SIGNAL & TRAIN CONTROL GROUP
FACTUAL REPORT OF INVESTIGATION**

**Head-On Collision between
Southbound Amtrak P091-03 and
Standing CSXT Freight F777-03 near
Cayce South Carolina on
February4, 2018**

RRD 18 MR 003

**NATIONAL TRANSPORTATION SAFETY BOARD
OFFICE OF RAILROAD, PIPELINE & HAZ-MAT
INVESTIGATIONS WASHINGTON, D.C. 20594**

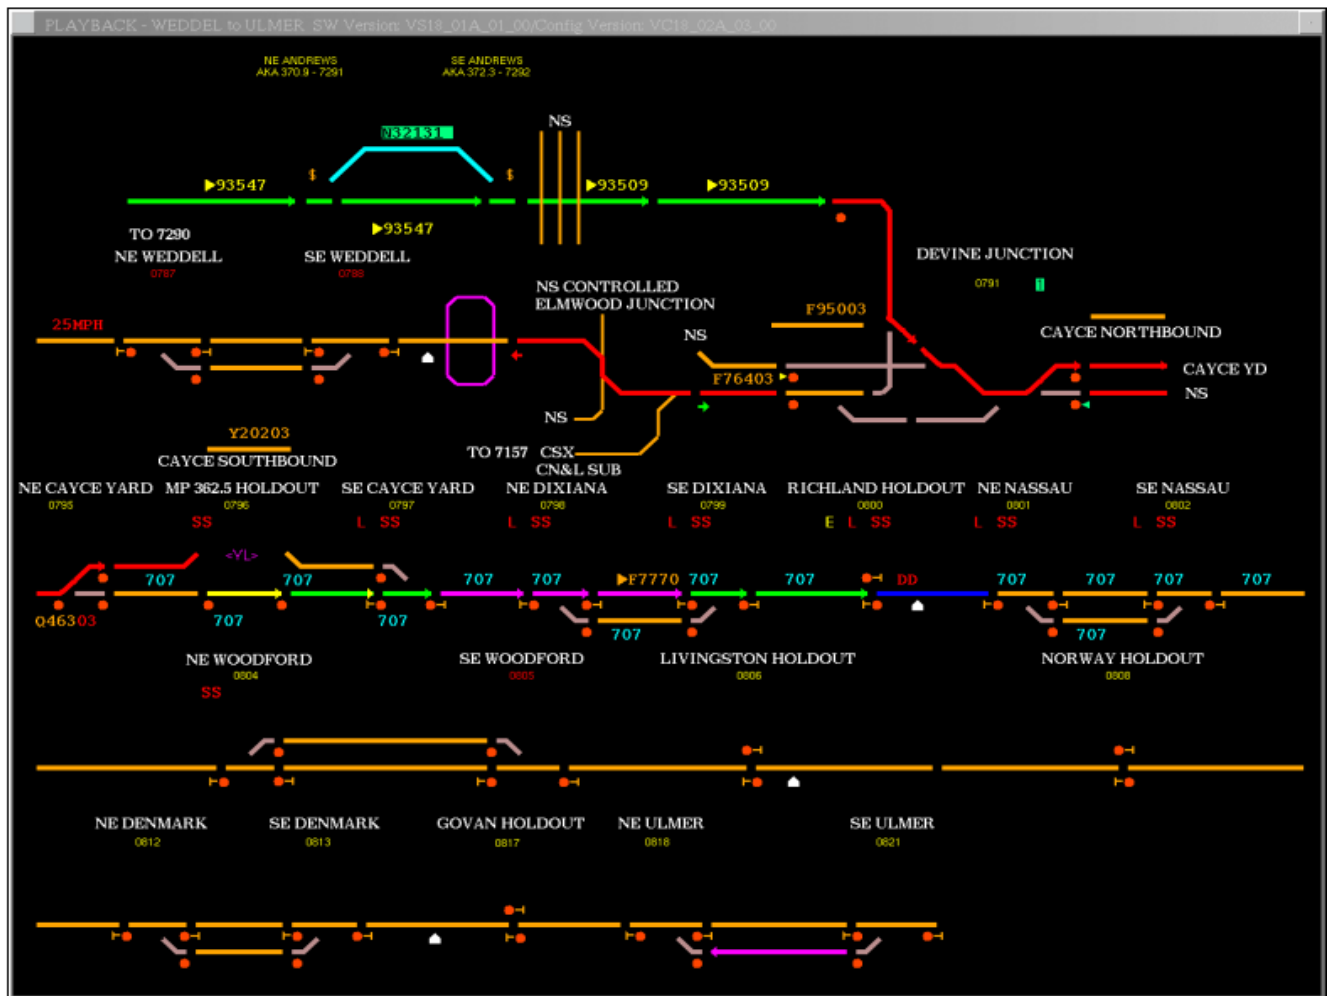
**1. CSX: 2/3/18 Cayce, SC Train Incident - CAD Log F77703
2029_16 This exhibit reflects F77703 occupying tracks between S.E.
Cayce Yard and S.E. Dixiana. Also depicting the track south of S.E.
Dixiana as unoccupied.**

Figure 1 depicts Train F777-03 occupying track segments between S.E. Cayce Yard and S.E. Dixiana.

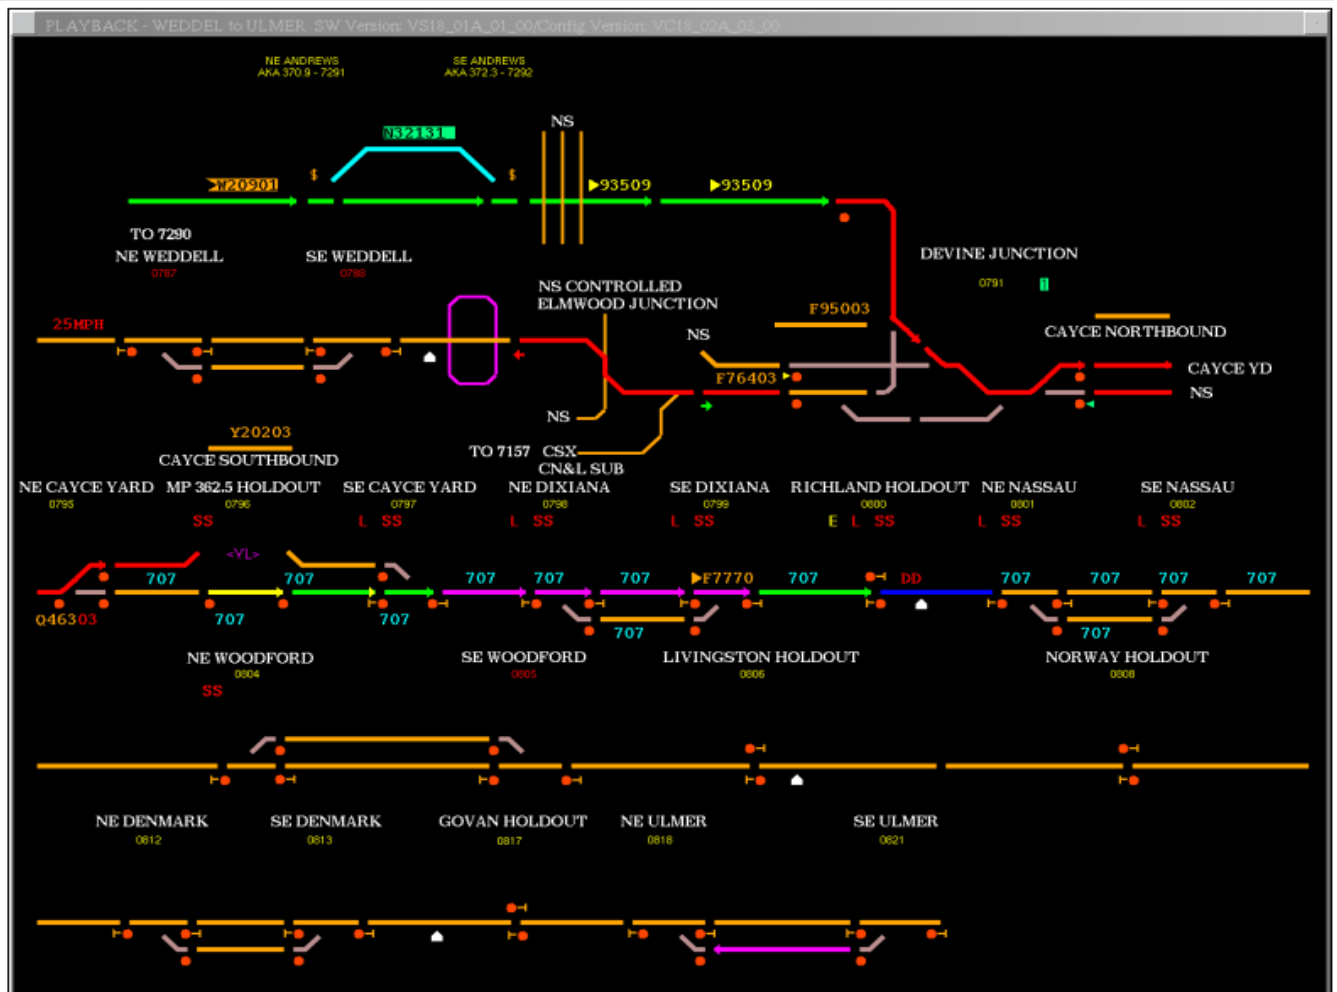
2. CSX: 2/3/18 Cayce, SC Train Incident - CAD Log F77703
 2030_17 screen shot depicts F77703 in the OS track of S.E. Dixiana
 with south track still reflecting unoccupied.

Figure 2 depicts train F777-03 entering OS track at the CP S.E. Dixiana while the south track where derailment occurred is unoccupied!

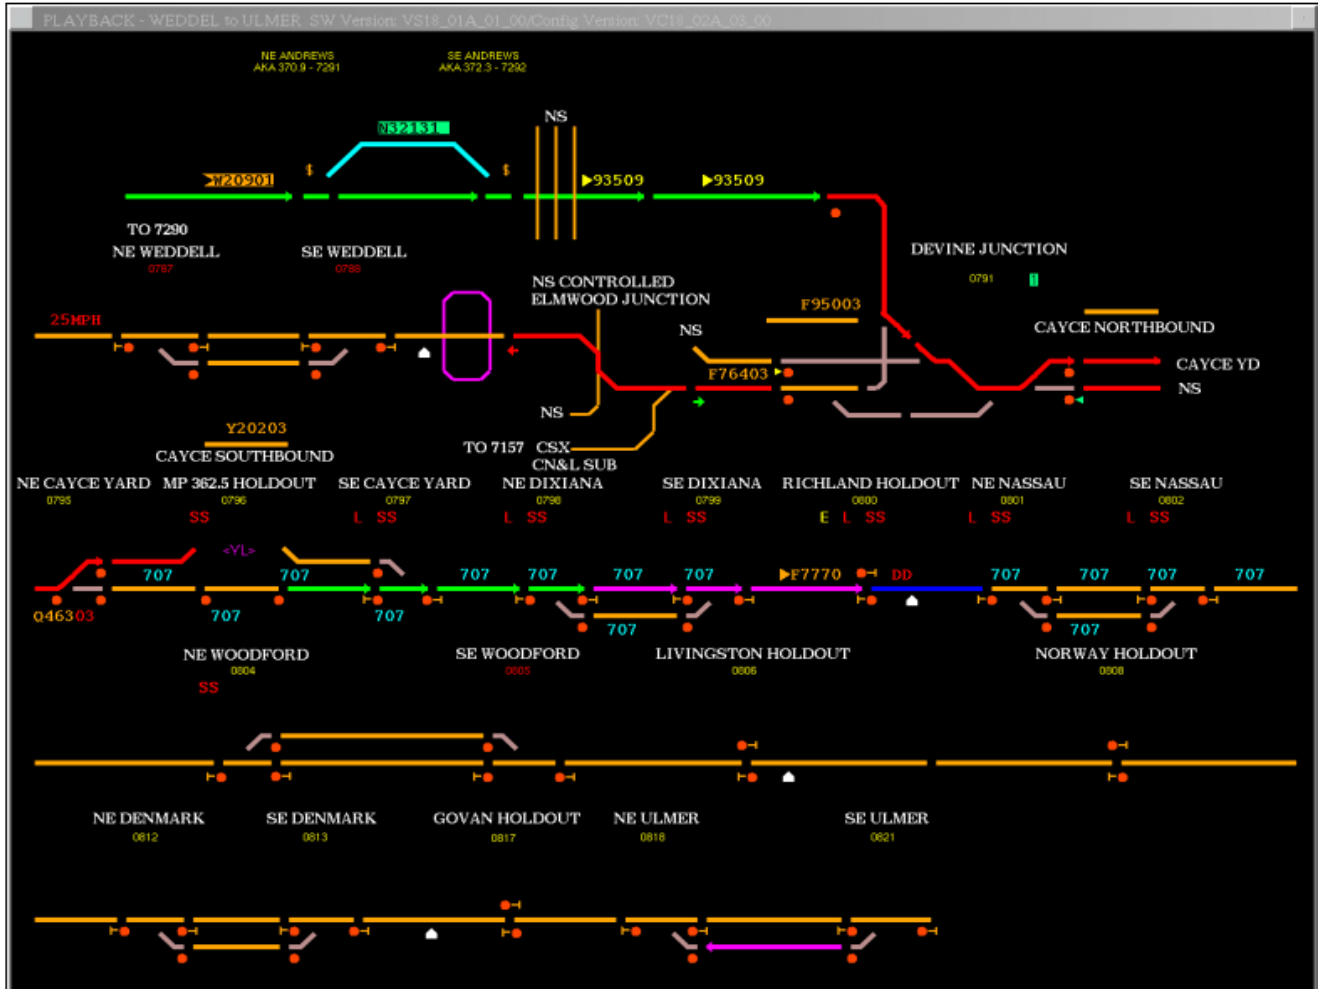
3. CSX: 2/3/18 Cayce, SC Train Incident - CAD Log F77703
 2031_00 screen shot reflecting F77703 occupying tracks between N.E. Dixiana and Richland Holdout Signal. The track between Richland Holdout and the S.E. Dixiana does not show unoccupied after this point.

Figure 3 depicts train F777-03 occupying tracks between N.E. Dixiana and the track south of the S.E. Dixiana.

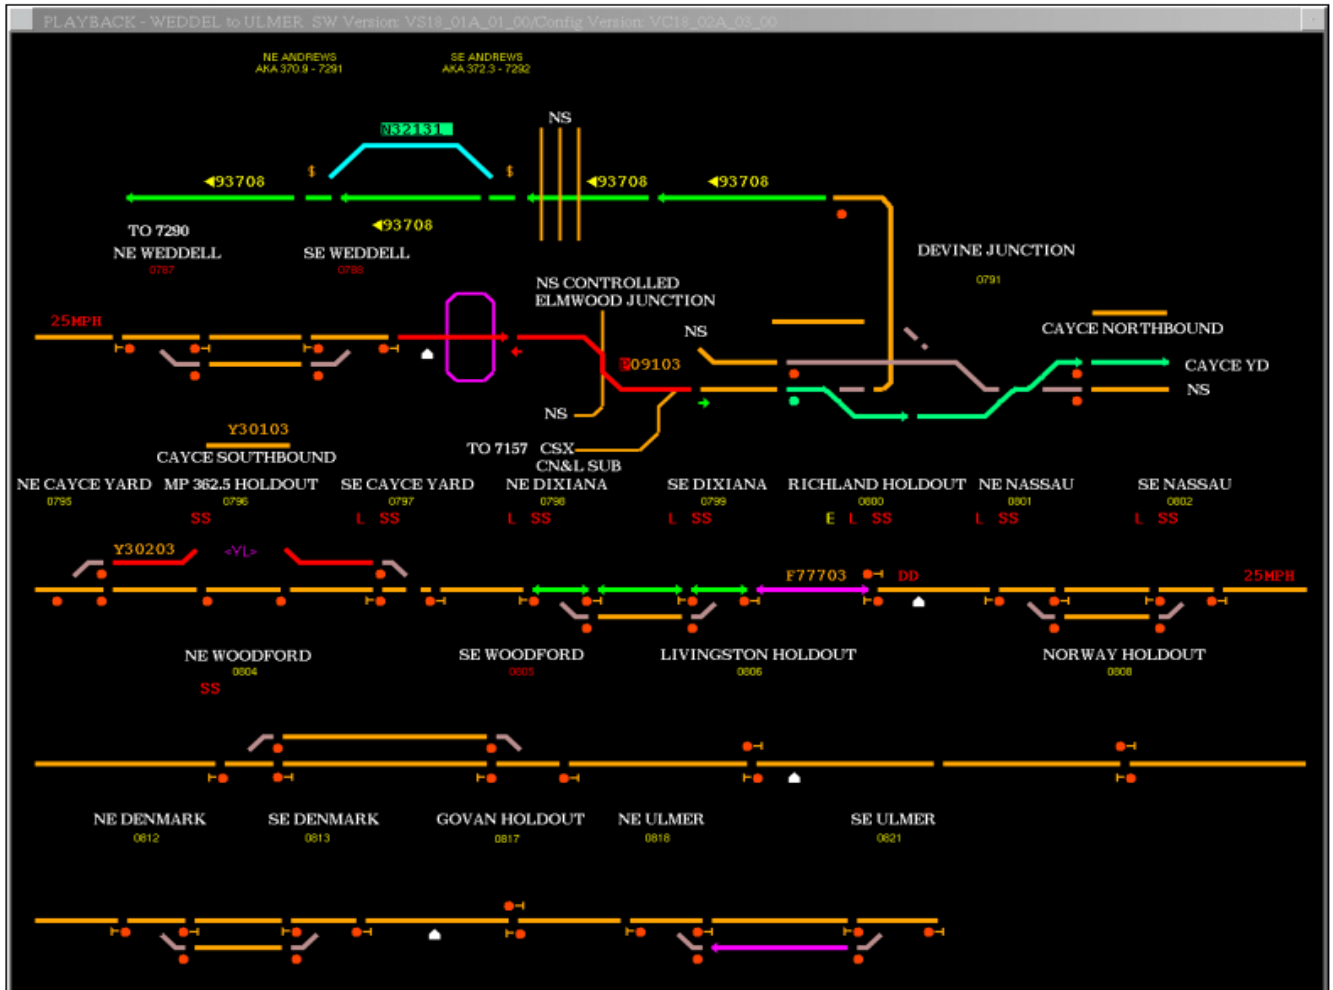
4. CSX: 2/4/18 Cayce, SC Train Incident - CAD Log F77703
 0151_00 reflects F77703 only occupying the track between S.E
 Dixiana and Richland Holdout.

Figure 4 depicts train F777-03 only occupying the track segment where collision occurred.

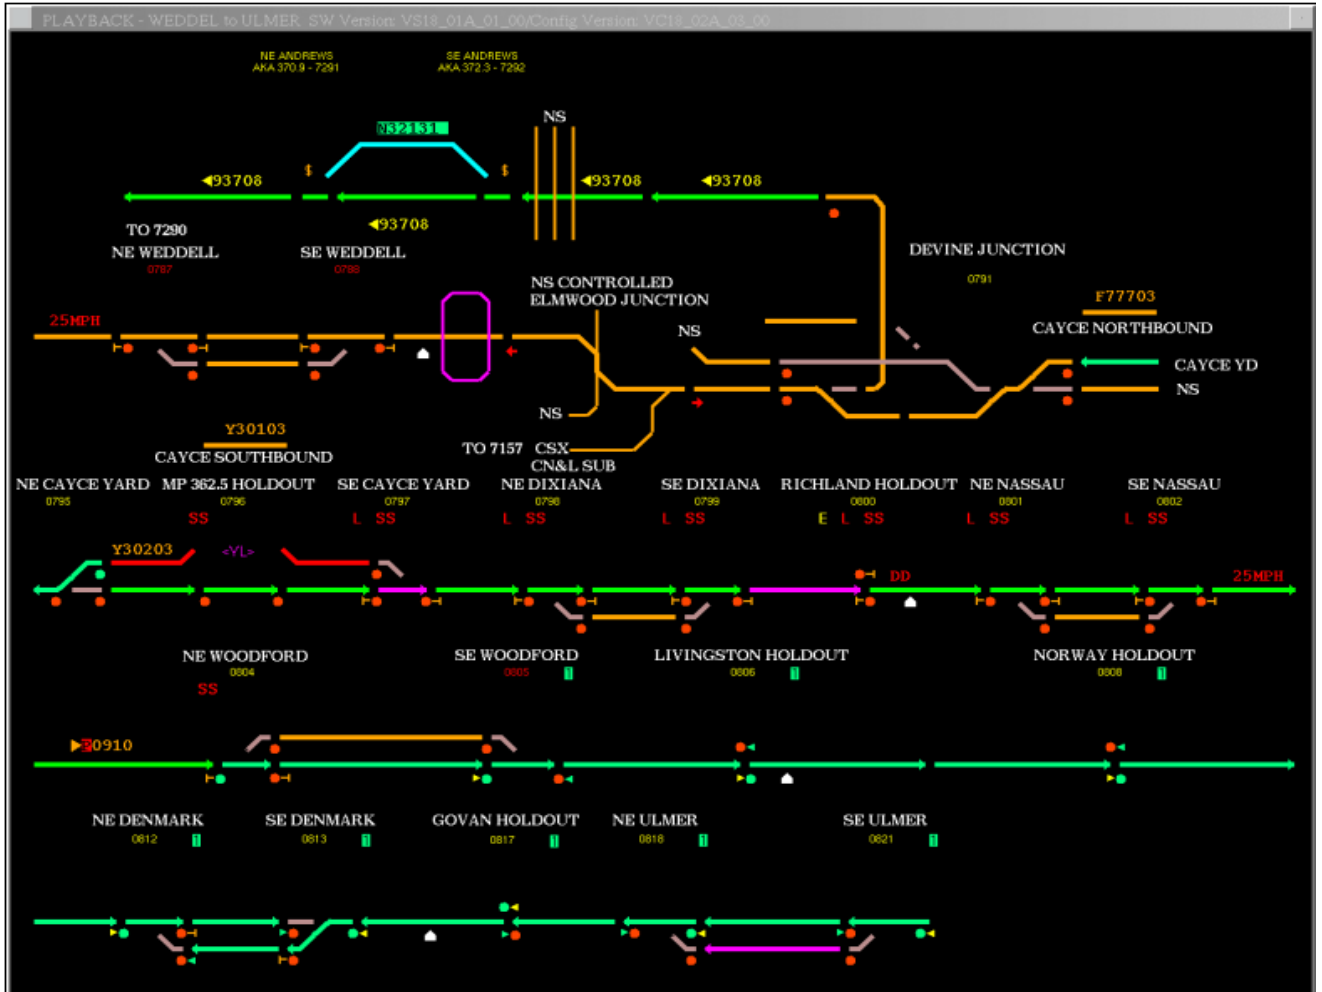
5. CSX: 2/4/18 Cayce, SC Train Incident - CAD Log P09103
 0222_53 reflects P091-03 occupying OS at the S.E. Cayce Yard and
 the track between S.E. Dixiana and Richland Holdout is still showing
 occupied without train designation.

Figure 5 depicts train P091-03 entering the OS track at the S.E. Cayce yard while the track segment where collision occurred is still reflecting occupied without train designation.

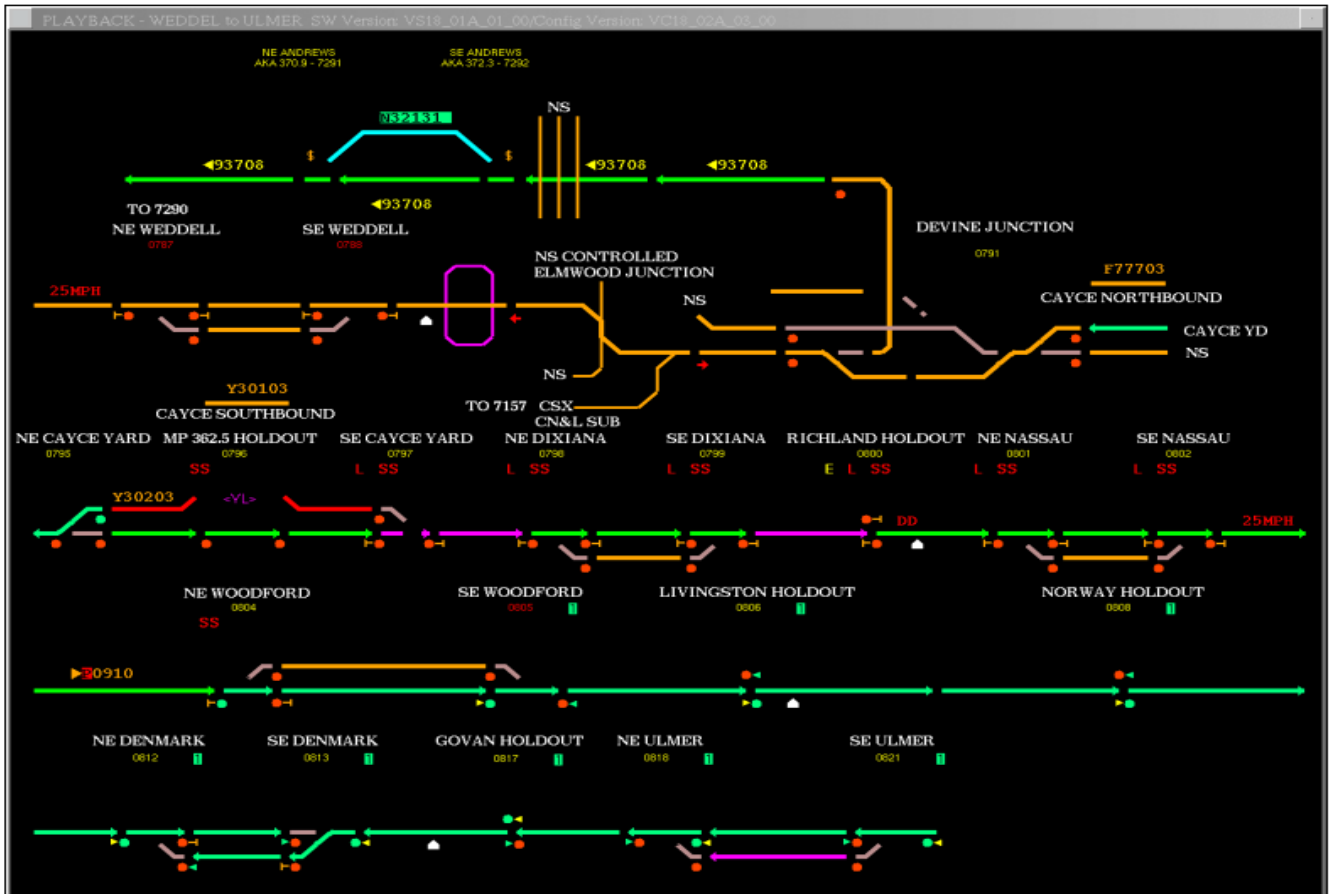
6. CSX: 2/4/18 Cayce, SC Train Incident - CAD Log P09103
 0223_02 reflects train P091-03 occupying S.E. Cayce Yard and N.E. Dixiana.

Figure 6 depicts train P091-03 occupying tracks in the OS at S.E. Cayce Yard and the north track at N.E. Dixiana

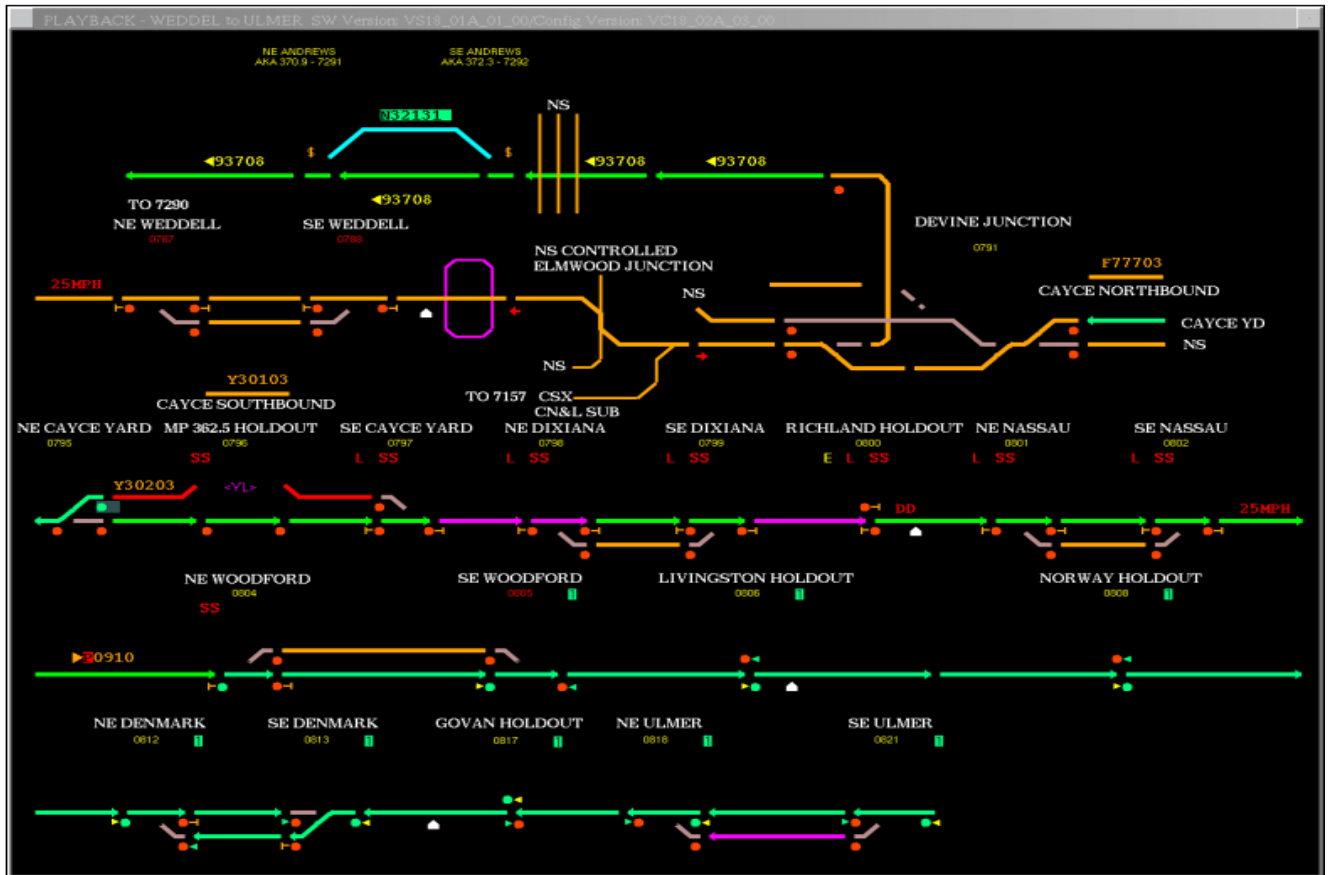
7. CSX: 2/4/18 Cayce, SC Train Incident - CAD Log P09103
0226_05 reflects P091-03 entering N.E. Dixiana with the track south of of
S.E. Dixiana still occupied.

Figure 7 depicts train P091-03 entering the OS at the N.E. Dixiana with the track segment at silica storage track still indicating occupied.

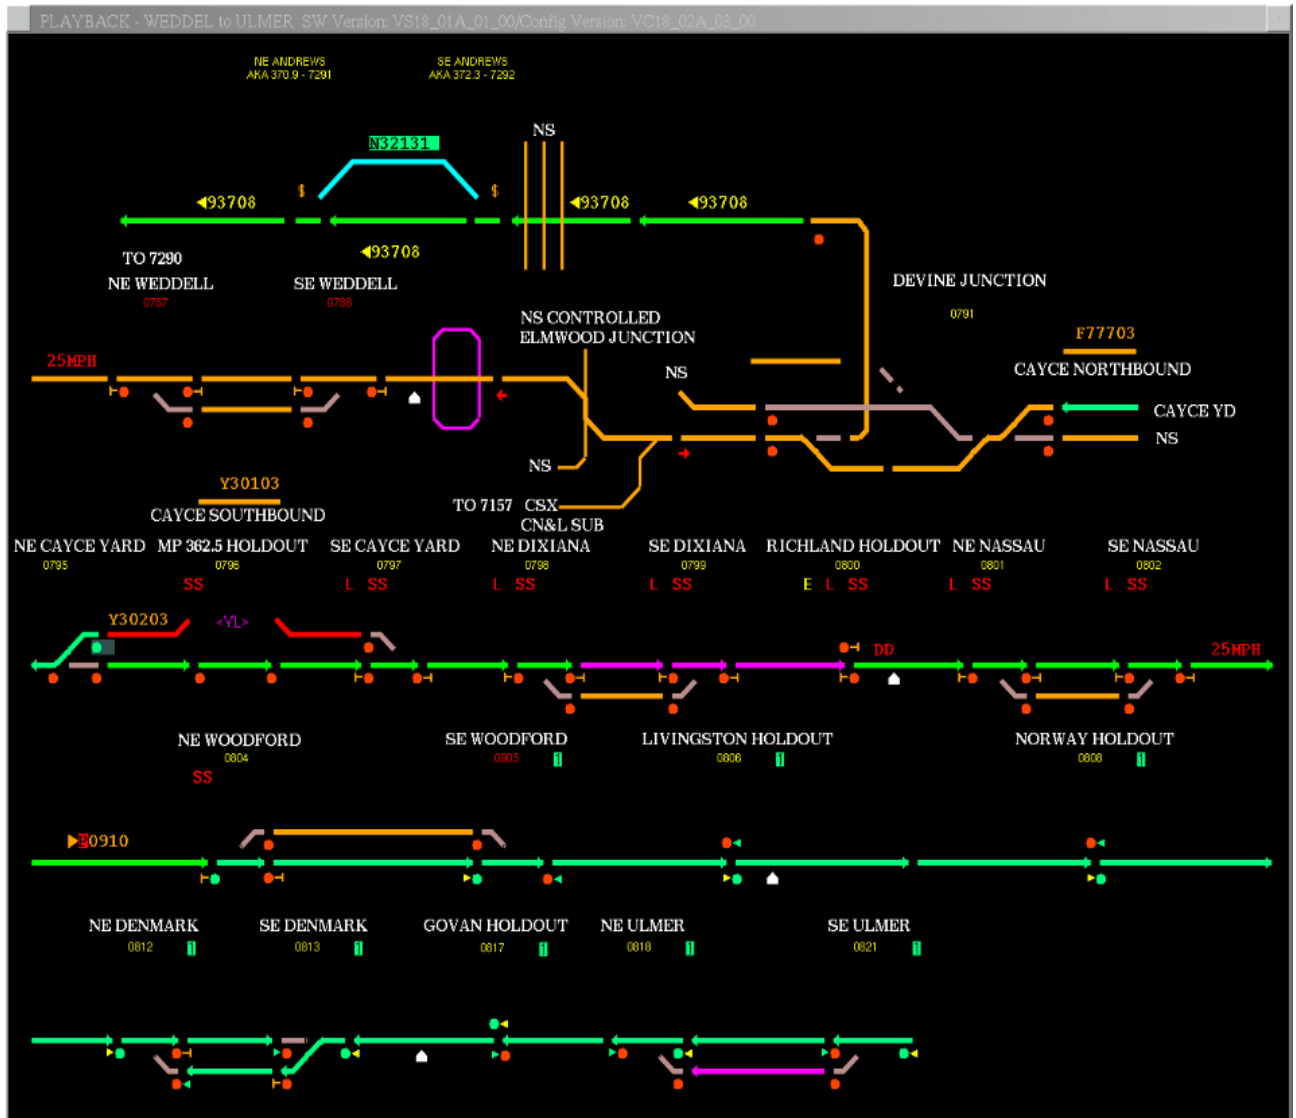
8. CSX: 2/4/18 Cayce, SC Train Incident - CAD Log P09103 0226_56 reflects P091-03 entering S.E. Dixiana OS Track with the track south of S.E. Dixiana still occupied.

Figure 8 depicts train P091-03 entering S.E. Dixiana OS track with track segment at silica storage track still indicating occupied.
