**RAILROAD SIGNAL & TRAIN CONTROL GROUP  
FACTUAL REPORT OF INVESTIGATION**

**Train Collision at End of Track  
Long Island Rail Road Commuter Train 2817  
Atlantic Terminal – Brooklyn, New York  
January 4, 2017**

**DCA 17 FR 002**

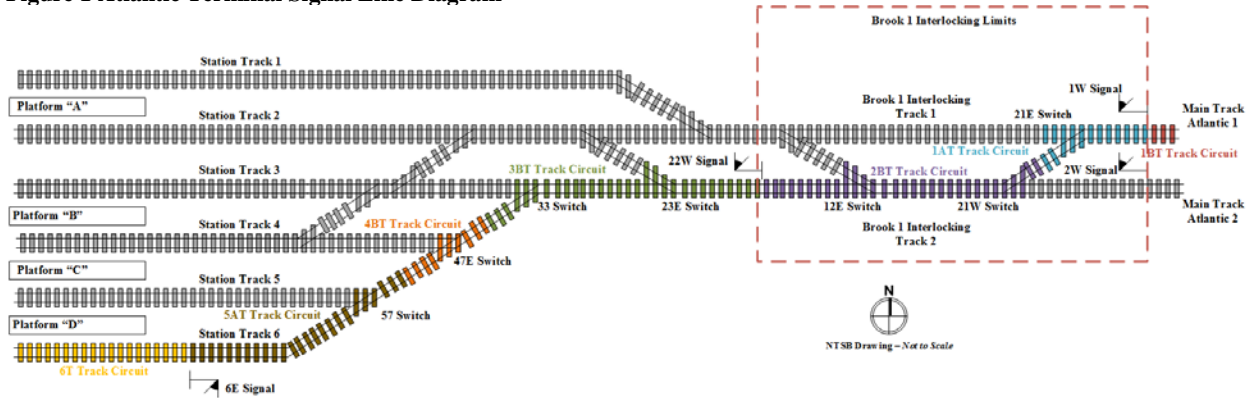
Figure 1 Atlantic Terminal Signal Line Diagram

Cab signal track codes are not transmitted west of the 1W signal on Brook track 1 and the 2W signal on Brook track 2 for westbound train movements approaching the Atlantic Terminal train station. Train movements into the passenger terminal platforms are at restricted speed. The ATC enforces a maximum speed of 15 mph into the Atlantic Terminal platform tracks. Train 2817 was routed into the Atlantic Terminal train station on track 1, through the 21 crossover switches and into platform track 6. LIRR uses US&S, A-5 pneumatic switch machines.
