**RAILROAD SIGNAL & TRAIN CONTROL GROUP  
FACTUAL REPORT OF INVESTIGATION**

**Train Collision of  
Union Pacific Railroad and  
BNSF Railway in  
Chaffee, Missouri on  
May 25, 2013**

**DCA-13-MR-004**

**NATIONAL TRANSPORTATION SAFETY BOARD  
OFFICE OF RAILROAD, PIPELINE &  
HAZARDOUS MATERIALS INVESTIGATIONS  
WASHINGTON, D.C. 20594**

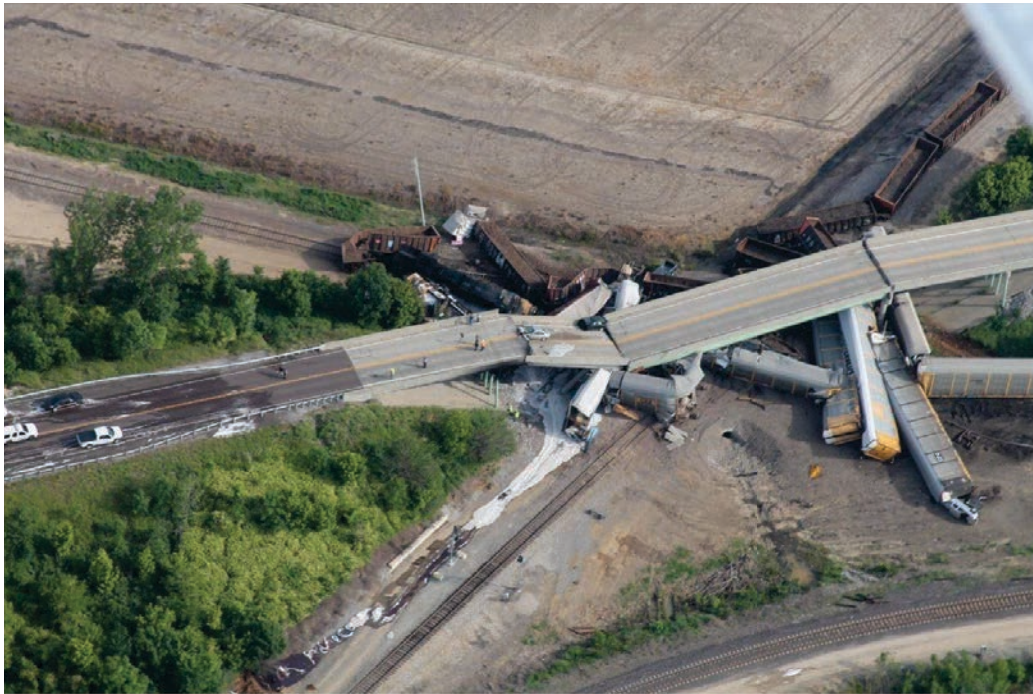
**Figure 1. Aerial view of accident scene.**

On May 25, 2013 at approximately 2:30 a.m., central daylight time<sup>1</sup>, near Chaffee, Missouri, Union Pacific (UP) southbound freight train, 2ASMAR-25 collided with BNSF southbound<sup>2</sup> freight train U-KCKHKMO-O5T, where UP and BNSF tracks cross at Rockview interlocking. The BNSF train was occupying the interlocking when the UP train struck the 12<sup>th</sup> car behind the locomotives of the BNSF train. As a result of the collision, 13 cars of the BNSF train were derailed. Two locomotives and 11 cars on the UP train were derailed. Spilled diesel fuel from the derailed UP locomotives caught fire. Missouri State Highway M Bridge is above the Rockview interlocking and collision forces resulted in the collapse of portions of the highway bridge. The engineer and conductor on the UP train were the only crew members that were injured and they were transported to a local hospital. Subsequent to the bridge collapse, two motor vehicles struck damaged highway elements and were involved in fires. Five occupants of the motor vehicles were transported to a local hospital. It was clear and 48° F at the time of the accident. The preliminary damage was estimated to be in excess of \$8 Million.
