**RAILROAD SIGNAL & TRAIN CONTROL GROUP  
FACTUAL REPORT OF INVESTIGATION**

**Head-On Collision between  
Westbound UP Freight Train KG1LAC-13 and  
Eastbound UP Freight Train LCK41-14 near  
Granger, Wyoming on  
March 14, 2016**

**DCA 16 FR 005**

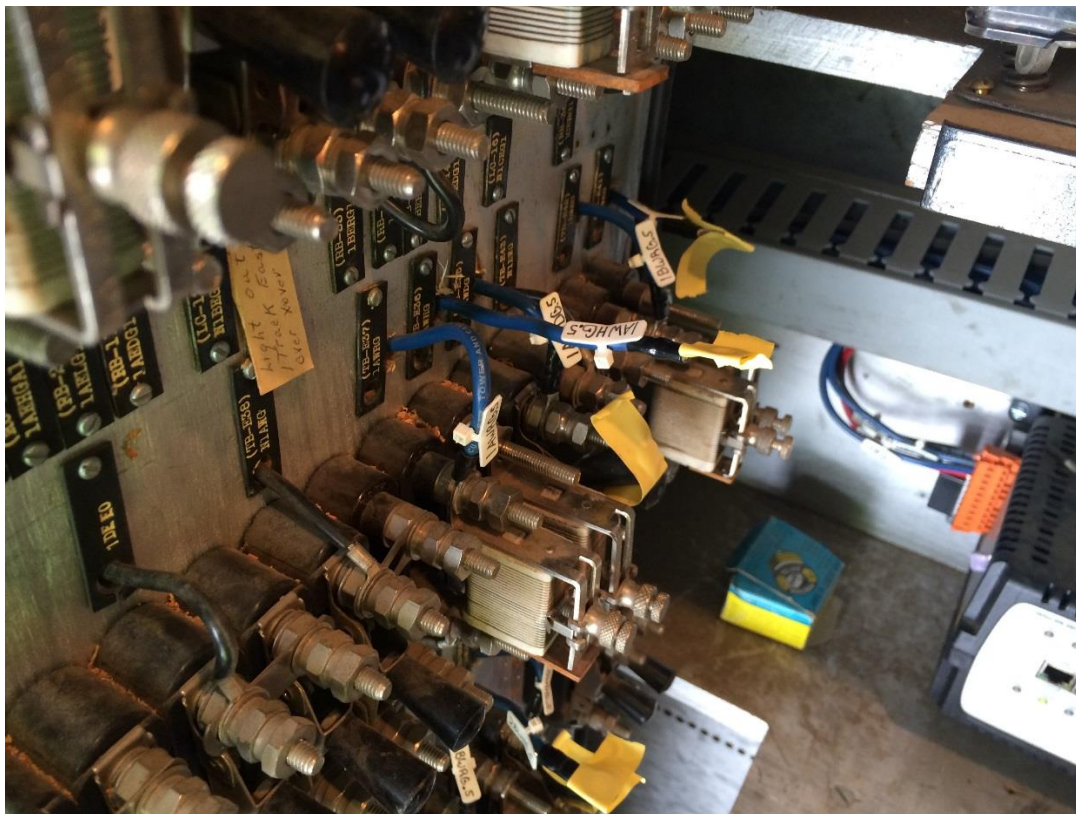
During the signal construction project, dual-control power switches at the limits of the signal suspension remained under dispatcher control while the dual-control power switches within the signal suspension limits were placed in the hand-throw position. Signals within the signal suspension were arranged to display Red signal aspects for all directions. Signal personnel disabled the green and yellow aspects at each location going into the signal suspension limits. The signals were set to display a stop, red aspect and were not capable of displaying a more permissive aspect (See Figure 1). Dispatchers were able to request routes and signals for train movements leaving the signal suspension limits at CP G002 on the Pocatello Subdivision and at CP G844 on the Evanston Subdivision

**Figure 1 Disabled Lighting Circuits at CP G844**
