National Transportation Safety Board

Marine Accident Brief

Sinking of Commercial Fishing Vessel *Orin C*

Accident no.	DCA16PM008
Vessel name	<i>Orin C</i>
Accident type	Sinking
Location	Atlantic Ocean, 13 miles* east of Cape Ann, Massachusetts 42°34.39' N, 70°21.91' W
Date	December 3, 2015
Time	2018 eastern standard time (coordinated universal time – 5 hours)
Injuries	1 fatality
Property damage	Total loss
Environmental damage	None reported
Weather	Overcast, winds west at 30 knots gusting to 35 knots, seas 8–10 feet, air temperature 45–48°F
Waterway information	Open waters of the Atlantic Ocean

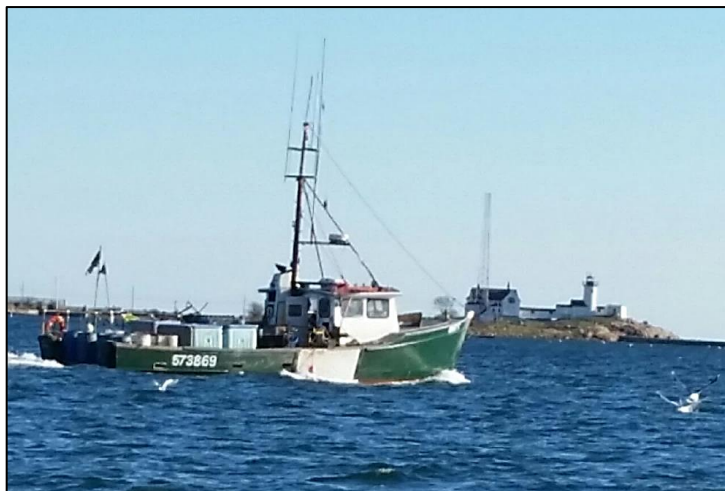
***Orin C* on the day the vessel departed Gloucester, Massachusetts, December 1, 2015. (Photo by M. Ring)**

Surviving crewmembers estimated they had about 6,500–10,000 pounds of hagfish (slime eel) on board at the time the engine problems were discovered. About 5,000 pounds were located in the main fish hold below deck with the remainder evenly distributed in vats; two on each side of the boat. The crewmembers said that there was nothing unusual with the load distribution on the boat. They also noted that the deck was mostly clear, with any loose items secured in preparation for the oncoming weather. The vessel had a low freeboard and its deck scuppers were close to the water (see photo page 1). The aft deck was awash most of the time during the tow.

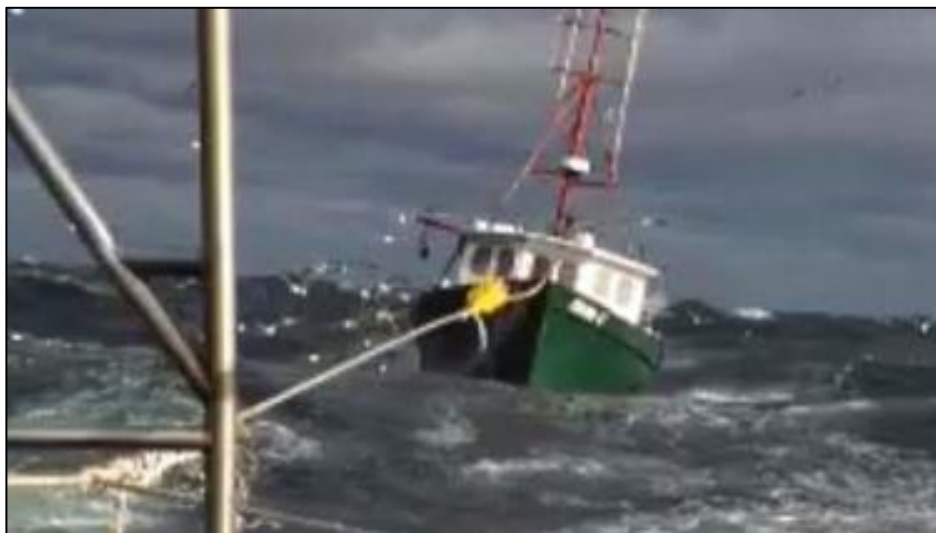
Photo of the *Orin C* taken at 1324 from the aft deck of the *Foxy Lady*.
(Photo by *Foxy Lady* captain)

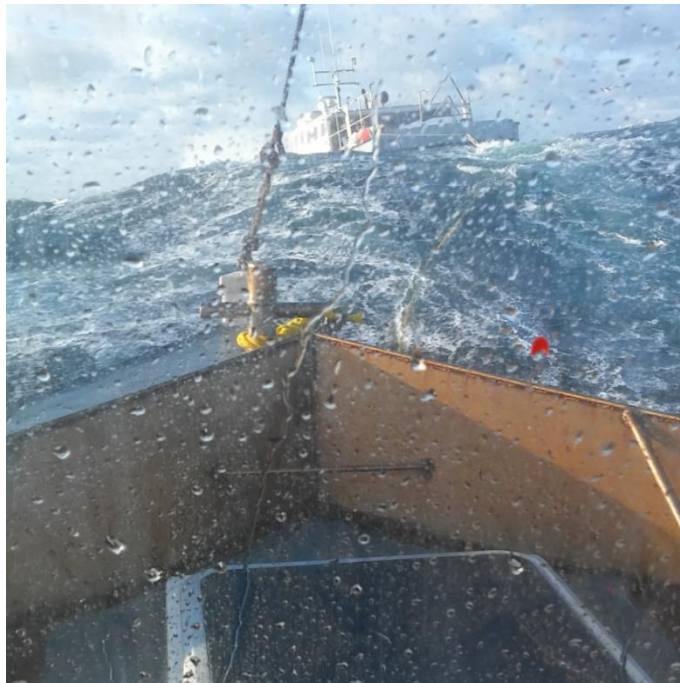
The tow was rigged with a bridle attached to both aft corners of the *Foxy Lady*, with the tow line extending to the *Orin C* from the middle of the bridle. The other end of the tow line was attached to the forward bow post of the *Orin C*. According to the *Foxy Lady* captain, the *Orin C* had no cleats on its forward deck, and the attachment using the forward bow post allowed the tow line to constantly move back and forth across the *Orin C*'s bow. The *Foxy Lady* captain expressed concern because the movement caused the line to chafe, lose strength, and eventually break. After the tow commenced, he communicated to the *Orin C* crewmembers that they needed to take measures to prevent the line from chafing. Each time the tow line parted, materials such as rubber hose, rain gear, and duct tape were added around the line to prevent it from chafing.

Photo taken from the *Orin C*, while being towed by the *Foxy Lady*, moments before the *Orin C* was hit by the wave that caused damage. Note the yellow tow line on the bow post, the bow stem with guy wire, and the lead of the tow line off the starboard bow into the water.
