Sinking of US Cargo Vessel SS *El Faro*
Atlantic Ocean, Northeast of Acklins and Crooked Island,
Bahamas
October 1, 2015

Accident Report

NTSB/MAR-17/01
PB2018-100342

The National Transportation Safety Board (NTSB) determines that the probable cause of the sinking of *El Faro* and the subsequent loss of life was the captain's insufficient action to avoid Hurricane Joaquin, his failure to use the most current weather information, and his late decision to muster the crew. Contributing to the sinking was ineffective bridge resource management on board *El Faro*, which included the captain's failure to adequately consider officers' suggestions. Also contributing to the sinking was the inadequacy of both TOTE's oversight and its safety management system. Further contributing factors to the loss of *El Faro* were flooding in a cargo hold from an undetected open watertight scuttle and damaged seawater piping; loss of propulsion due to low lube oil pressure to the main engine resulting from a sustained list; and subsequent downflooding through unsecured ventilation closures to the cargo holds. Also contributing to the loss of the vessel was the lack of an approved damage control plan tha

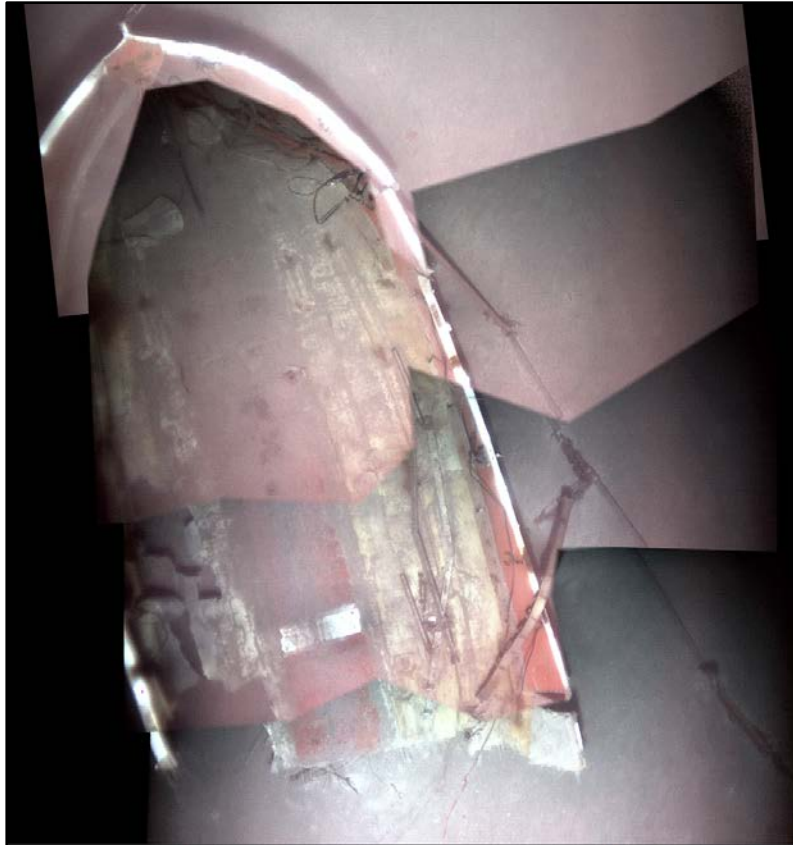
Figure 24. Photomosaic of *El Faro's* port lifeboat from images taken during second search mission. Bench seats and other internals are missing. Reflective tape on top of gunwales is illuminated.

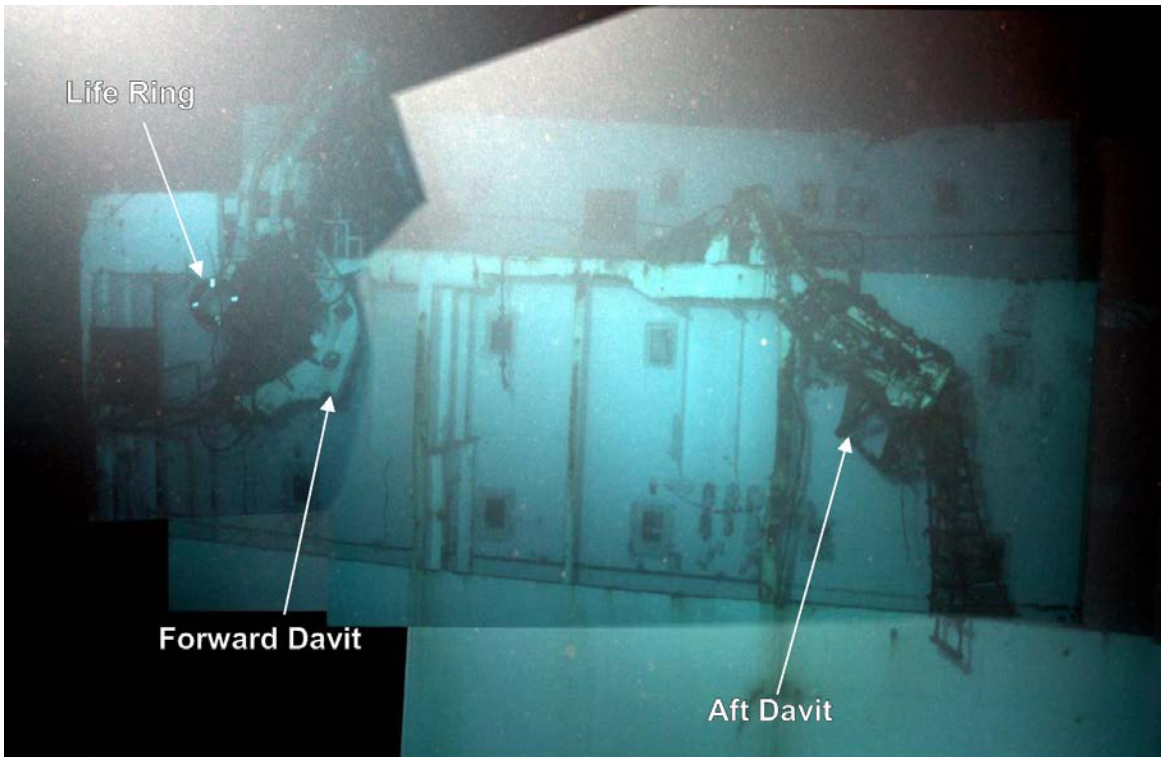
Figure 26. Gravity davits for port lifeboat, showing forward davit in place but damaged and aft davit broken and dangling. (Photomosaic image from mission 2)

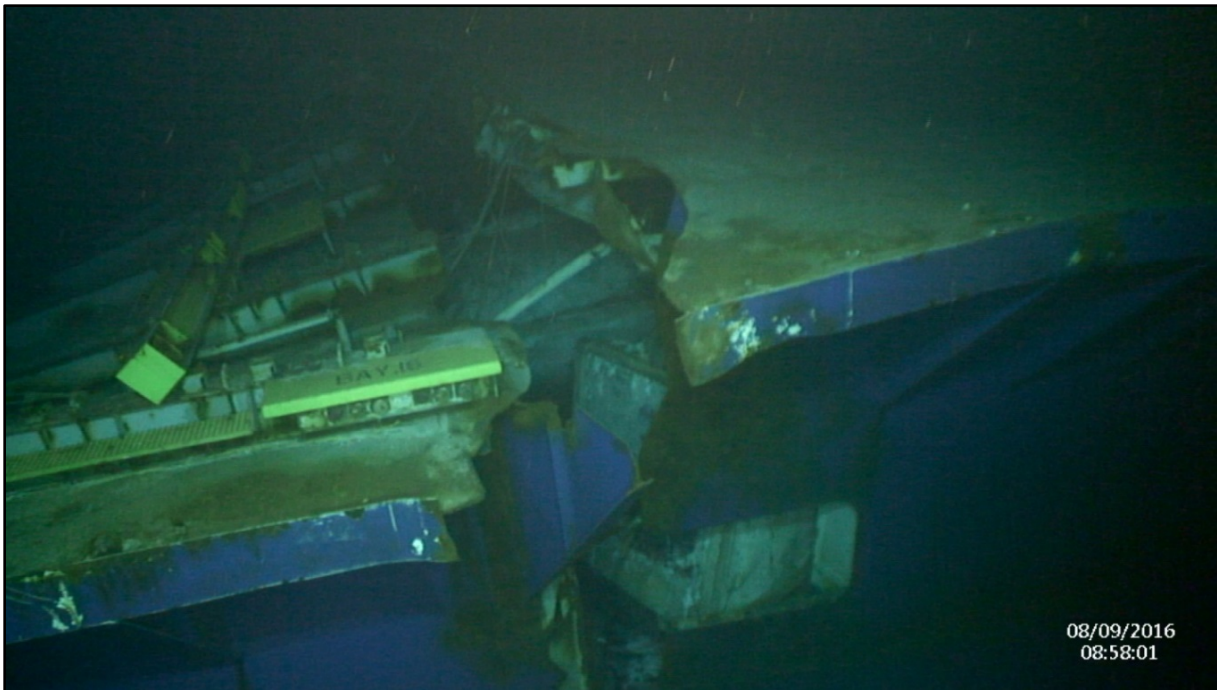
Figure 30. Hull fracture in starboard sideshell and across main deck at container bay 16, forward of frame 200. (Image from mission 3)

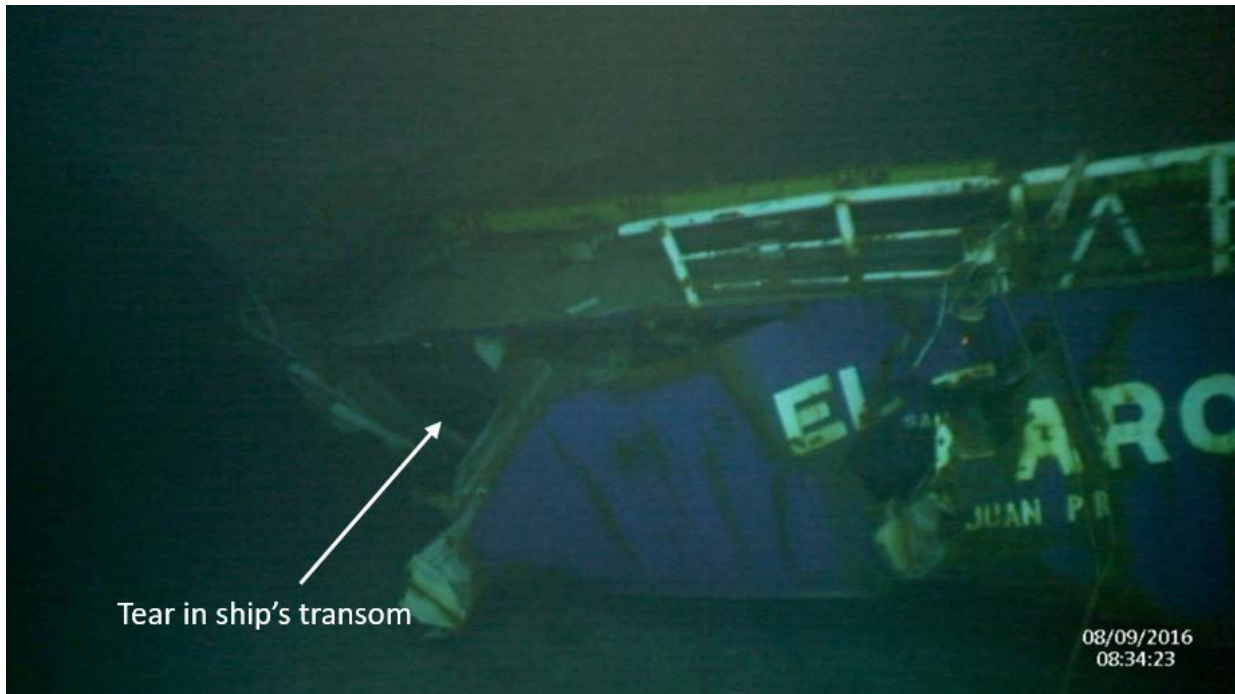
Figure 31. Tear in ship's transom. (Image from mission 3)

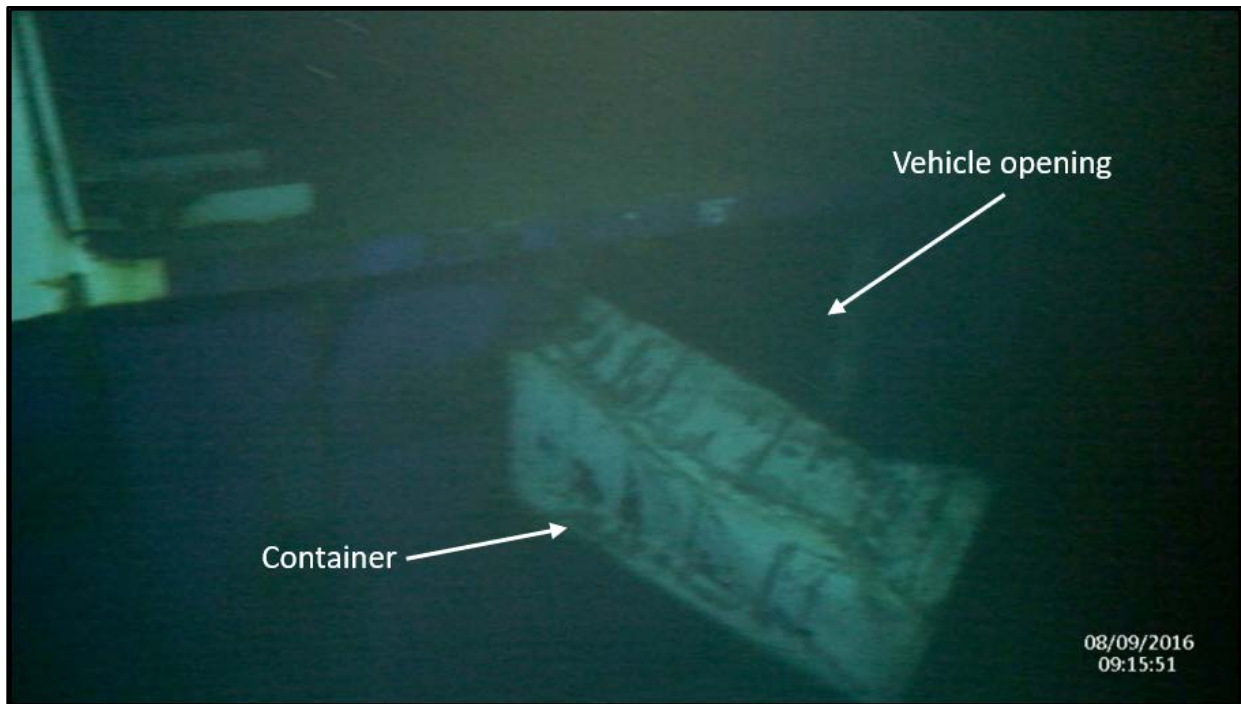
Figure 33. Container protruding through vehicle opening in bay 15, starboard side. (Image from mission 3)

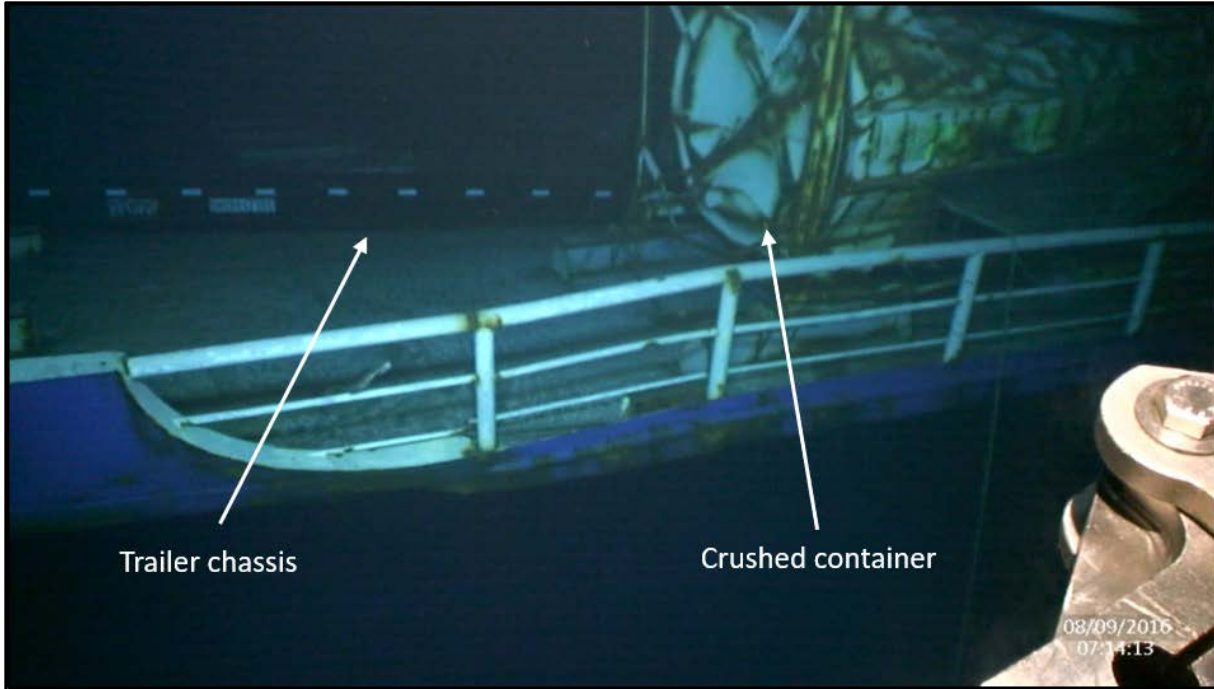
Figure 34. Crushed tank container in bay 2, starboard side. (Image from mission 3)

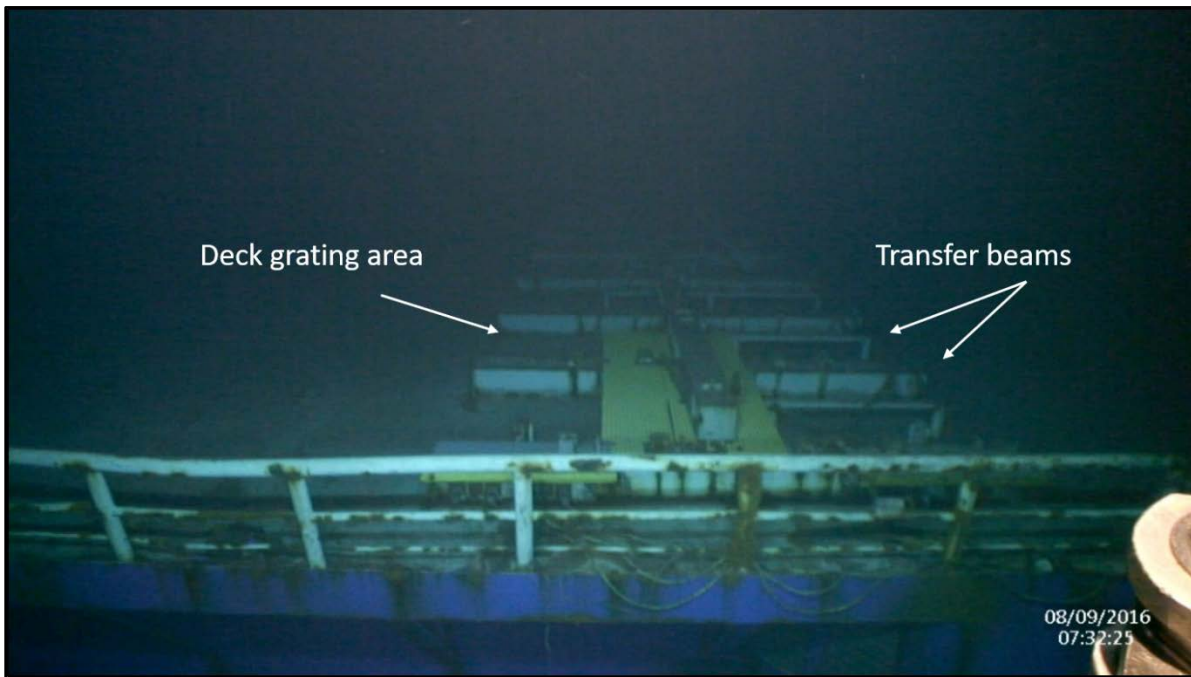
Figure 35. Fiberglass deck grating missing from container support beams, port side, with intact transfer beams. (Image from mission 3)

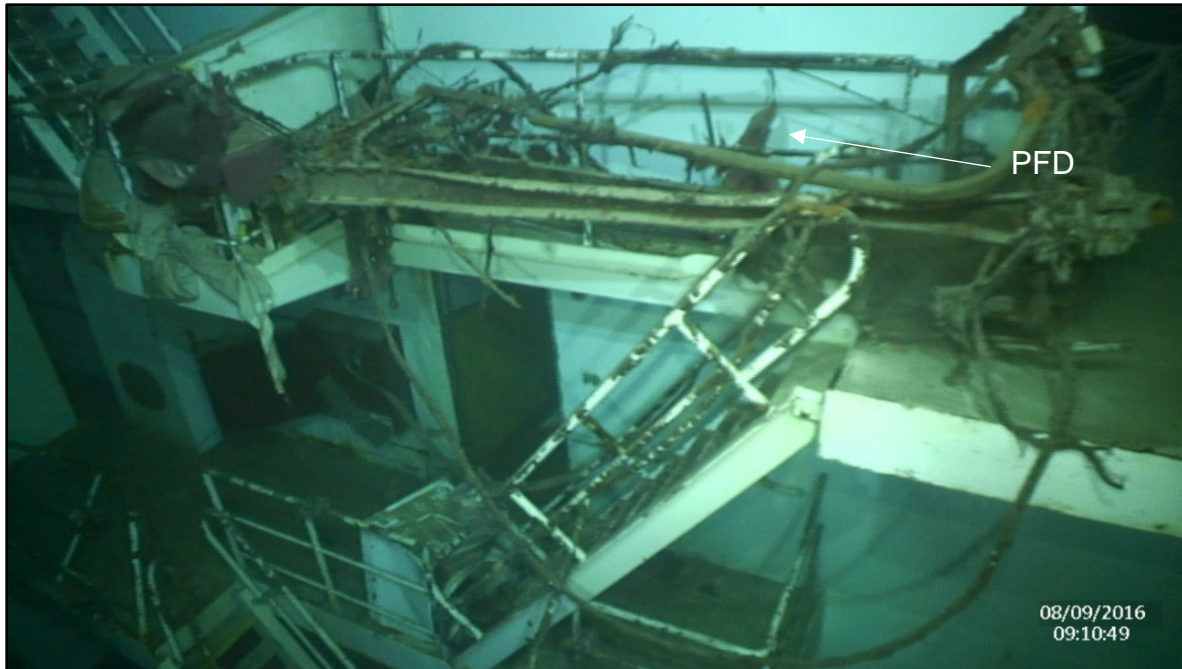
Figure 36. PFD entangled on boat deck walkway. (Image from mission 3)

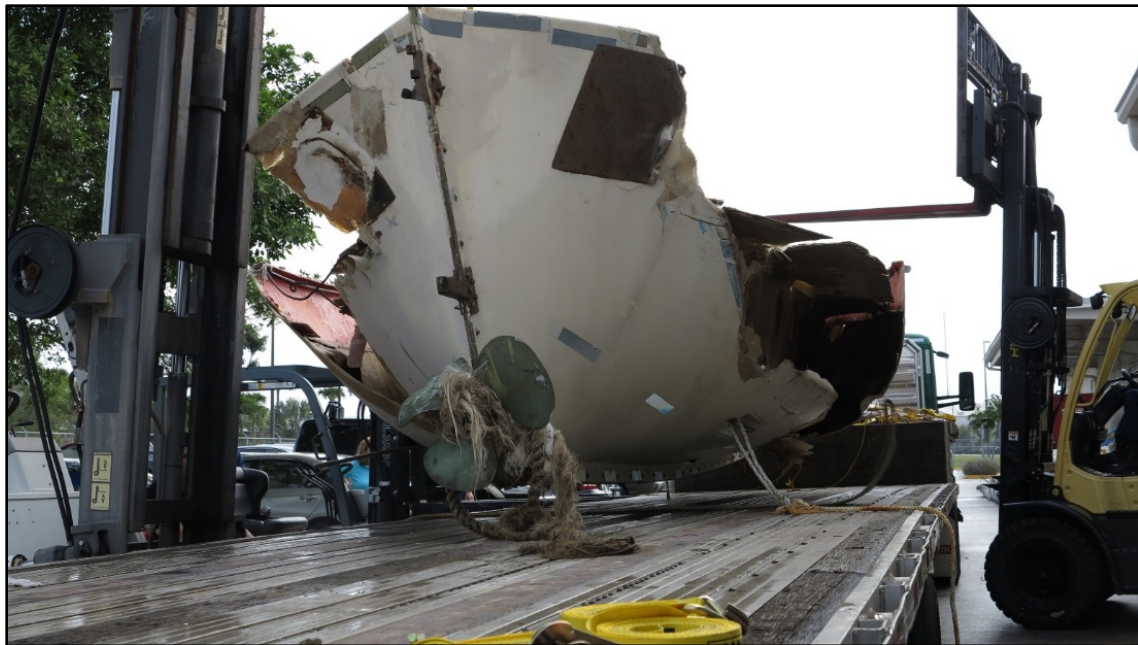
Figure 53. *El Faro's* starboard lifeboat on arrival at Coast Guard Air Station Miami. Note fouled propeller, bent propeller blade, and damage to port and starboard sides of hull.

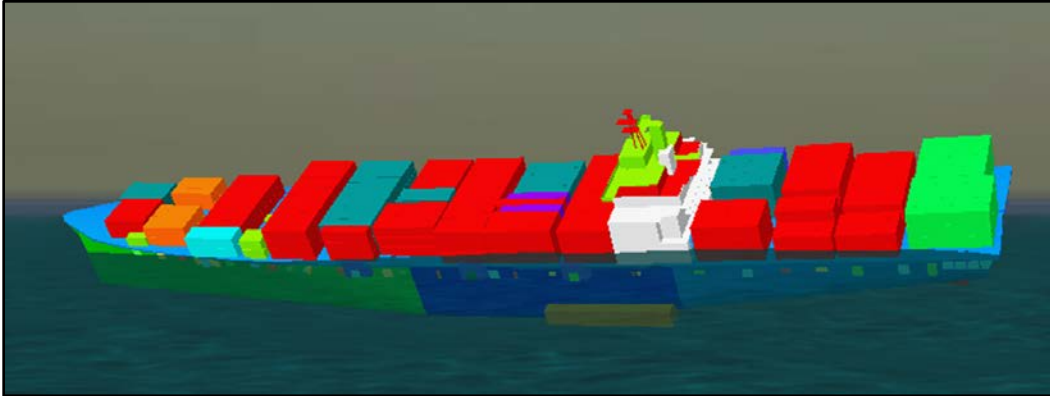
Figure 61. *El Faro* rolling about a 15° to 18° static heel with waves or green water reaching ventilation openings after propulsion loss. (Screen shot at extreme position from CSRA video simulation)

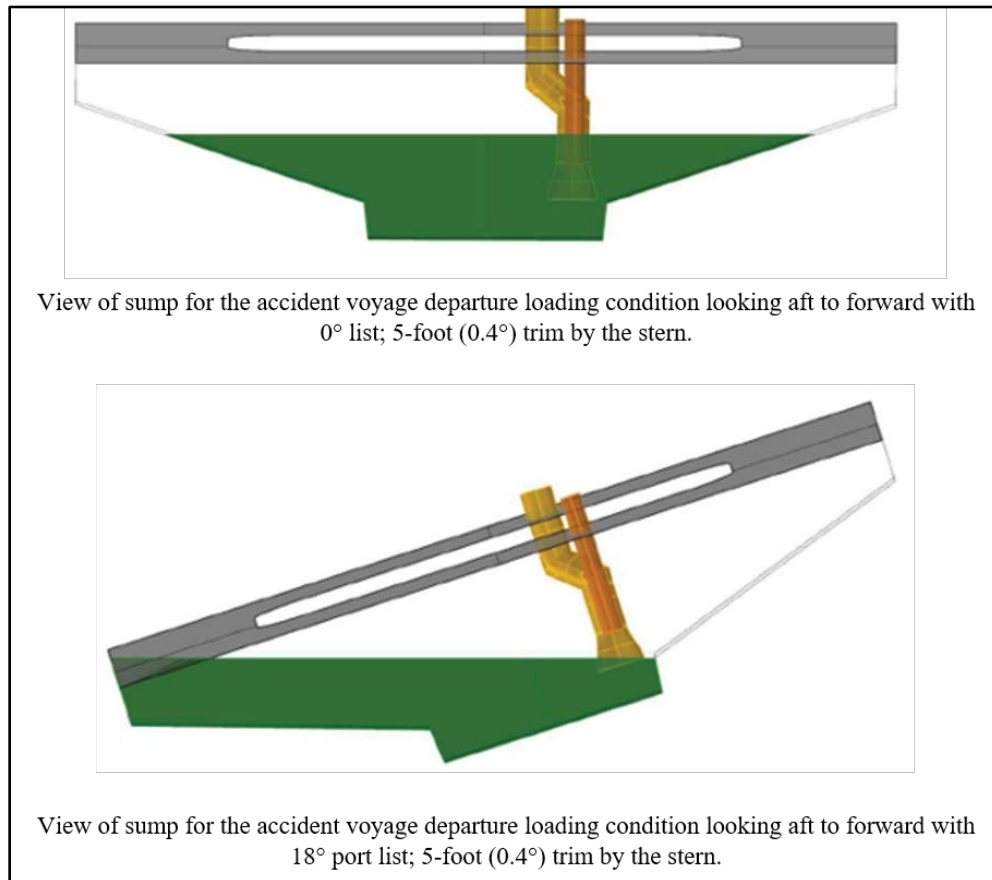
Figure 64. Effect of 18° port list on lube oil system with oil level at 26 inches. (Graphic by Coast Guard Marine Safety Center, modified by NTSB)

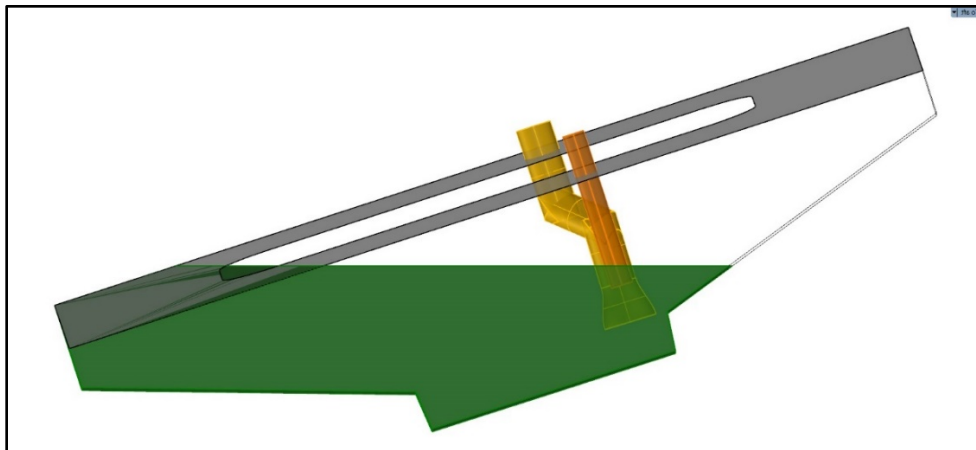
Figure 65. Effect of 18° port list on lube oil system for main engine with 32 inches of lube oil in sump, looking from aft to forward. (Graphic by Coast Guard Marine Safety Center, modified by NTSB)
