Sinking of US Cargo Vessel SS *El Faro*
Atlantic Ocean, Northeast of Acklins and Crooked Island,
Bahamas
October 1, 2015

NTSB/MAR-17/01
PB2018-100342

Marine Accident Report

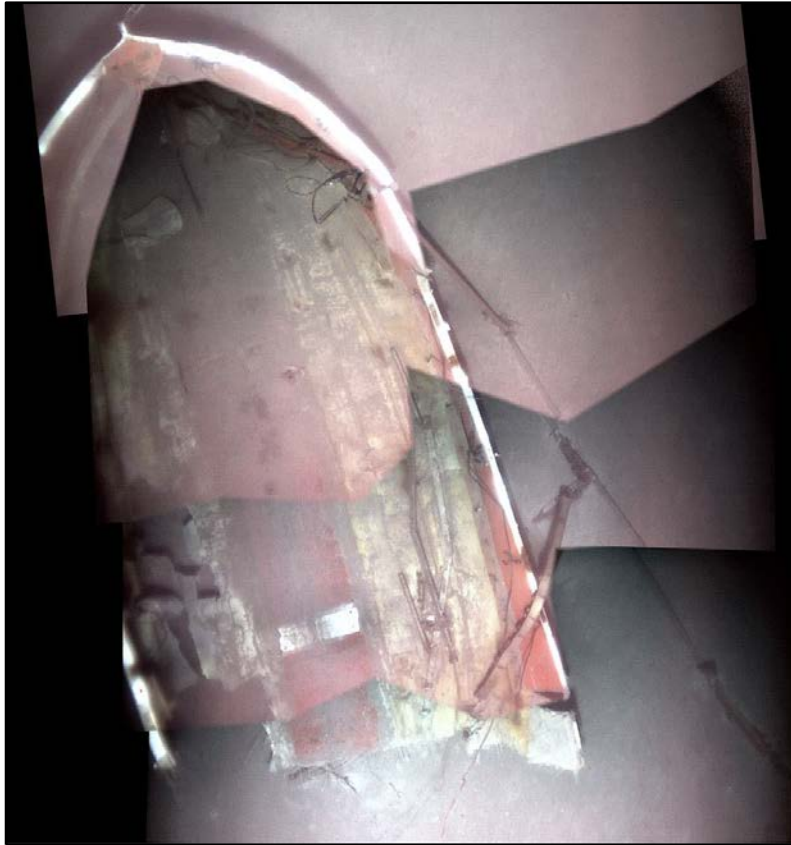
Figure 24. Photomosaic of *El Faro*'s port lifeboat from images taken during second search mission. Bench seats and other internals are missing. Reflective tape on top of gunwales is illuminated.

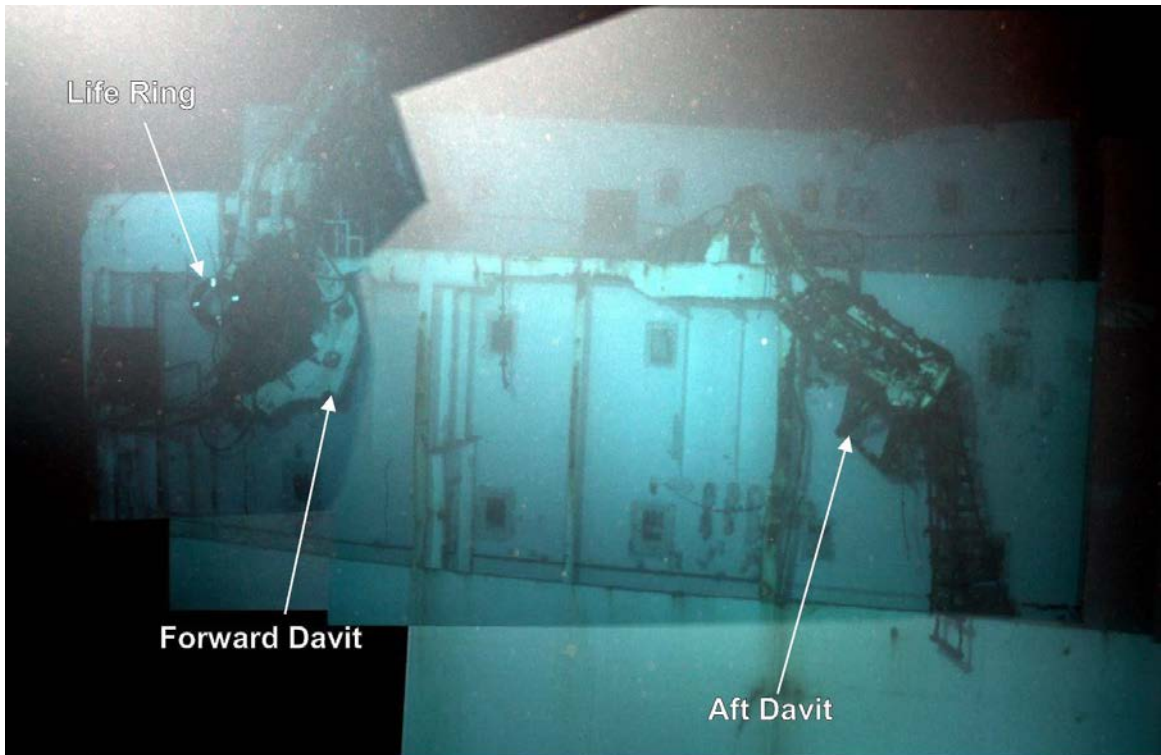
Figure 26. Gravity davits for port lifeboat, showing forward davit in place but damaged and aft davit broken and dangling. (Photomosaic image from mission 2)

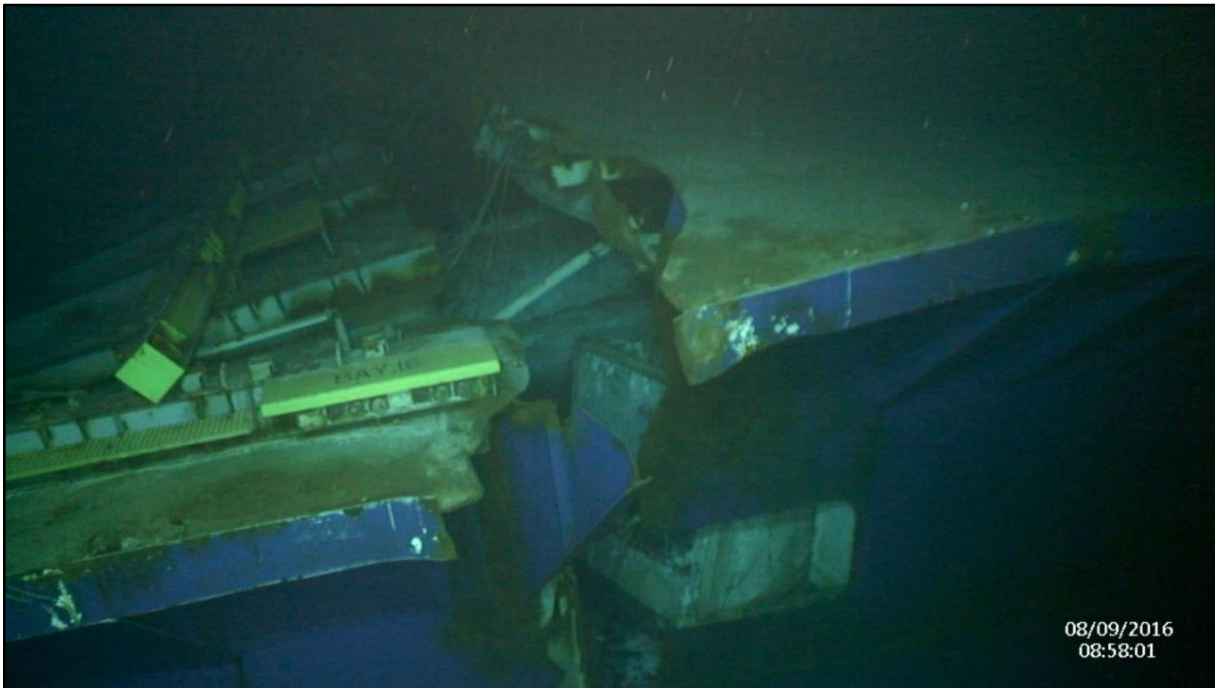
Figure 30. Hull fracture in starboard sideshell and across main deck at container bay 16, forward of frame 200. (Image from mission 3)

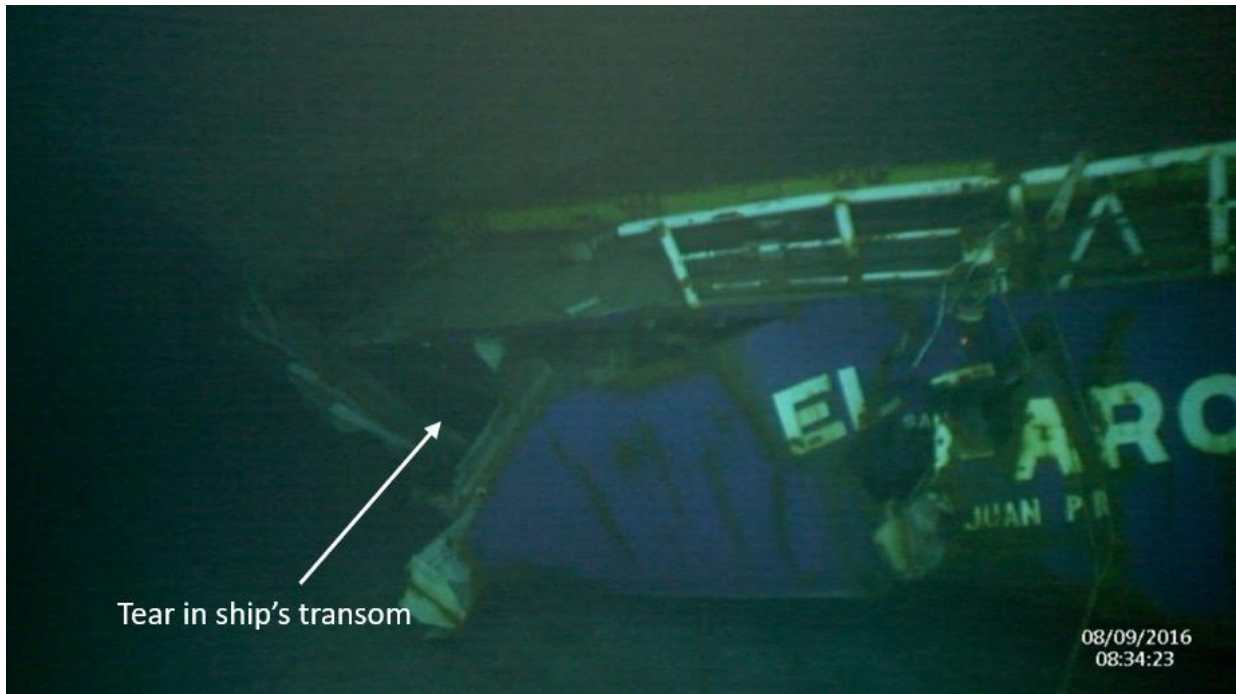
Figure 31. Tear in ship's transom. (Image from mission 3)

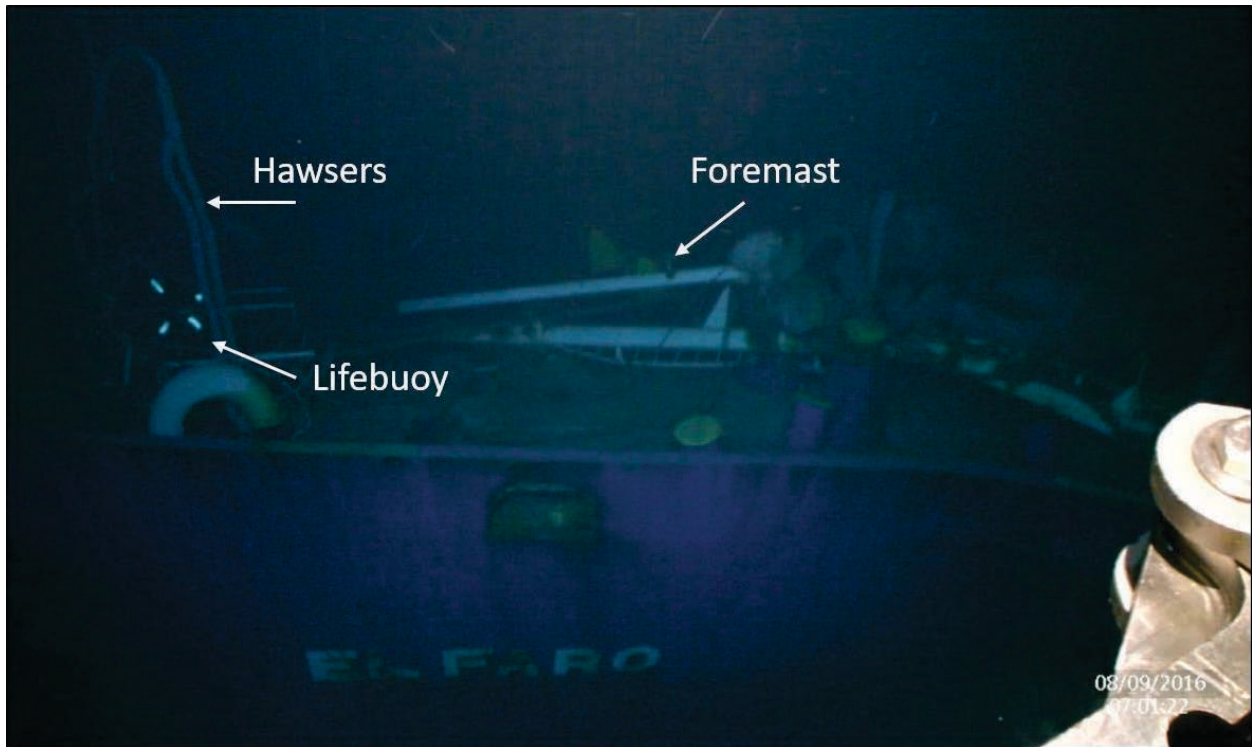
Figure 32. Foremast toppled on port side of bow; reflection is from lifebuoy on railing next to hawsers. (Image from mission 3)

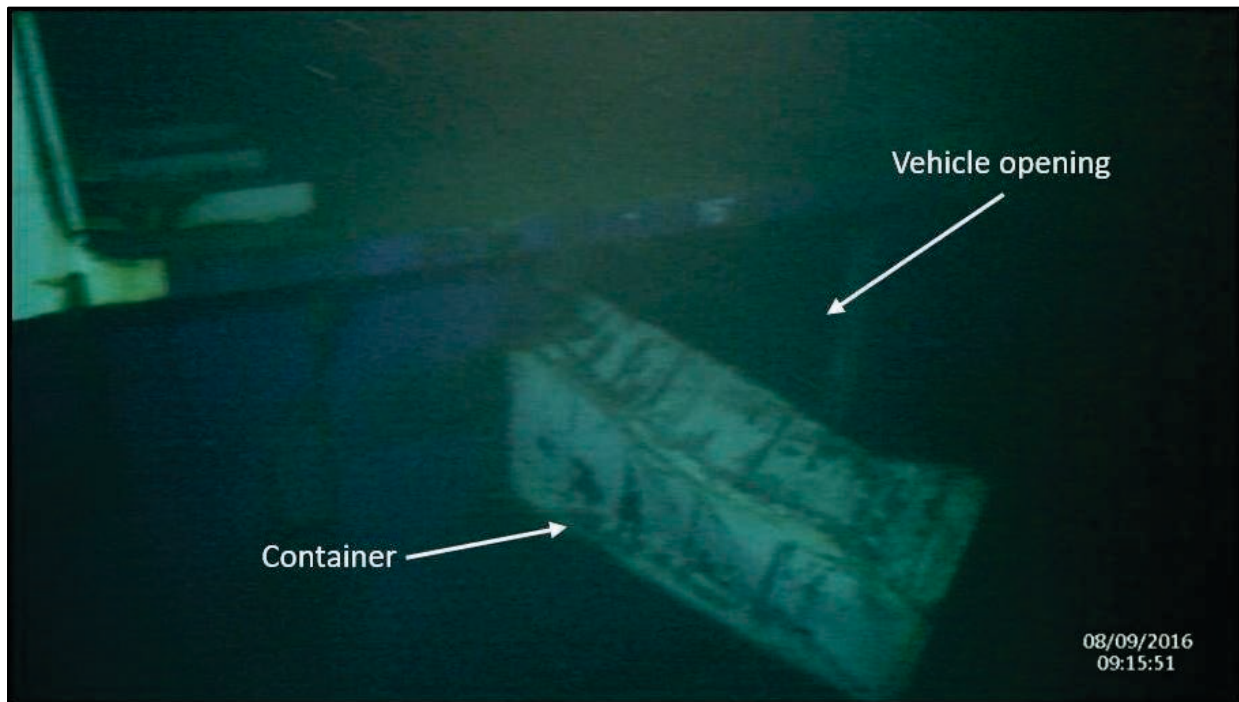
Figure 33. Container protruding through vehicle opening in bay 15, starboard side. (Image from mission 3)

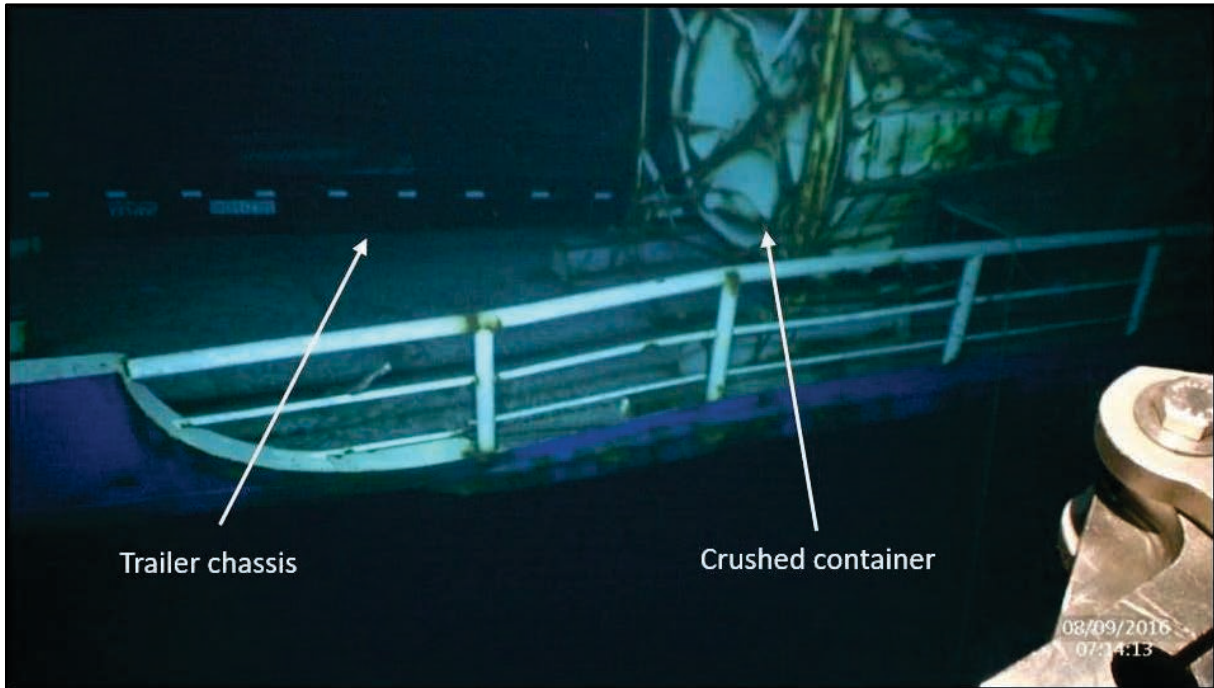
Figure 34. Crushed tank container in bay 2, starboard side. (Image from mission 3)

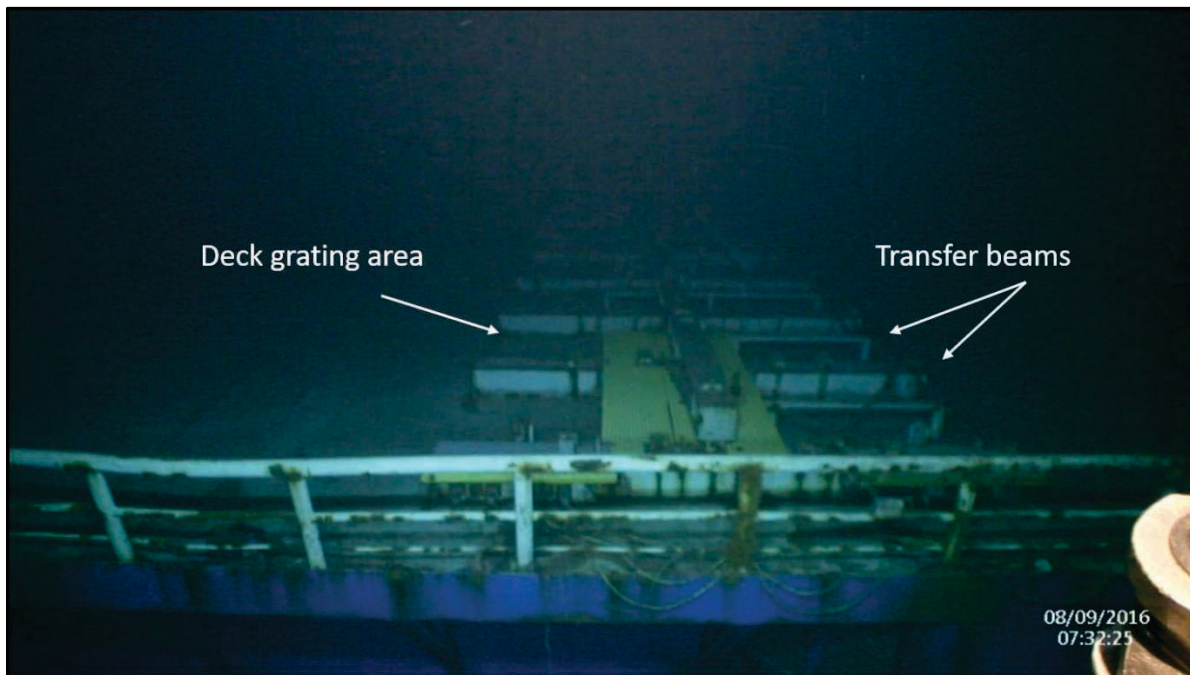
Figure 35. Fiberglass deck grating missing from container support beams, port side, with intact transfer beams. (Image from mission 3)

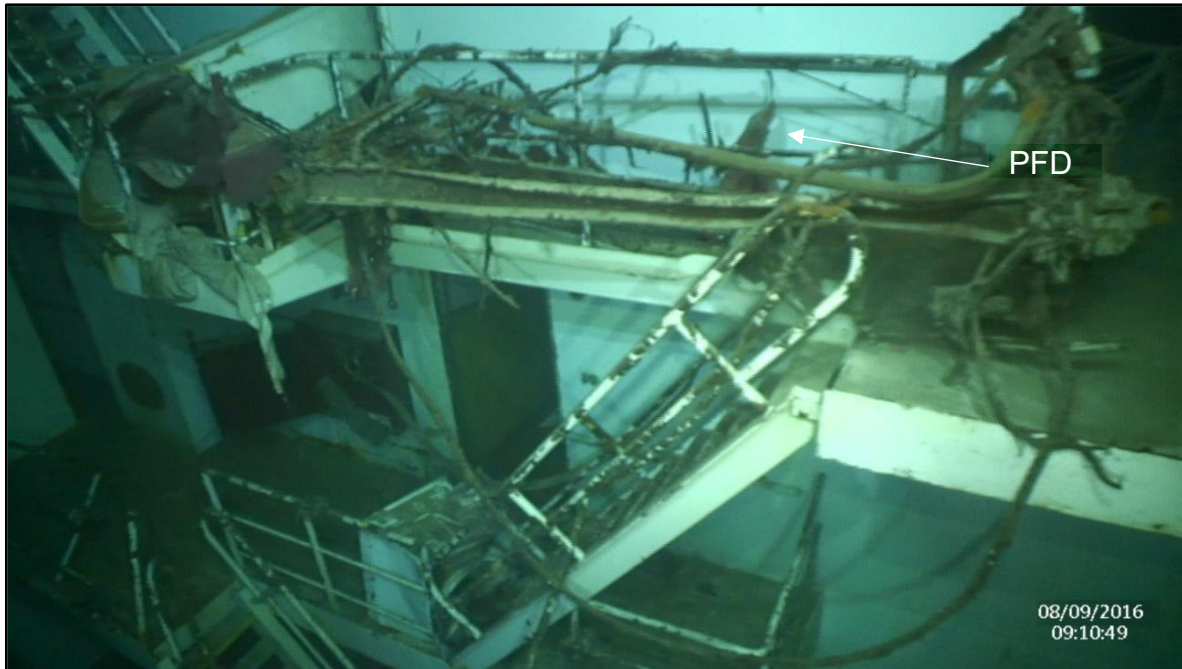
Figure 36. PFD entangled on boat deck walkway. (Image from mission 3)

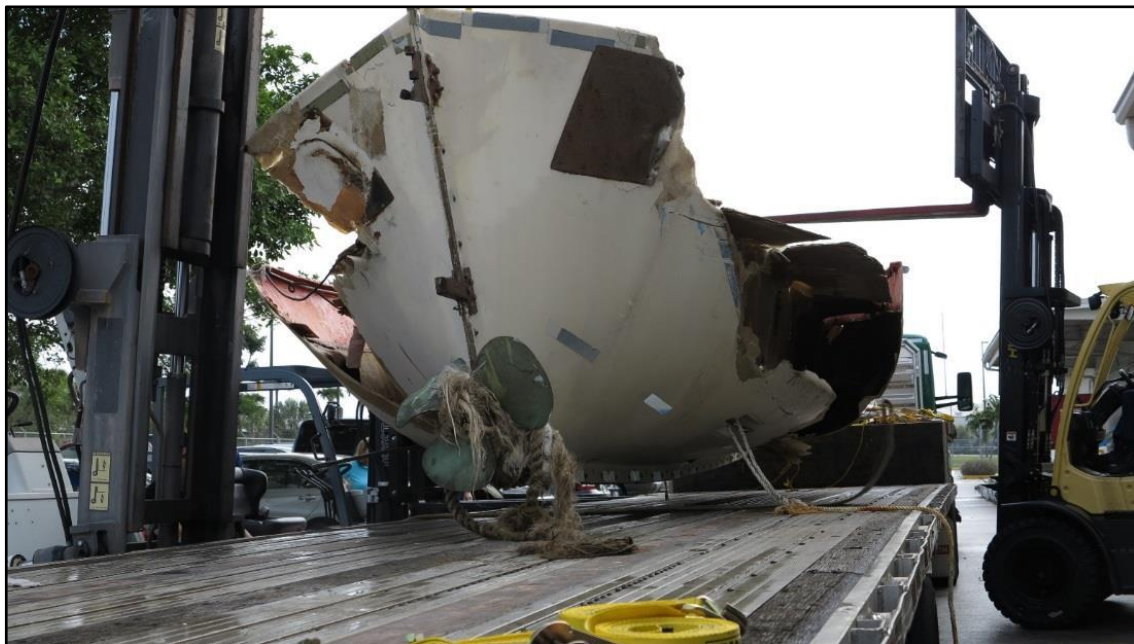
Figure 53. *El Faro's* starboard lifeboat on arrival at Coast Guard Air Station Miami. Note fouled propeller, bent propeller blade, and damage to port and starboard sides of hull.

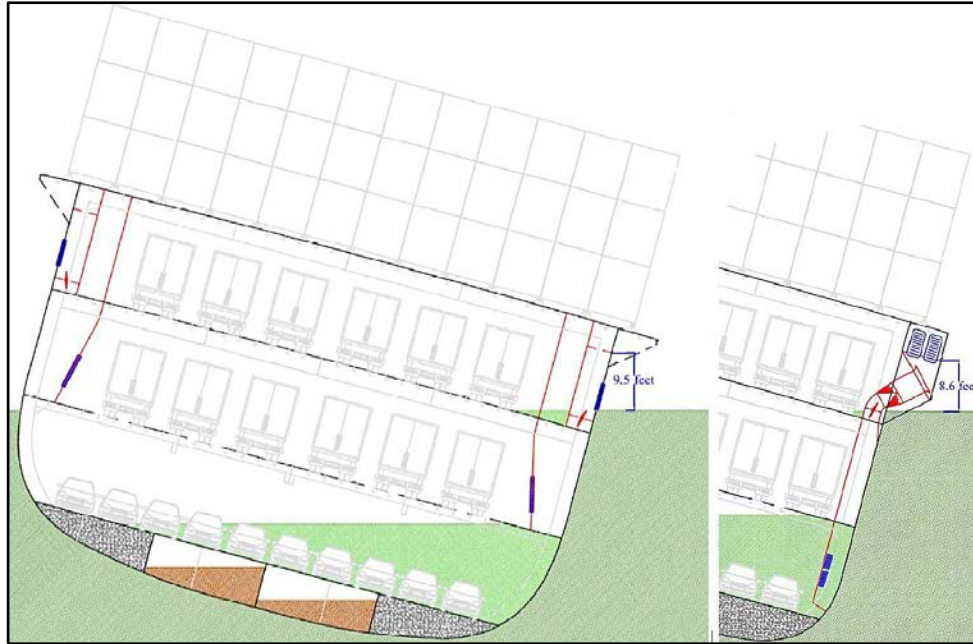
Figure 59. Ventilation supply trunk (right) and aft exhaust trunk (left) in hold 3, with flooding of hold to 20 percent (0.7 permeability) and heel angle of 15°. (Adapted from figure 6-18 in MSC 2017)

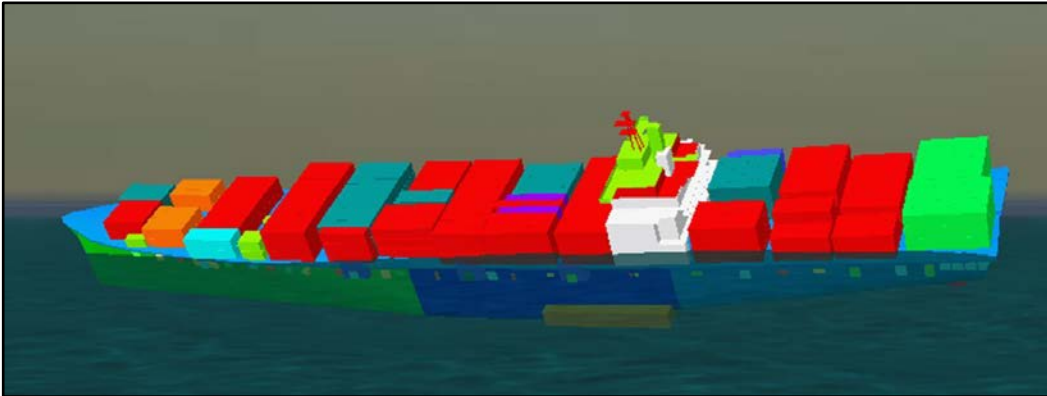
Figure 61. *El Faro* rolling about a 15° to 18° static heel with waves or green water reaching ventilation openings after propulsion loss. (Screen shot at extreme position from CSRA video simulation)

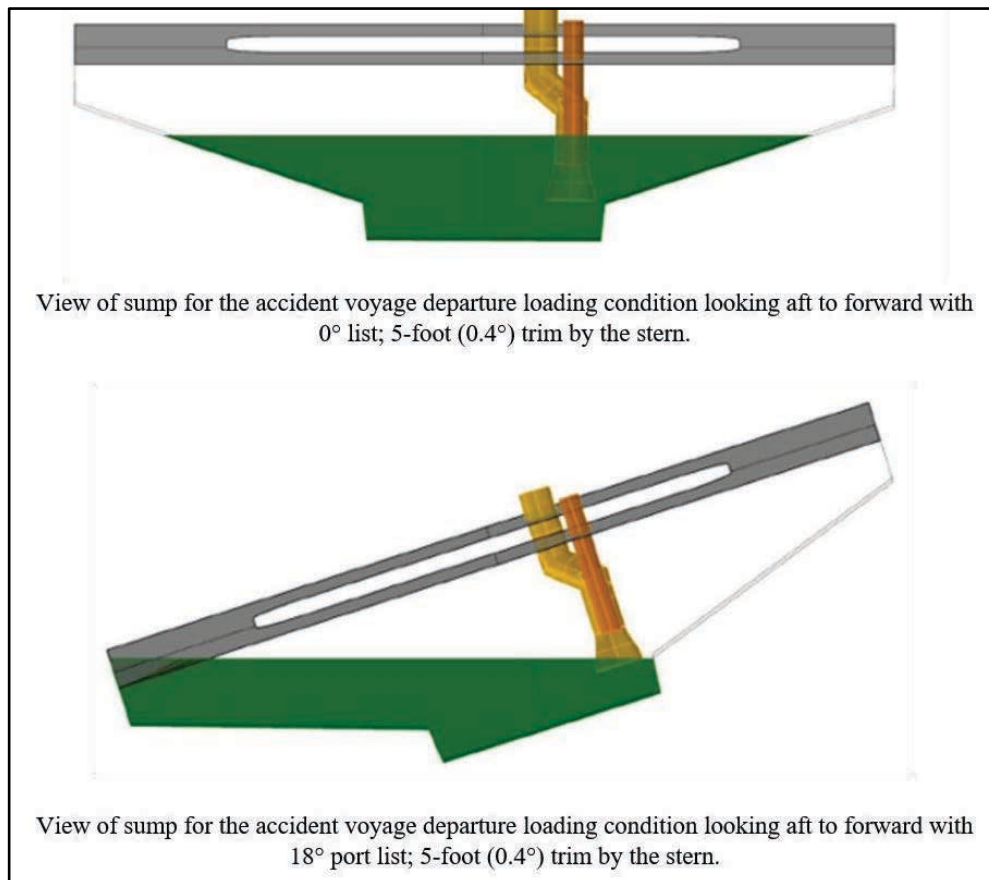
Figure 64. Effect of 18° port list on lube oil system with oil level at 26 inches. (Graphic by Coast Guard Marine Safety Center, modified by NTSB)

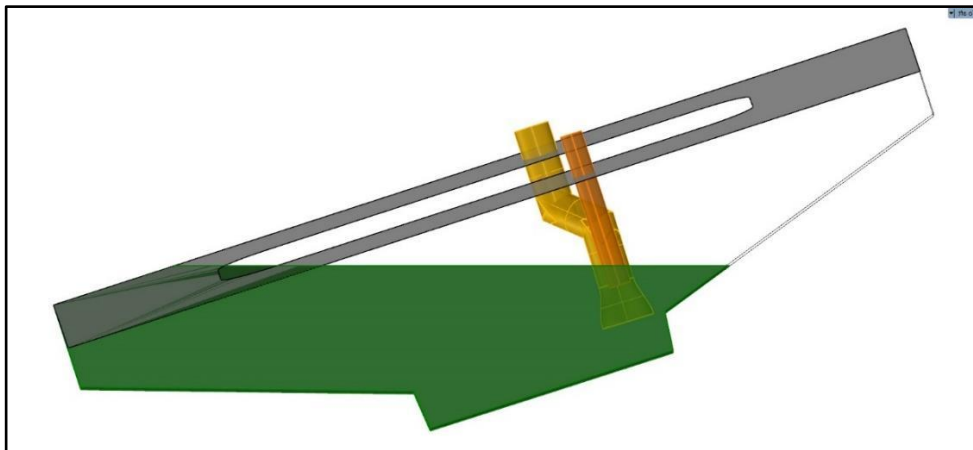
Figure 65. Effect of 18° port list on lube oil system for main engine with 32 inches of lube oil in sump, looking from aft to forward. (Graphic by Coast Guard Marine Safety Center, modified by NTSB)
