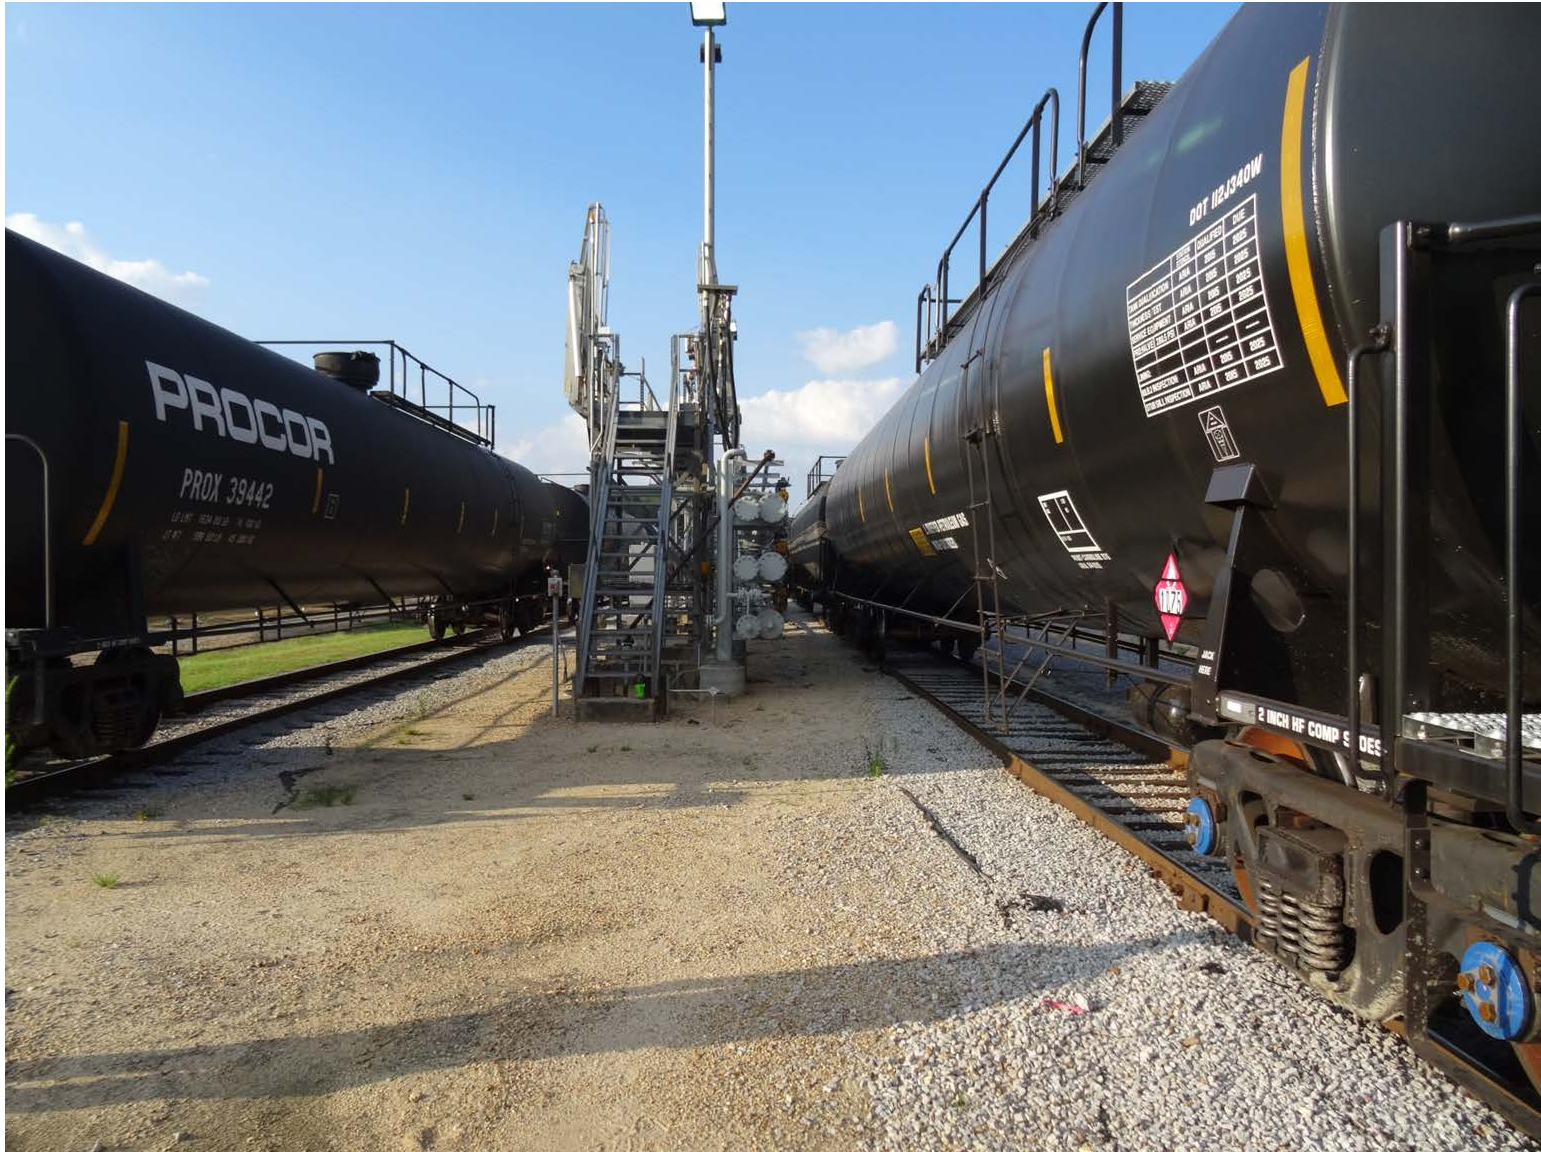
Photo facing south, showing two tracks separated by pipe rack

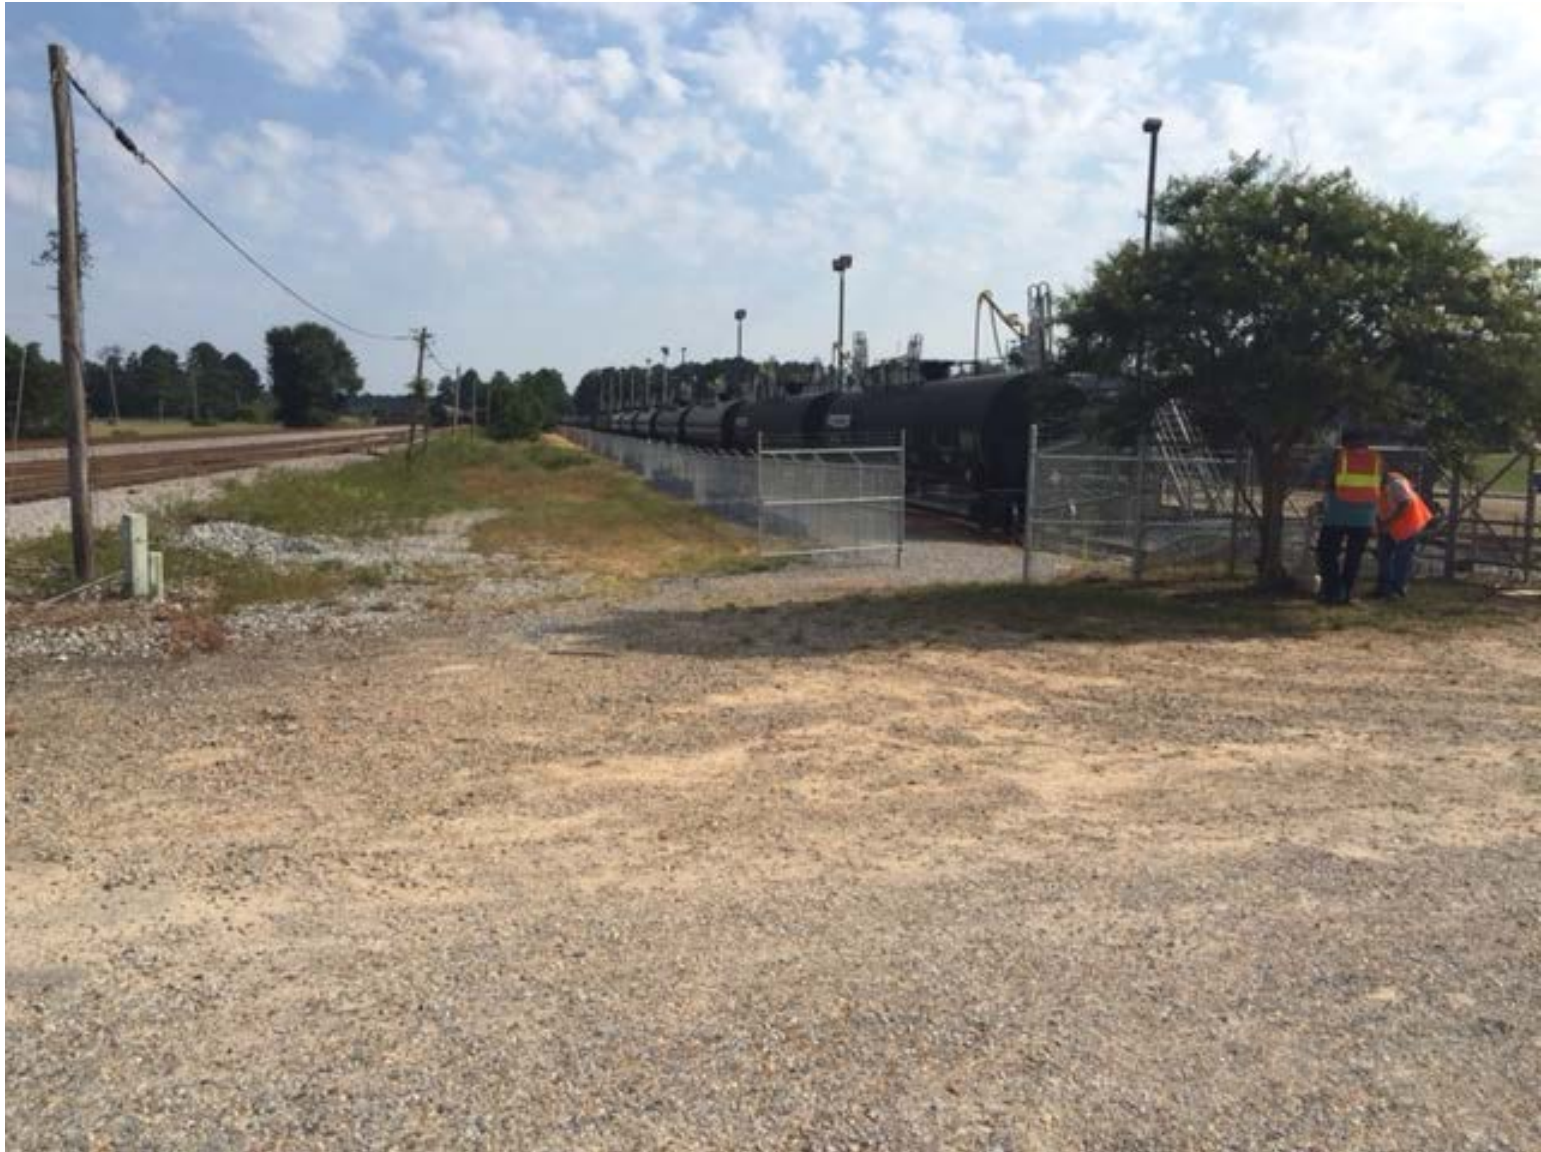
Photo looking at gate at south end (end of tracks) in plant.

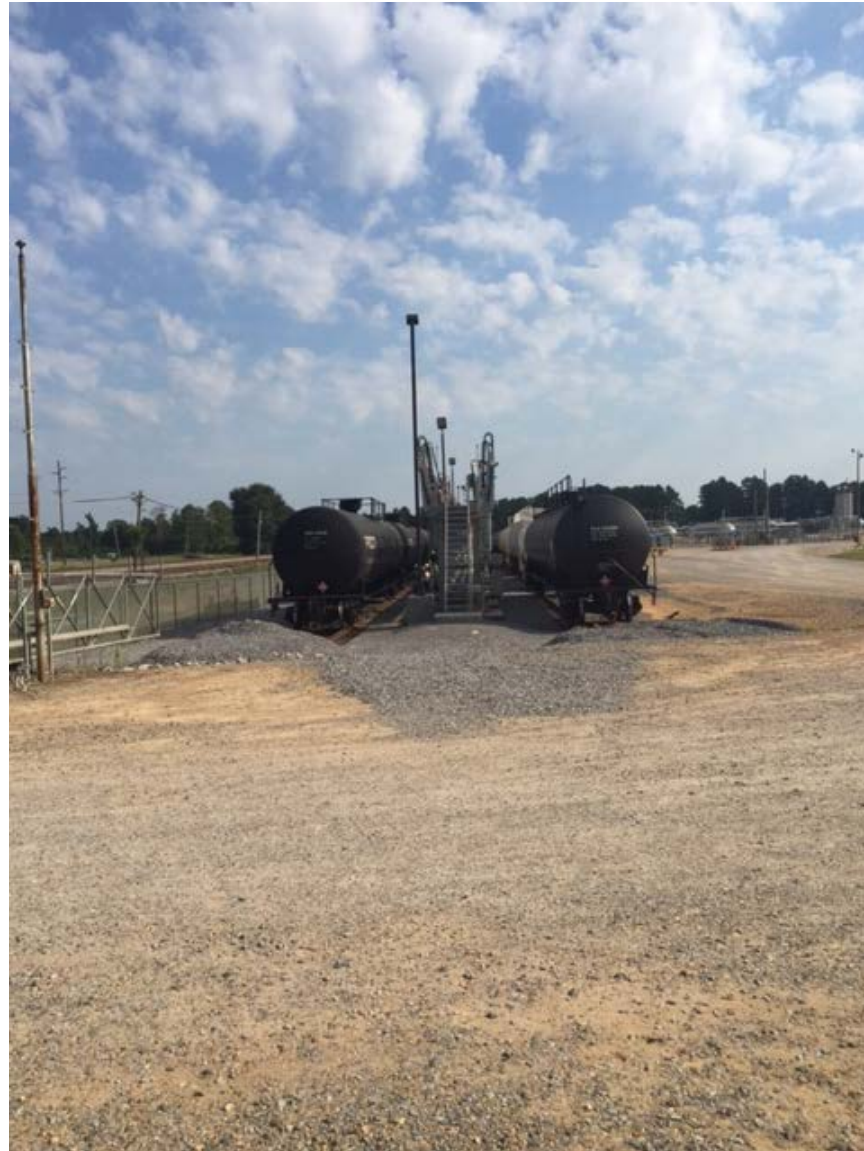
Photo facing north toward the end of the tracks.

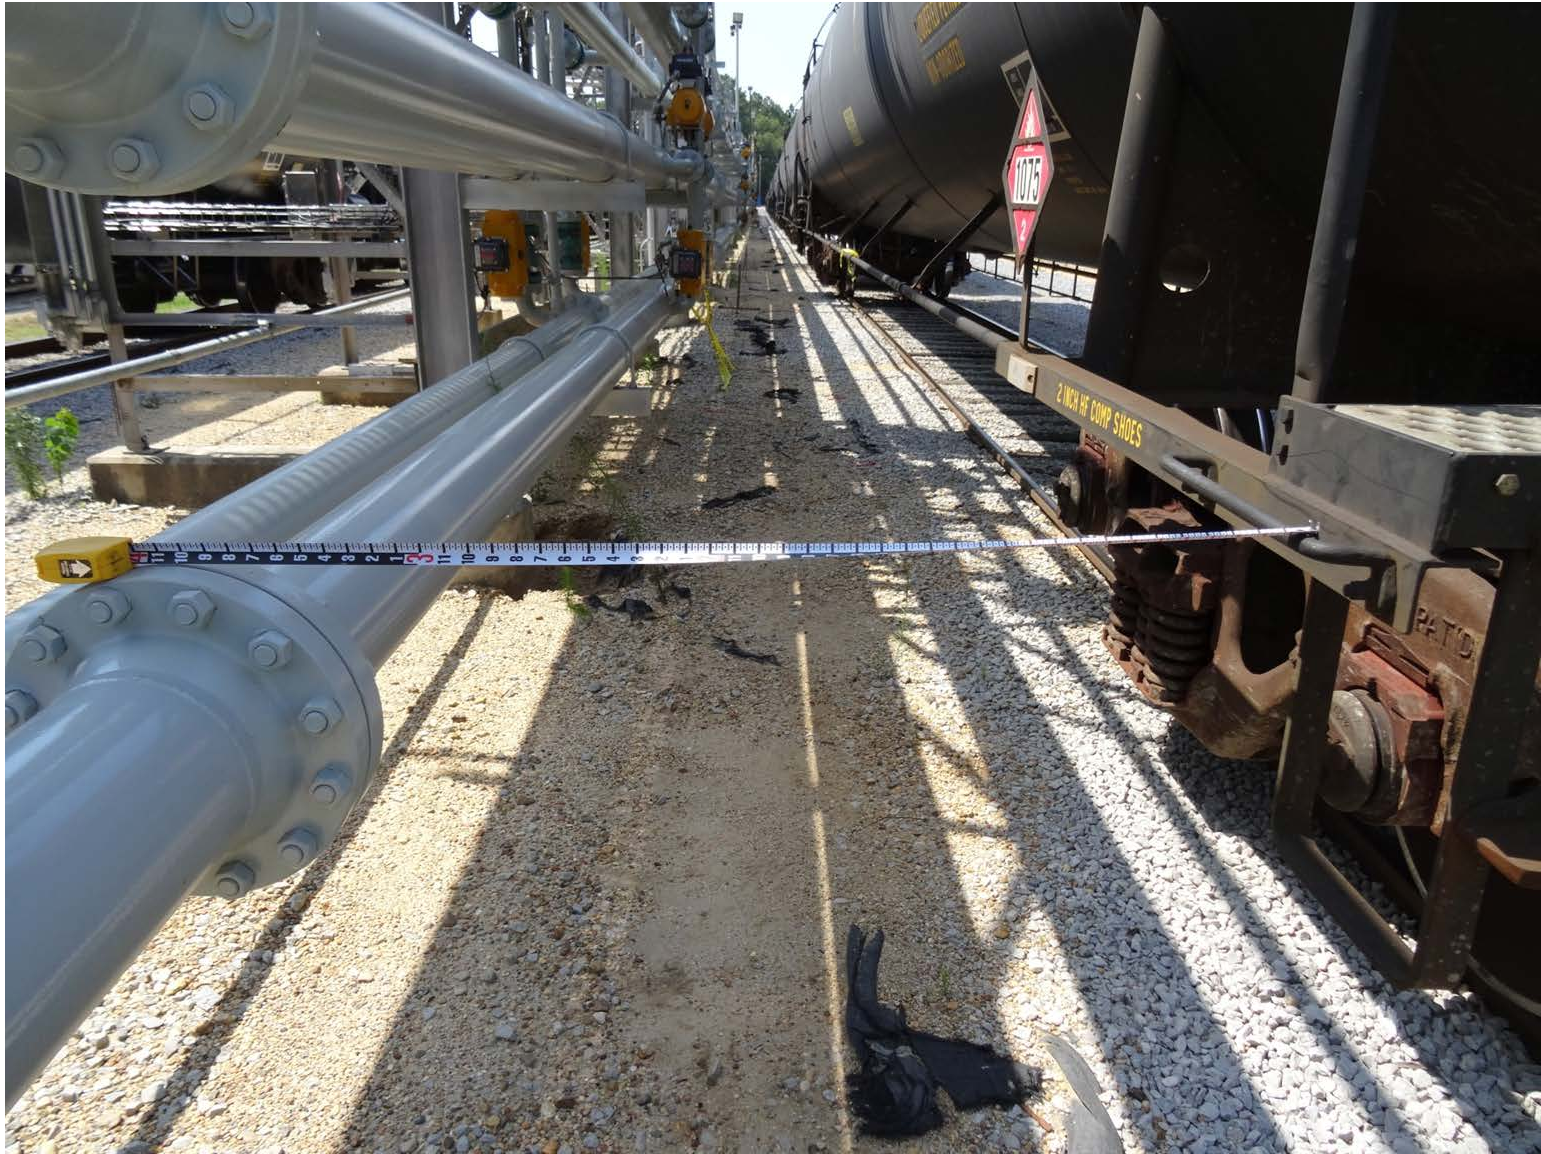
Photo between east track and pipe rack, measurement of clearance shown.

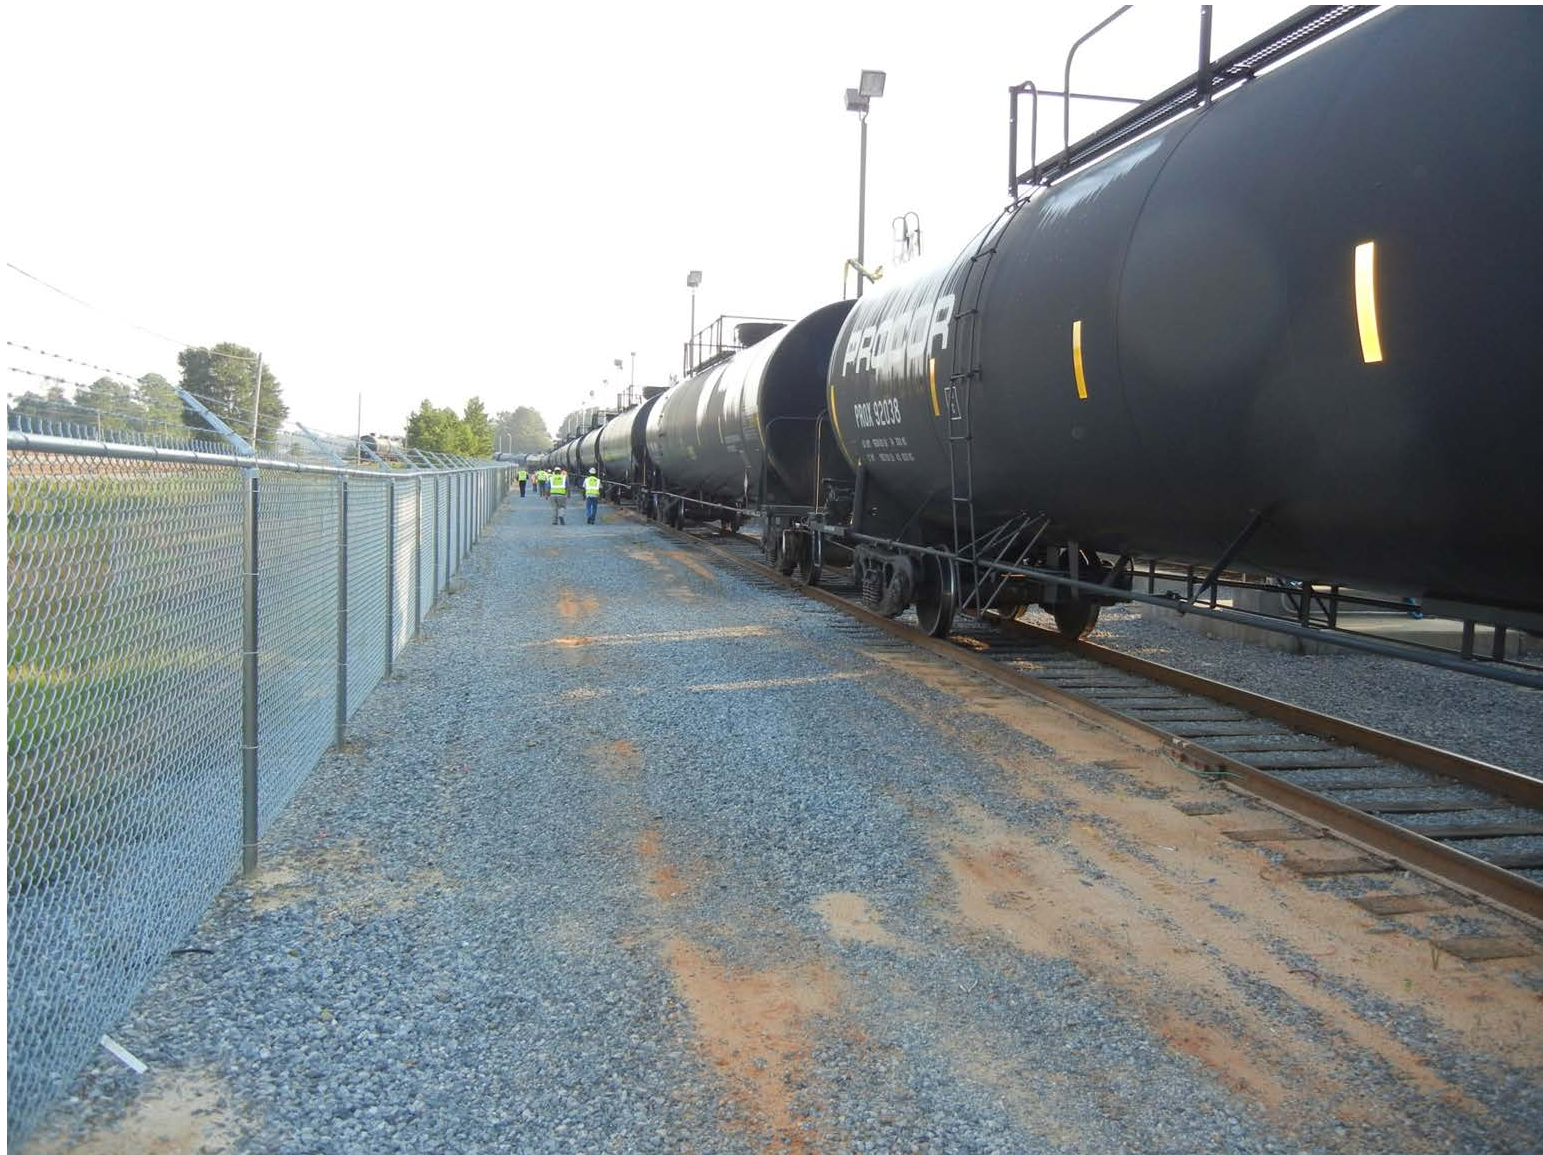
Photo facing north approaching the accident location from the roadbed, east of the east track.

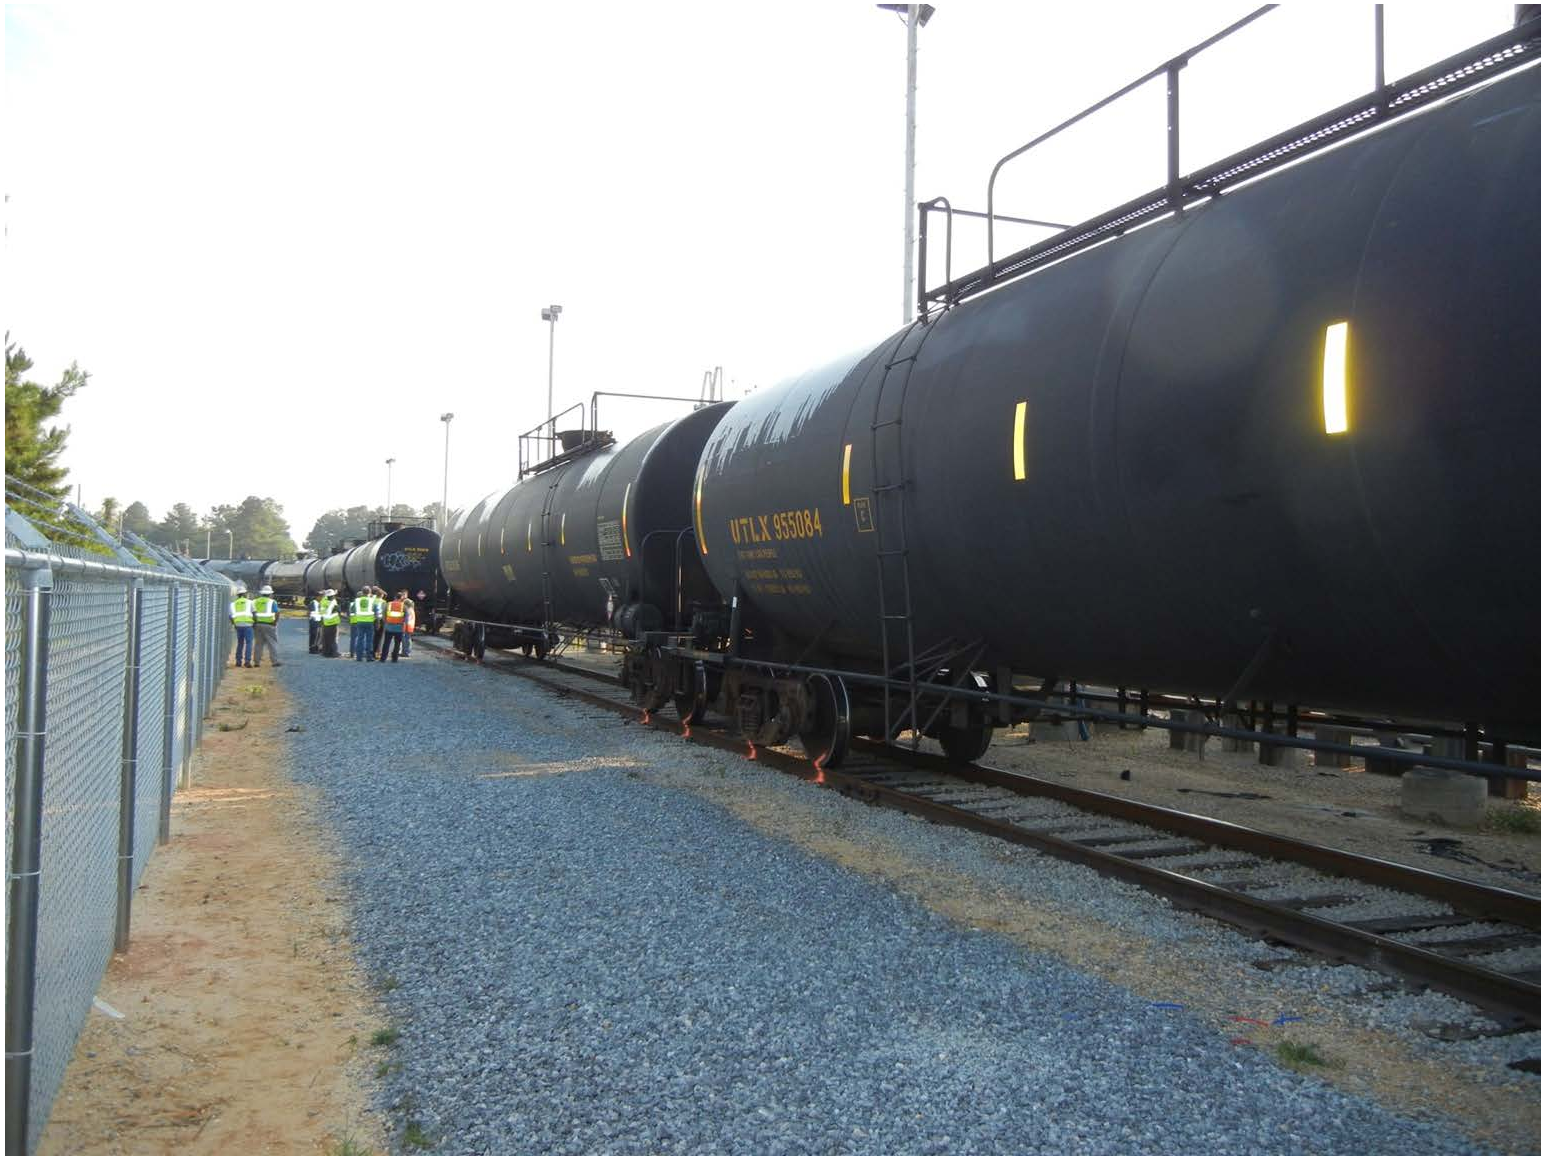
Photo facing north, accident occurred where the cars are separated, adjacent to group of people in photo. Note location of wheels are marked where they came to rest following the accident.

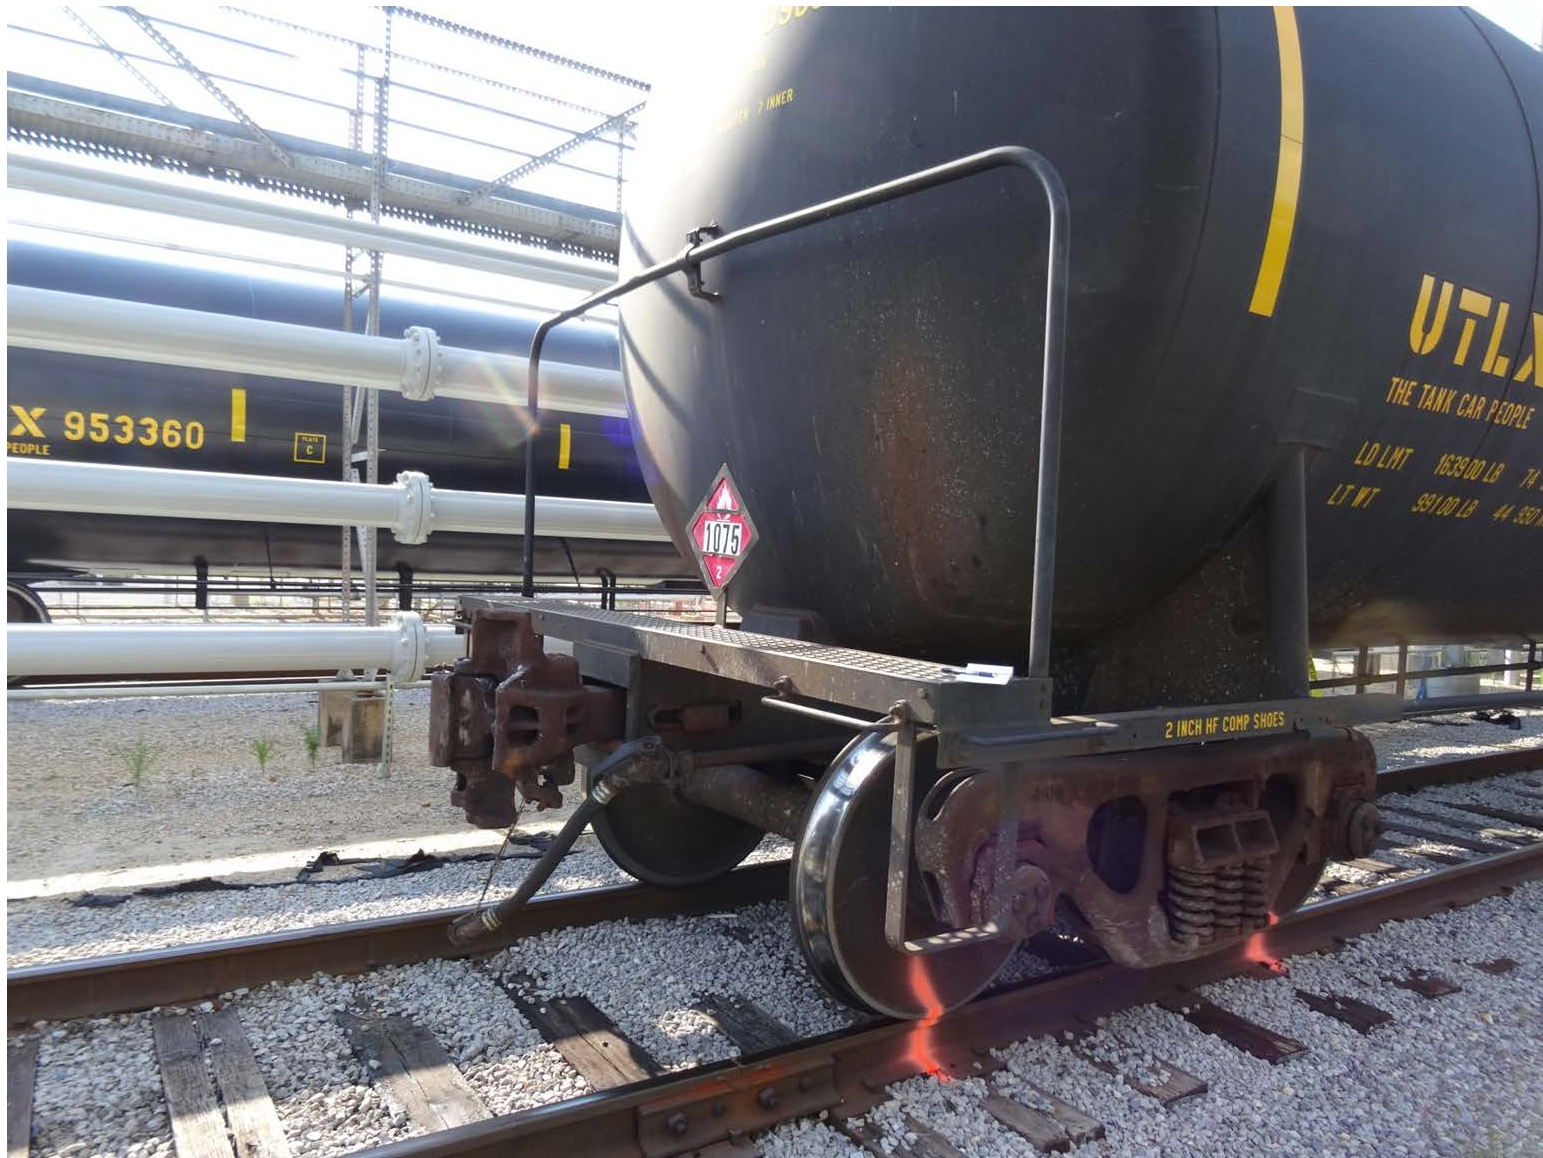
A-end of Car Number UTLX-953966, employee was found in this location.

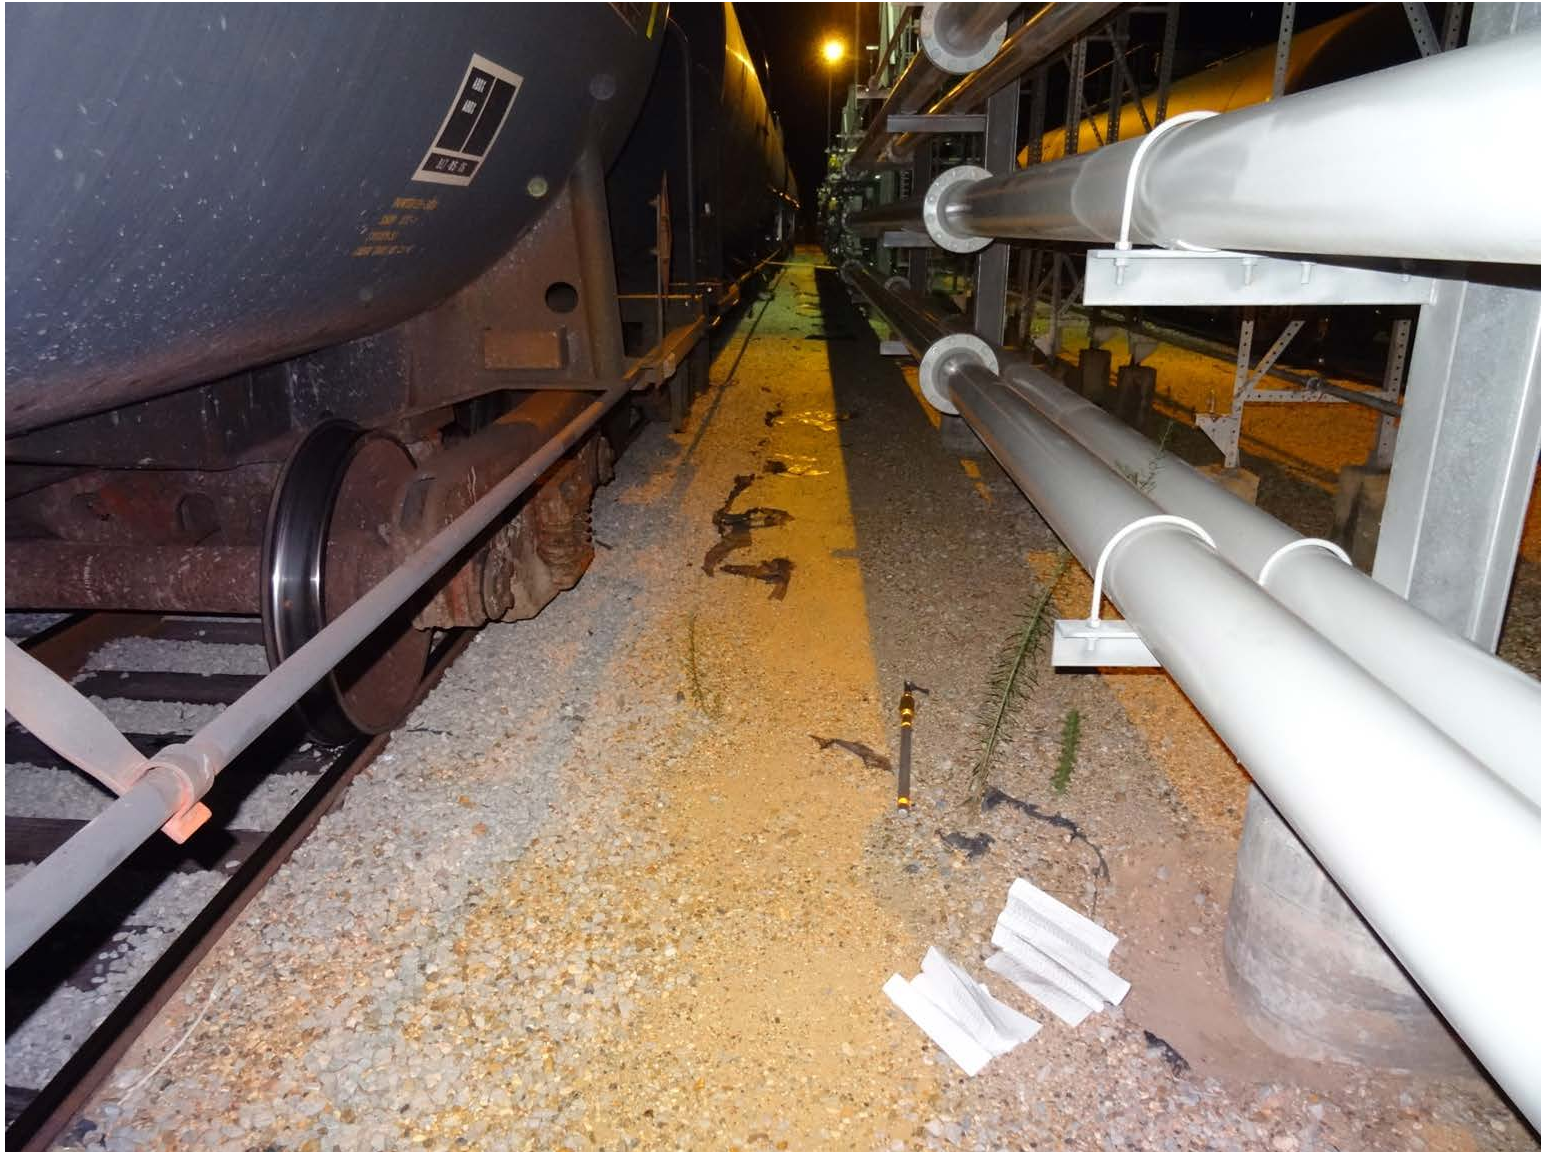
Photo facing north between the east track and the pipe rack.  
Note a brake stick and train documentation on the ground.
