NATIONAL TRANSPORTATION SAFETY BOARD

SITE and ON-SCENE INFORMATION

**NTSB Accident: WPR17FA055
Accident Date: January 12, 2017**

Location: Lake Hughes, California
Date: January 12, 2017
Aircraft: Mooney M20J, N6201N, Serial # 24-0590
NTSB IIC: Michael Huhn

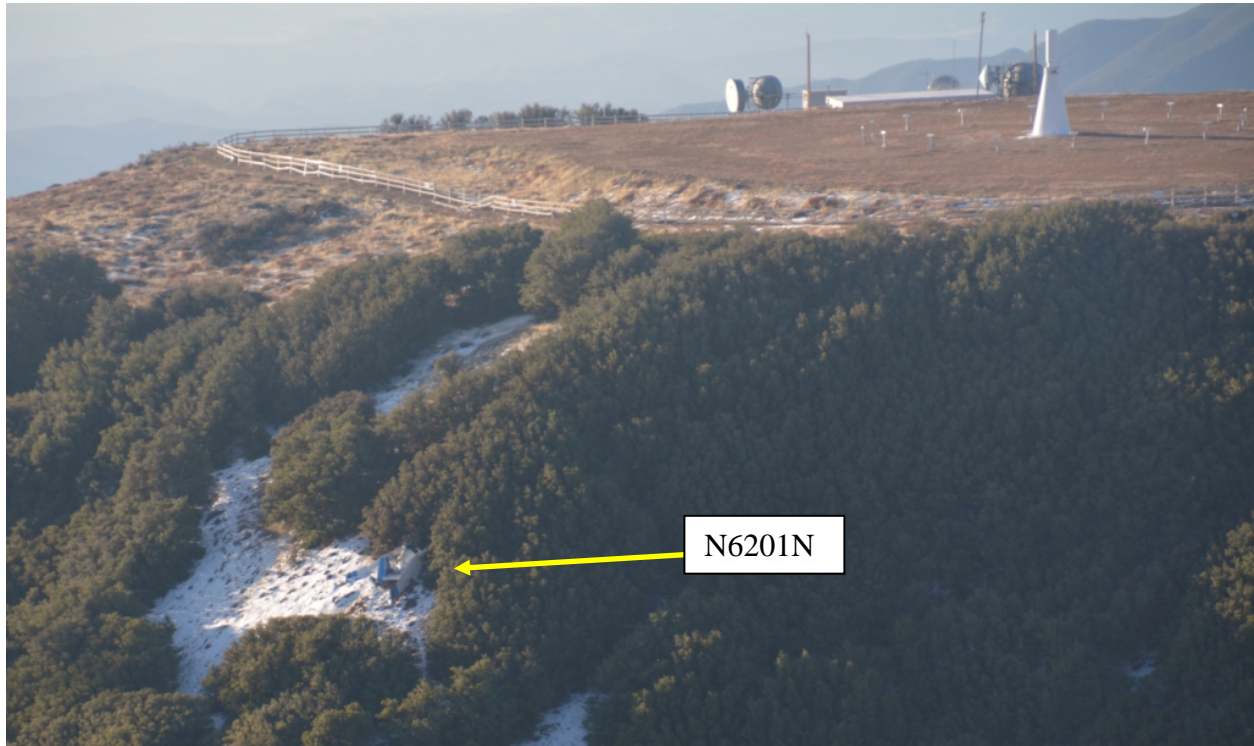
LHS VOR is situated on a leveled-off mountaintop; its elevation is 5,793 feet. The wreckage was situated on the north slope of that peak, about 70 feet below, and 380 feet from, the LHS VOR antenna. The wreckage site was at the terminus of the ATC ground tracking radar data track that originated from TSP on January 12.

Figure 1 - Wreckage and Lake Hughes VOR

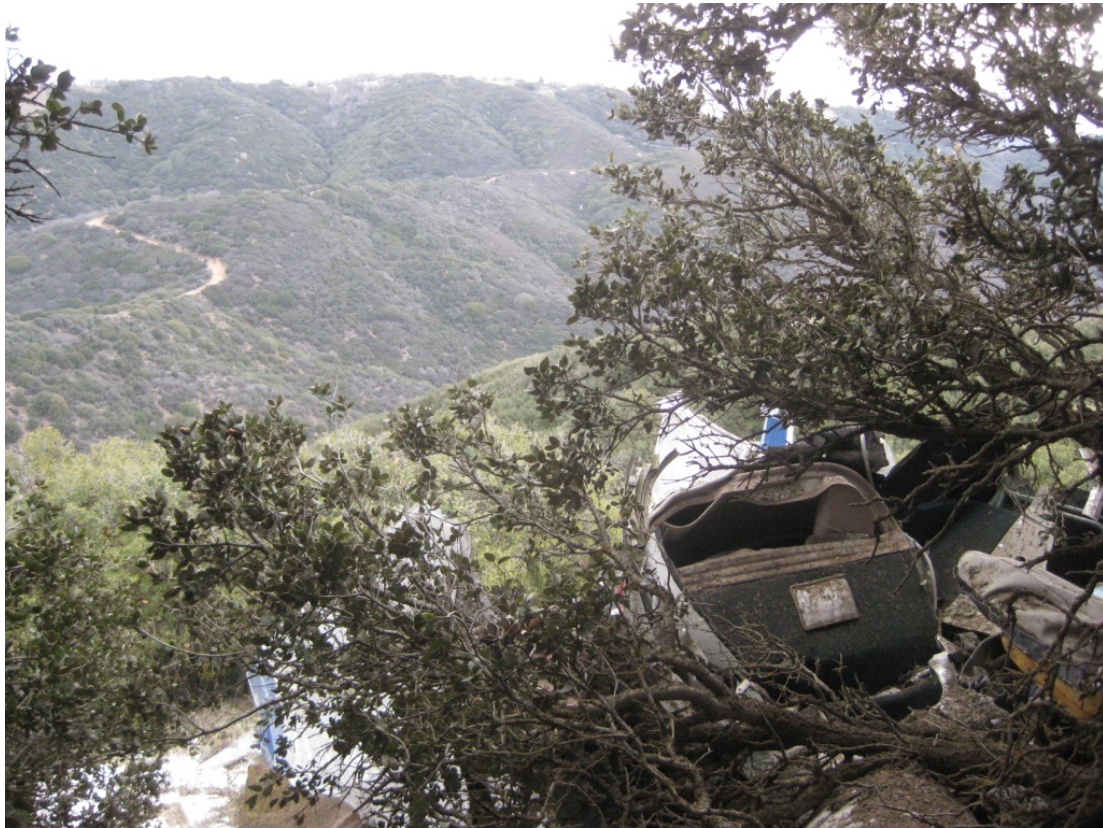
Figure 2 - View Back Along Flight Path

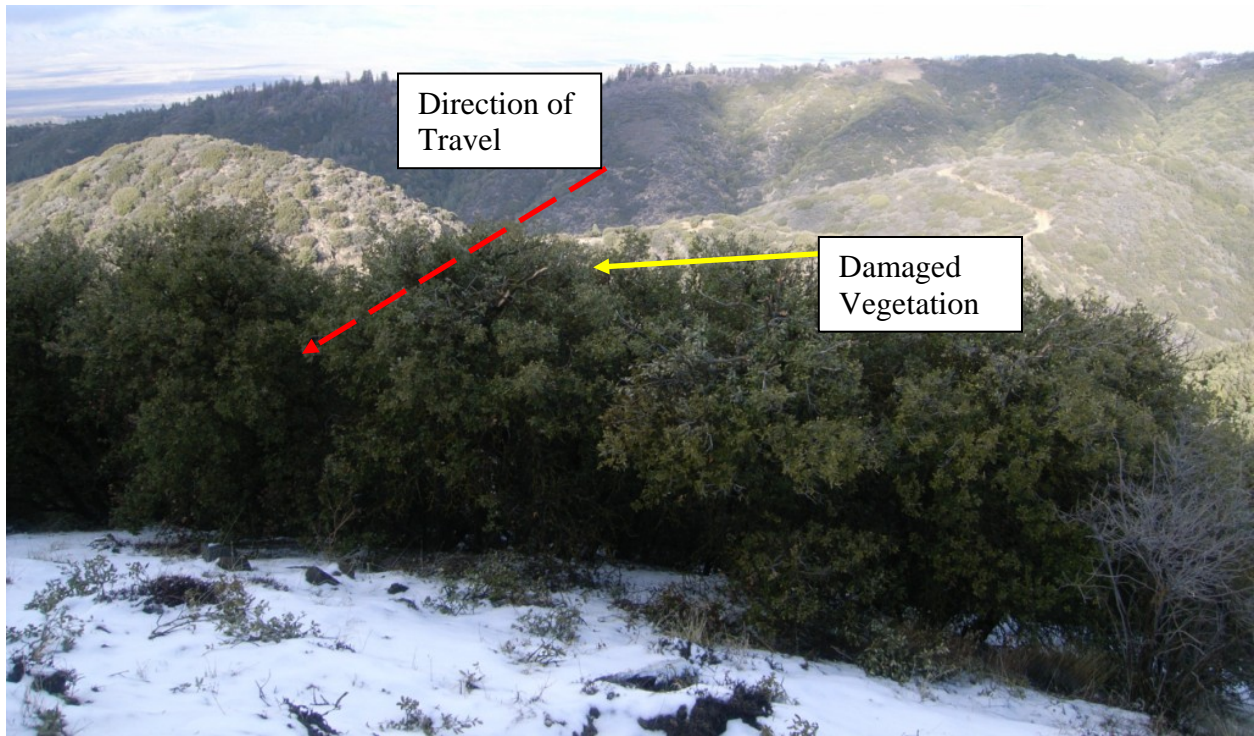
- The airplane first struck low (up to about 10 feet) scrub vegetation, and then grassy earth, before impacting the heavy scrub vegetation where it came to rest

Figure 3 - View Back Along Flight Path (note damaged vegetation)

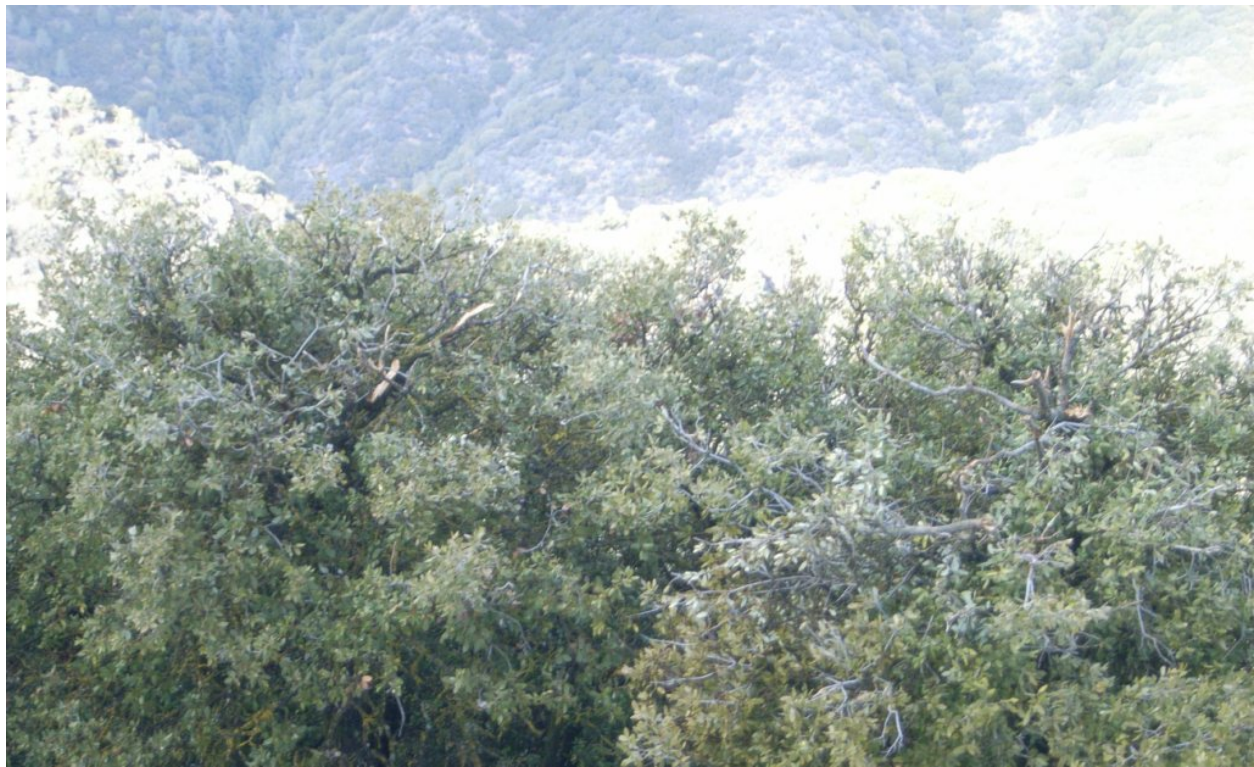
Figure 4 - Damaged Vegetation

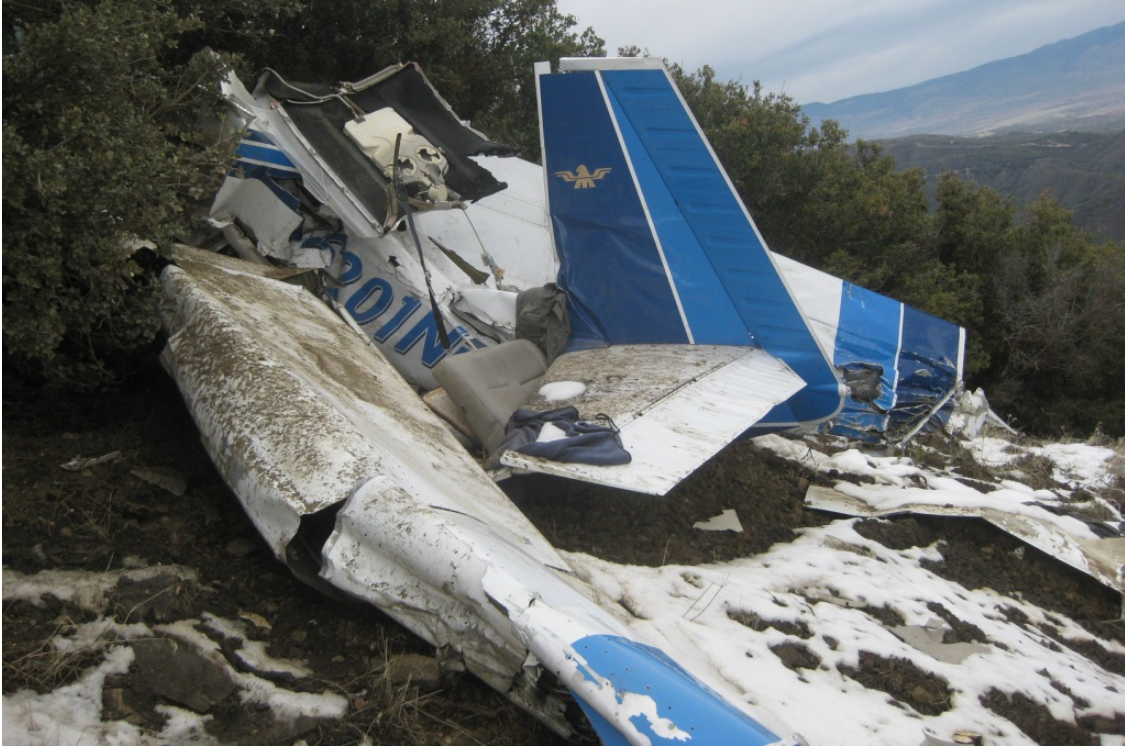
Figure 5 - Left Wing and Empennage

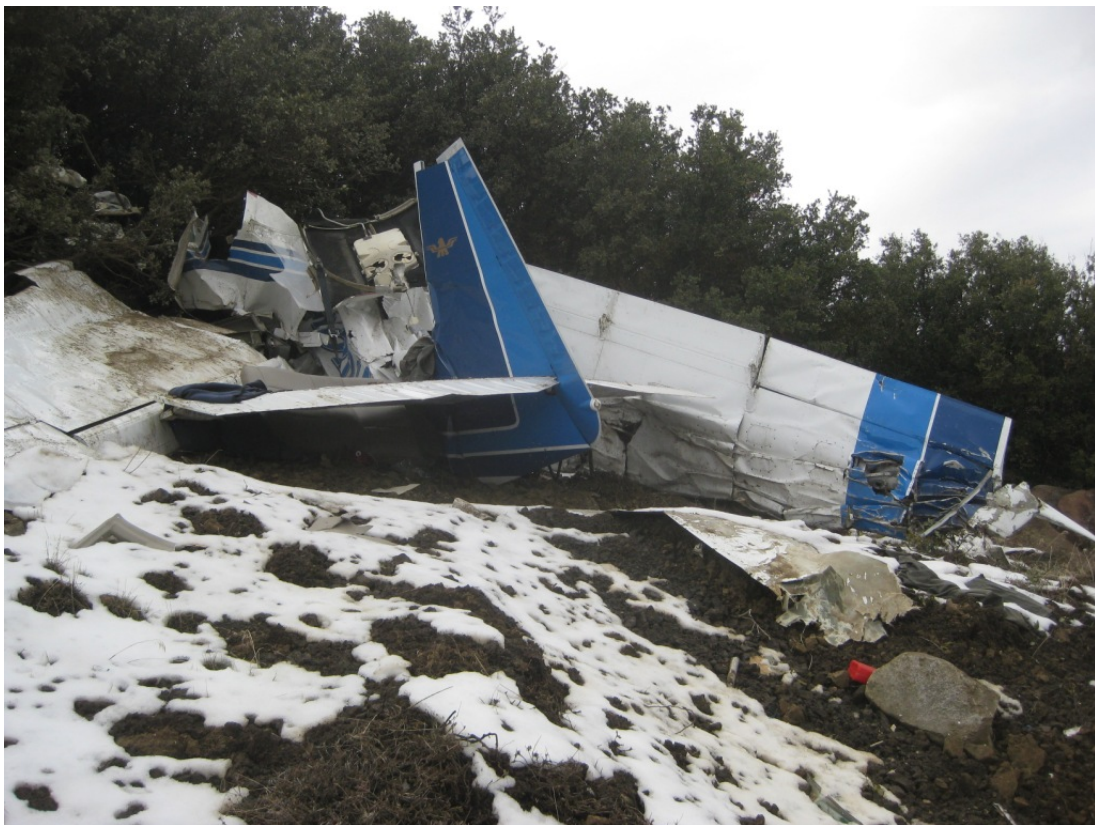
Figure 6 - Left Aft View

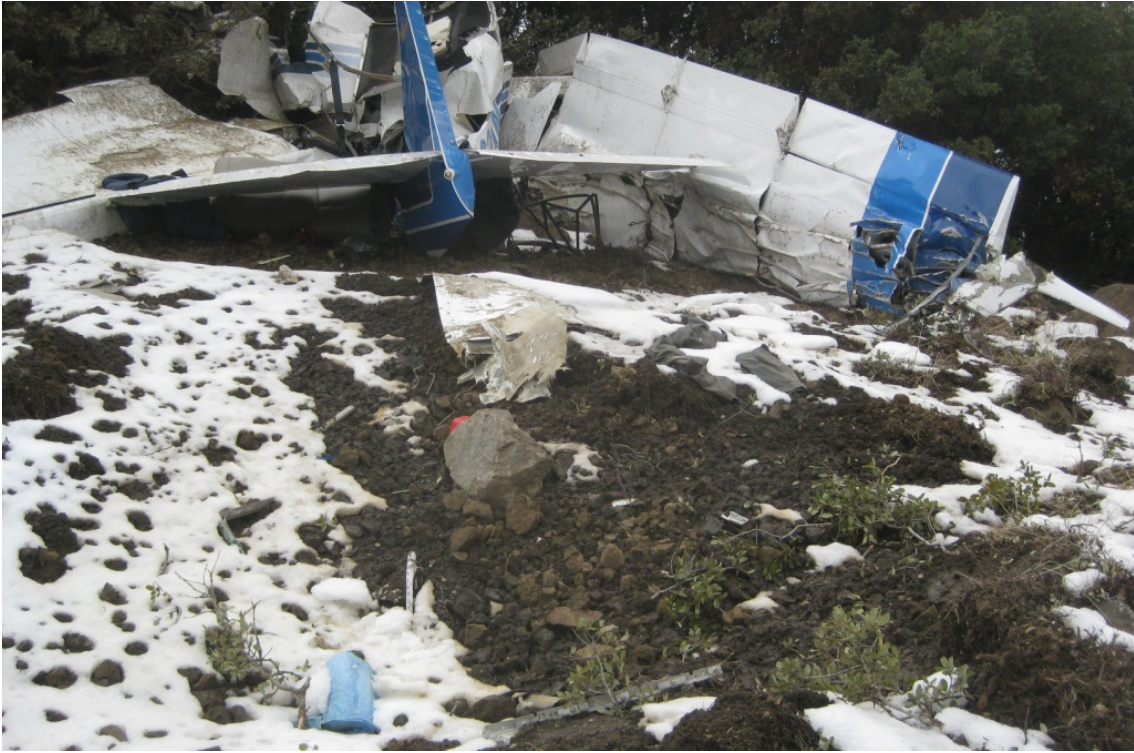
Figure 7 - Aft View

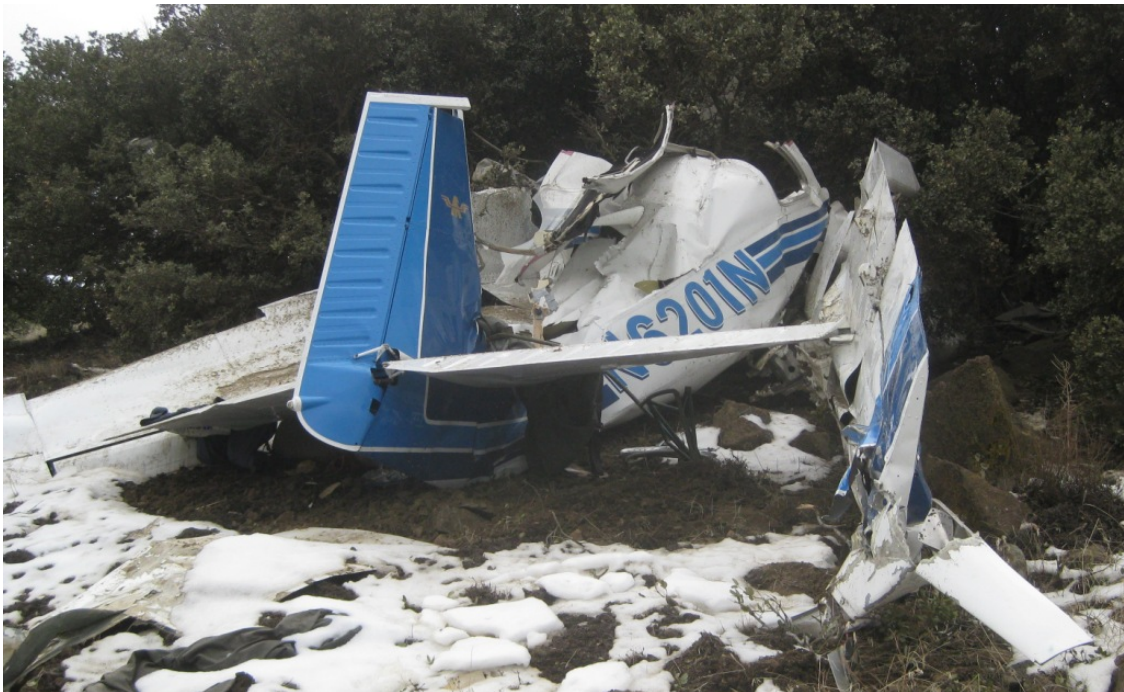
Figure 8 - Right Aft View

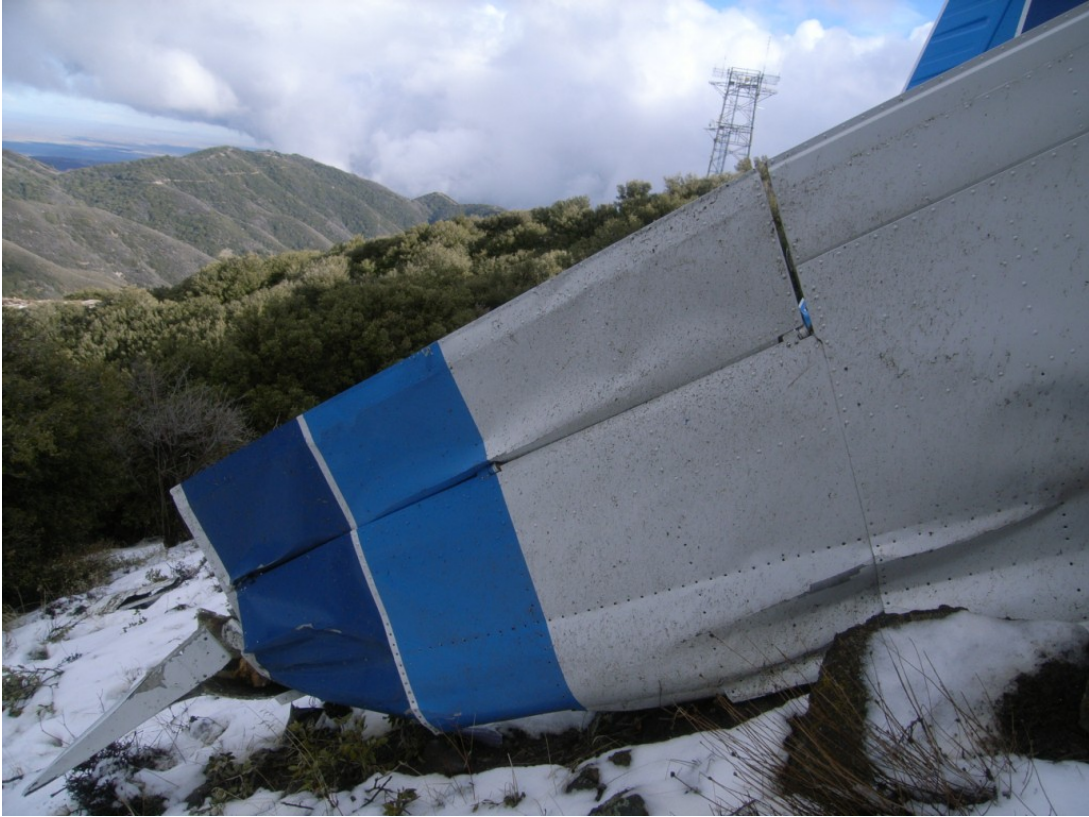
- The left aileron balance weight remained attached to the aileron
- Right Wing
 - The wing was relatively intact, but folded aft, and rotated LE down
 - The flap remained attached and was free to travel through its entire range, consistent with a fractured link in the system

- Although not able to be determined, this fracture was likely a result of impact
 - The right aileron remained attached to the outboard wing section
 - The right aileron was only able to be moved through a small range of its normal travel, likely due to post accident deformation & binding

Figure 9 - Right Wing and Aileron

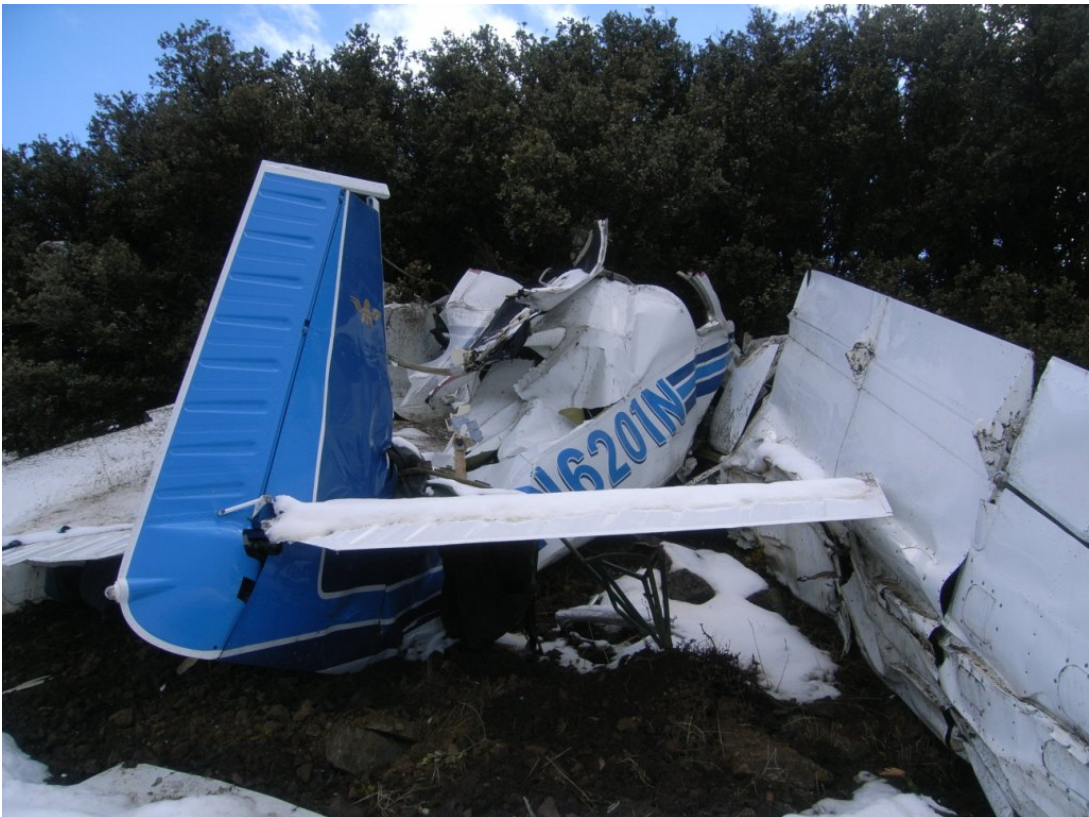
Figure 10 - Empennage and Right Wing

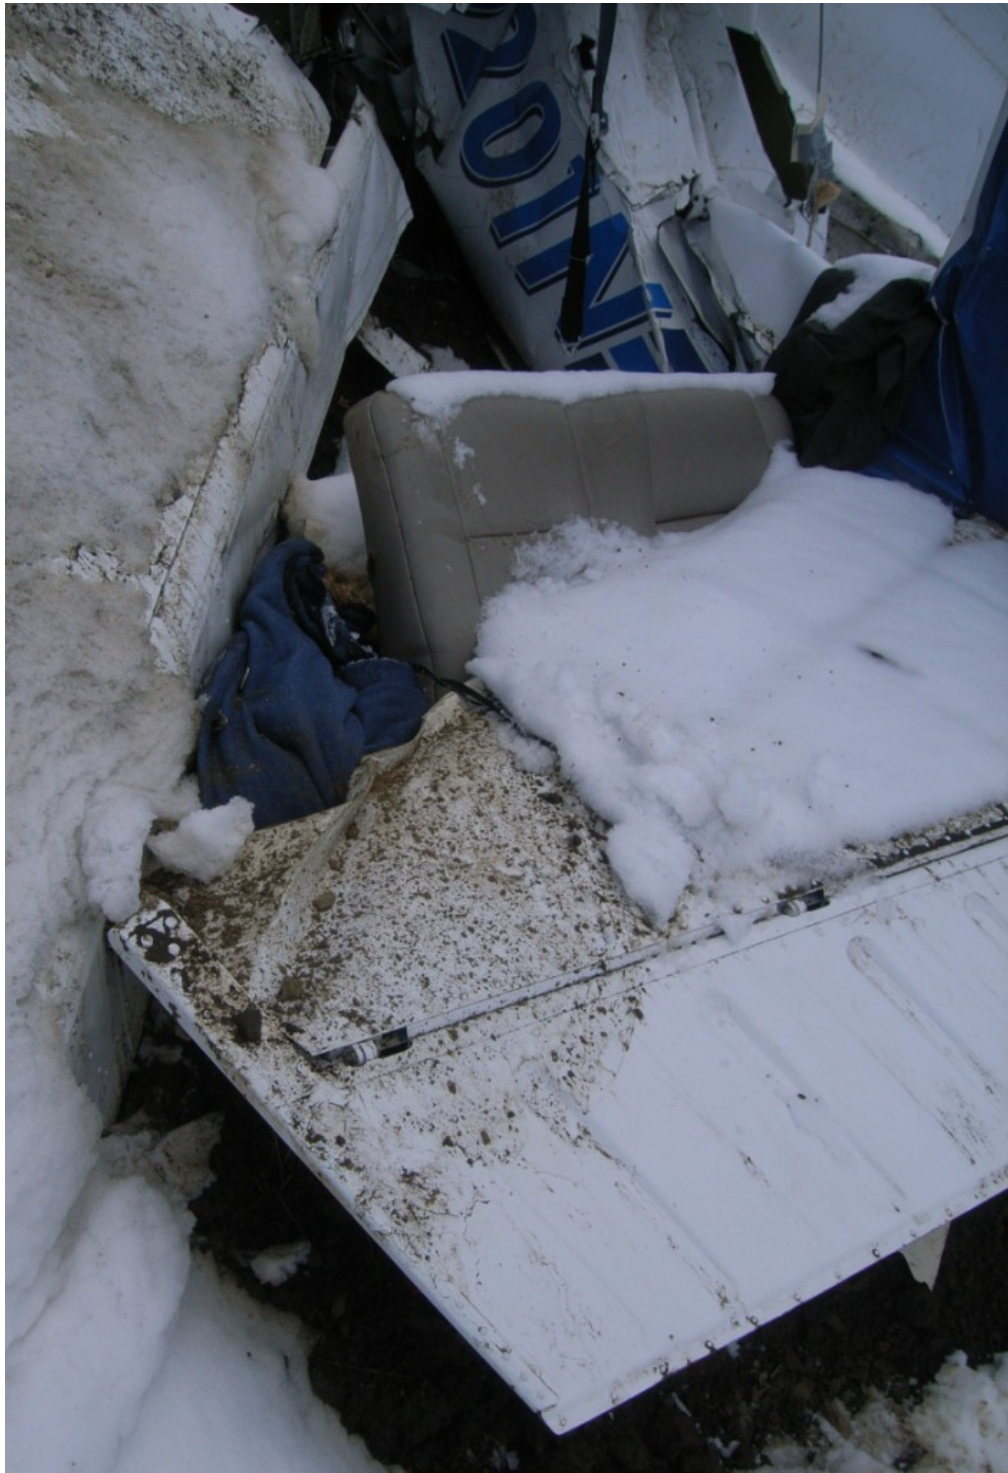
- The right aileron balance weight remained attached to the aileron
- The left and right horizontal stabilizers remained attached to the empennage
- The left and right elevators remained attached to their respective stabilizers, and to one another

Figure 11 - Left Elevator and Balance Weight

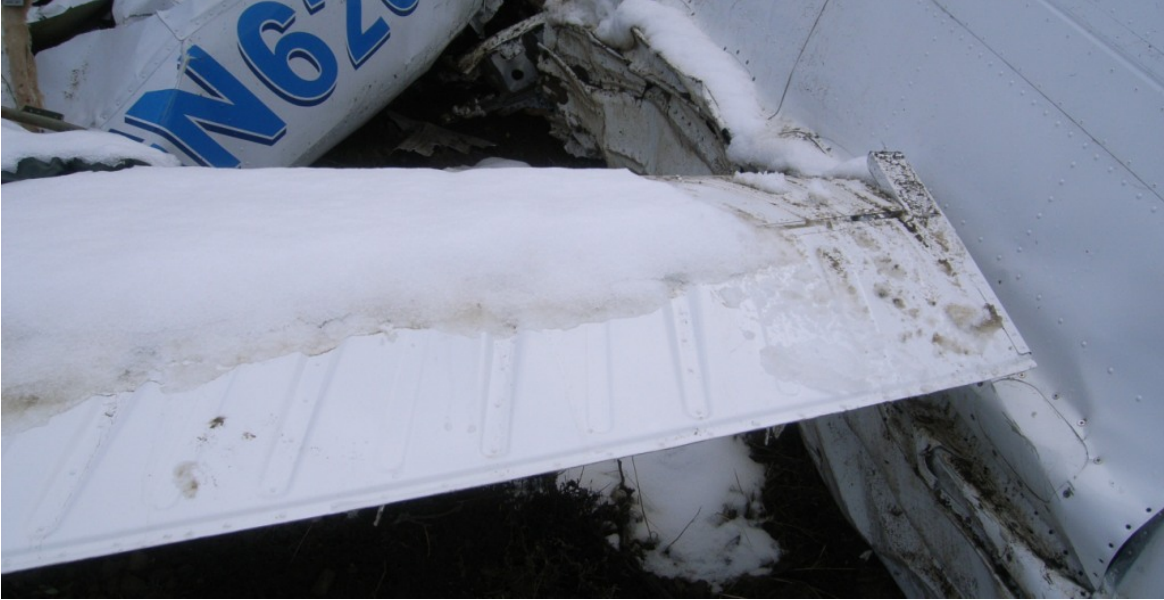
Figure 12 - Right Elevator and Balance Weight

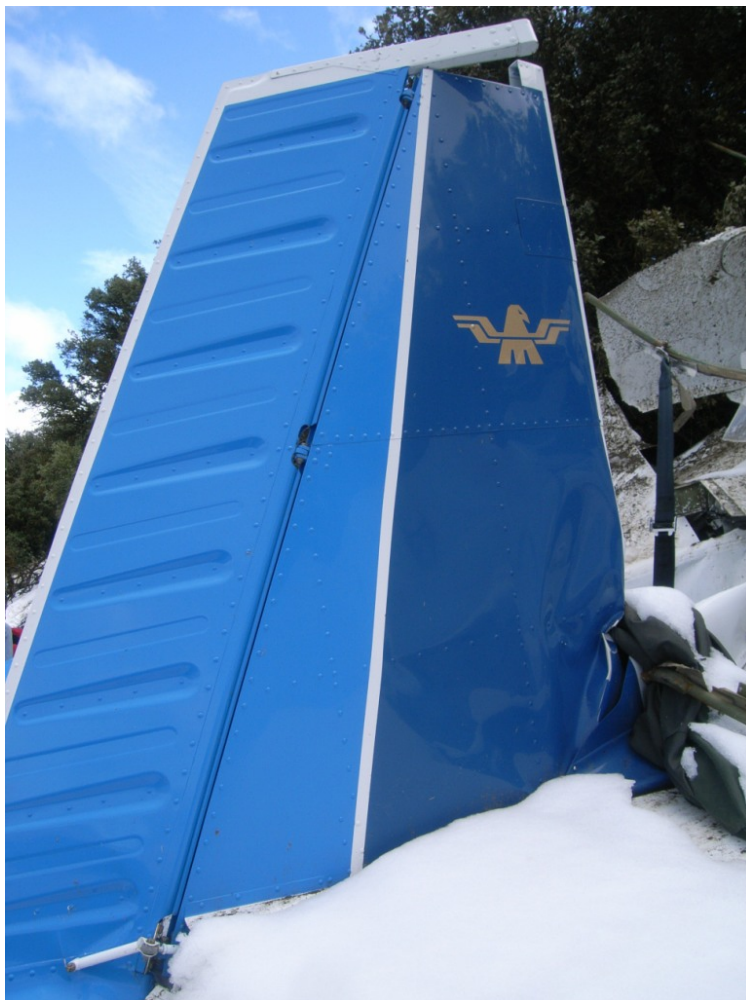
- The vertical stabilizer remained attached to the empennage
- The rudder remained attached to the vertical stabilizer
- The balance weights for the rudder and the two elevators remained attached to their respective control surfaces

Figure 13 - Fin, Rudder, and Balance Weight

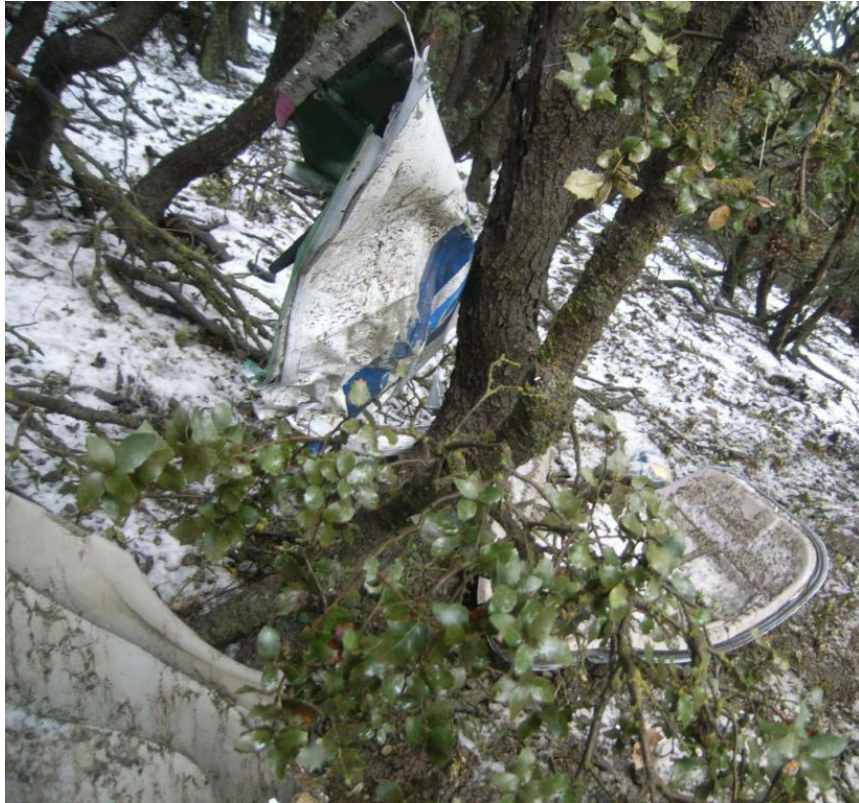
- The pilots seat, as well as some interior items from the cabin, were also found near that location
- Portions of the cabin sidewalls, floor, and roof were found strewn in and also in the tops of the vegetation forward of the main wreckage

Figure 14 - Cabin Sections

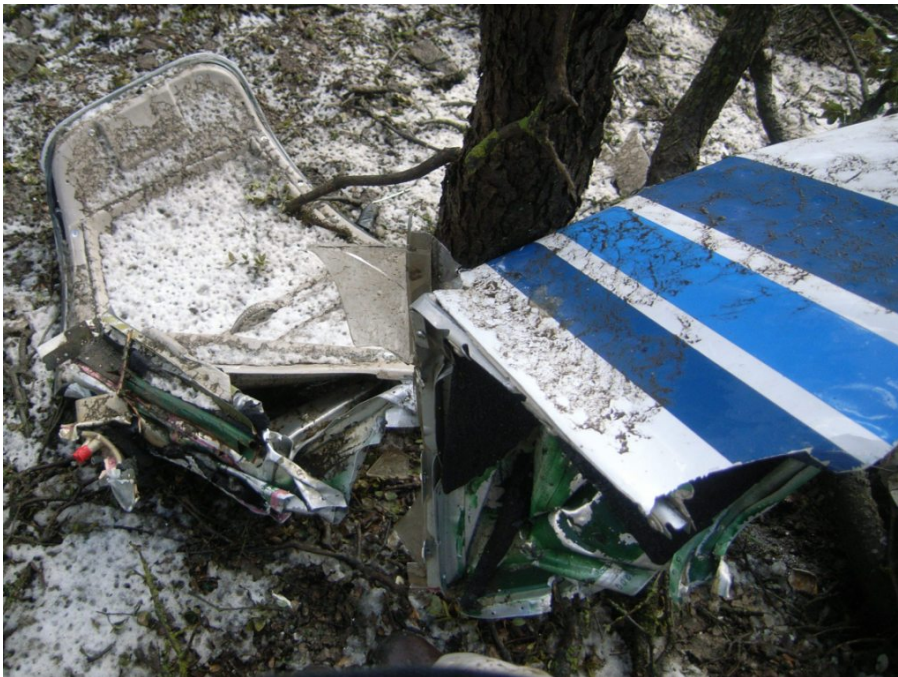
- The fuselage exhibited extensive disruption damage; essentially the cabin ceased to exist after the accident
- The single (right side) cabin door was found about 20 feet ahead of the wreckage

Figure 15 - Cabin Door and Skin

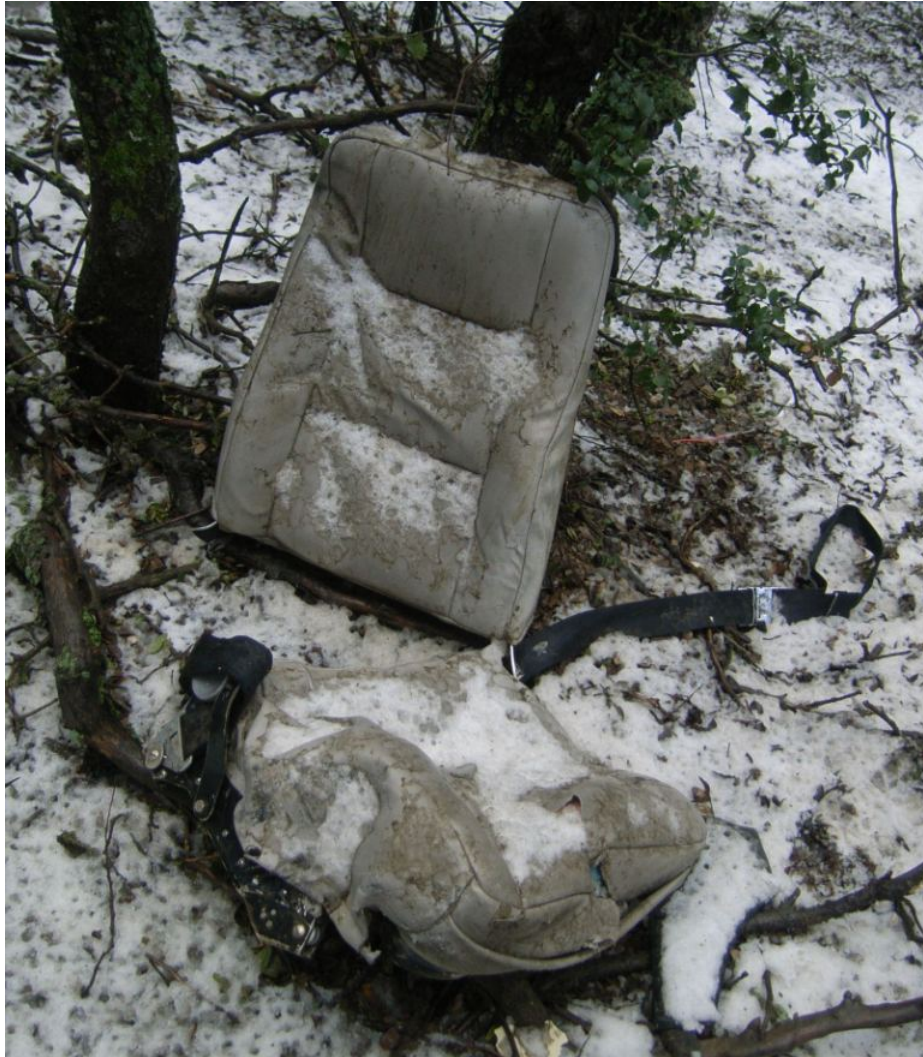
Figure 16 - Left Cockpit Seat

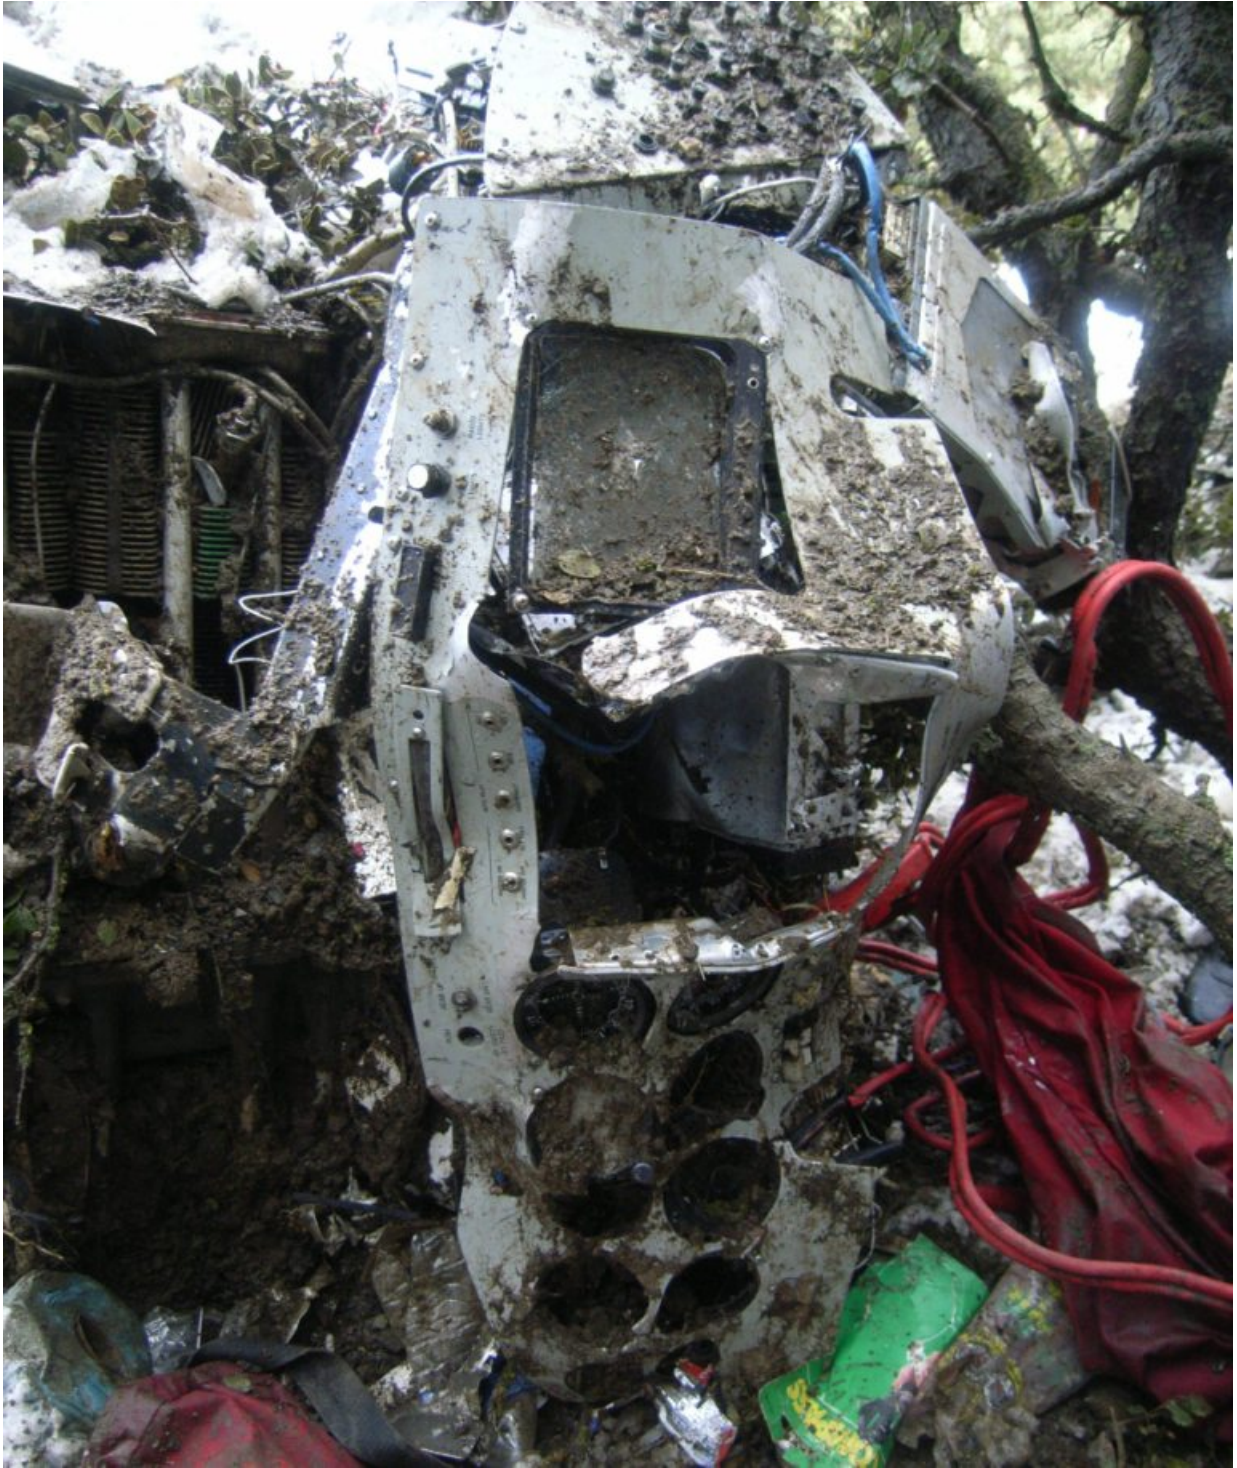
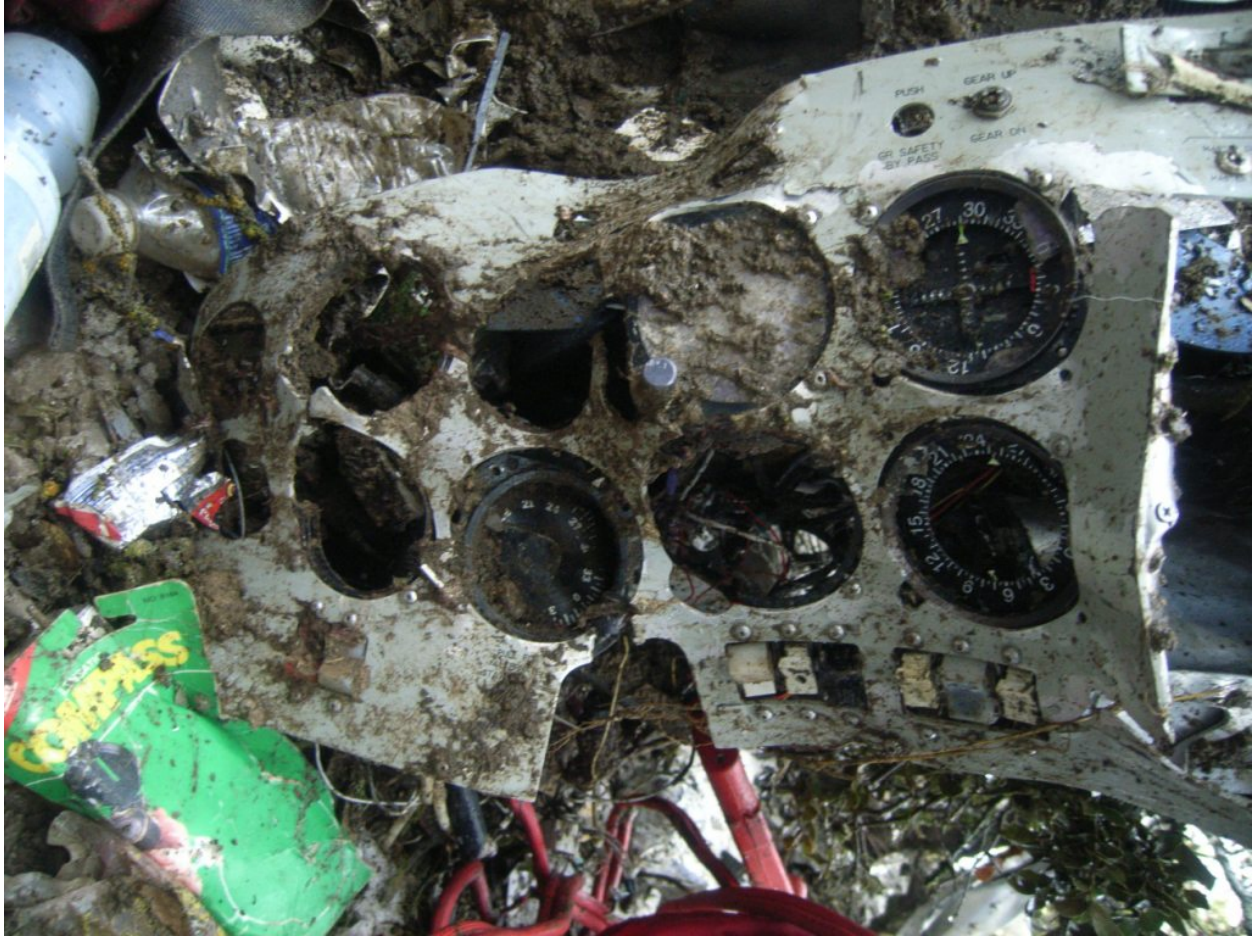
- The instrument panel was severely disrupted
 - About half of the instruments remained attached to the panel
- The circuit breaker and electrical switch panels were also severely disrupted

Figure 17 - Instrument Panel

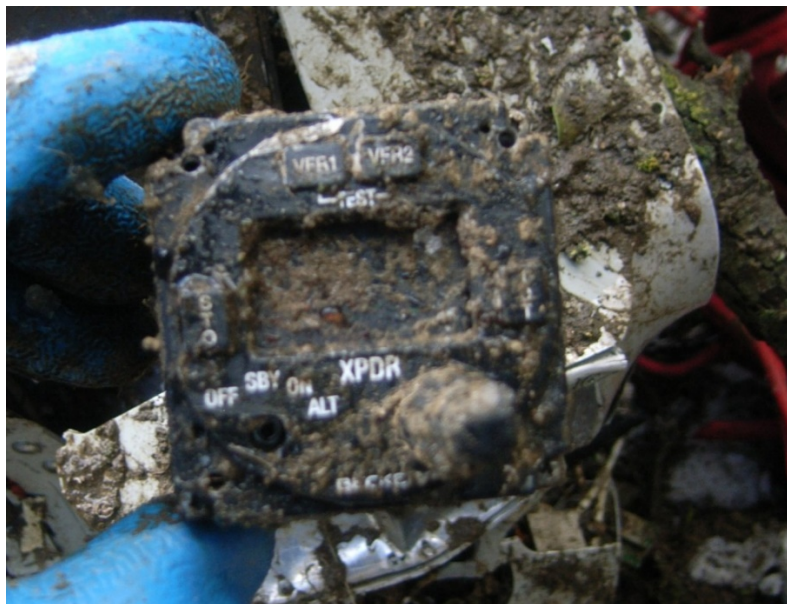
Figure 19 - Electronic Transponder Face

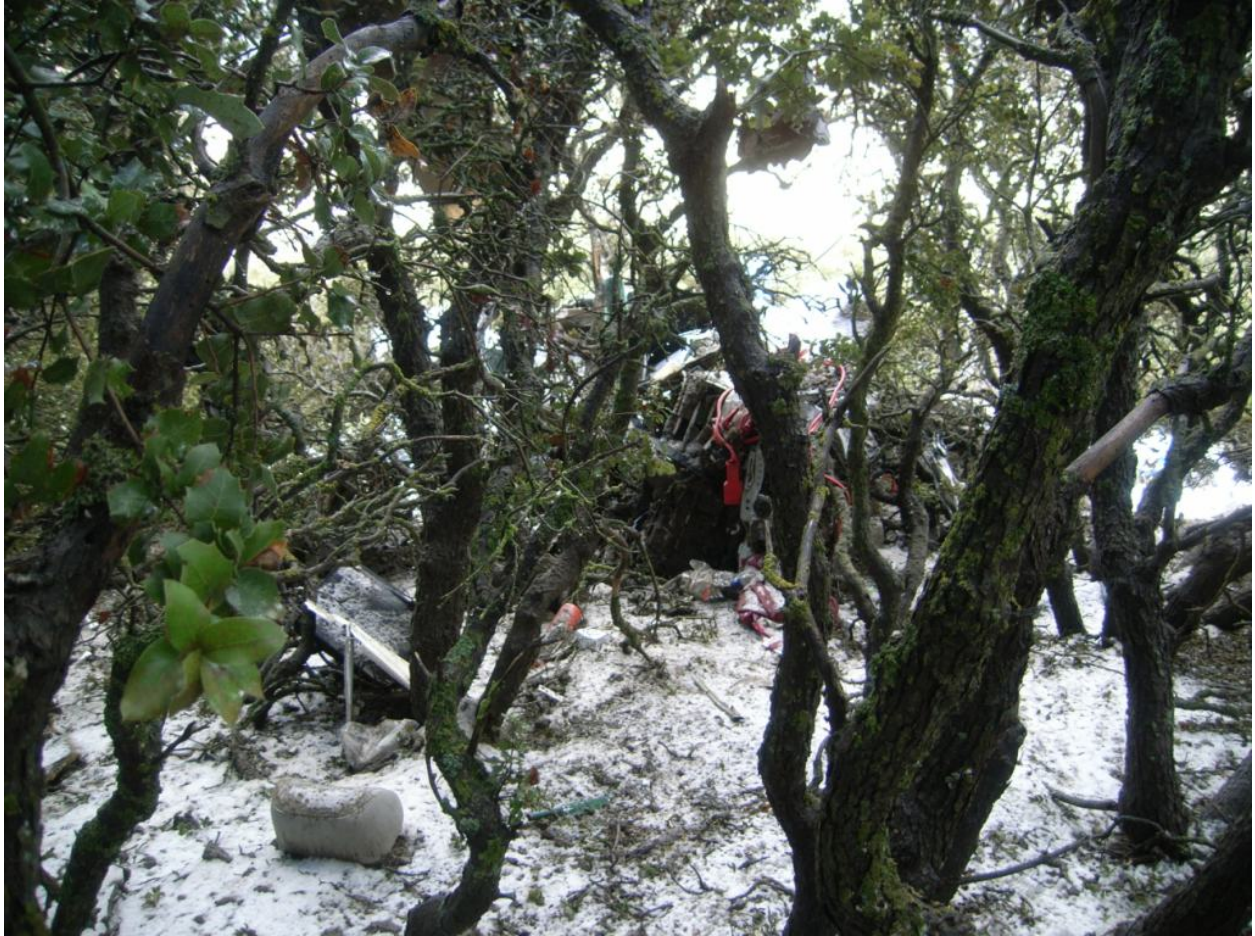
Figure 20 - View Back Towards Main Wreckage

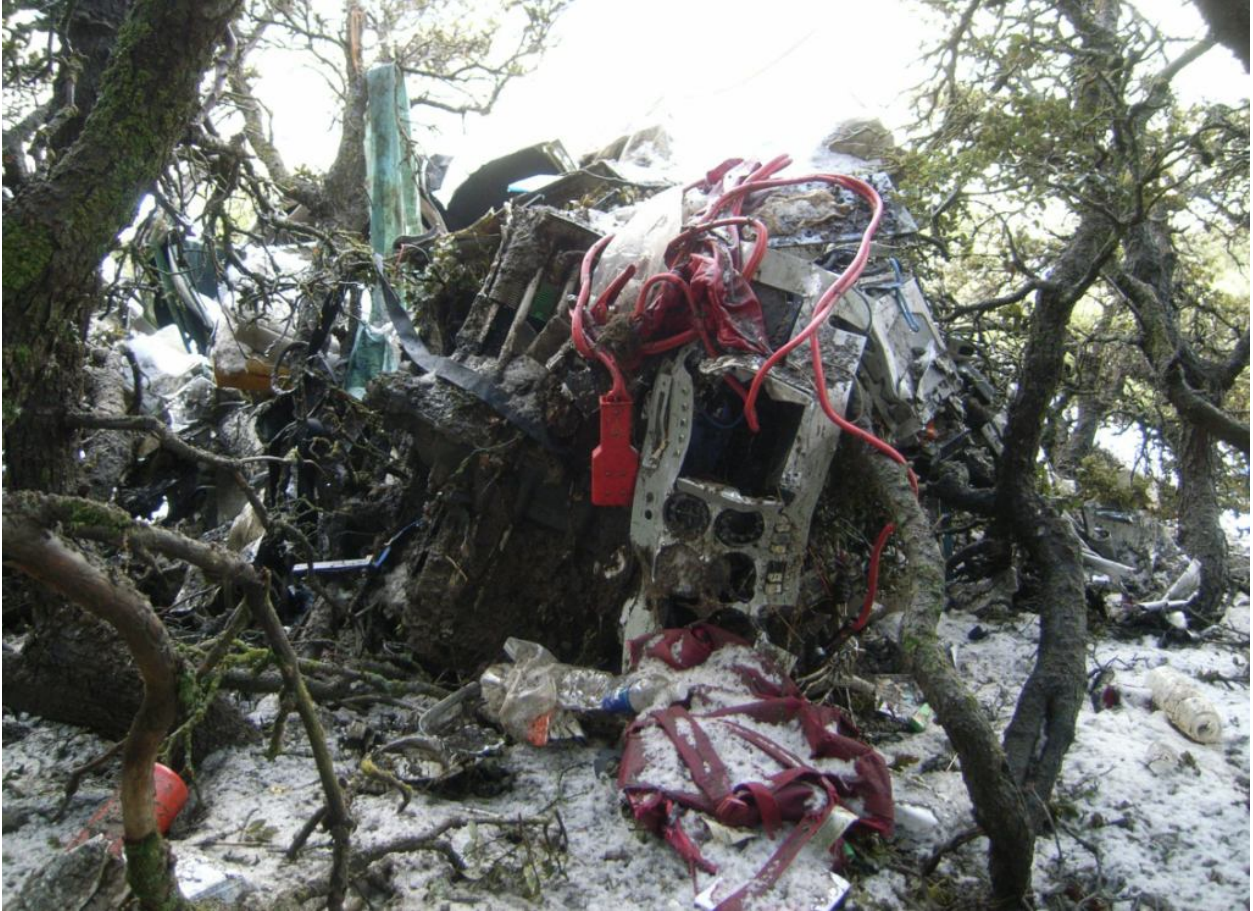
Figure 21 - Main Wreckage from Right Side

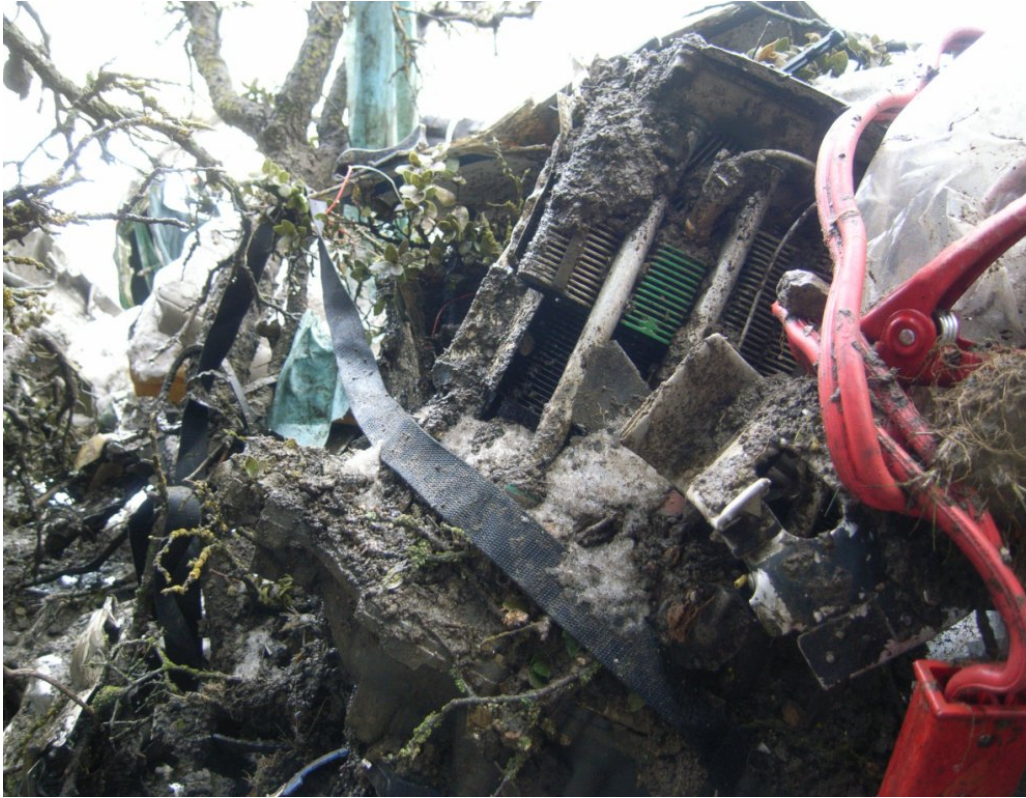
- The engine was partially attached to the fuselage mount structure, which was partially attached to the firewall/fuselage
- The engine was oriented on its left side
- The engine exhibited significant damage to its forward and lower sides
 - All cylinders remained attached/intact
 - No evidence of any pre-impact catastrophic failures was evident
- Some engine accessories and components were fracture-separated from the engine
- The propeller hub was fracture-separated from the engine at the crankshaft
- Two full-length blades remained in the hub
 - These blades exhibited moderate twisting and/or bending deformation
- The stub of the third blade, about 3 inches long, also remained in the hub
 - The blade was fracture-separated near the root
 - The main section of the blade was also moderately damaged, and found in close proximity to the hub

Figure 22 – Engine

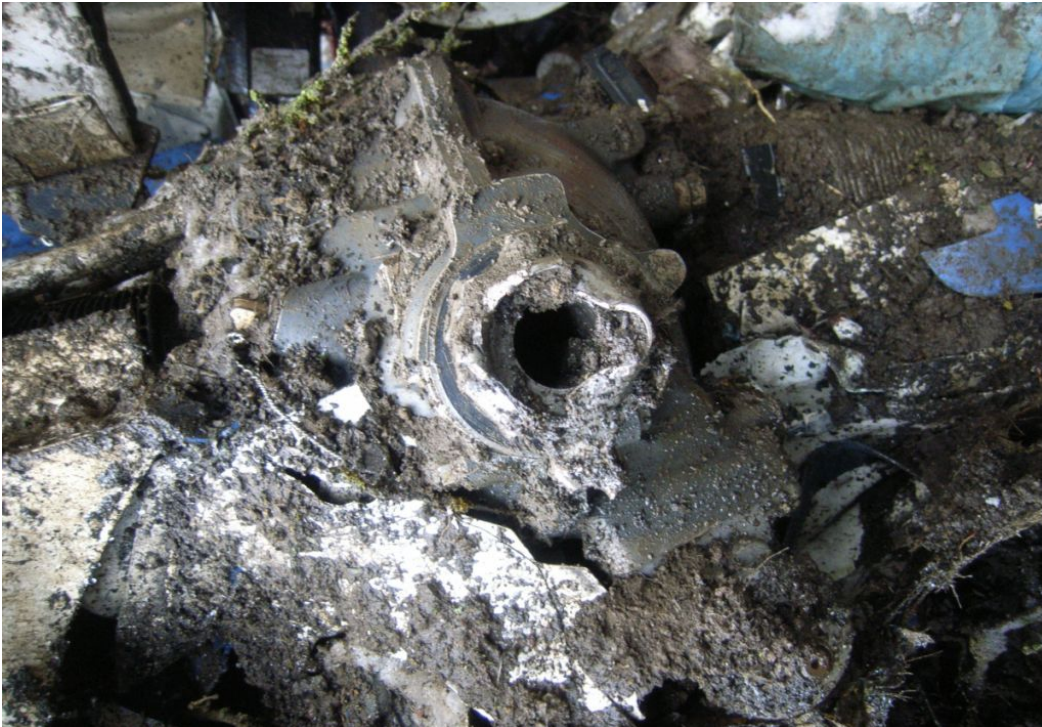
- The forward fuselage exhibited severe crush and fracture damage
- The engine was partially separated from the airframe, and the three-blade propeller and its hub was fracture-separated from the engine

Figure 23 - Fractured Crankshaft/Propeller Hub Junction
