NATIONAL TRANSPORTATION SAFETY BOARD

SITE and ON-SCENE INFORMATION

**NTSB Accident: WPR17FA055
Accident Date: January 12, 2017**

Location: Lake Hughes, California
Date: January 12, 2017
Aircraft: Mooney M20J, N6201N, Serial # 24-0590
NTSB IIC: Michael Huhn

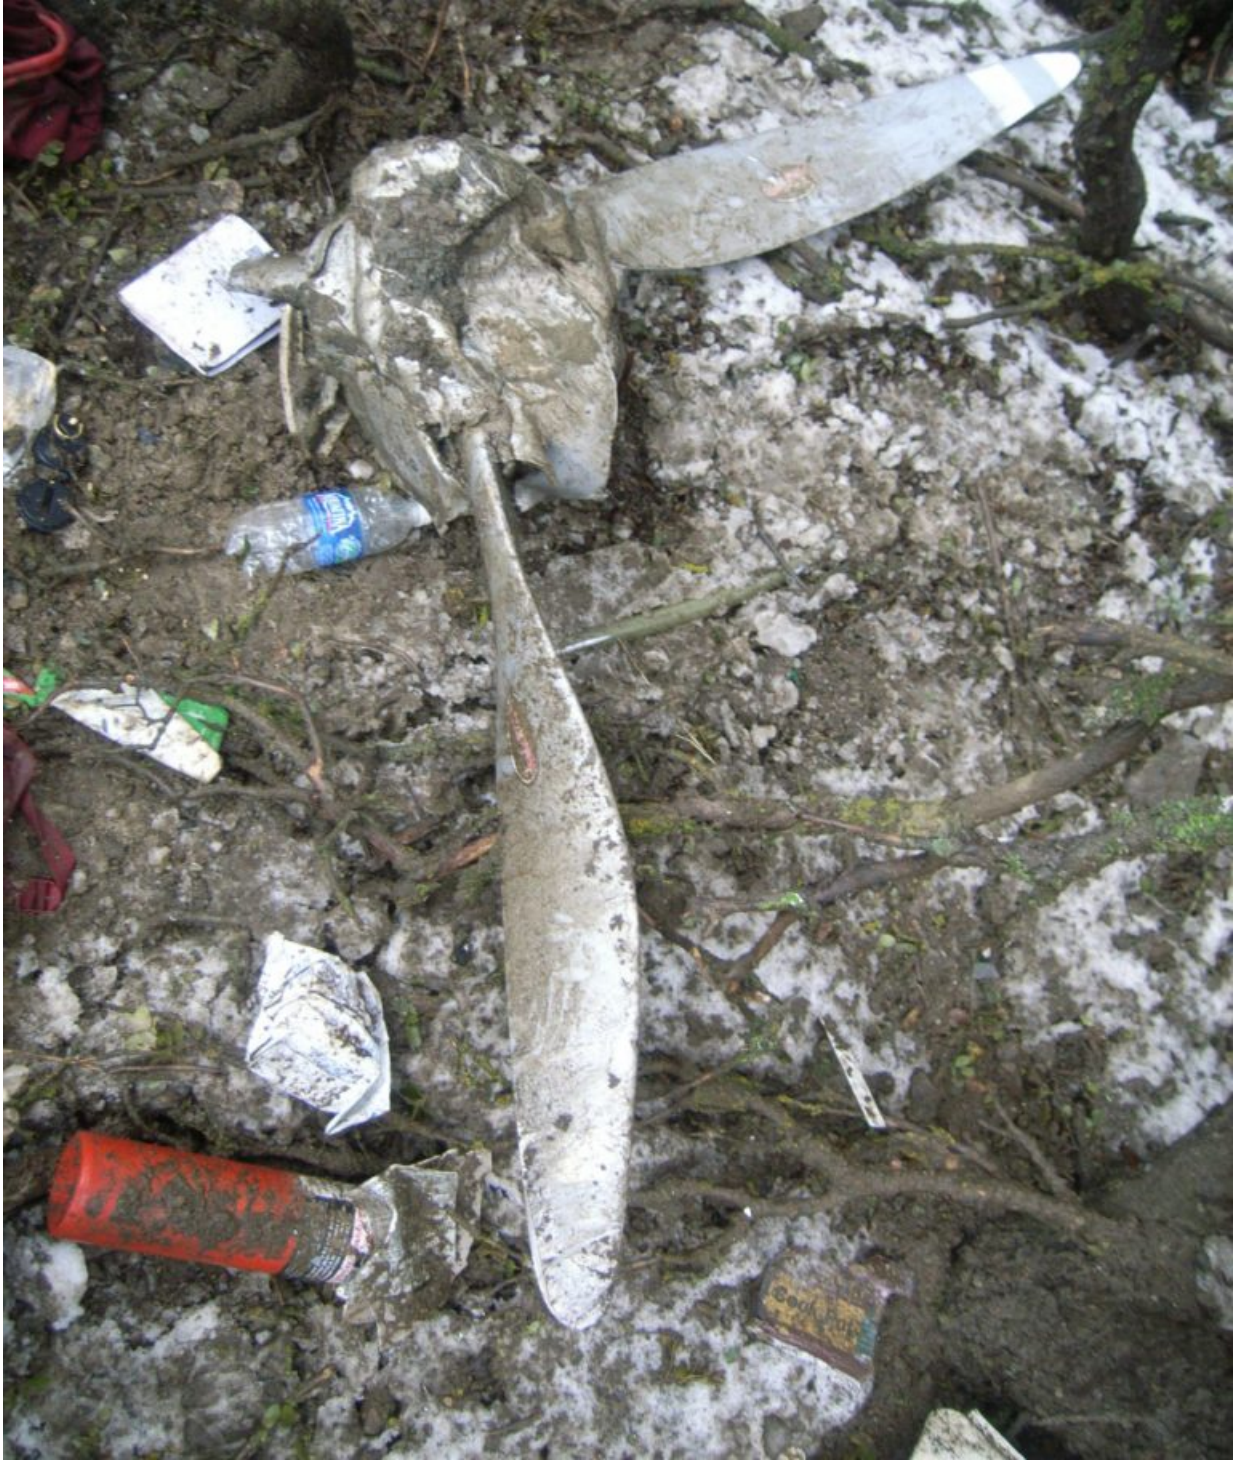
Figure 24 - Propeller

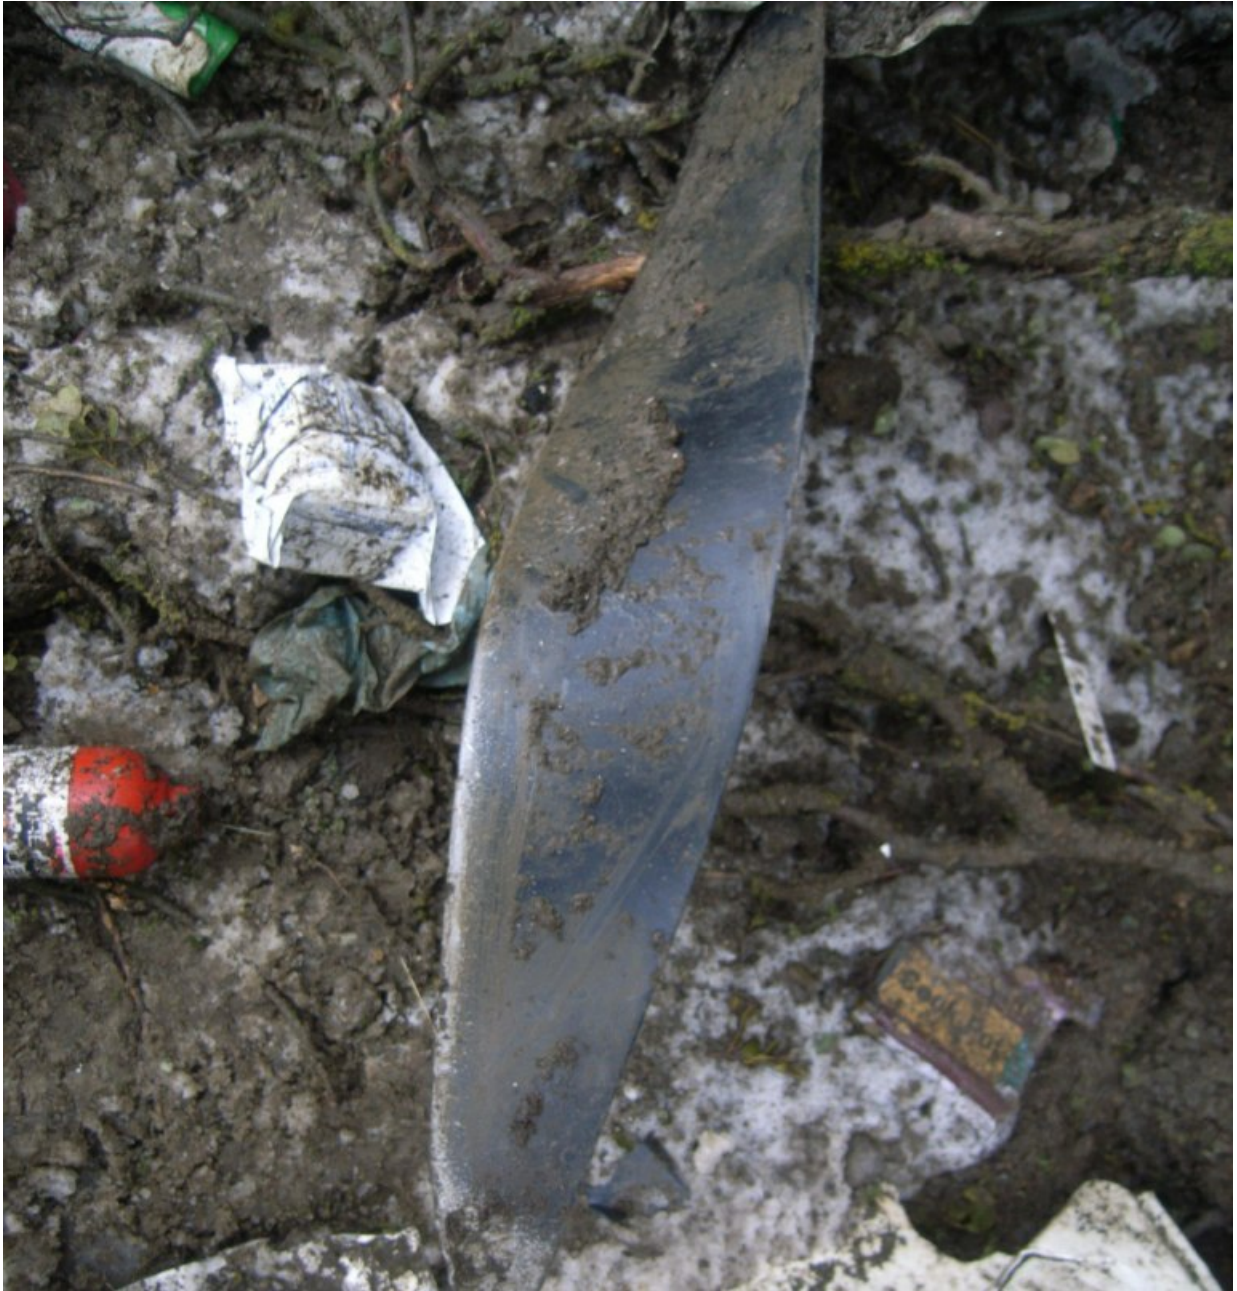
Figure 25 - Propeller Blade

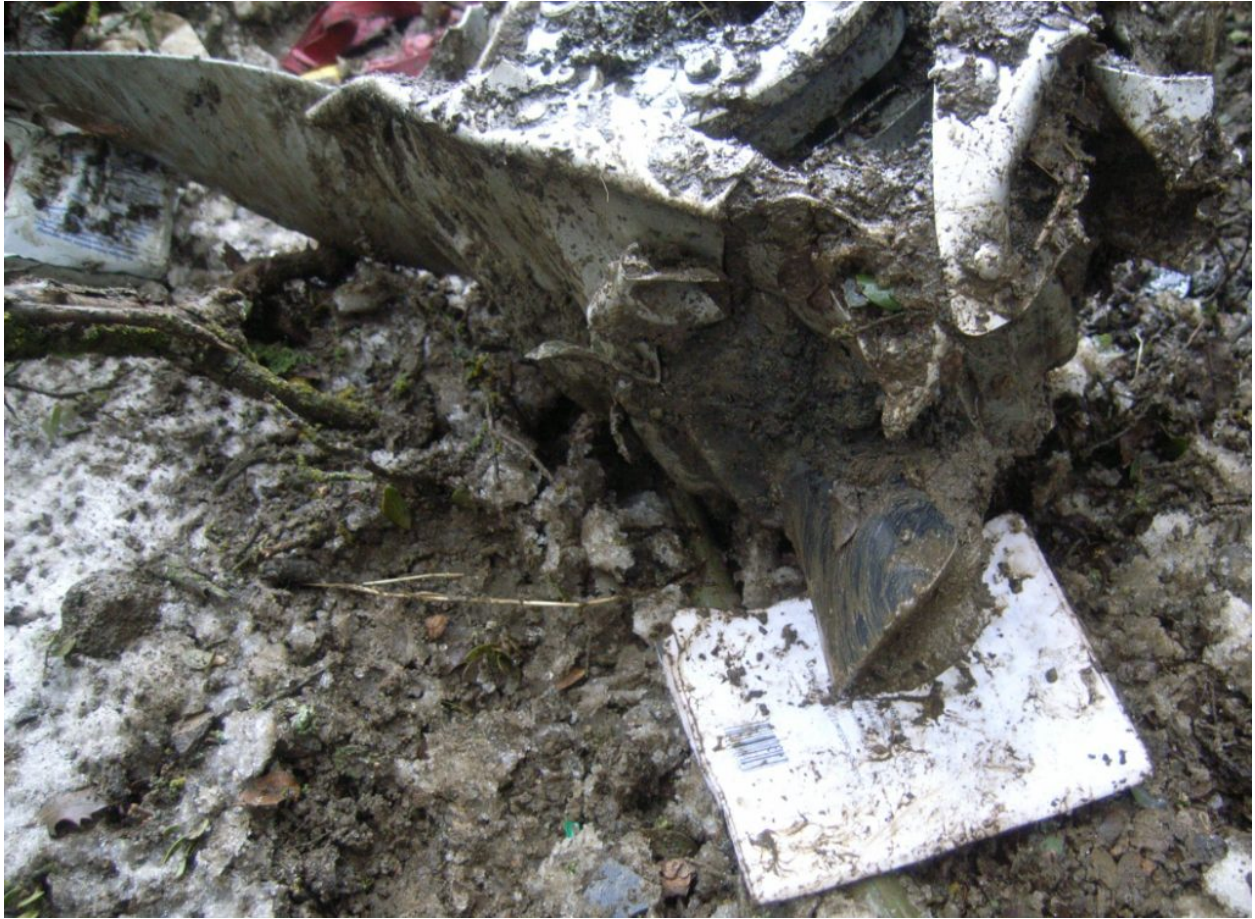
Figure 26 - Fractured Blade Root
