NATIONAL TRANSPORTATION SAFETY BOARD

SITE and ON-SCENE INFORMATION

**NTSB Accident: WPR18FA112
Accident Date: March 26, 2018**

Location: Marina, California
Date: March 26, 2018
Aircraft: Mooney M20E, N213EJ, Serial # 939
NTSB IIC: Michael Huhn

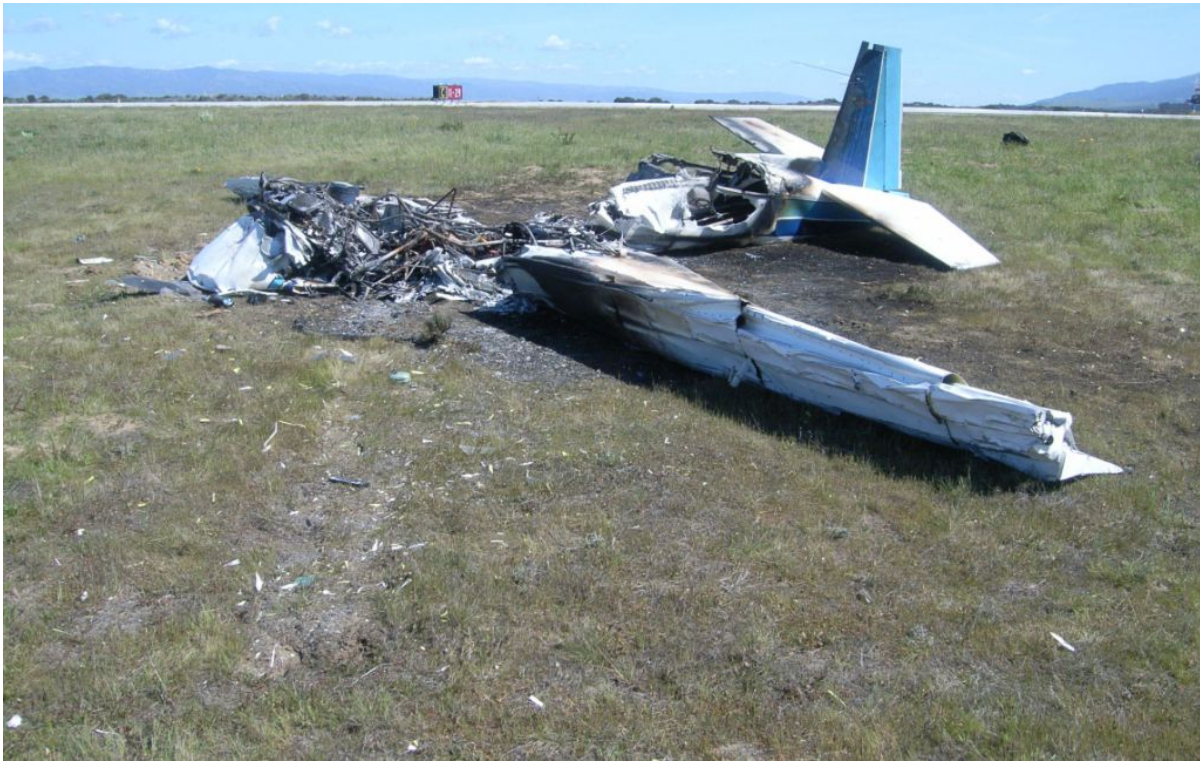
Figure 1 - Overall Wreckage View (note wing impact scar on ground)

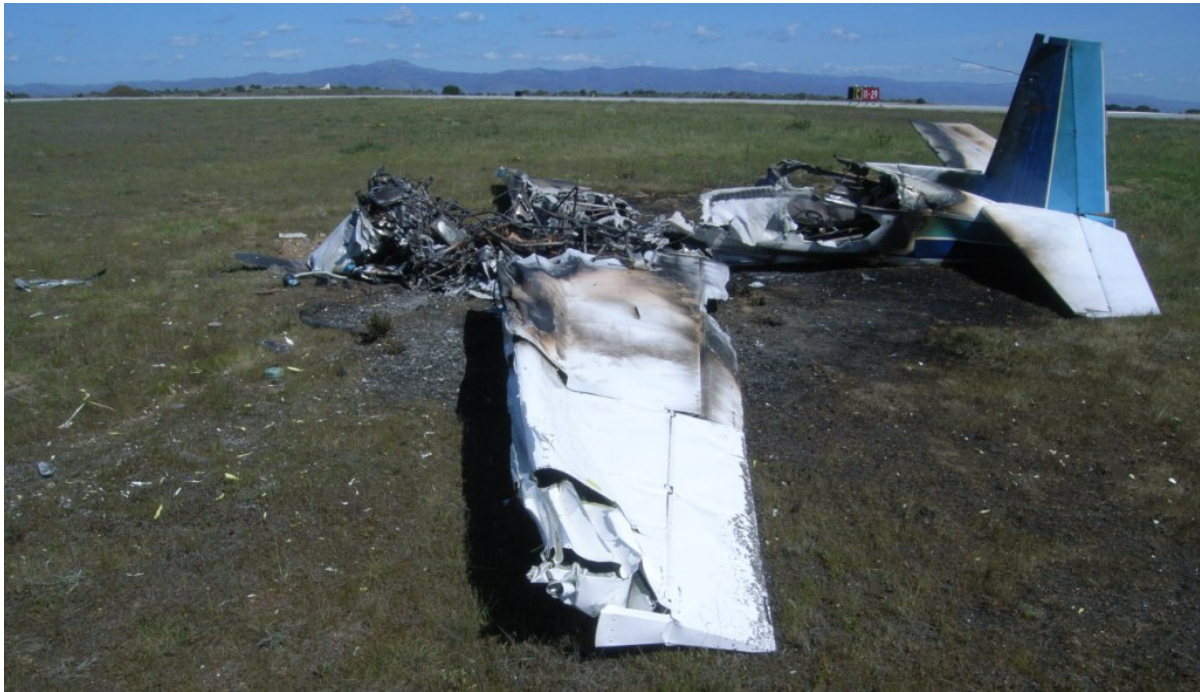
Figure 2 - Overall Wreckage View

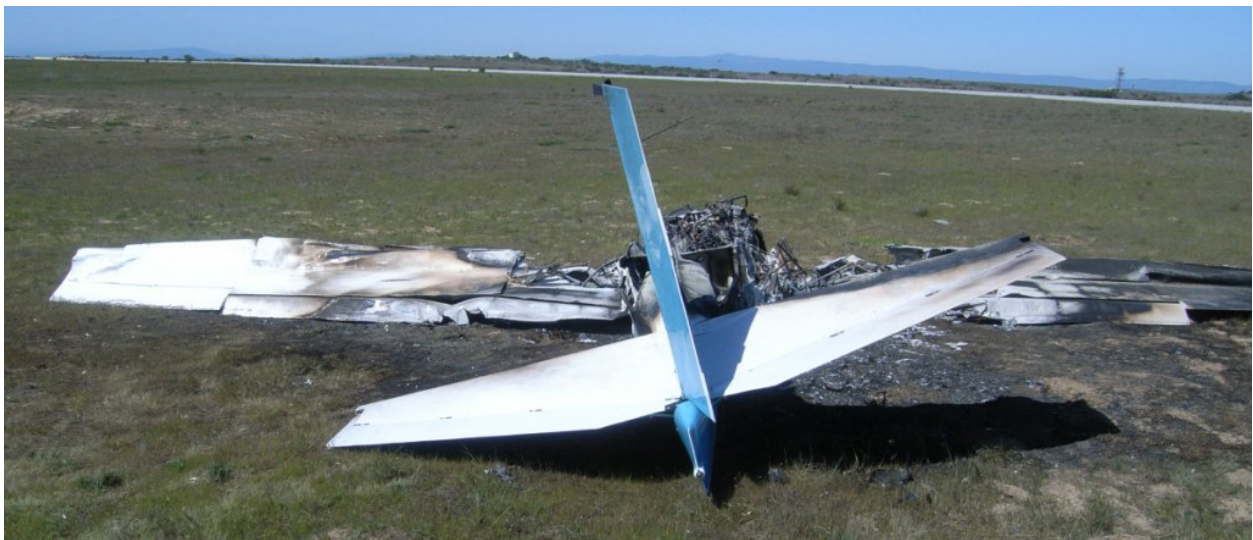
Figure 3 - Overall Wreckage View

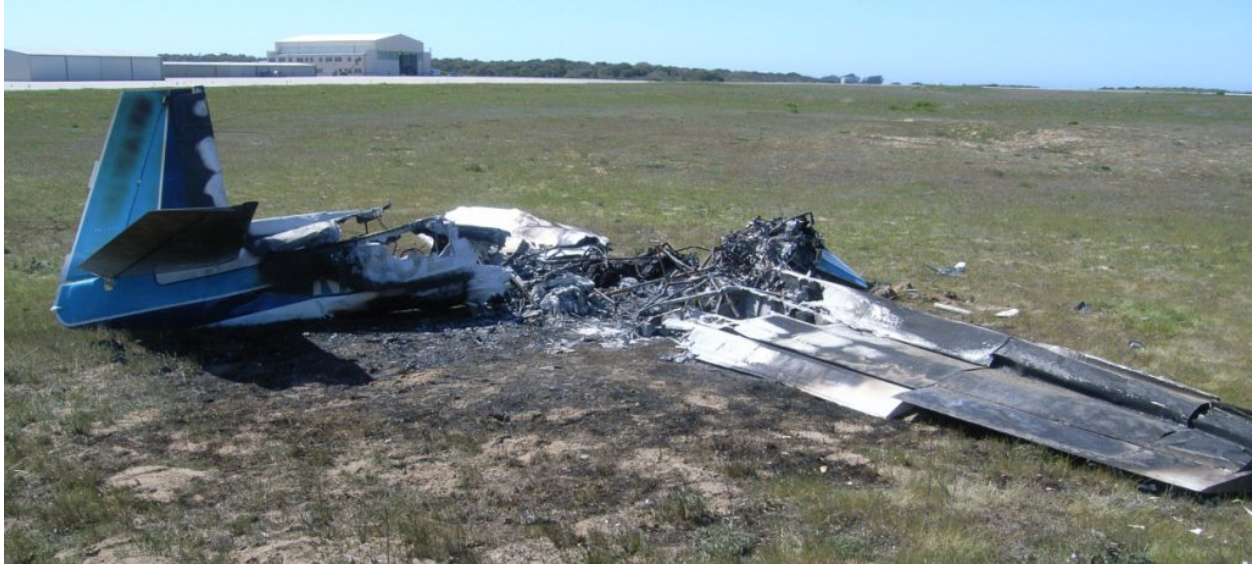
Figure 4 - Overall Wreckage View

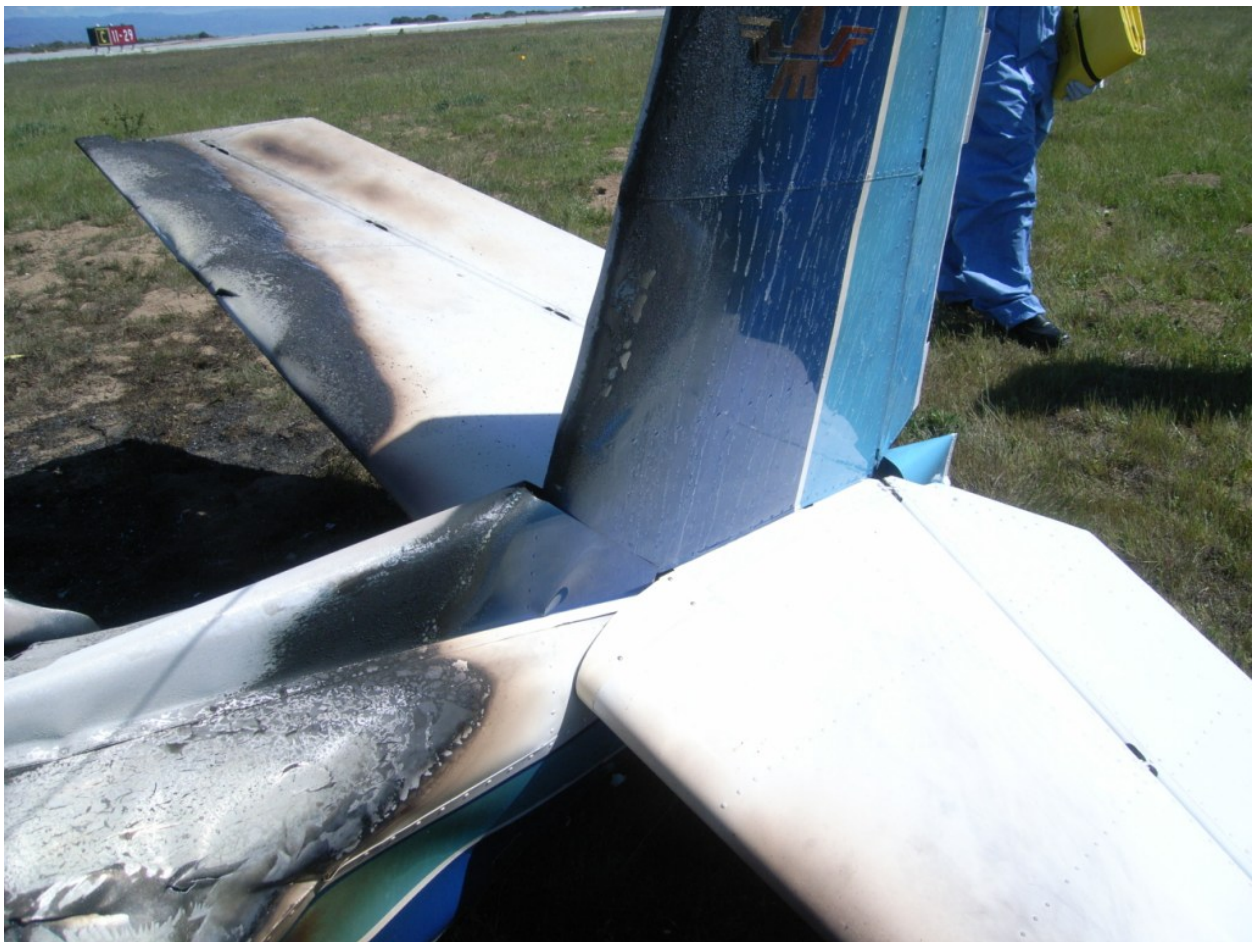
Figure 5 - Empennage

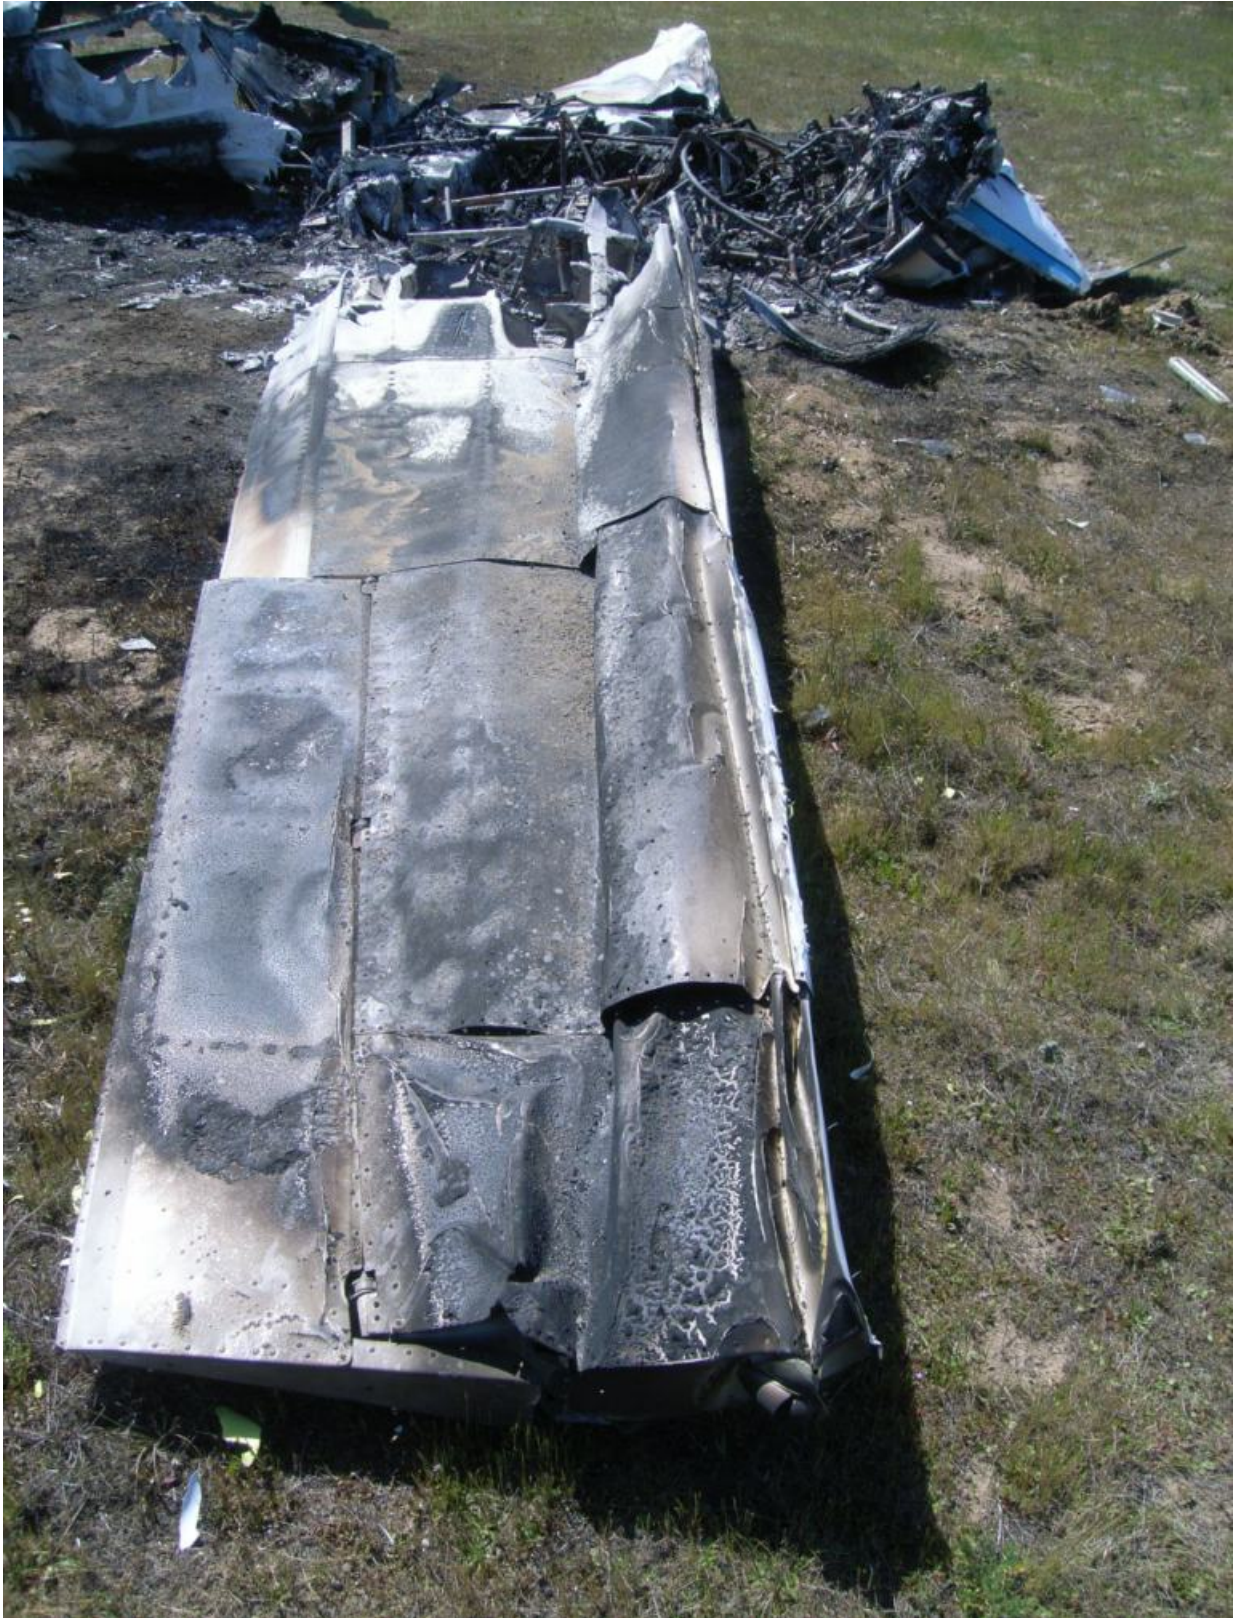
Figure 6 - Right Wing and Cabin

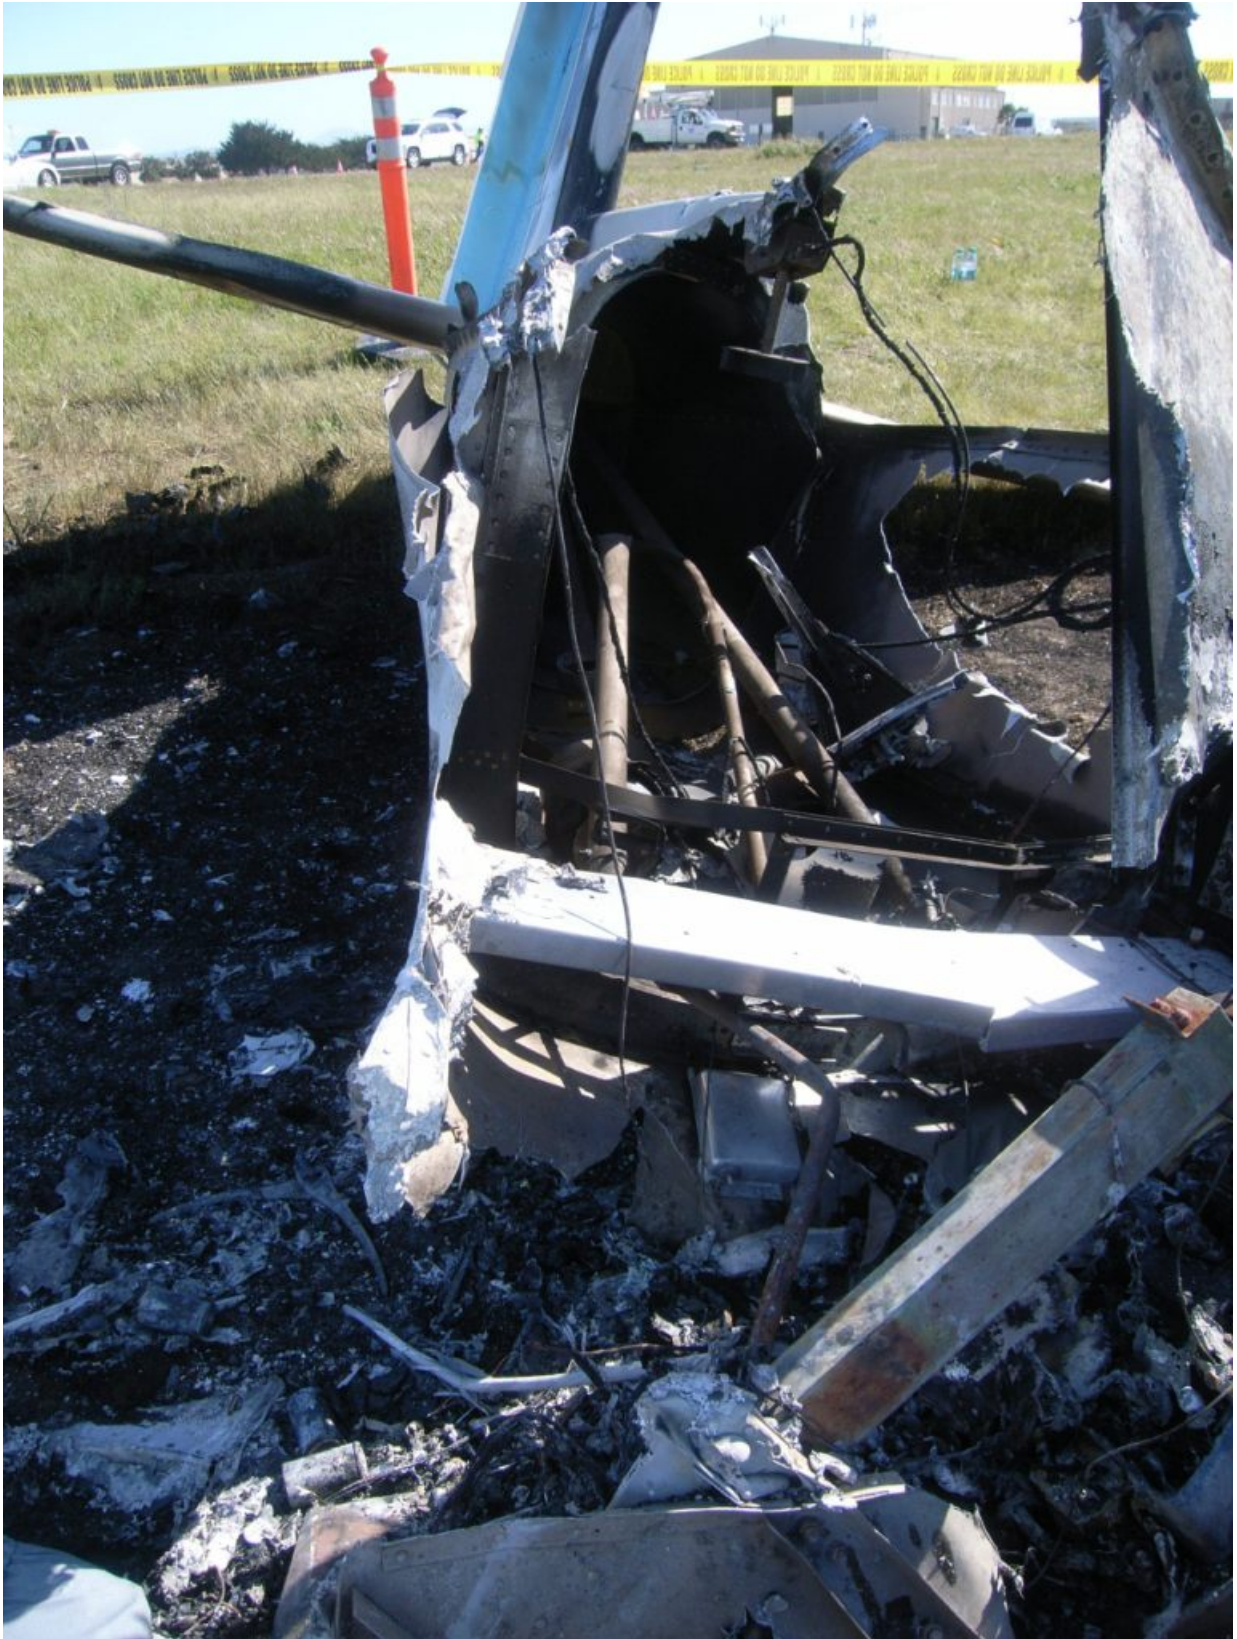
Figure 7 - Aft Fuselage and Control Rods

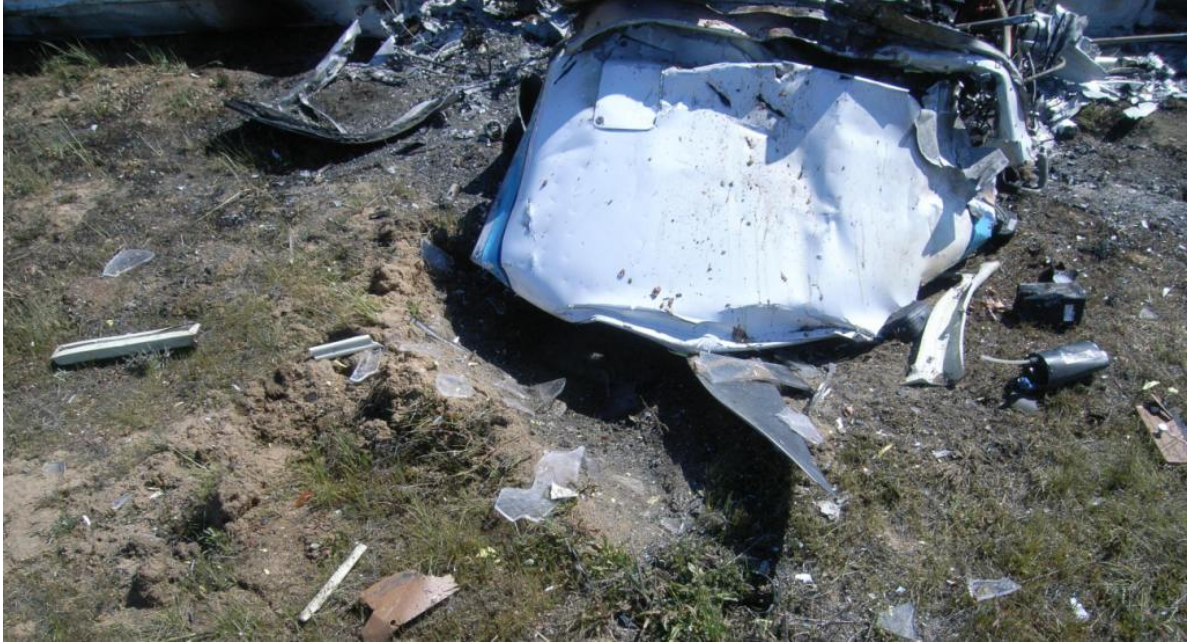
Figure 8 - Cowl and Propeller

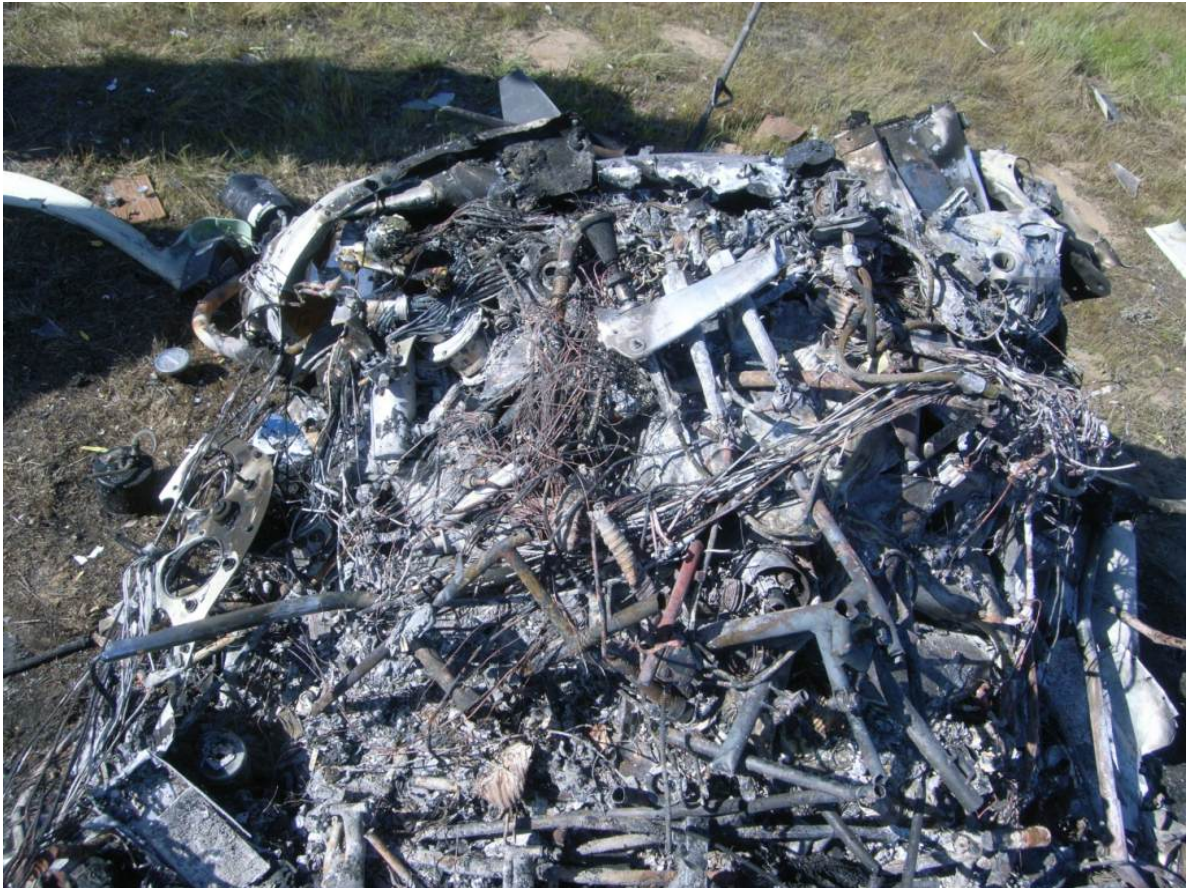
Figure 9 - Cockpit (Looking Forward)

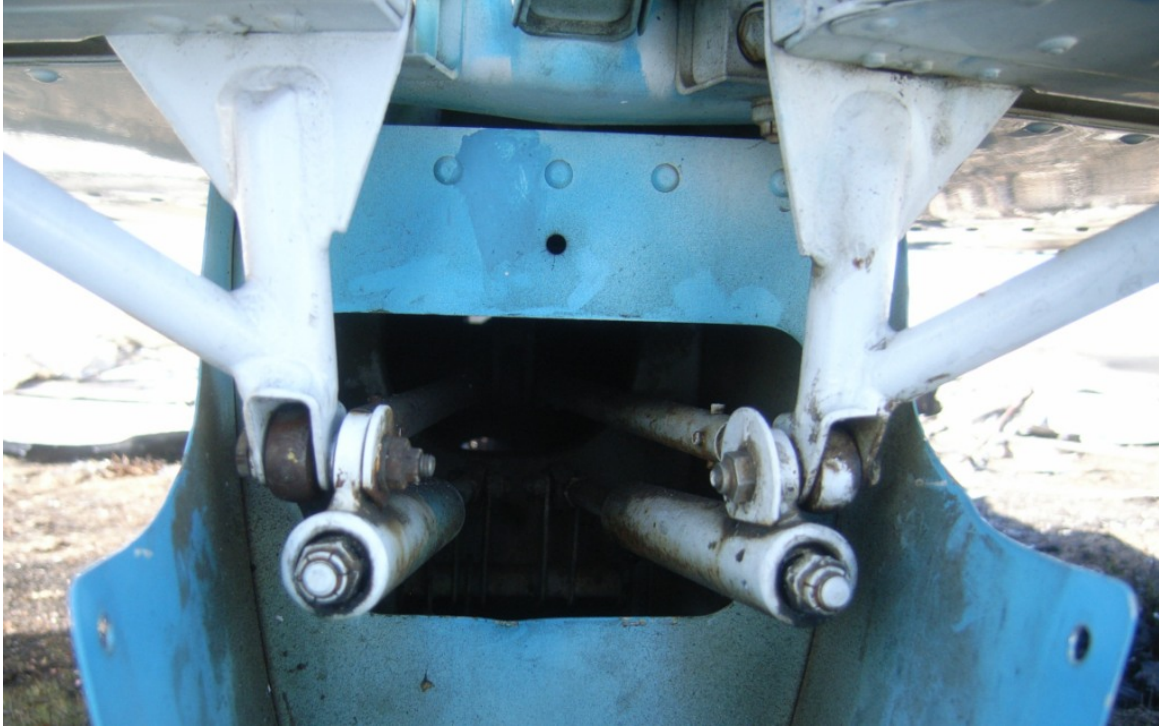
- Aileron control continuity between the ailerons and cockpit was confirmed
- Rudder control continuity between the rudder and cockpit was confirmed
- Elevator continuity between the elevator and cockpit, exclusive of fire damage to the right yoke connection rod, was confirmed

Figure 10 - Elevator Controls

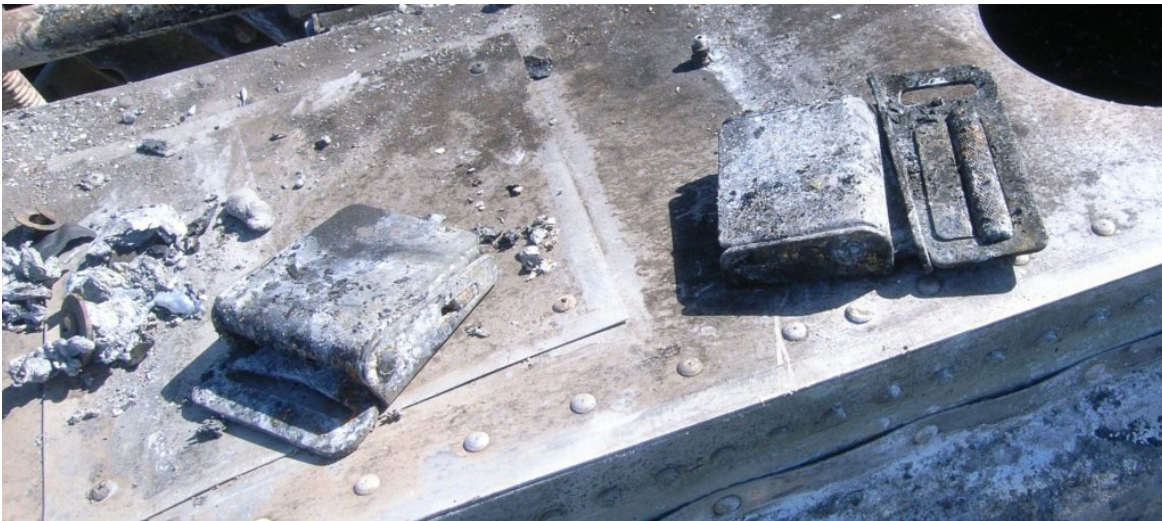
- Fire consumed most of the cabin/cockpit and its contents
- Flight and engine instruments and controls were significantly damaged by impact and fire
- All seat and seat belt fabric, cushion, & webbing material was consumed by fire
- One seat (lap) belt buckle assembly was found latched

Figure 11 - Buckled Lab Belt Latch

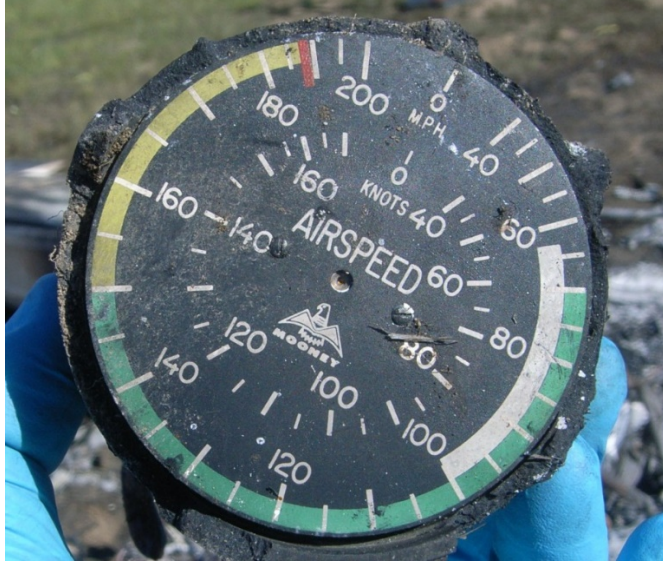
Figure 12 - Airspeed Indicator

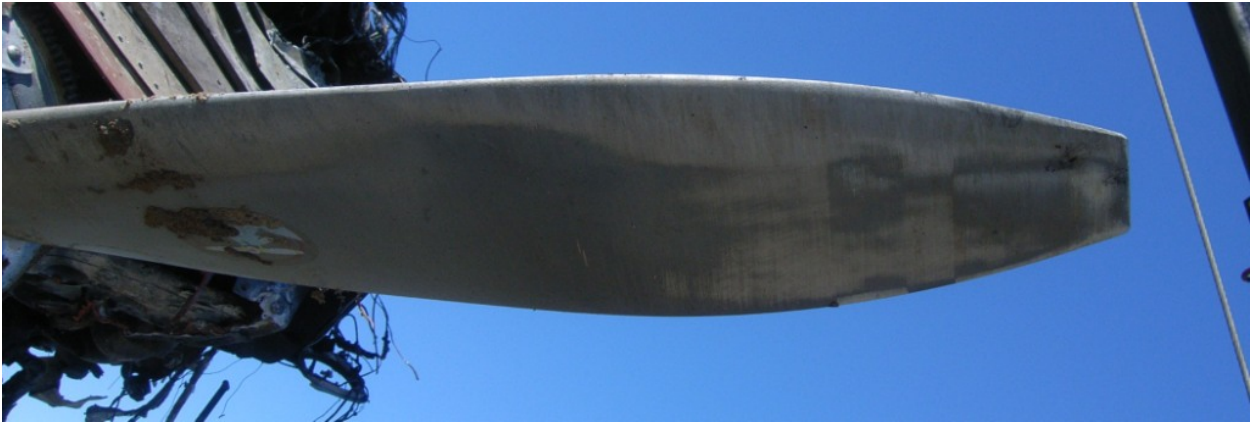
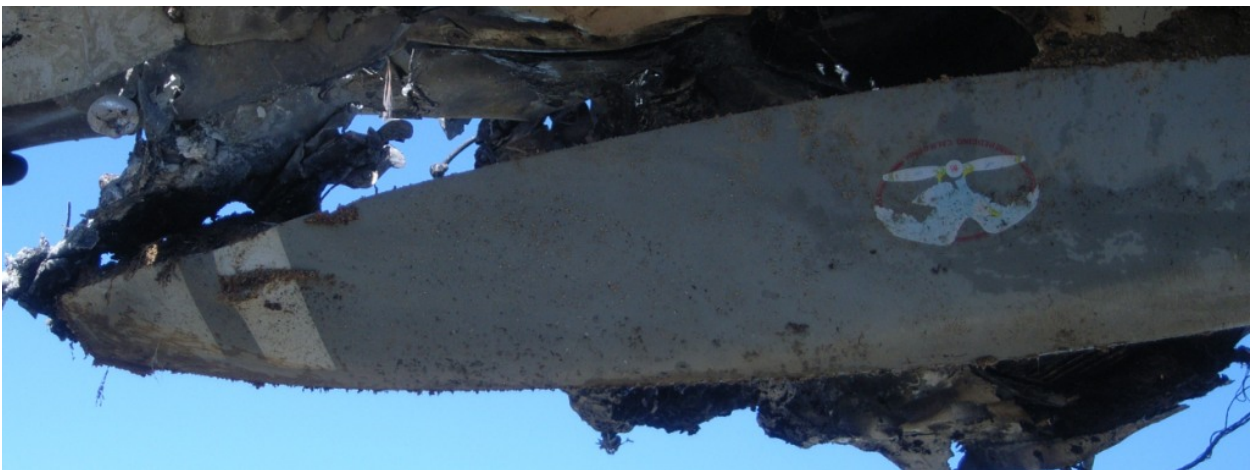
Figure 13 - Propeller Blade

Figure 14 - Propeller Blade

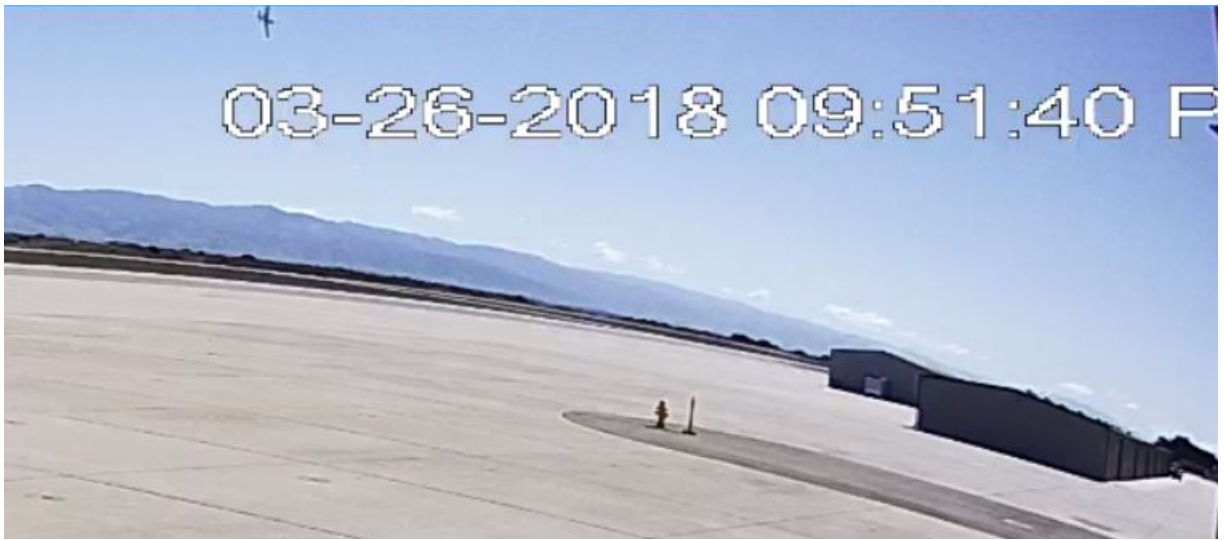
- The left wing was the first item to appear in the frame
- At that point the airplane appeared to be on a heading of about 160°, with about a 15° nose down pitch attitude, and in a descending flight path

Figure 15 - First Appearance in Frame

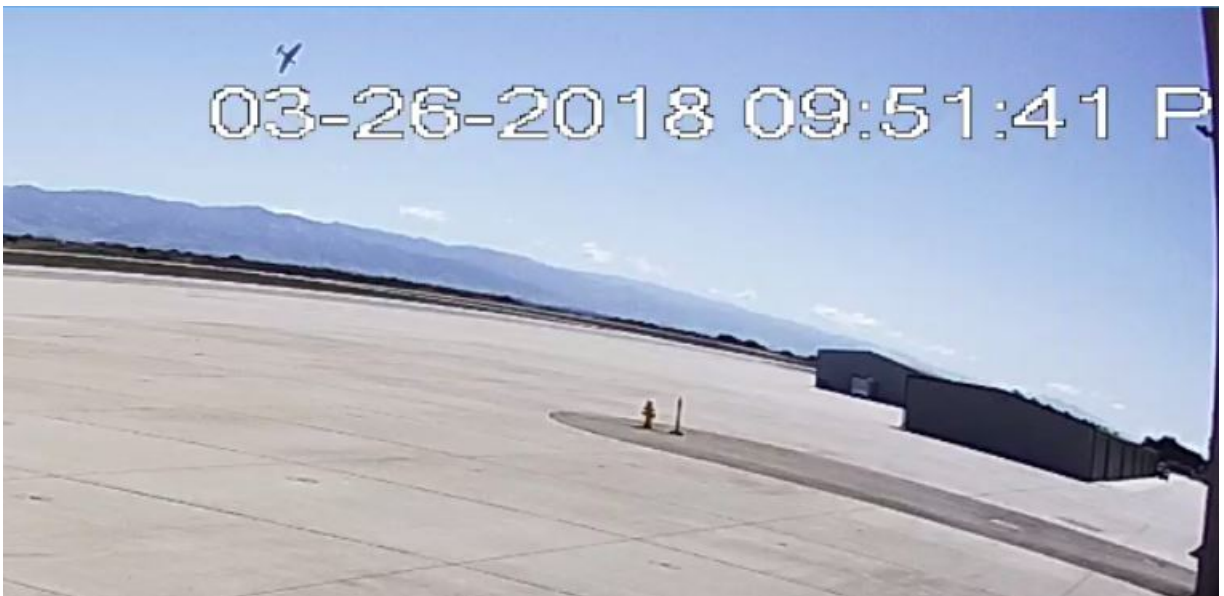
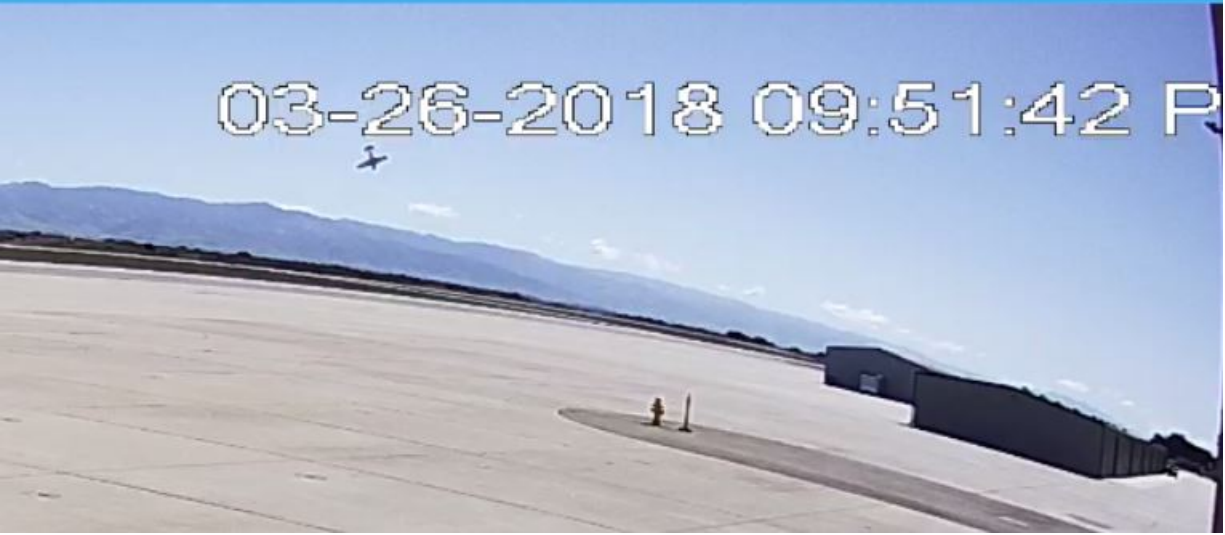
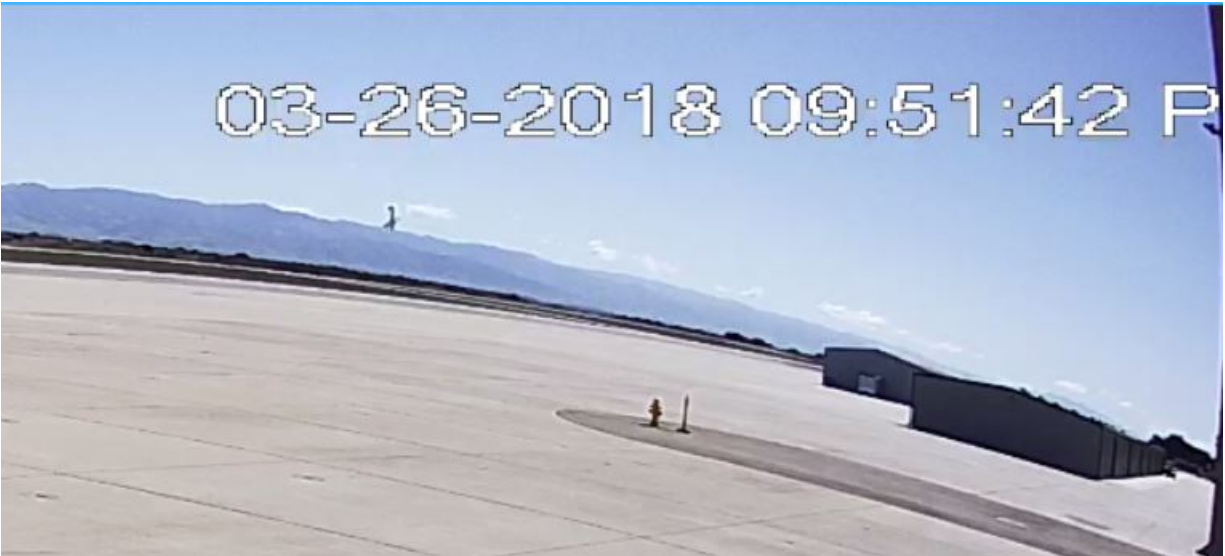
- The airplane continued to yaw left, the pitch attitude continued to decrease, and the trajectory became increasingly steep
- By the time the airplane was about 3 airplane lengths above the ground, the nose down pitch attitude was nearly vertical, the top of the airplane was facing the runway 11 threshold, and the trajectory was near vertical

Figure 16 - Developed Spin

Figure 17 - Spin Continuation

Figure 18 - Spin Continuation

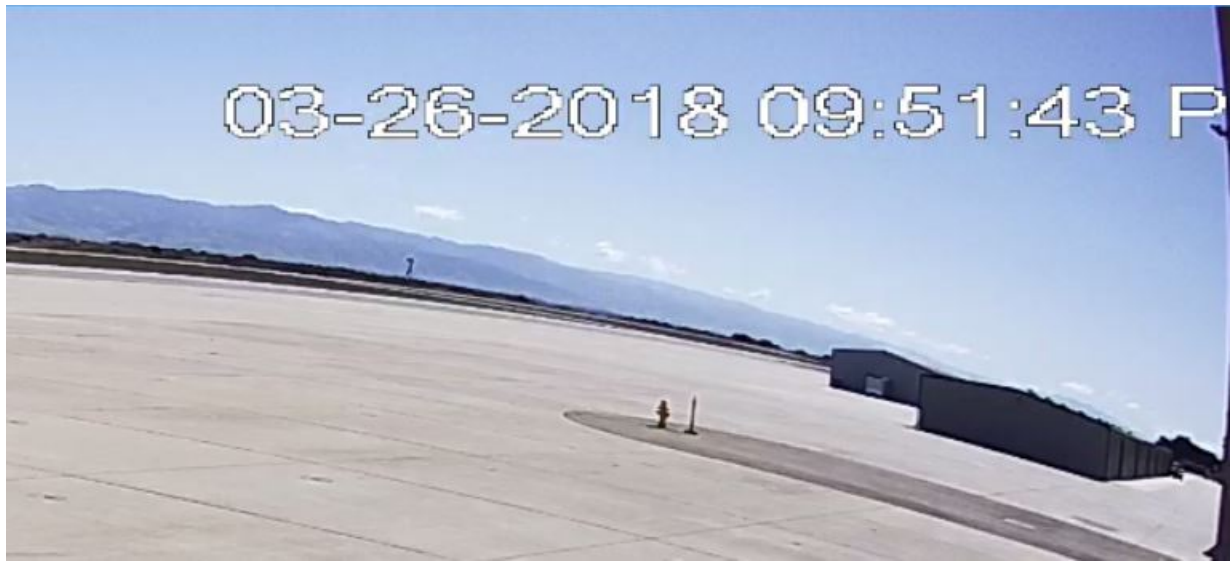
- The airplane struck the ground in a near-vertical nose down attitude, fell back onto its underside, and a fire began immediately
- The vertical distance from the top of the image frame to the impact point was about 10 airplane lengths, or about 230 feet.

Figure 19 - Just Prior to Impact

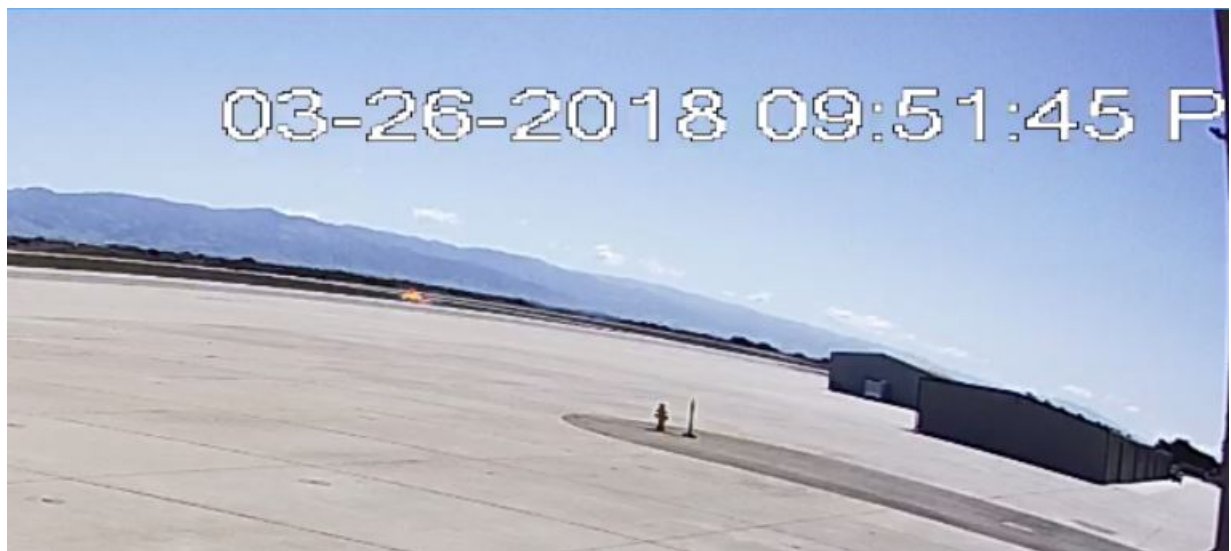
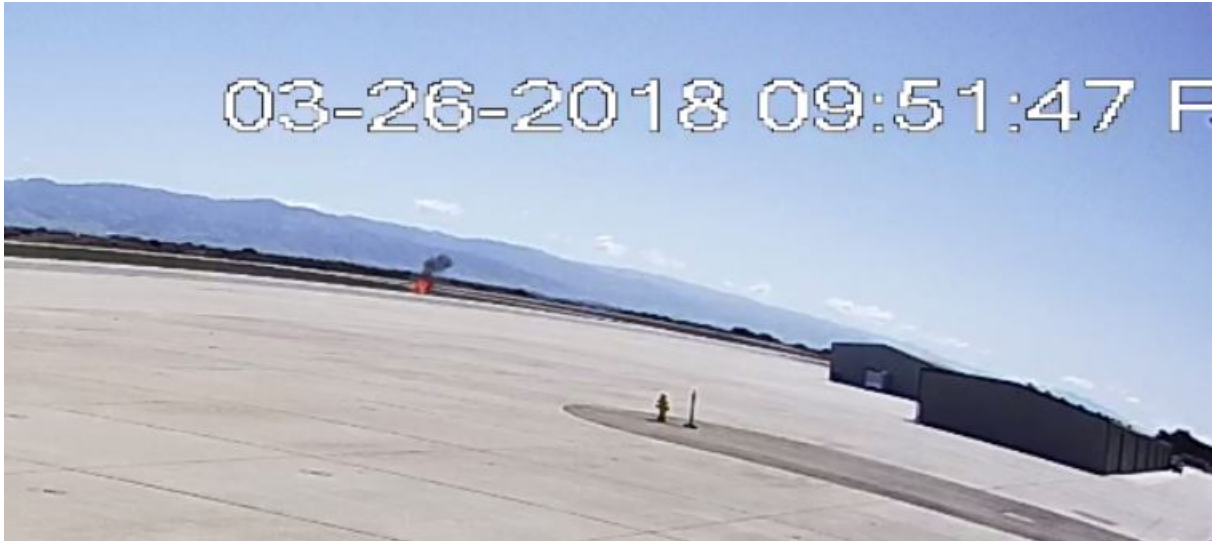
Figure 20 - Initial Fire

Figure 21 - Developing Fire

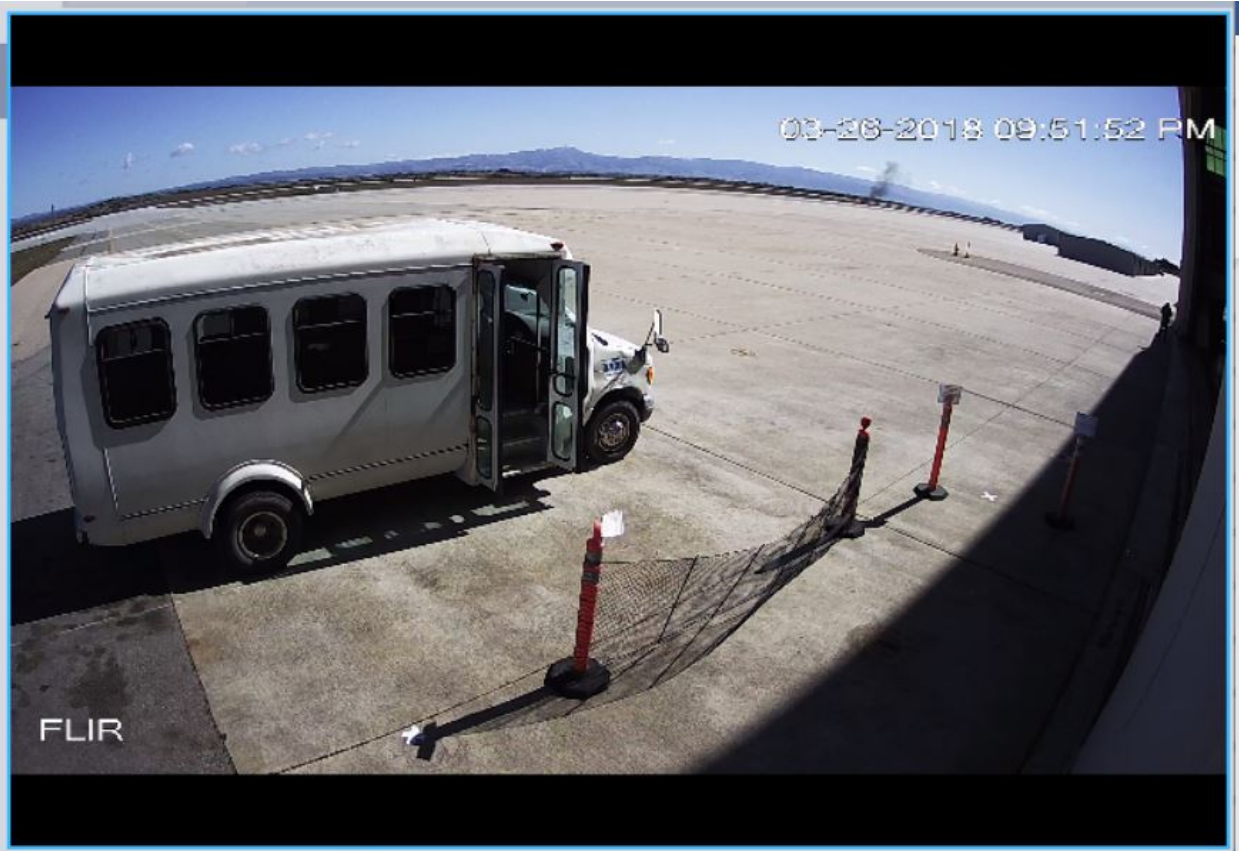
Figure 22 - Full Camera Field of View (including smoke)
